September 30, 2025

**Re: Arboricultural Consulting Services at Fifth Third Bank, 1820 S. Federal Highway, Delray Beach, FL**

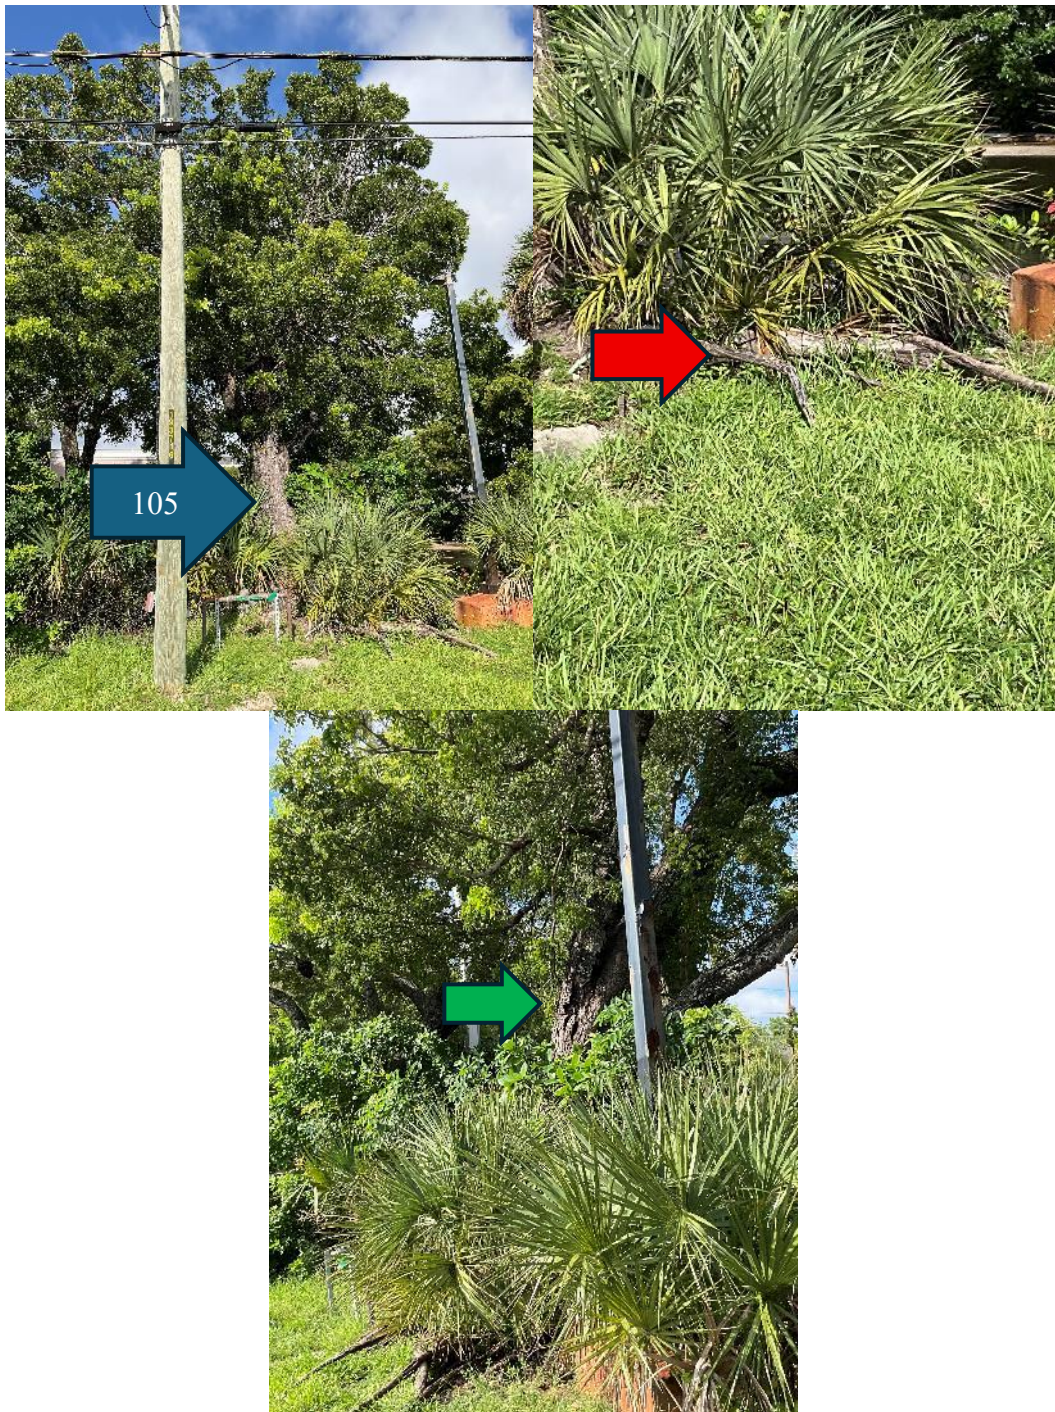
Tree 105

Mahogany (*Swietenia mahagoni*), facing south and west. Note poor structure, canopy crowding, confined root space, trunk lean, utility pruned, uplifted root zone (red arrow), unbalanced crown, and visual evidence of decay (green arrow).

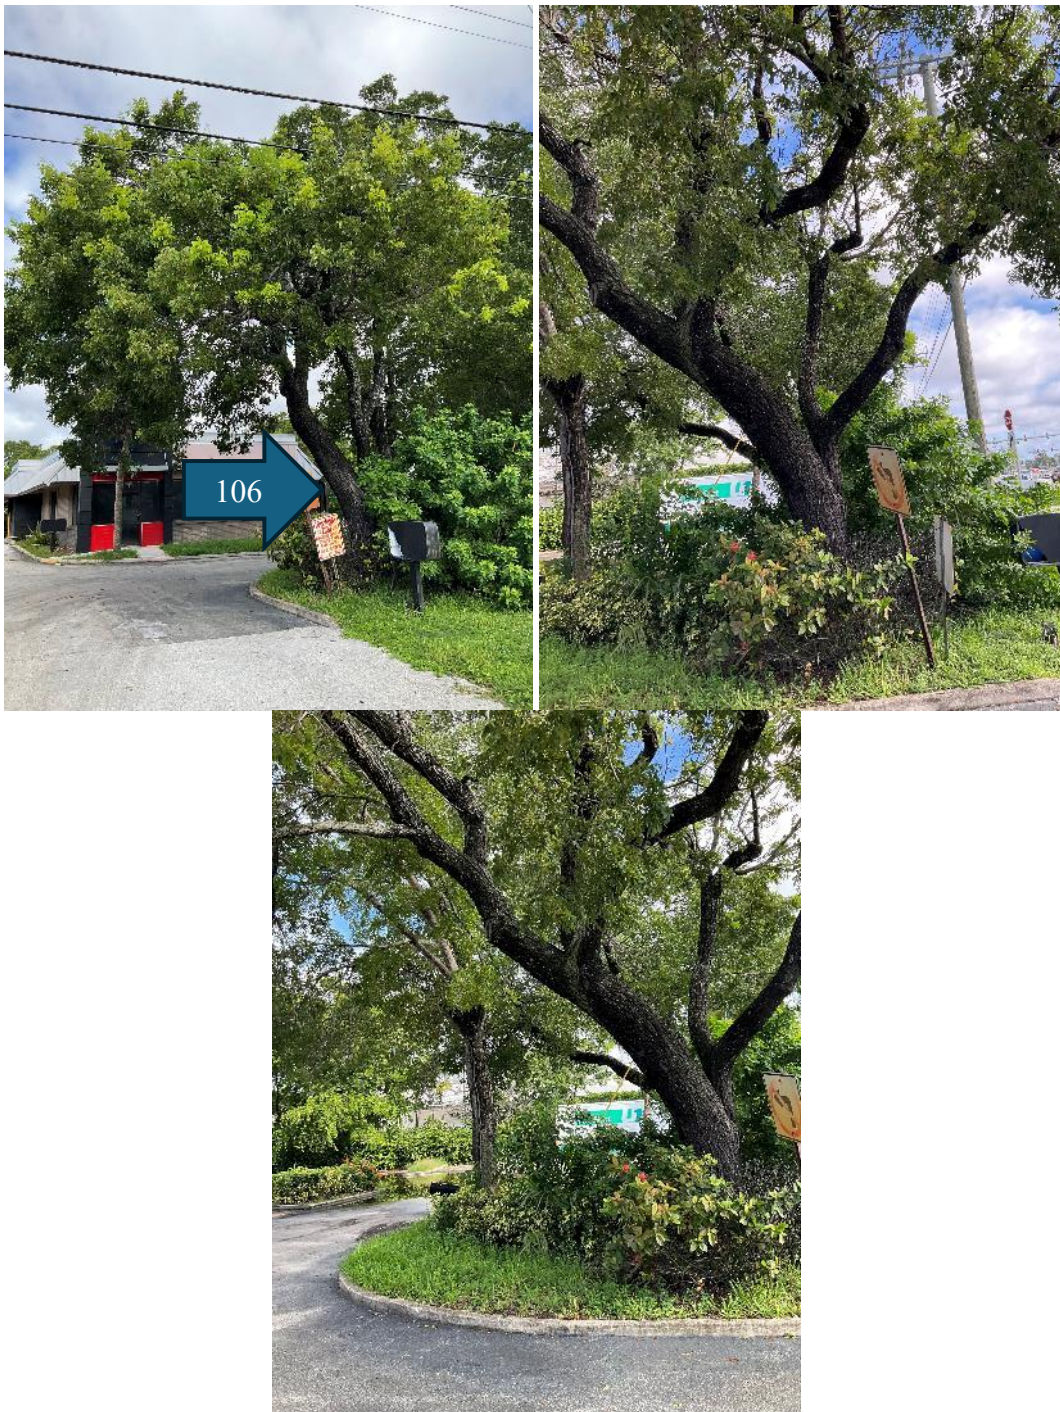
Tree 106

Mahogany (*Swietenia mahagoni*), facing west. Note poor structure, canopy crowding, confined root space, trunk lean, utility pruned, heading cuts, and canopy dieback.

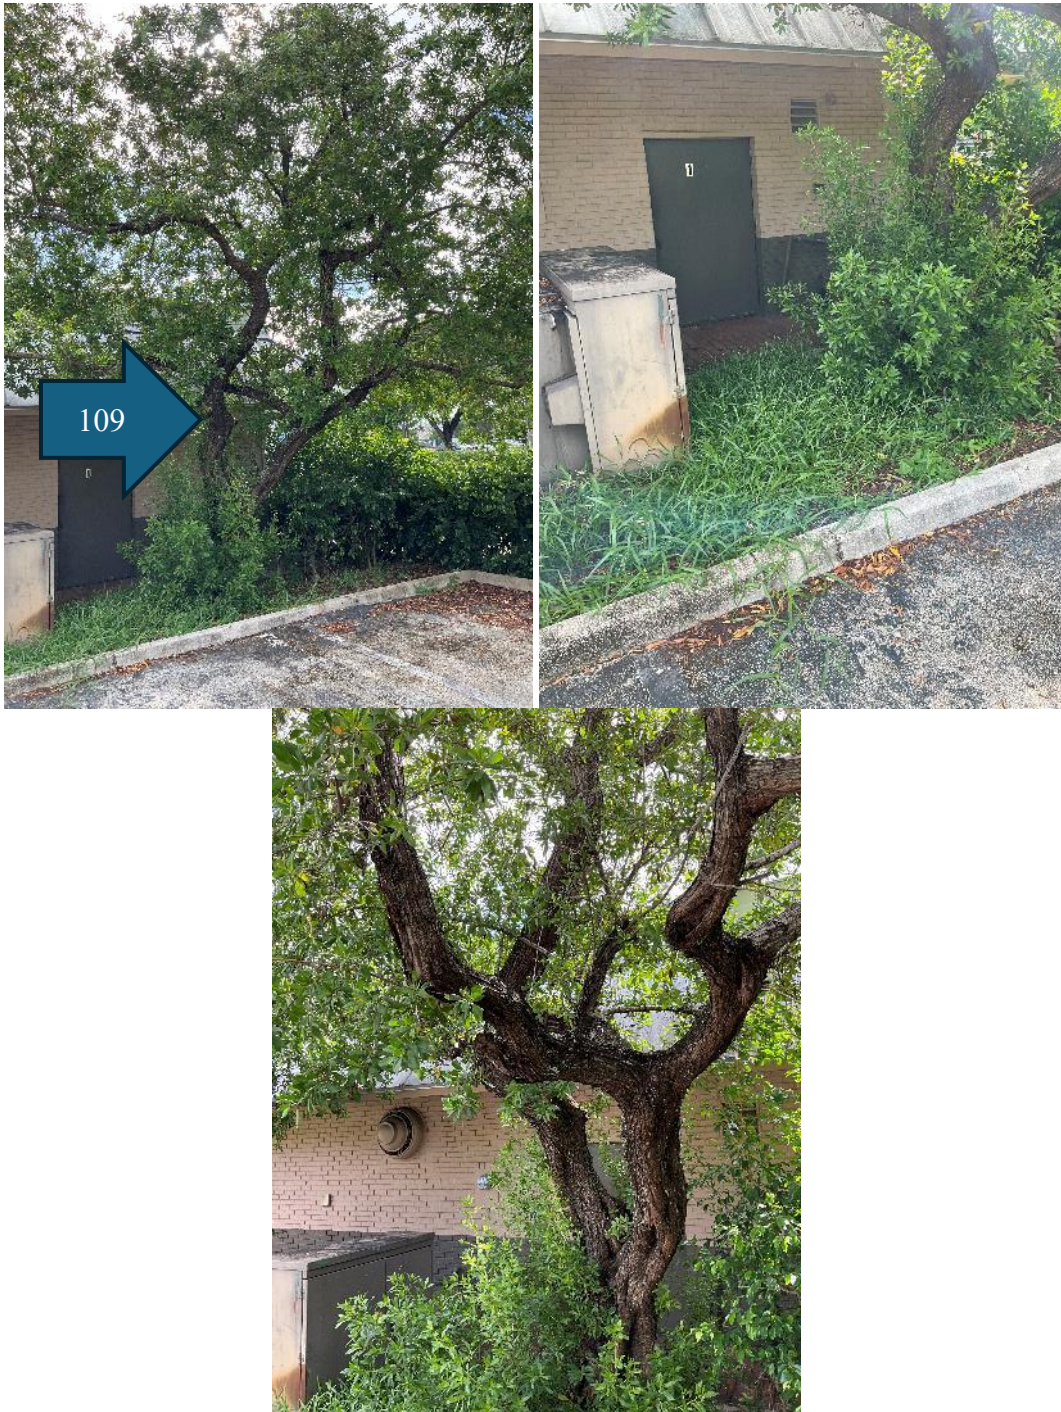
Tree 109

Green Buttonwood (*Conocarpus erectus*), facing east. Note poor structure, confined root space, heading cuts, and adjacent to underground utilities.

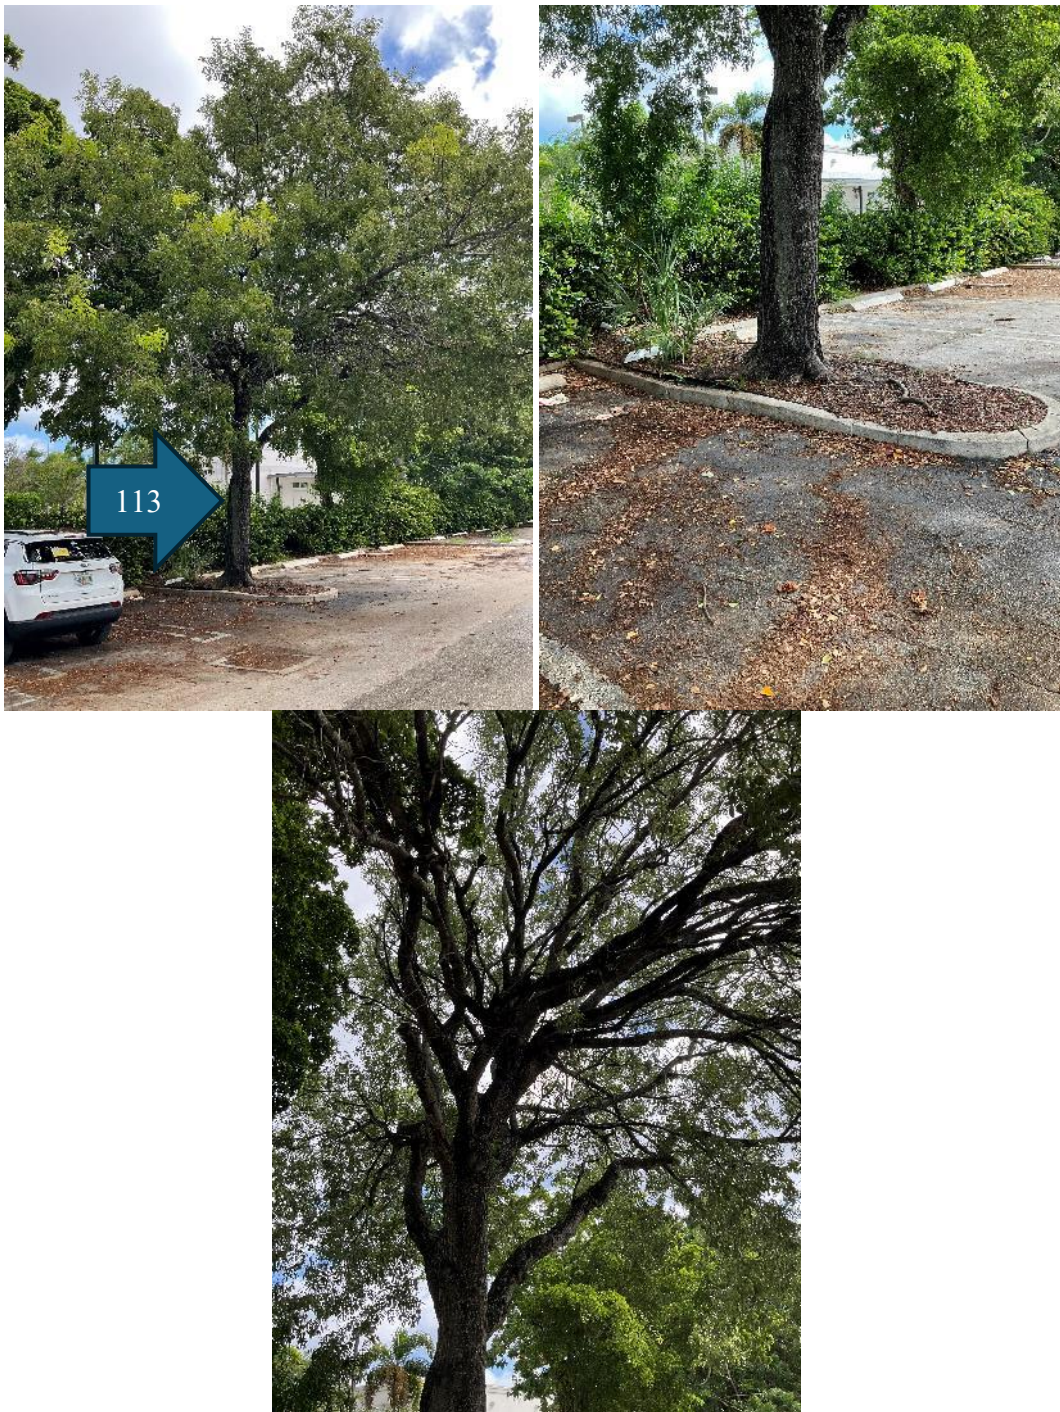
**Tree 113**

Mahogany (*Swietenia mahagoni*), facing north. Note poor structure, canopy dieback, deadwood, confined root space, and canopy crowding.

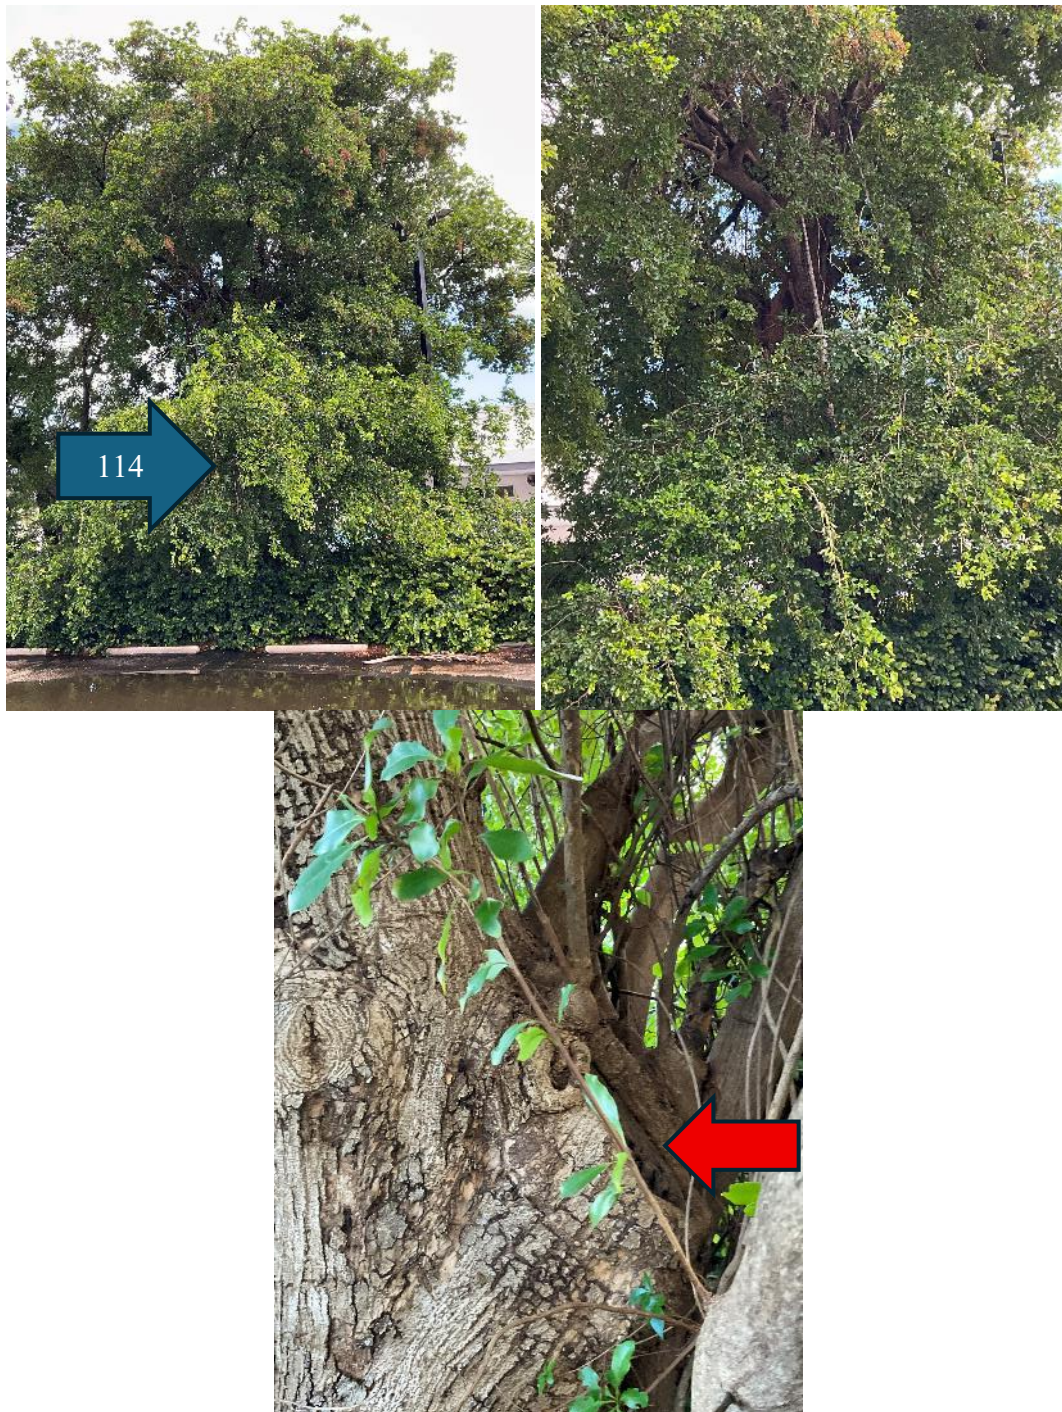
**Tree 114**

Black Olive (*Bucida buceras*), facing north. Note poor structure, canopy crowding, confined root space, flush cuts, and visual evidence of decay (red arrow).

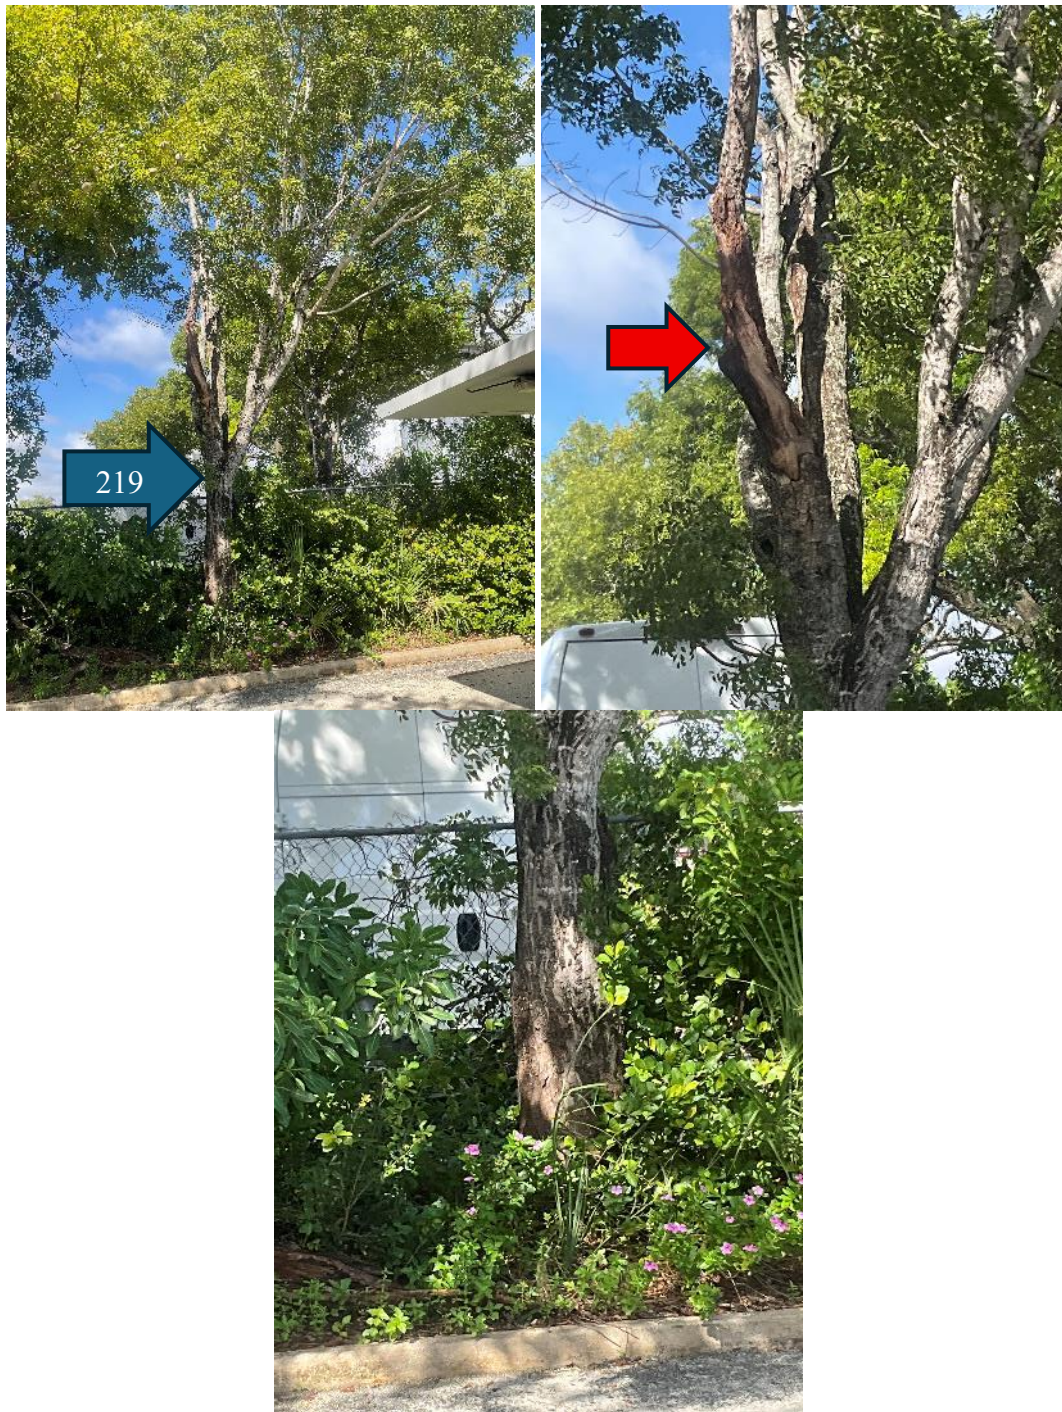
Tree 219

Mahogany (*Swietenia mahagoni*), facing west. Note poor structure, canopy crowding, canopy dieback, deadwood (red arrow), and visual evidence of decay.

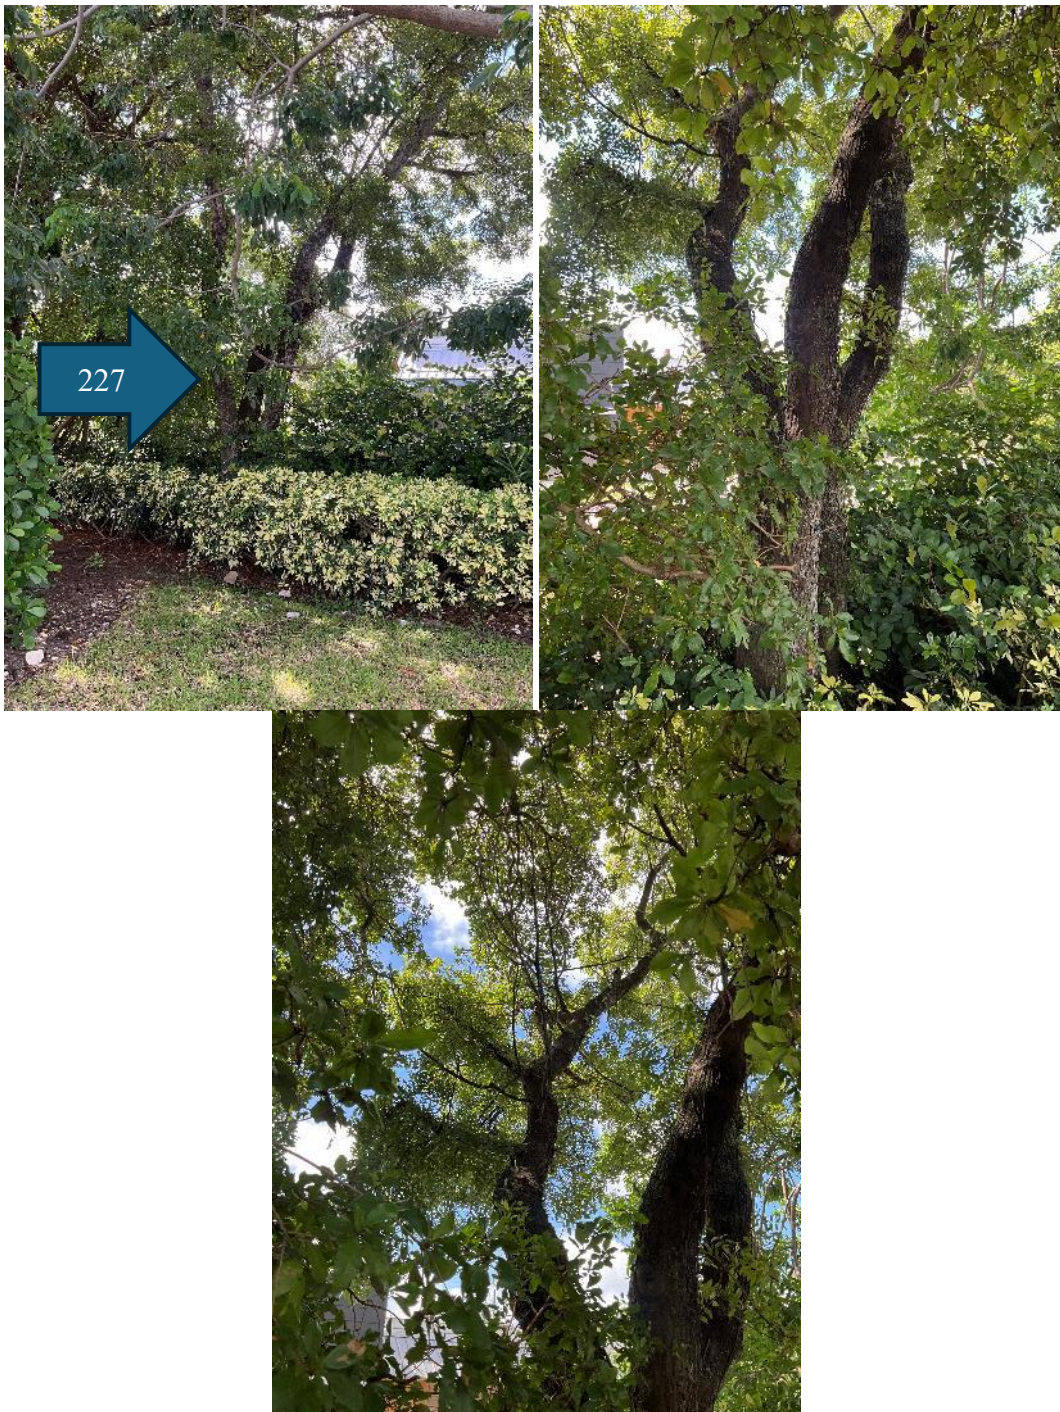
Tree 227

Mahogany (*Swietenia mahagoni*), facing south. Note poor structure, canopy crowding, canopy dieback, confined root space, and unbalanced crown.
