# CITY OF DELRAY BEACH

**SUBJECT:** Recommendation for Repair of Roof and Building Exterior of City Hall and the Community Center

## City Hall & Community Center Inspection

Prepared By  
Robert Moses

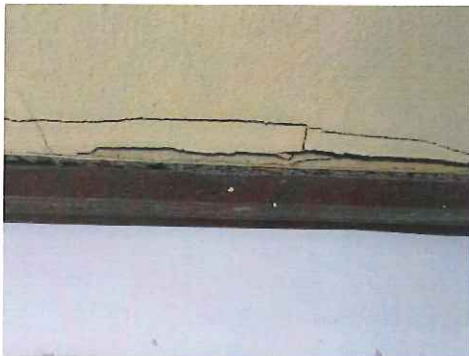
**Photo 2**

Exterior cracks under the window frame.

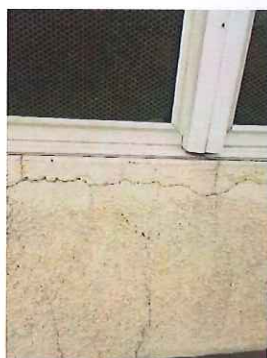
**Photo 26**

Coating failure.

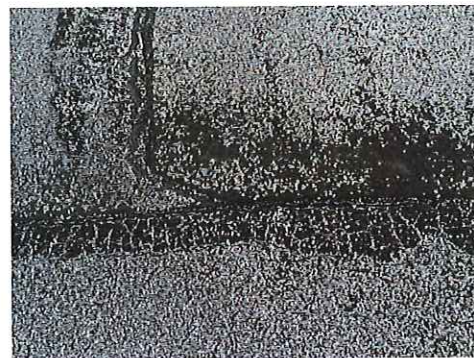
**Photo 11**

Failed seam. Insufficient bleed out.

Action Year:	2016
Square Footage:	1,027	Expected Life Years:	25
Budget Range:	\$15,405.00 - \$19,513.00		
Complete replacement is necessary. The roof will need to be removed down the to the deck and replaced. Estimated budget is \$15-\$19sqft. This variation depends on on the system design of 20-30yr warranty.

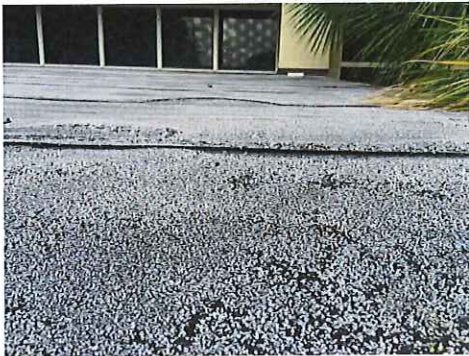
**Photo 18**

**Pitch Pocket Deterioration:** Metal protrusions that penetrate the roof system to allow conduits to run from the rooftop into the building. Movement from the protrusion can break the waterproofing compound, creating cracks. Over time, the release of solvents from the compound can cause the material to shrink, leaving gaps along the edges of the pan and around structural support. Water can enter through a defective pitch pan and find its way into the interior of the building. Moisture can also penetrate into the roof system leading to premature failure.

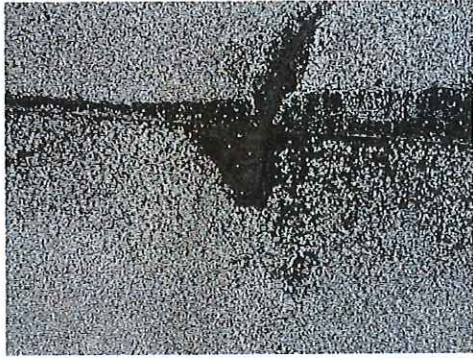
**Photo 24**

**Blisters:** Soft spongy pockets or swellings in the roofing material. They occur between layers of felt or between the roof membrane and substrate. Air or moisture vapor entrapped within a blister expands as the roof and outside air temperatures rise. This results in sufficient pressure to push the roofing felts upwards and apart. Blisters may be ruptured by roof traffic, expanding frozen water, or hail (especially during colder weather). Some blisters may become so large as to affect drainage, which may then cause ponding water. Laps could also be pulled apart, resulting in leakage. A ruptured blister will immediately allow water to penetrate and damage the roof system.

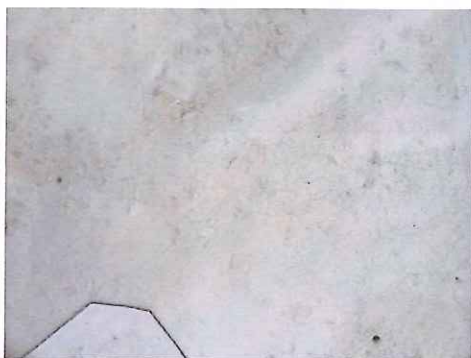
**Photo 8**

Membrane failure. The membrane has reached its life expectancy and has split wide open allowing water to penetrate the interior roofing structure and roof deck.

The single ply roof system has failed. The membrane has surpassed its life expectancy and is failing along all the seams and in the field. An immediate replacement is needed. Estimated budget is \$15-\$19/sqft. This variation depends on the system design of 20-30yr warranty.

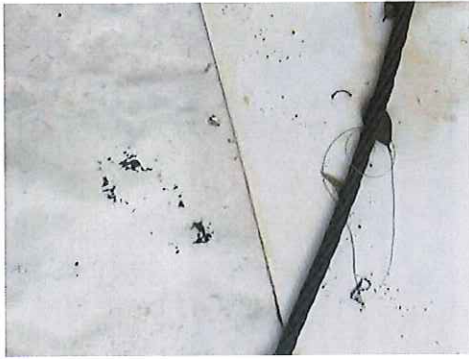
**Photo 10**

Membrane failure.

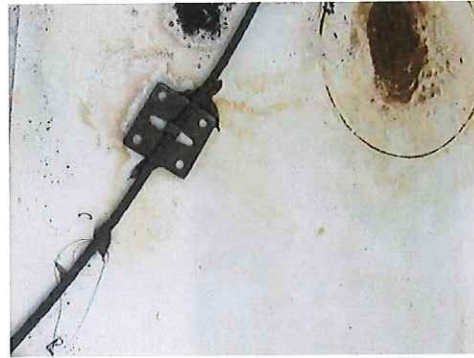
**Photo 11**

Membrane failure.

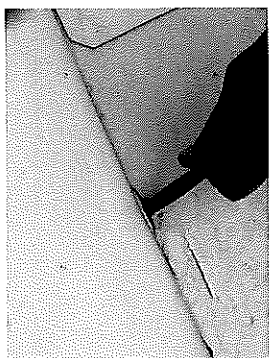
**Photo 22**

Membrane failure.

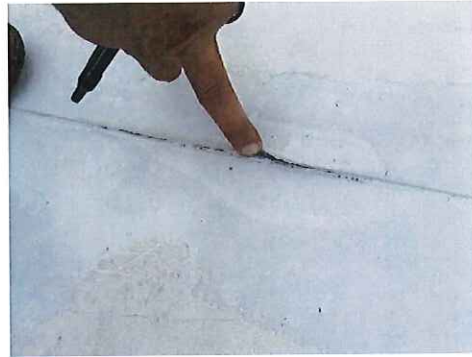
**Photo 55**

Single ply seam deterioration.

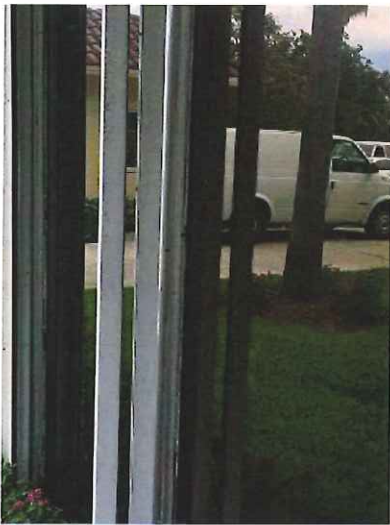
**Photo 2**

Window sealant failure.

Immediate re-coating of the building exterior is needed. Stucco, concrete and wood repairs are needed. Window replacement, window sealant, door frame sealant, floor joints are all needed.

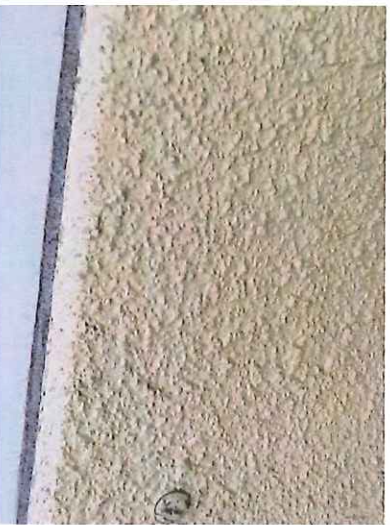
**Photo 4**

Concrete damage.

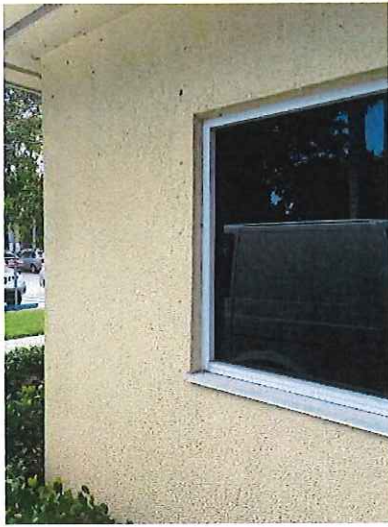
**Photo 5**

Sealant failure.

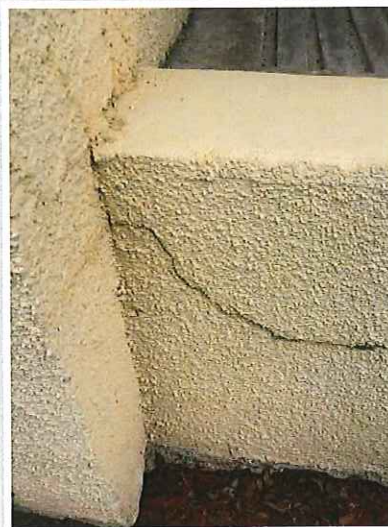
**Photo 7**

Missing joint sealant.

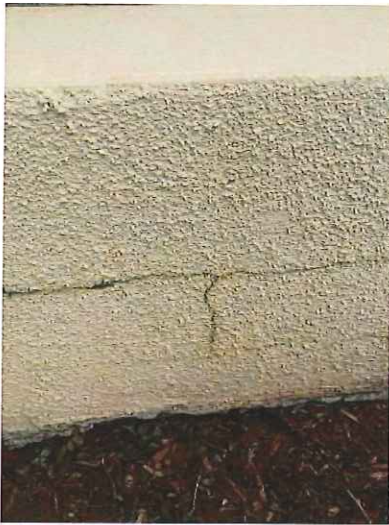
**Photo 8**

Cracks in the stucco walls.

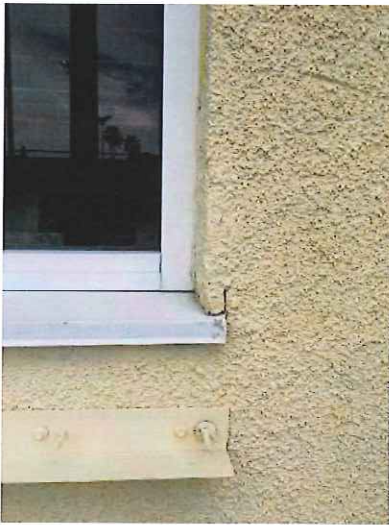
**Photo 9**

Crack in the stucco walls.

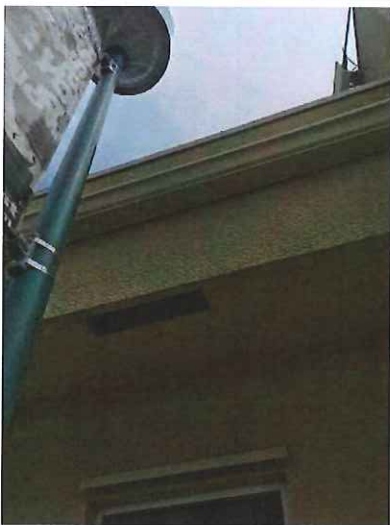
**Photo 10**

Crack in the stucco walls.

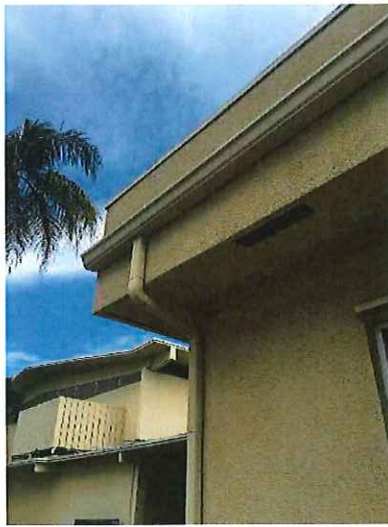
**Photo 12**

Crack in the stucco walls.

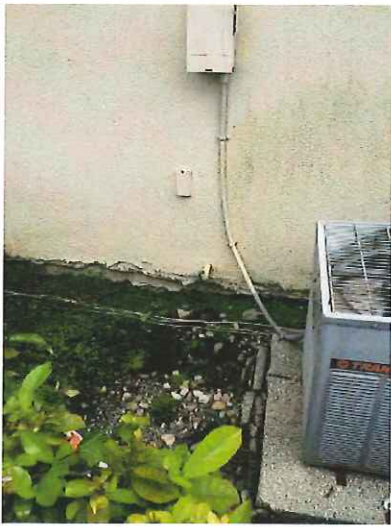
**Photo 15**

Stucco damage.

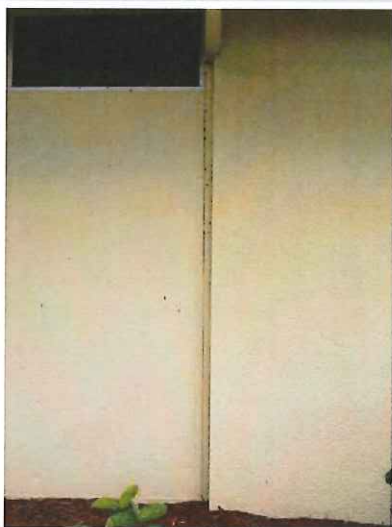
**Photo 16**

Concrete and stucco damage along the perimeter.

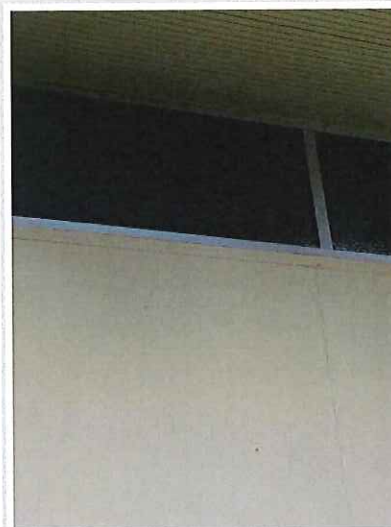
**Photo 19**

Broken glass.

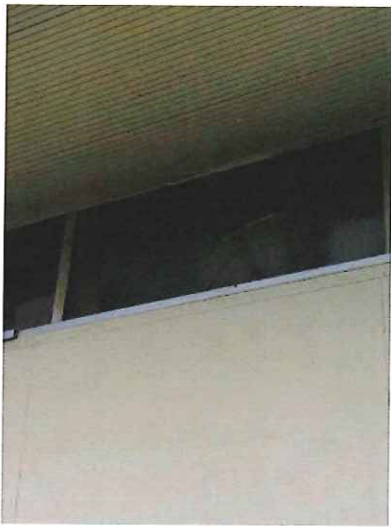
**Photo 20**

Cracks in the stucco.

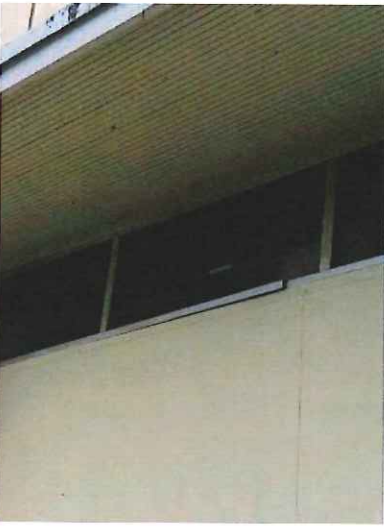
**Photo 21**

Broken glass.

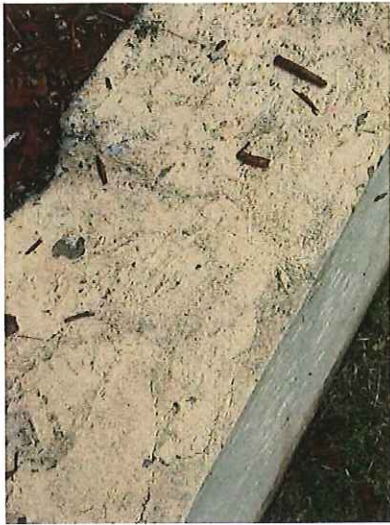
**Photo 23**

Concrete deterioration.

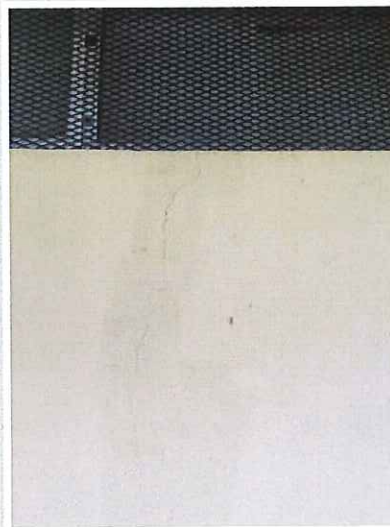
**Photo 25**

Truss and soffit damage.

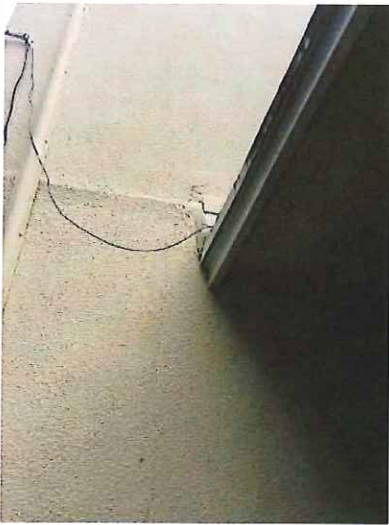
**Photo 26**

Vertical wall cracks.

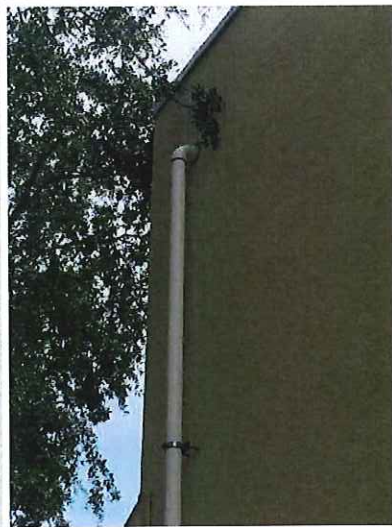
**Photo 30**

Vertical wall repairs made previously.

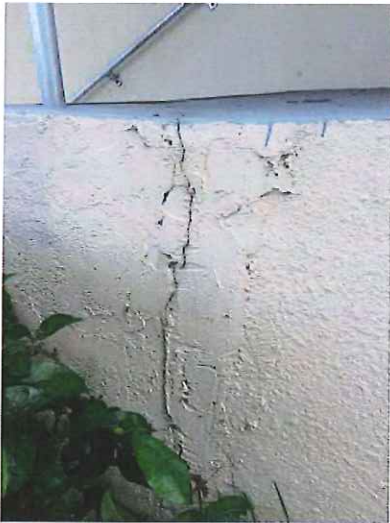
**Photo 38**

Vertical wall crack.

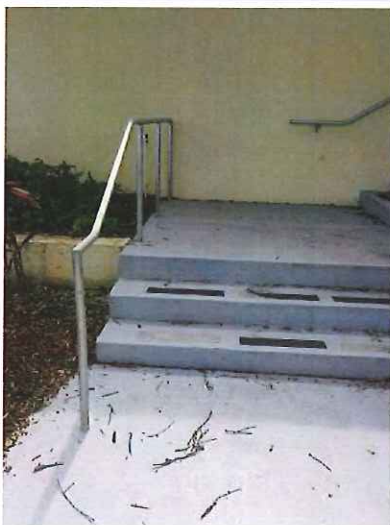
**Photo 40**

Vertical wall crack and field crack on concrete slab.

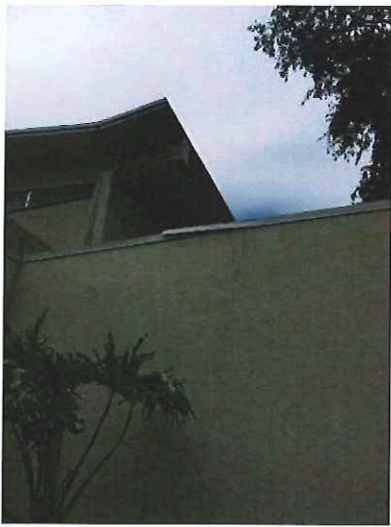
**Photo 44**

Soffit deterioration.

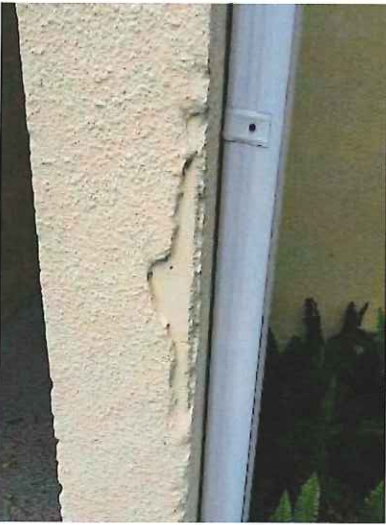
**Photo 45**

Drip edge damage and vertical wall crack.

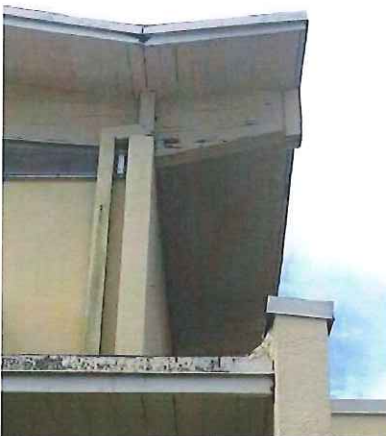
**Photo 46**

Previous damage to wall not properly fixed.

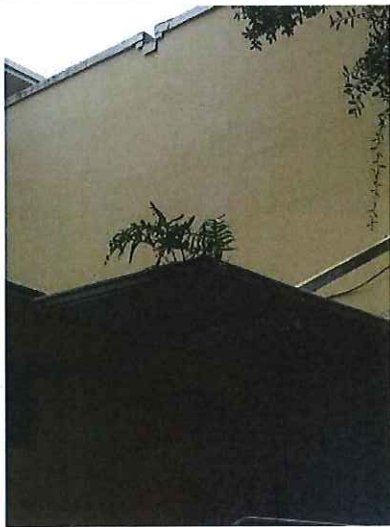
**Photo 47**

Soffit and truss damage.

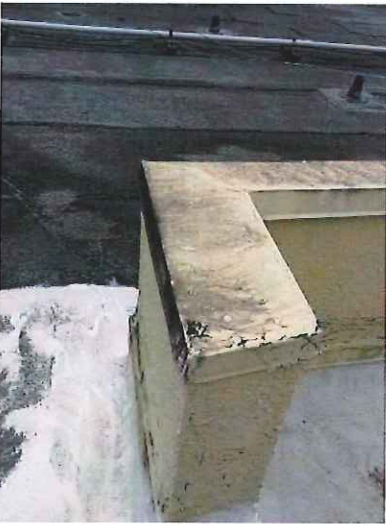
**Photo 51**

Vertical wall cracks and stucco damage.

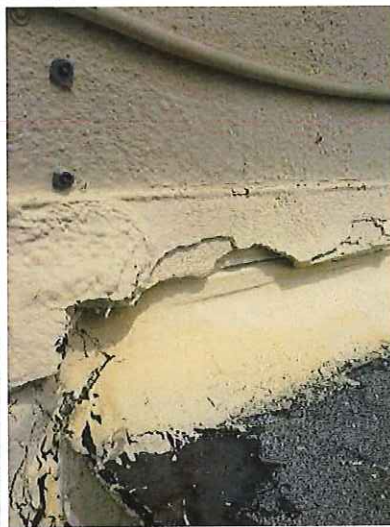
**Photo 54**

Cracks along the stucco stop.

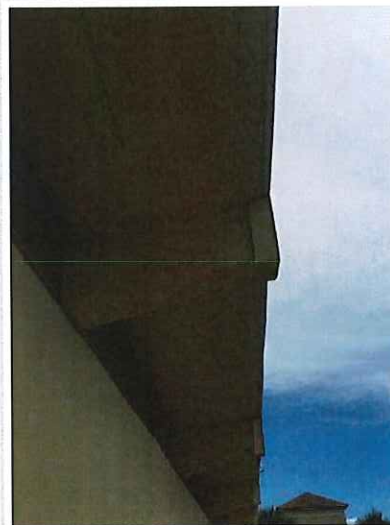
**Photo 55**

Improper stucco installation.

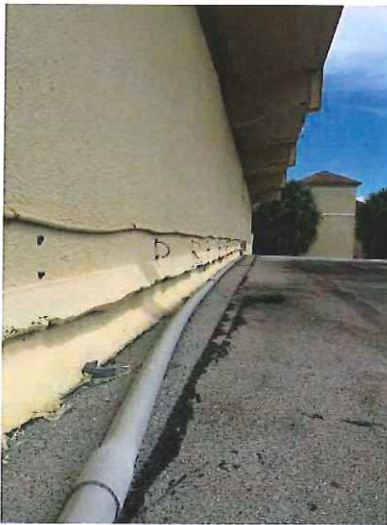
**Photo 56**

Soffit damage.

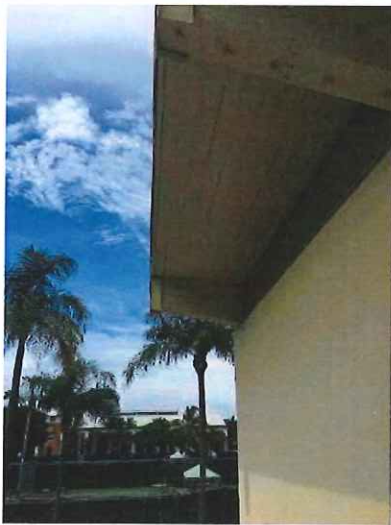
**Photo 57**

Improper detail.

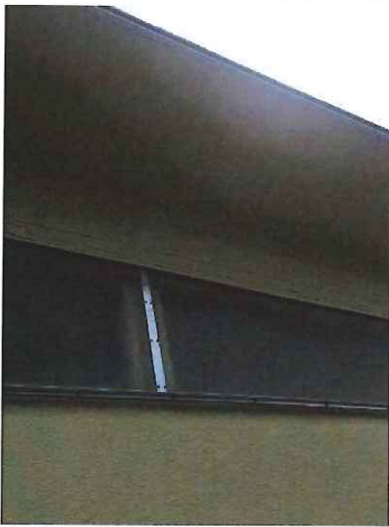
**Photo 62**

Wood damage.

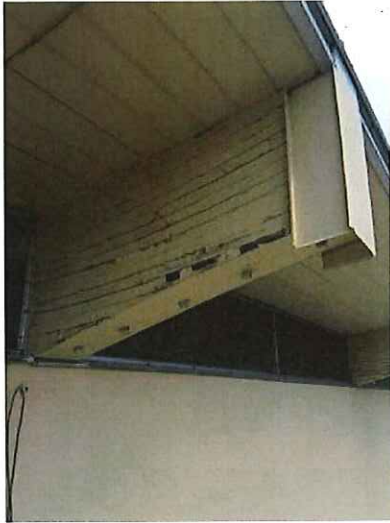
**Photo 65**

Wood fascia damage.

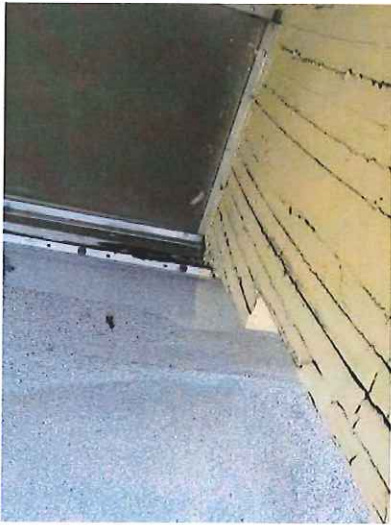
**Photo 69**

Improper wood sealant.

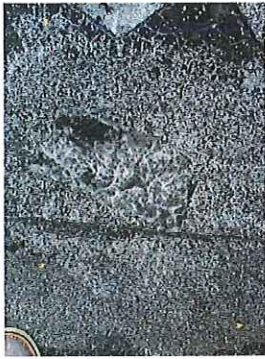
**Photo 2**

Bad detail, failing cap sheet.

Full roof replacement of all roof sections. New coping cap, metal edge, soffit and fascia replacement where needed. Remove all non essential roof top vents, units, stands etc. Properly fasten all roof top wires, cables, condensation lines etc. per code.

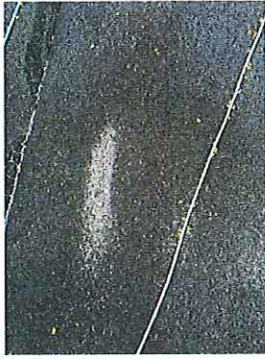
**Photo 8**

Failing seams.

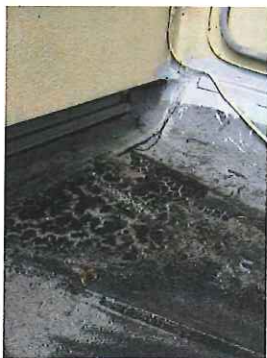
**Photo 20**

Granule loss.

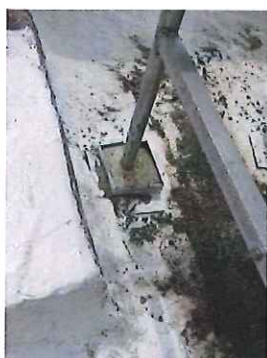
**Photo 24**

Improper pitch pockets, not sealed.

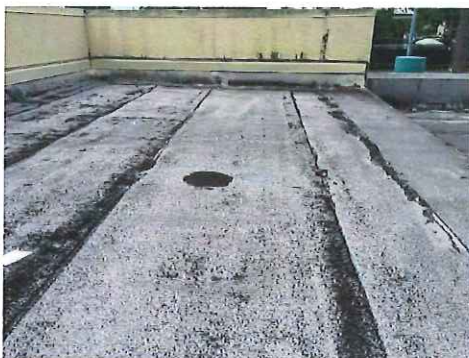
**Photo 40**

**Bare or Exposed Felts:** Weathering causes the roofs surfacing materials to oxidize and wear away after a period of time. Loss of protection from the surfacing material results in accelerated deterioration of the primary waterpoofer asphalt, along with the systems reinforcement plies which provide the strength for the system. Heat and UV rays dry out unprotected asphalt which then leave the bare reinforcement plies exposed to the elements. The exposed reinforcement will begin to absorb and wick moisture into the built up layers of the roof system. This condition leads to accelerated damage via blisters and interlayer delamination. Roof system damage occurs when these weakened areas of the roof system are affected by thermal shock, typical roof traffic and normal seasonal conditions.
