# Kimley»Horn

**RE: *Delray Beach DDA Christmas Tree Evaluation***

# Delray Beach DDA Christmas Tree Frame

## Photograph Sheet

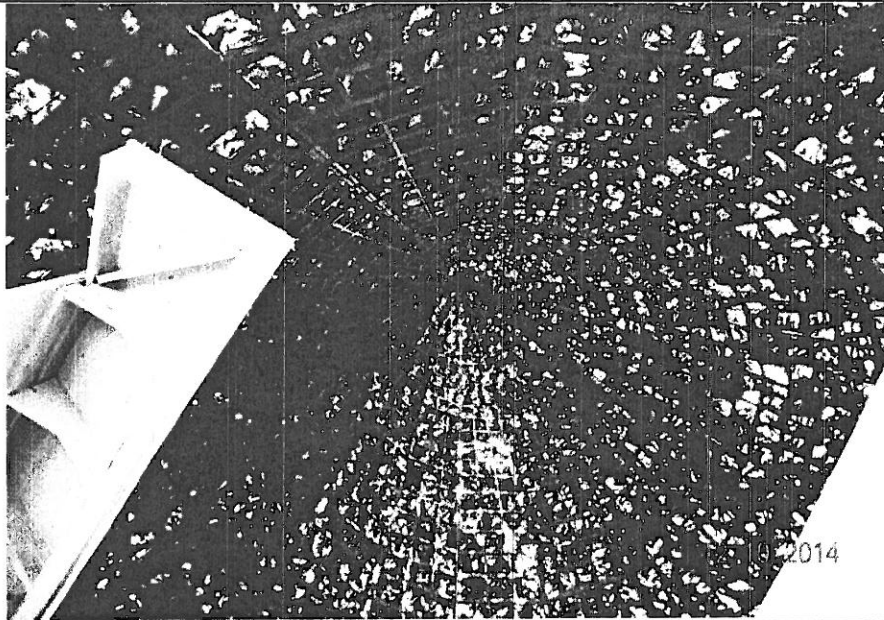
Photo No. 1

Remarks: View of tree frame from within while in place for display.

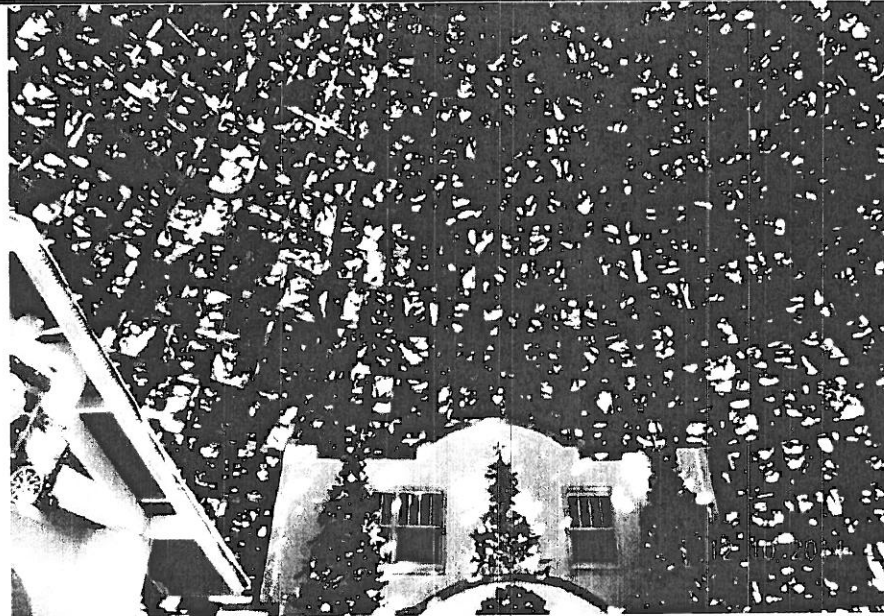
Photo No. 2

Remarks: Closer view of tree frame from within while in place for display. Note frames tapering with tree height.

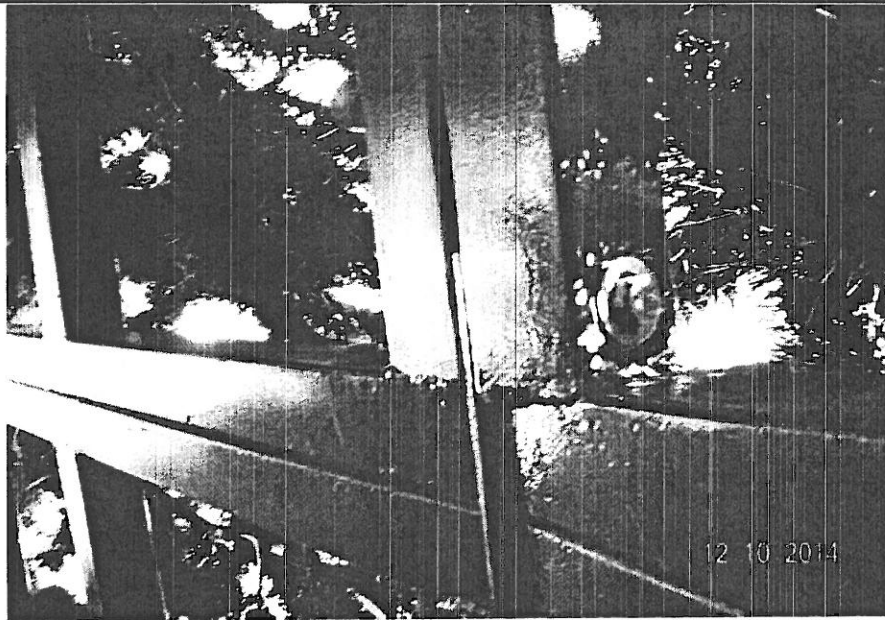
Photo No. 3

Remarks: Close-up view of tree frame connection from within while in place for display.

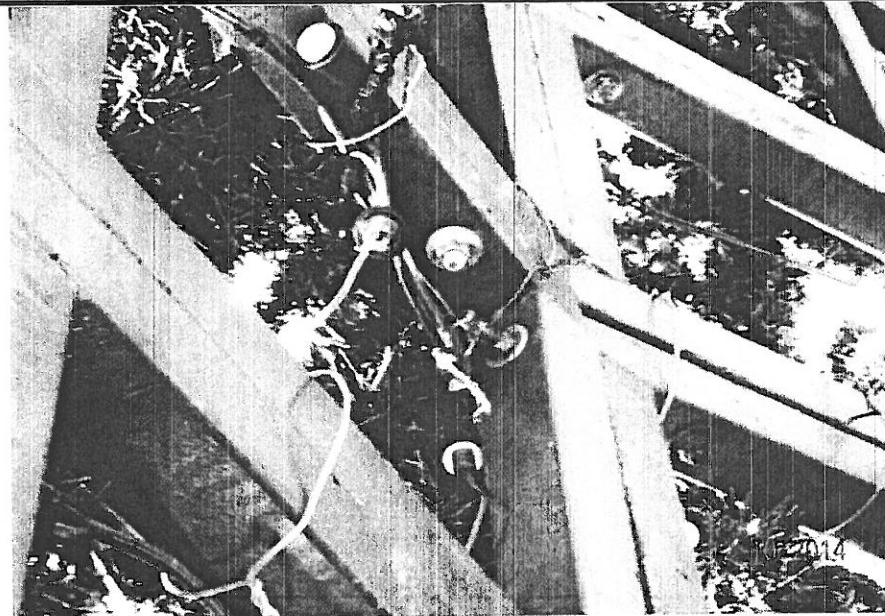
Photo No. 4

Remarks: Close-up view of attachment of tree greenery and lighting from within while in place for display.  
Note corrosion of bolted connections.

1. Drill drain holes in the closed vertical leg sections of the frames to prevent trapping water.
2. Replace all fastener components (bolts, washers and nuts) with non-corrosive galvanized or stainless steel assemblies.

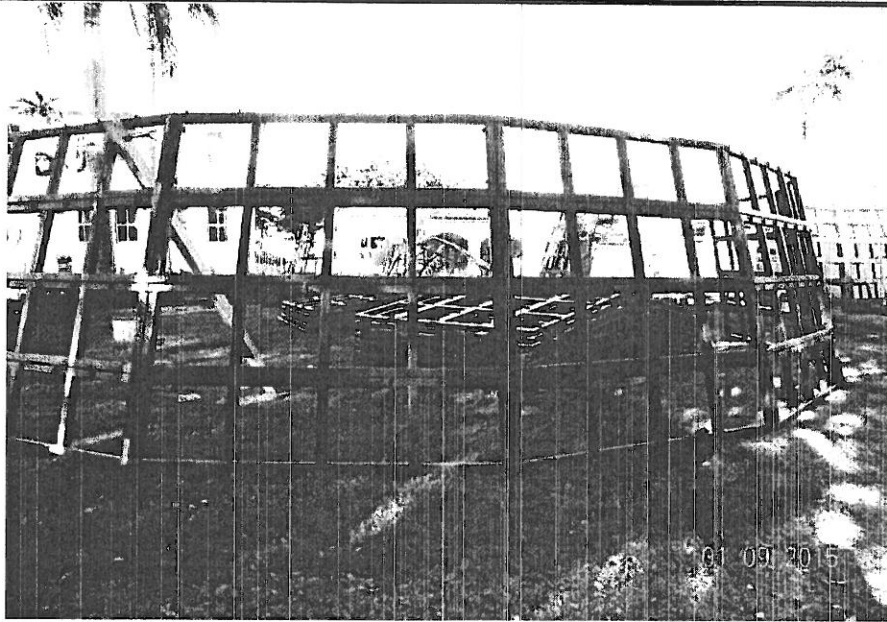
Photo No. 5

Remarks: View of tree section on site during removal. This section was reportedly recently refurbished.

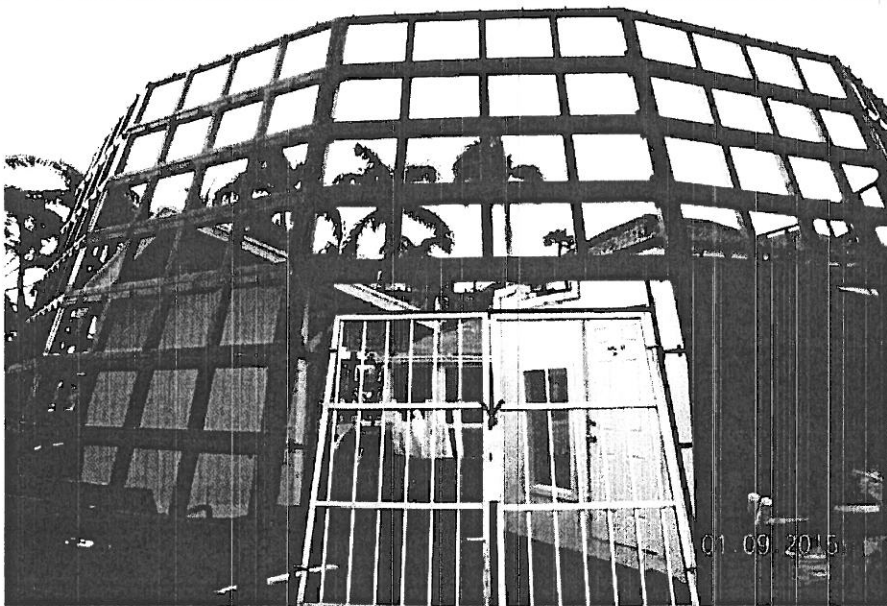
Photo No. 6

Remarks: View of lowest tree section on site during removal. This section was reportedly recently refurbished.

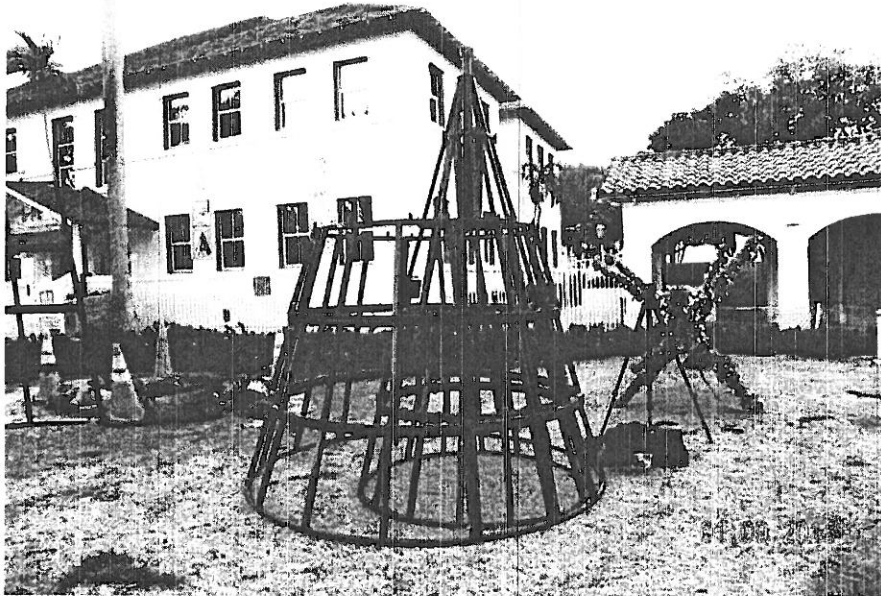
Photo No. 7

Remarks: View of upper portion of top tree section on site during removal. This section was recently refurbished.

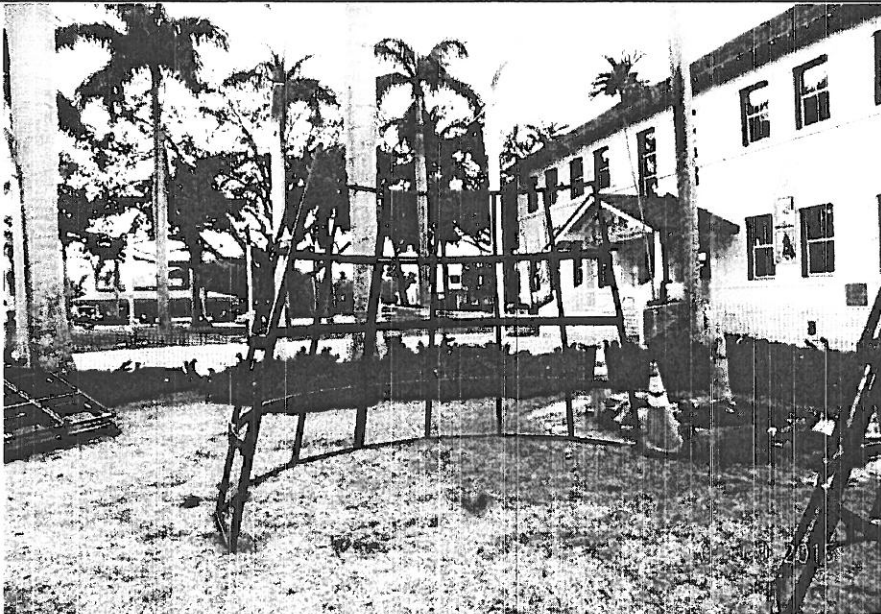
Photo No. 8

Remarks: View of lower portion of top tree section on site during removal. This section is in fairly good condition.

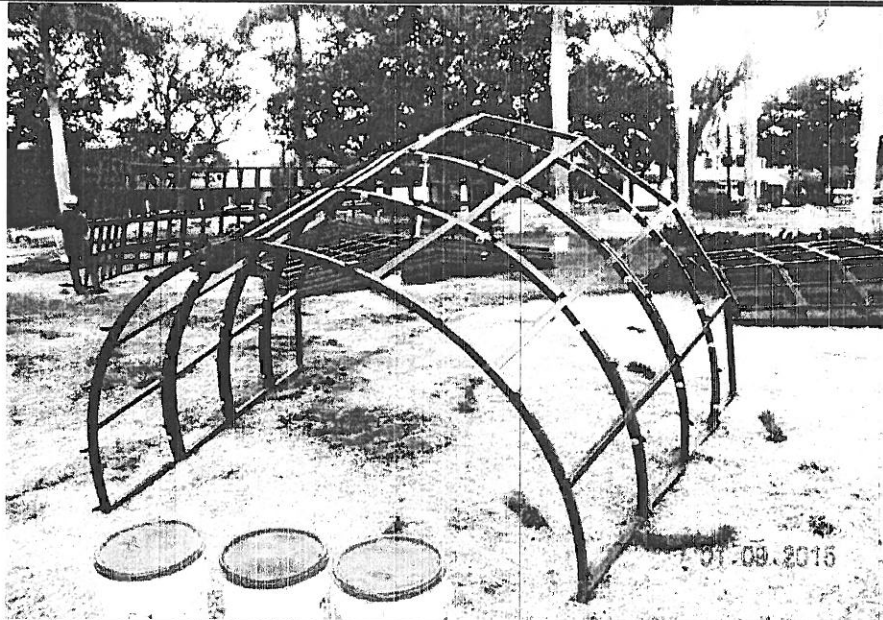
Photo No. 9

Remarks: View of portion of tree section near top on site during removal. This section is in fairly good condition.

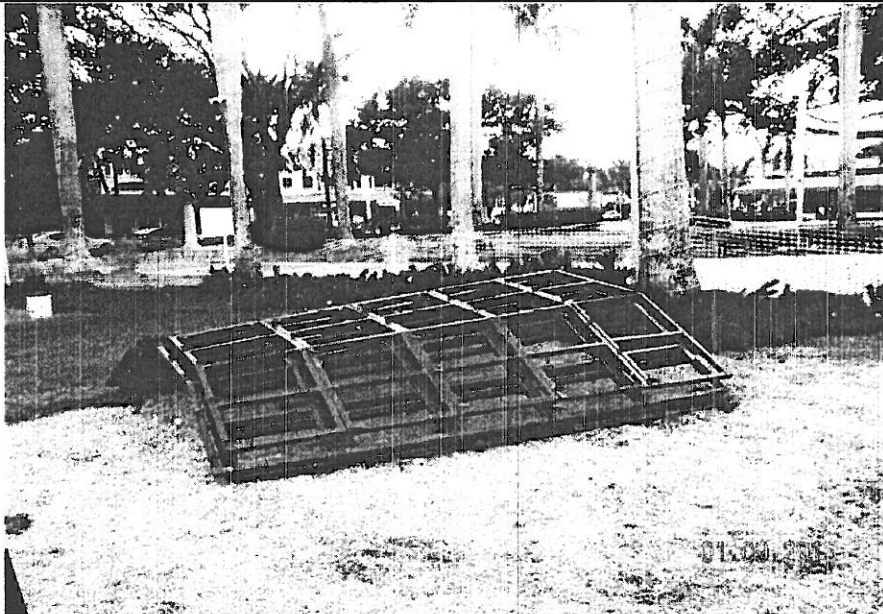
Photo No. 10

Remarks: View of stacked portion of tree section near top on site during removal.  
This section is in fairly good condition.

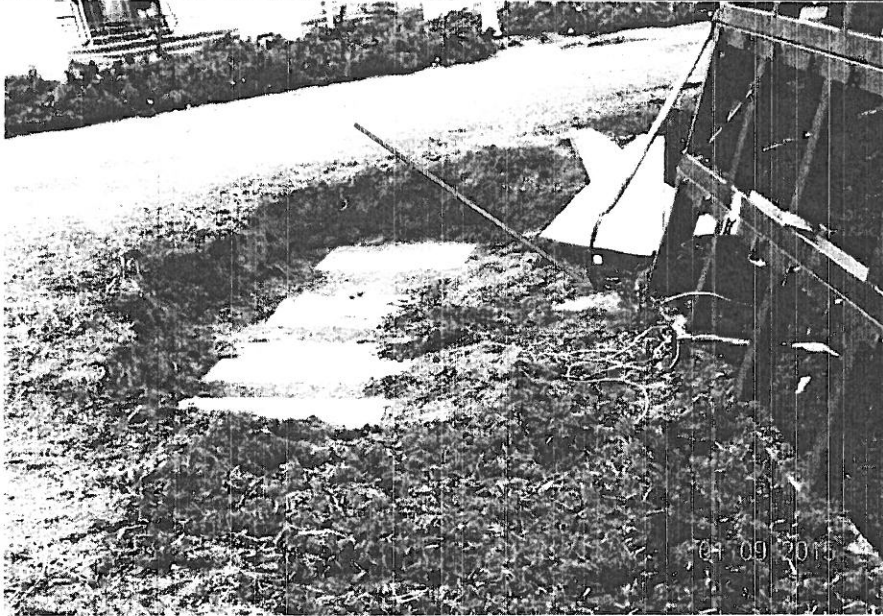
Photo No. 11

Remarks: View of concrete foundation ring below bottom section. Note foundation is sunken relative to grade.

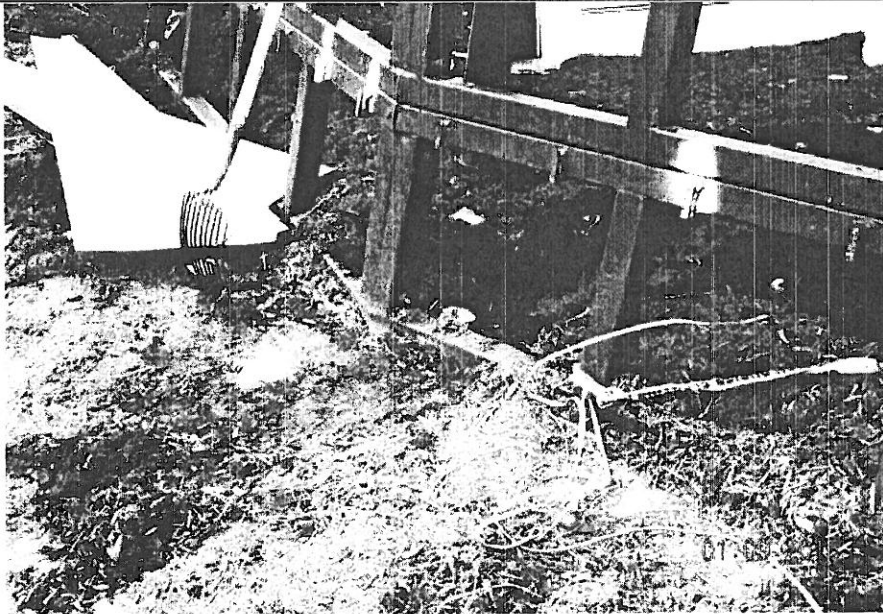
Photo No. 12

Remarks: Close up view of foundation area indicated by red arrow in Photo 11 above.

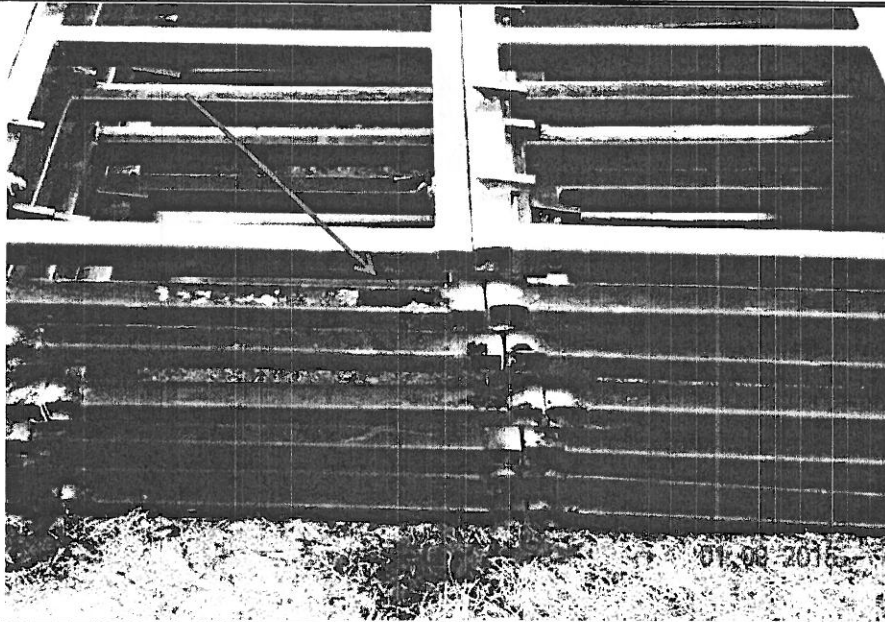
Photo No. 13

Remarks: View of end of frames stacked on site. Note corrosion near connections.

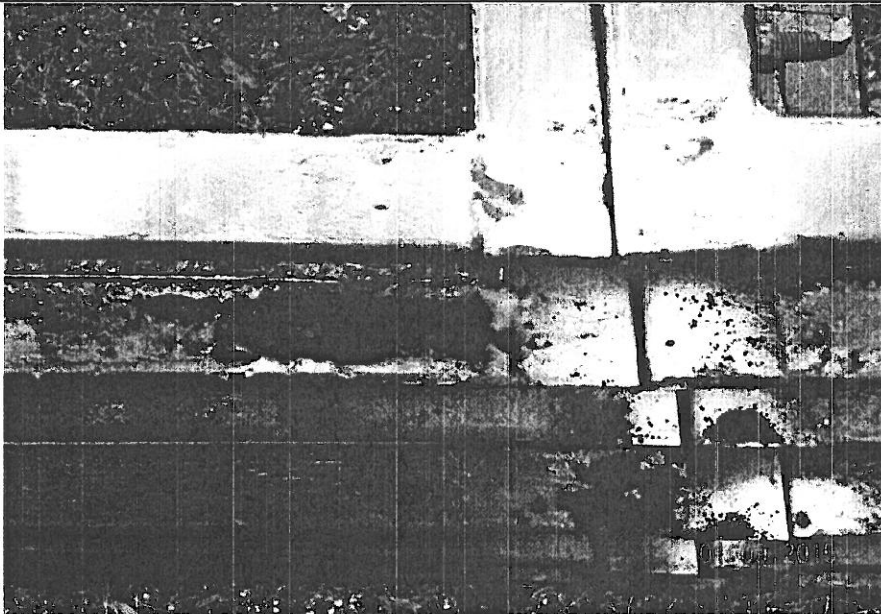
Photo No. 14

Remarks: Close-up view of corroded connection points indicated by red arrow in Photo 13 above.

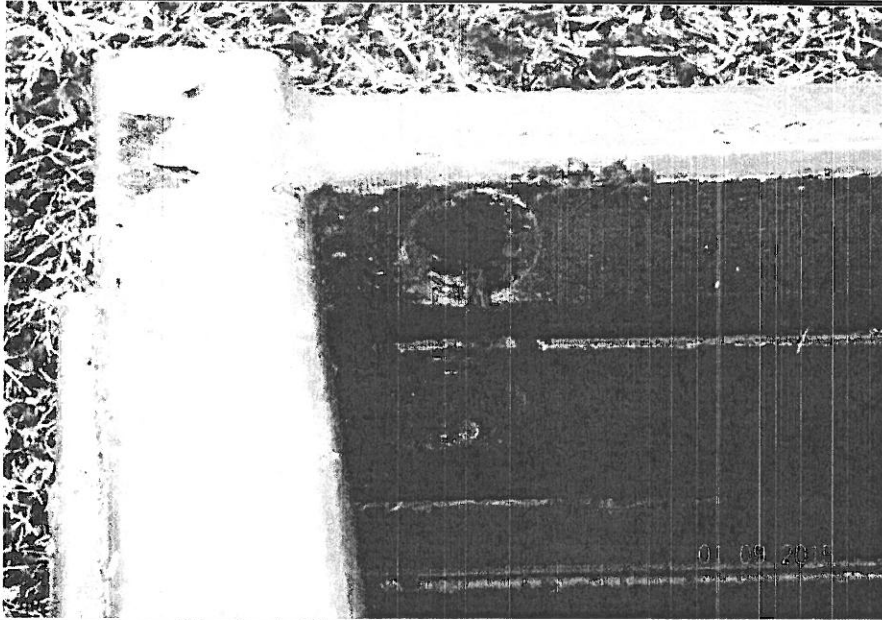
Photo No. 15

The orientation in which the frames are stacked (horizontally) allows rainwater to enter the bolt holes in the vertical legs, where it gets trapped because the vertical legs do not have drains. The only openings in the vertical legs are the bolt holes.

The primary cause of the deterioration of the frame is due to the existing frame configuration that does not allow for proper ventilation/drying of the interior of the tubular members. Water gets trapped inside the tubular members.

Remarks: Typical view of corrosion around bolt hole in vertical leg of frame.

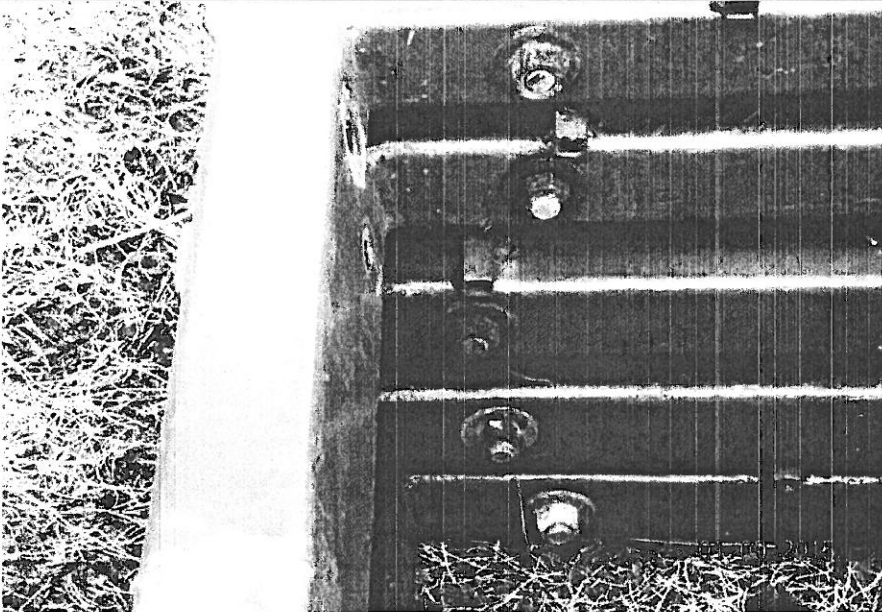
Photo No. 16

Remarks: Typical view of corroded fasteners.

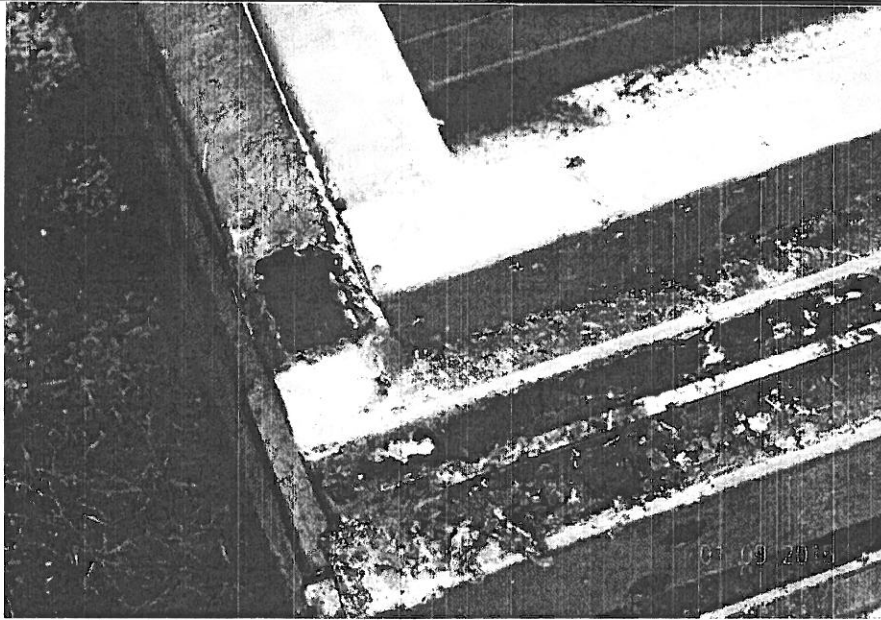
Photo No. 17

Remarks: Close-up view of corner of frame subject to corrosion damage.

5. Develop a rack system for storage that holds the frames vertical, elevated off the floor, thereby minimizing trapped water intrusion.
6. Continue to remove any loose rust and patch, weld or replace severely corroded sections as needed.

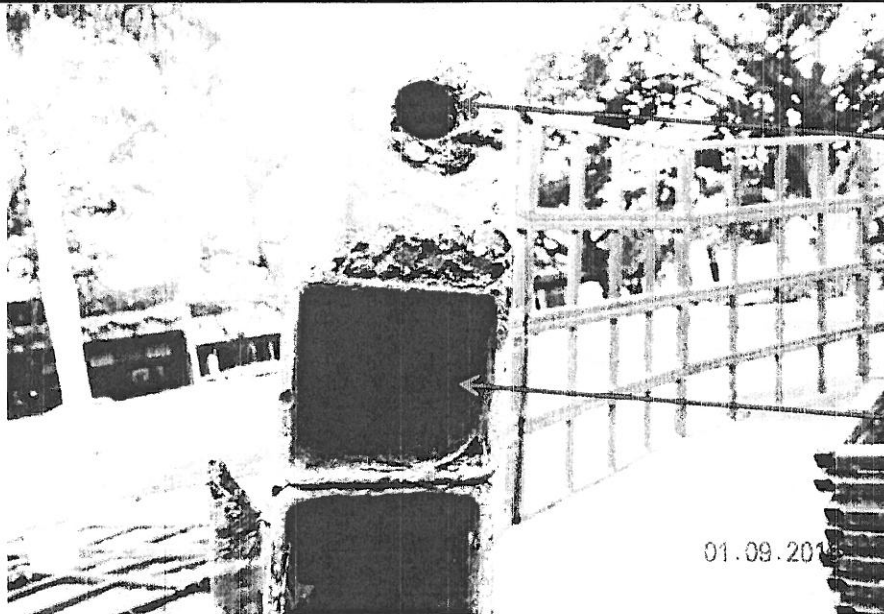
Photo No. 18

Typical bolt  
hole in  
vertical leg of  
frame

Typical  
horizontal  
frame member  
with no drain  
hole under  
connection

Remarks: View of typical connection at bottom of vertical leg of frame. Bolt hole cannot drain into horizontal leg.

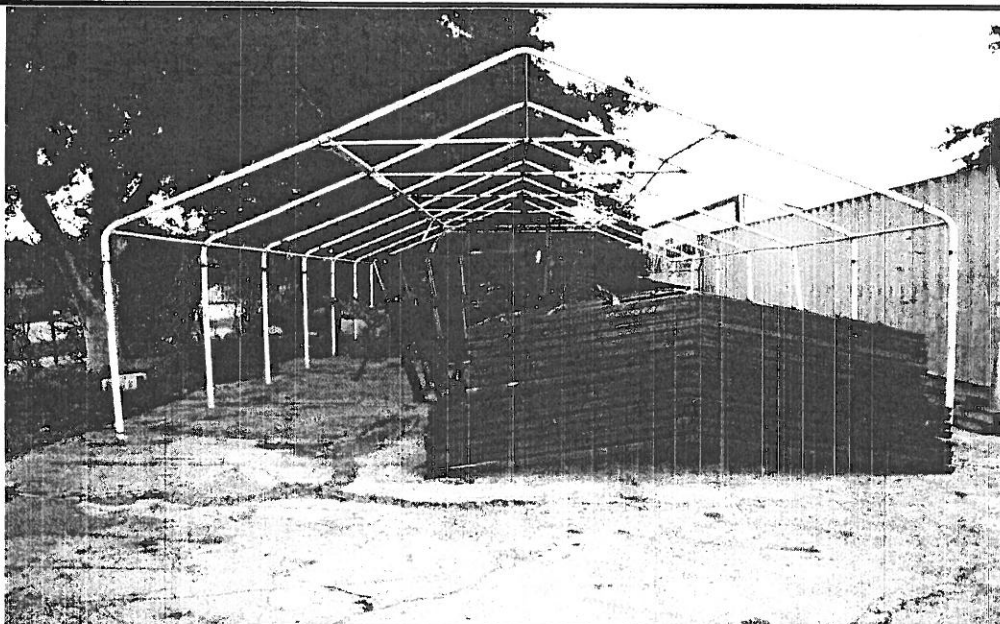
Photo No. 19

The partially connected frames are transported and stacked in the back of the Public Works yard facility in an area that used to have a framed canopy. The frame is still visible, but the tarp is no longer in place. The condition of the canopy frame indicates that the tarp has been missing for several years. The overall plan size of the framed canopy is approximately 20 feet by 30 feet.

The frames are placed directly on the pavement, with some frames connected with bolted fasteners still in place.

Location: TREE STORAGE

9. Construct or install an insulated closed shed-type structure for storage and protection of the frames.

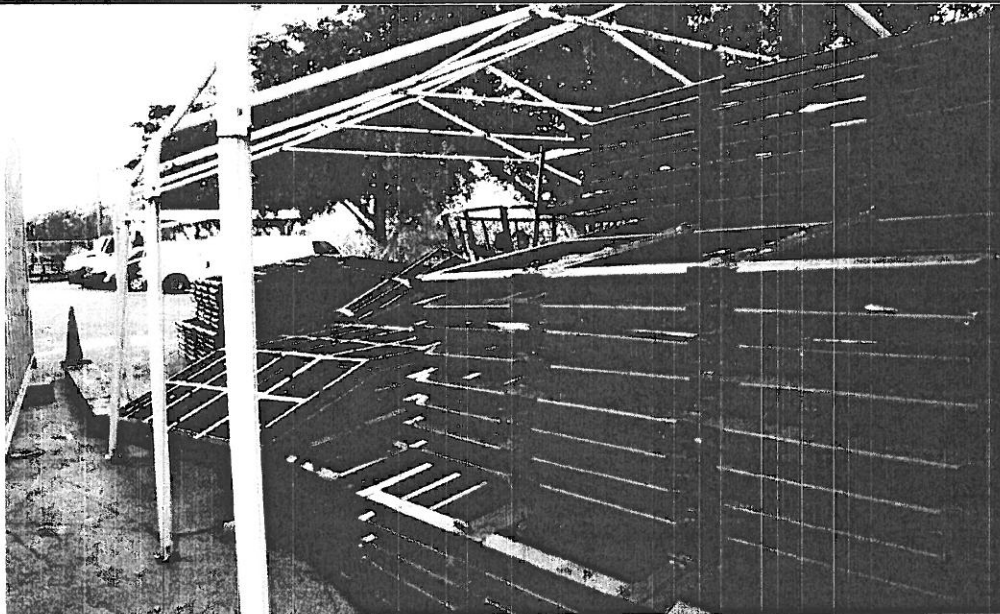
Photo No. 20

Location: TREE STORAGE
