19 N Dixie Blvd

History

Site Before/Exterior Appearance Before

Site After/Exterior renovations

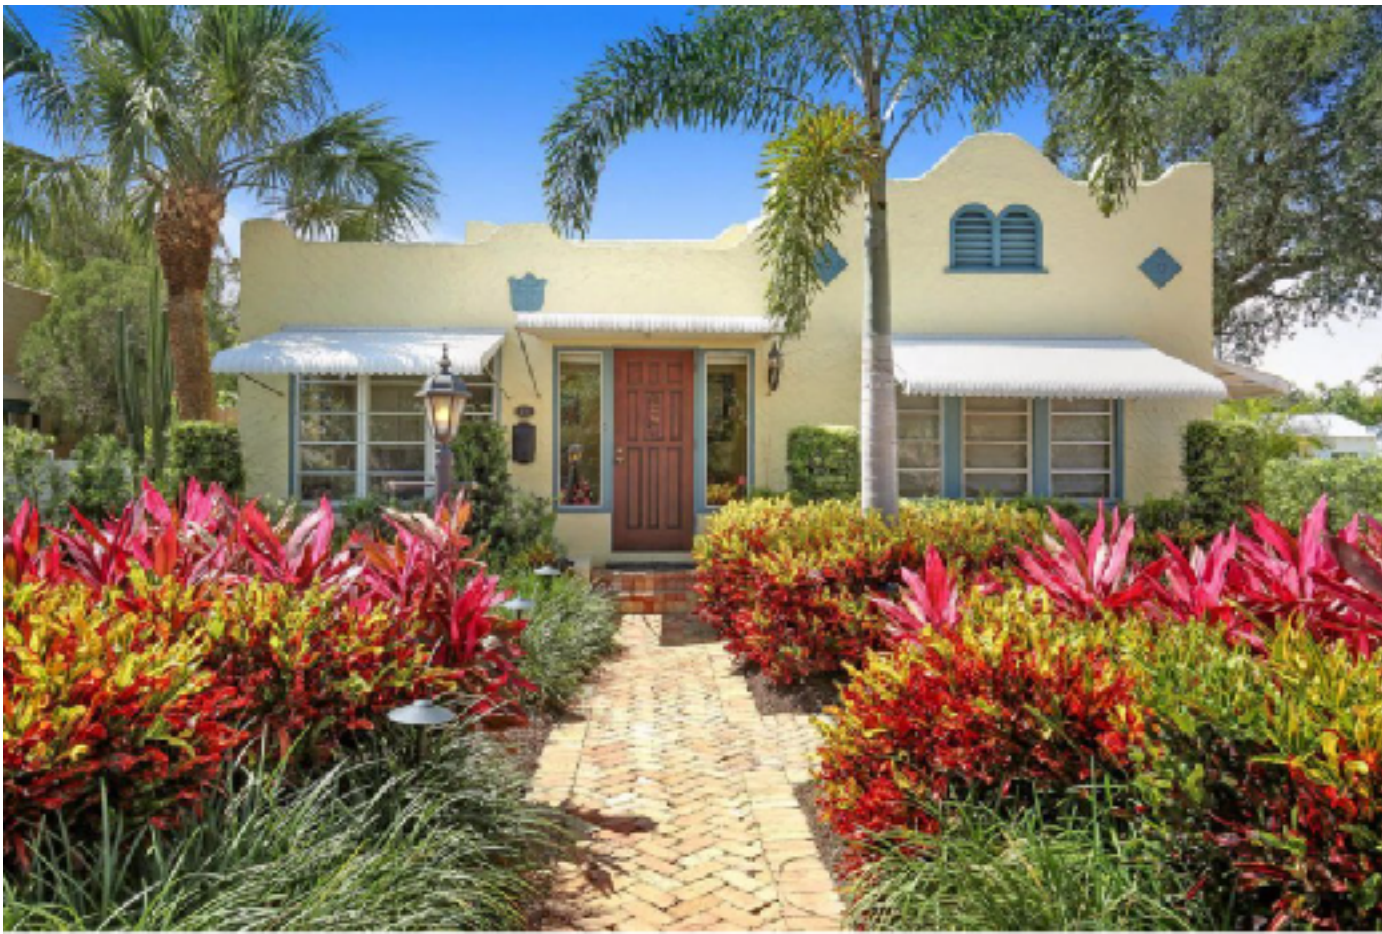
EAST ELEVATION BEFORE

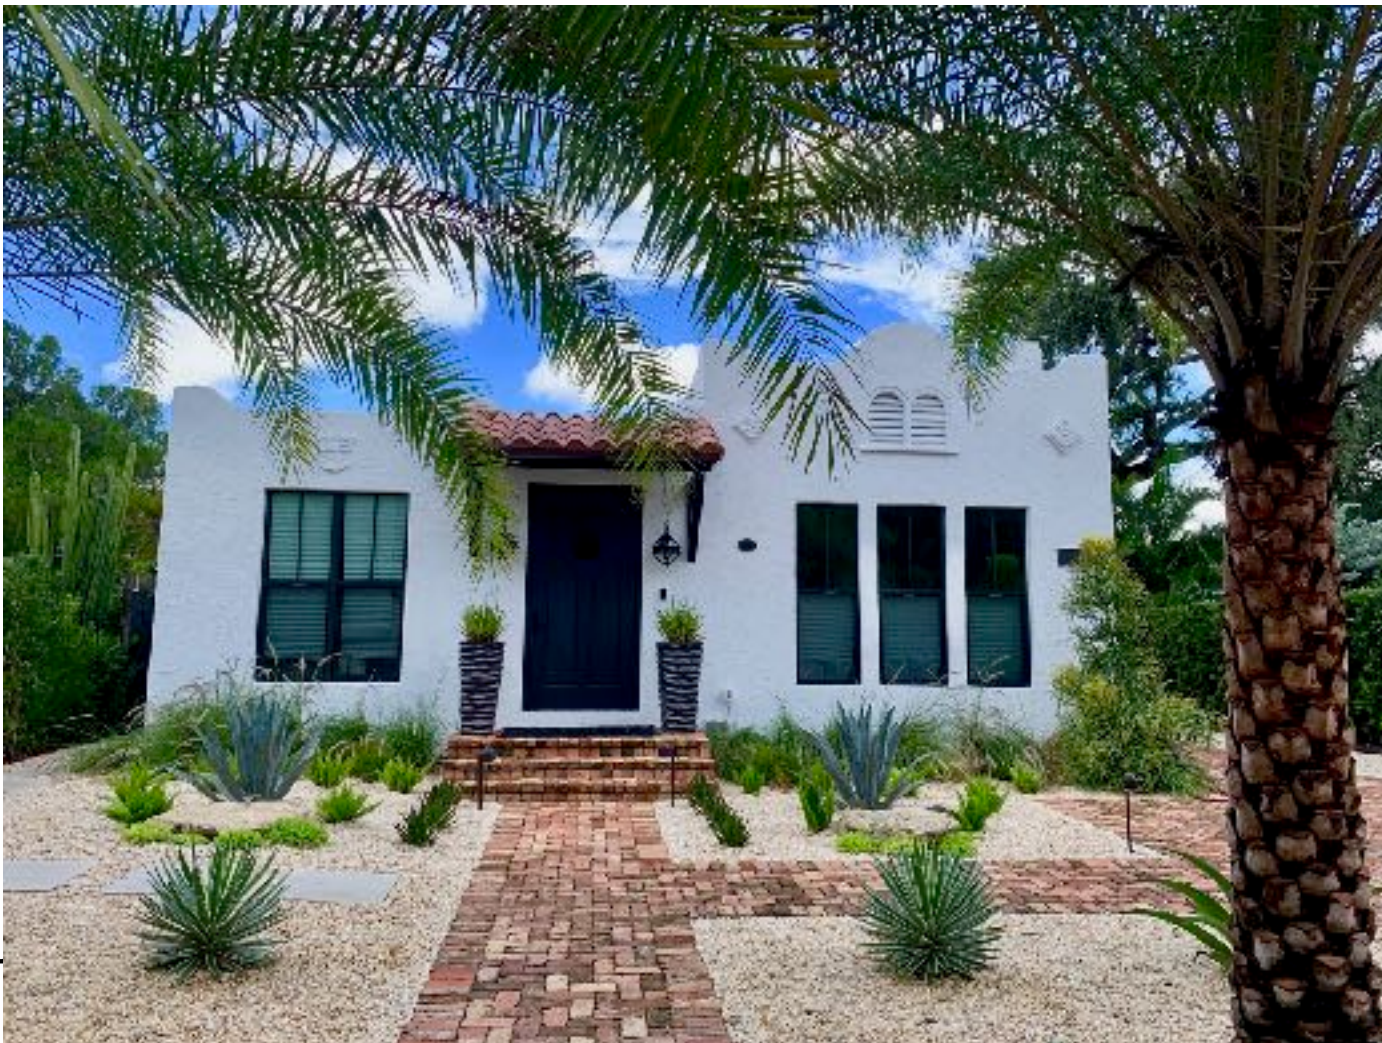
EAST ELEVATION AFTER

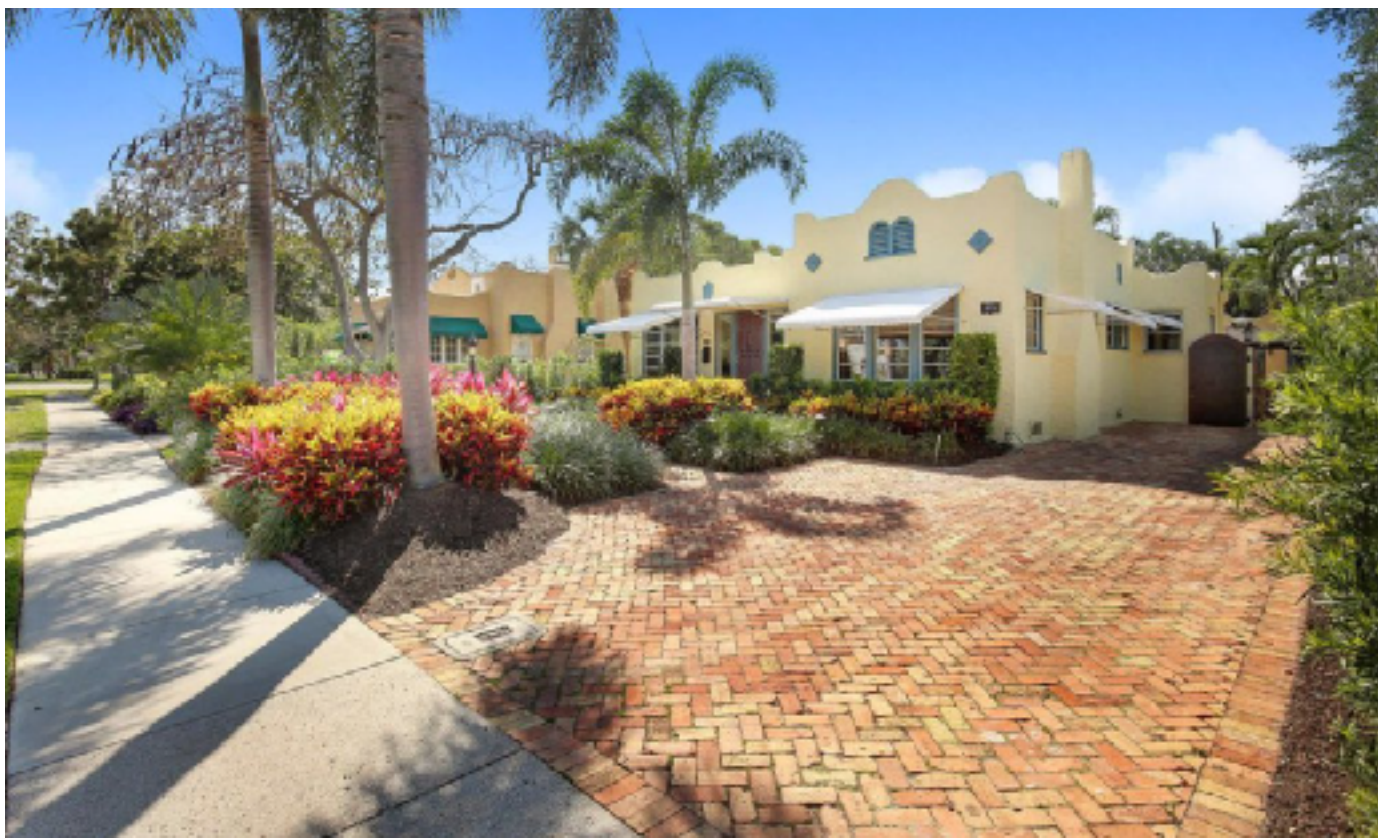
NORTH/EAST CORNER BEFORE

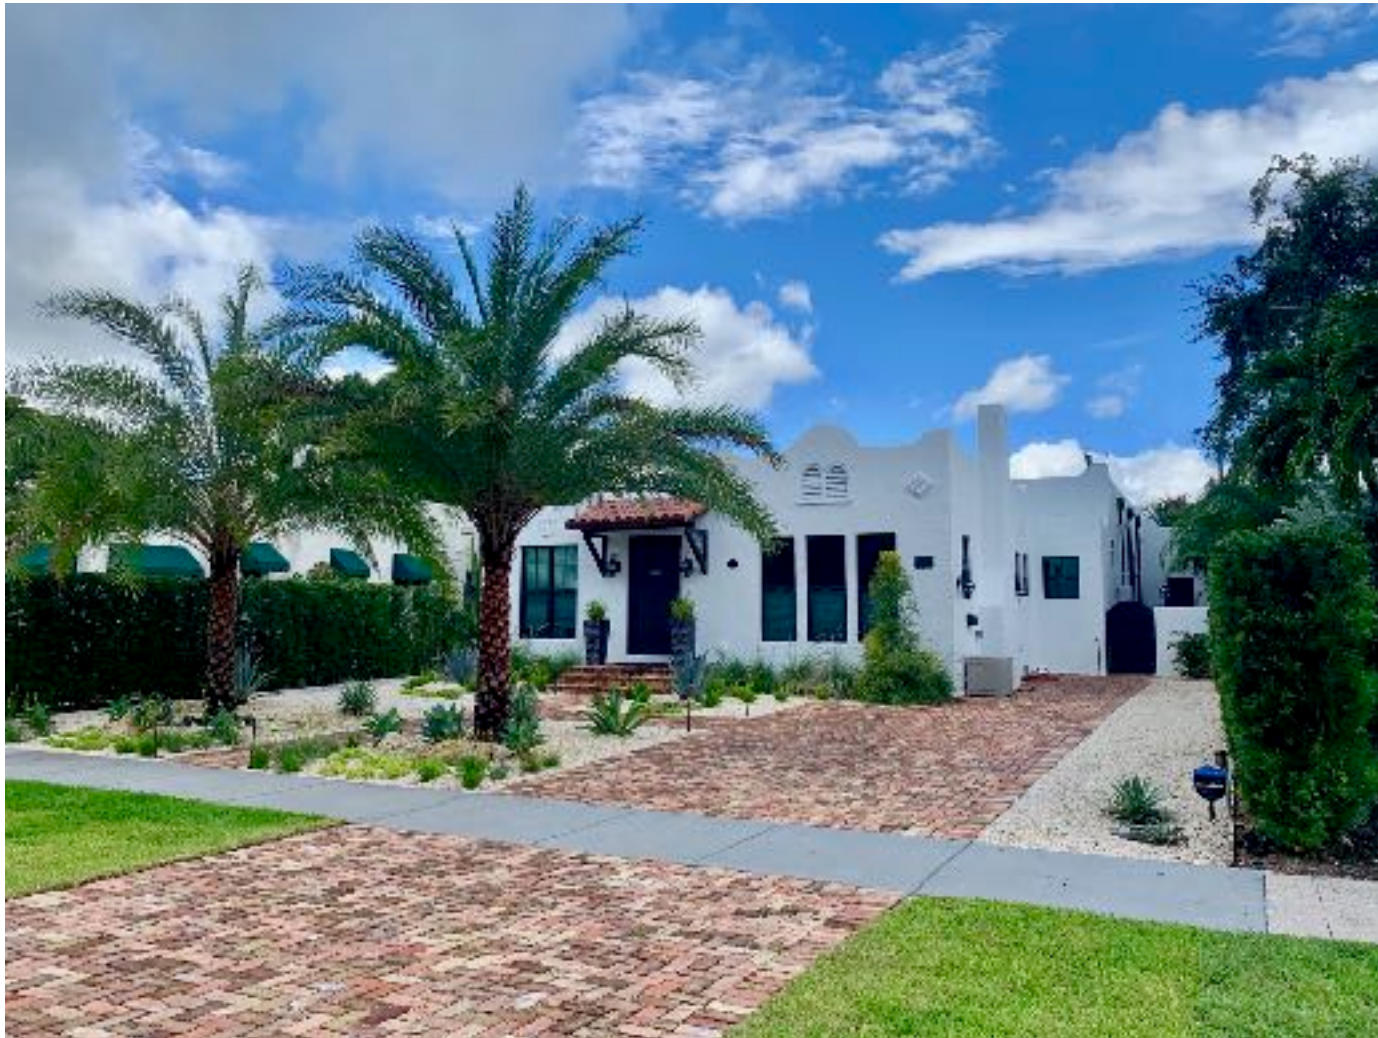
NORTH/EAST CORNER AFTER

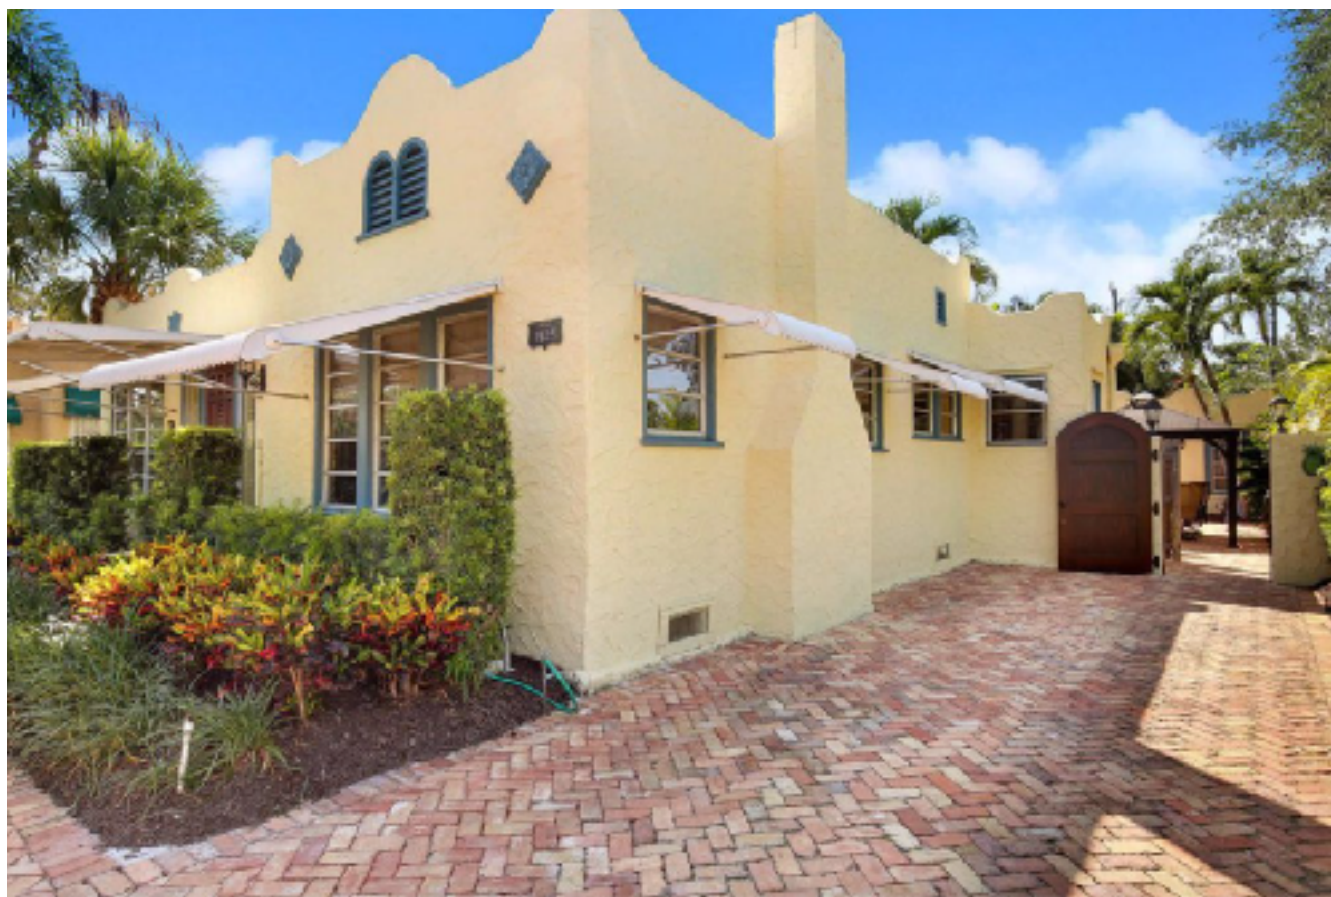
NORTH ELEVATION BEFORE

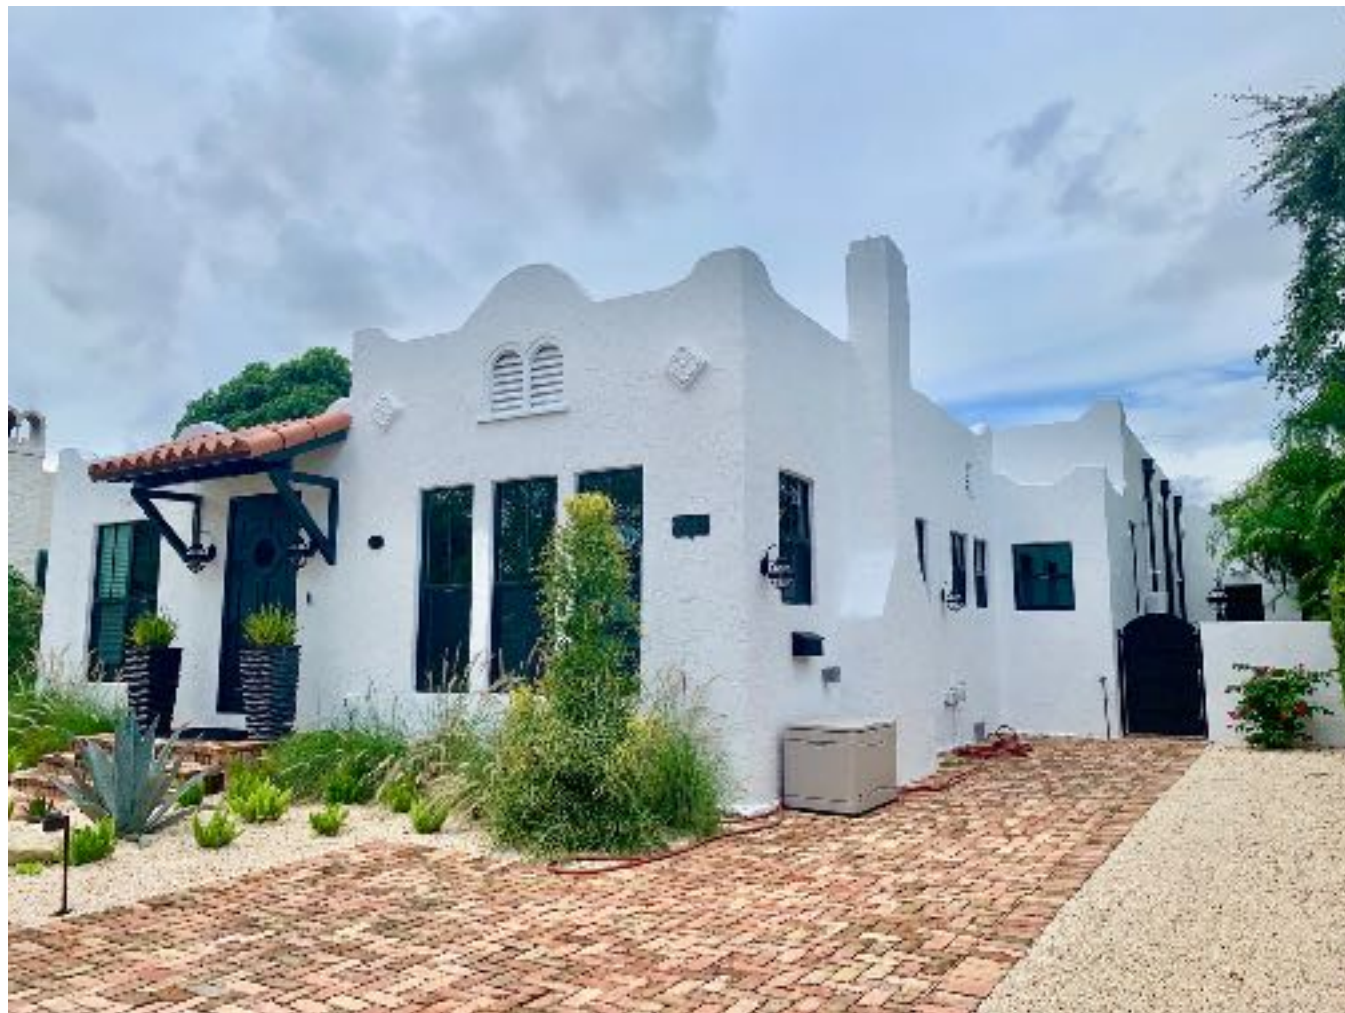
NORTH ELEVATION AFTER

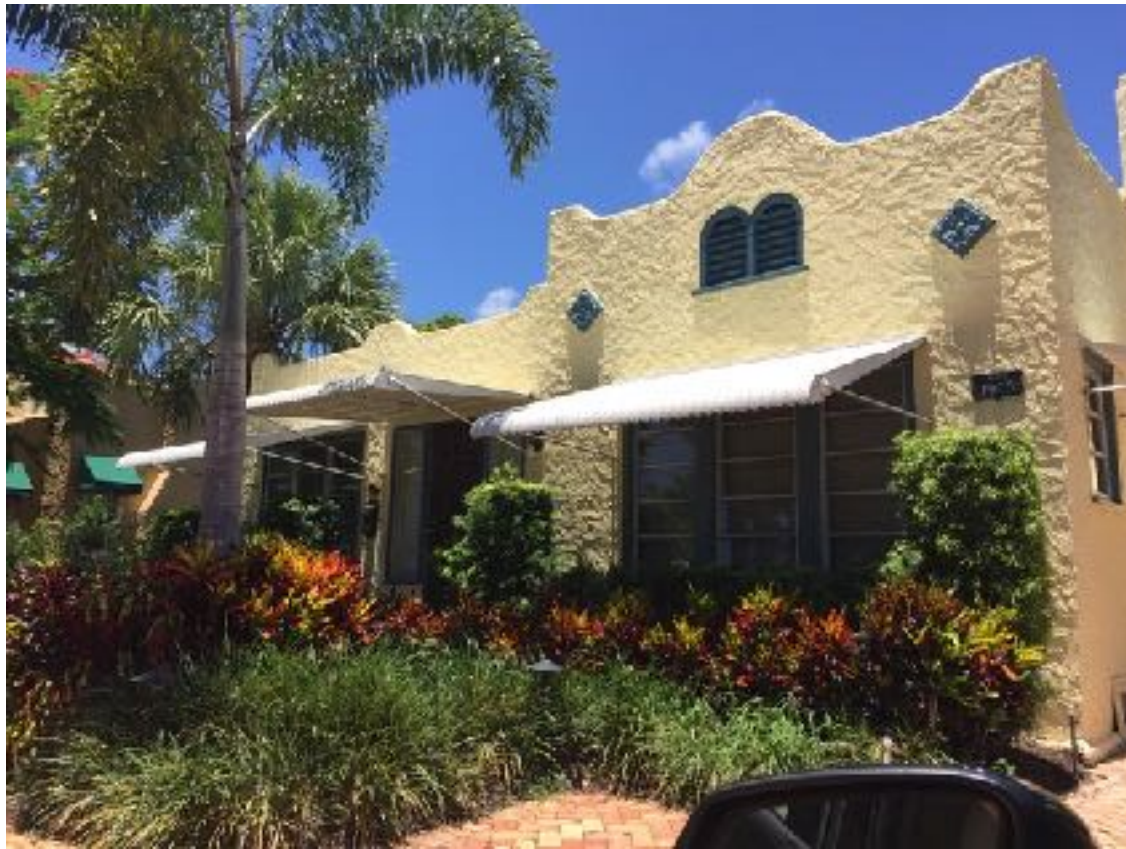
FRONT FACADE DETAIL BEFORE

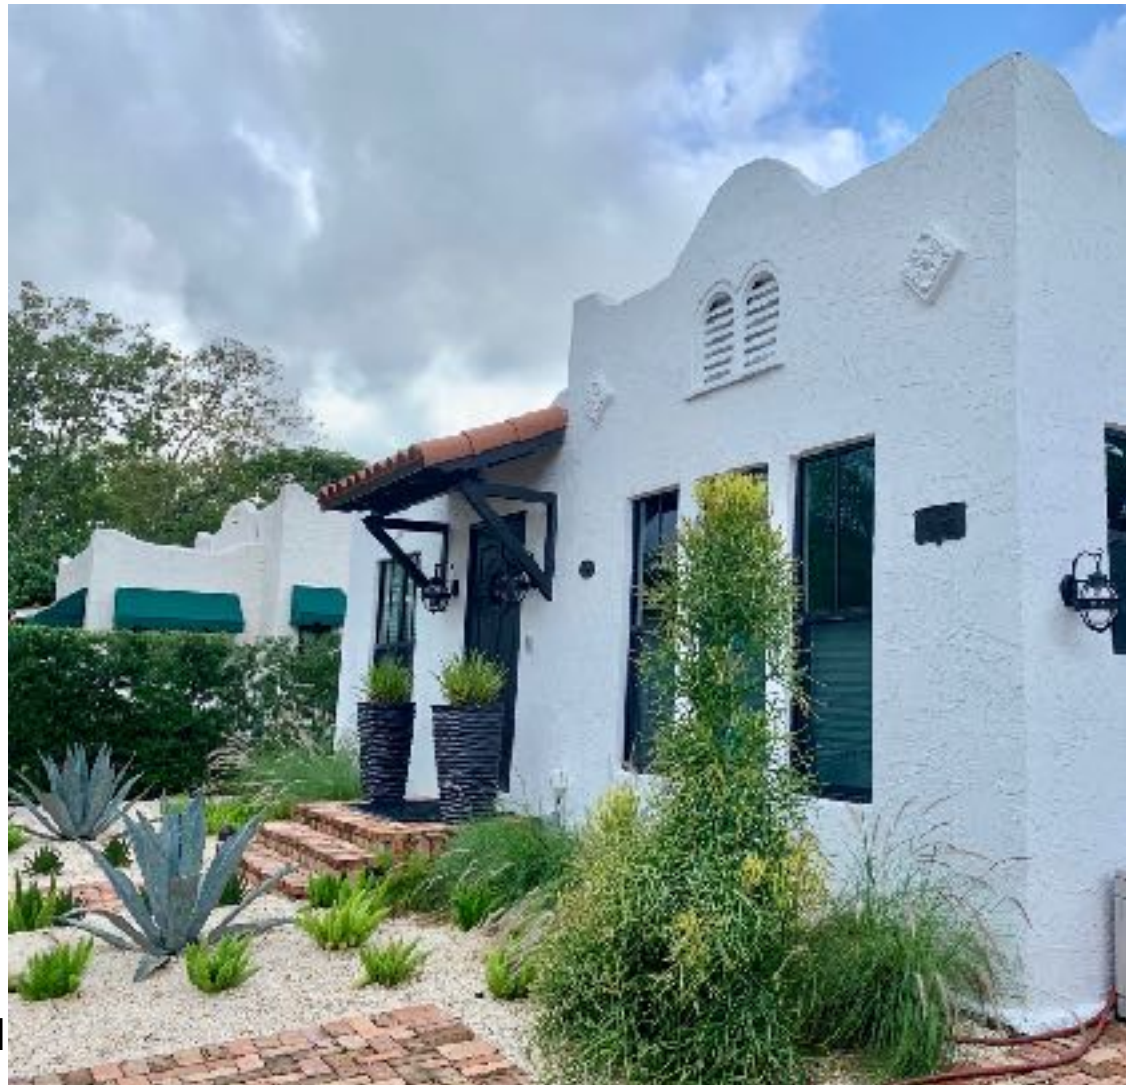
FRONT FACADE DETAIL AFTER

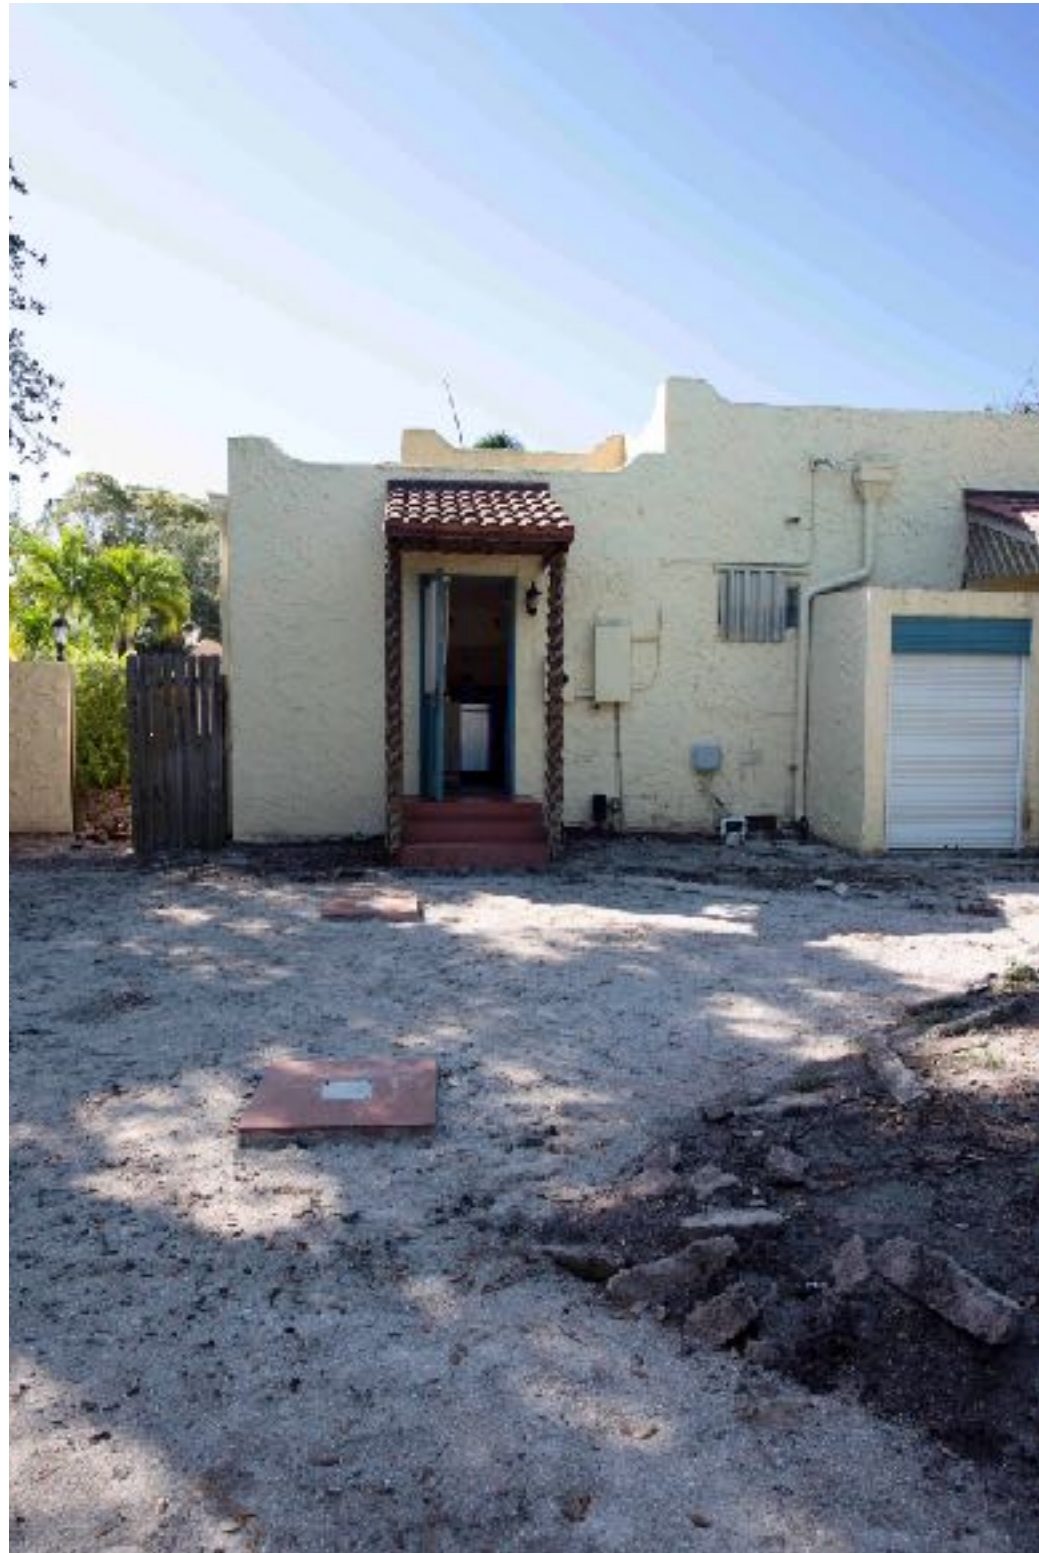
WEST ELEVATION BEFORE/
VIEW FROM REAR COTTAGE TO MAIN HOUSE

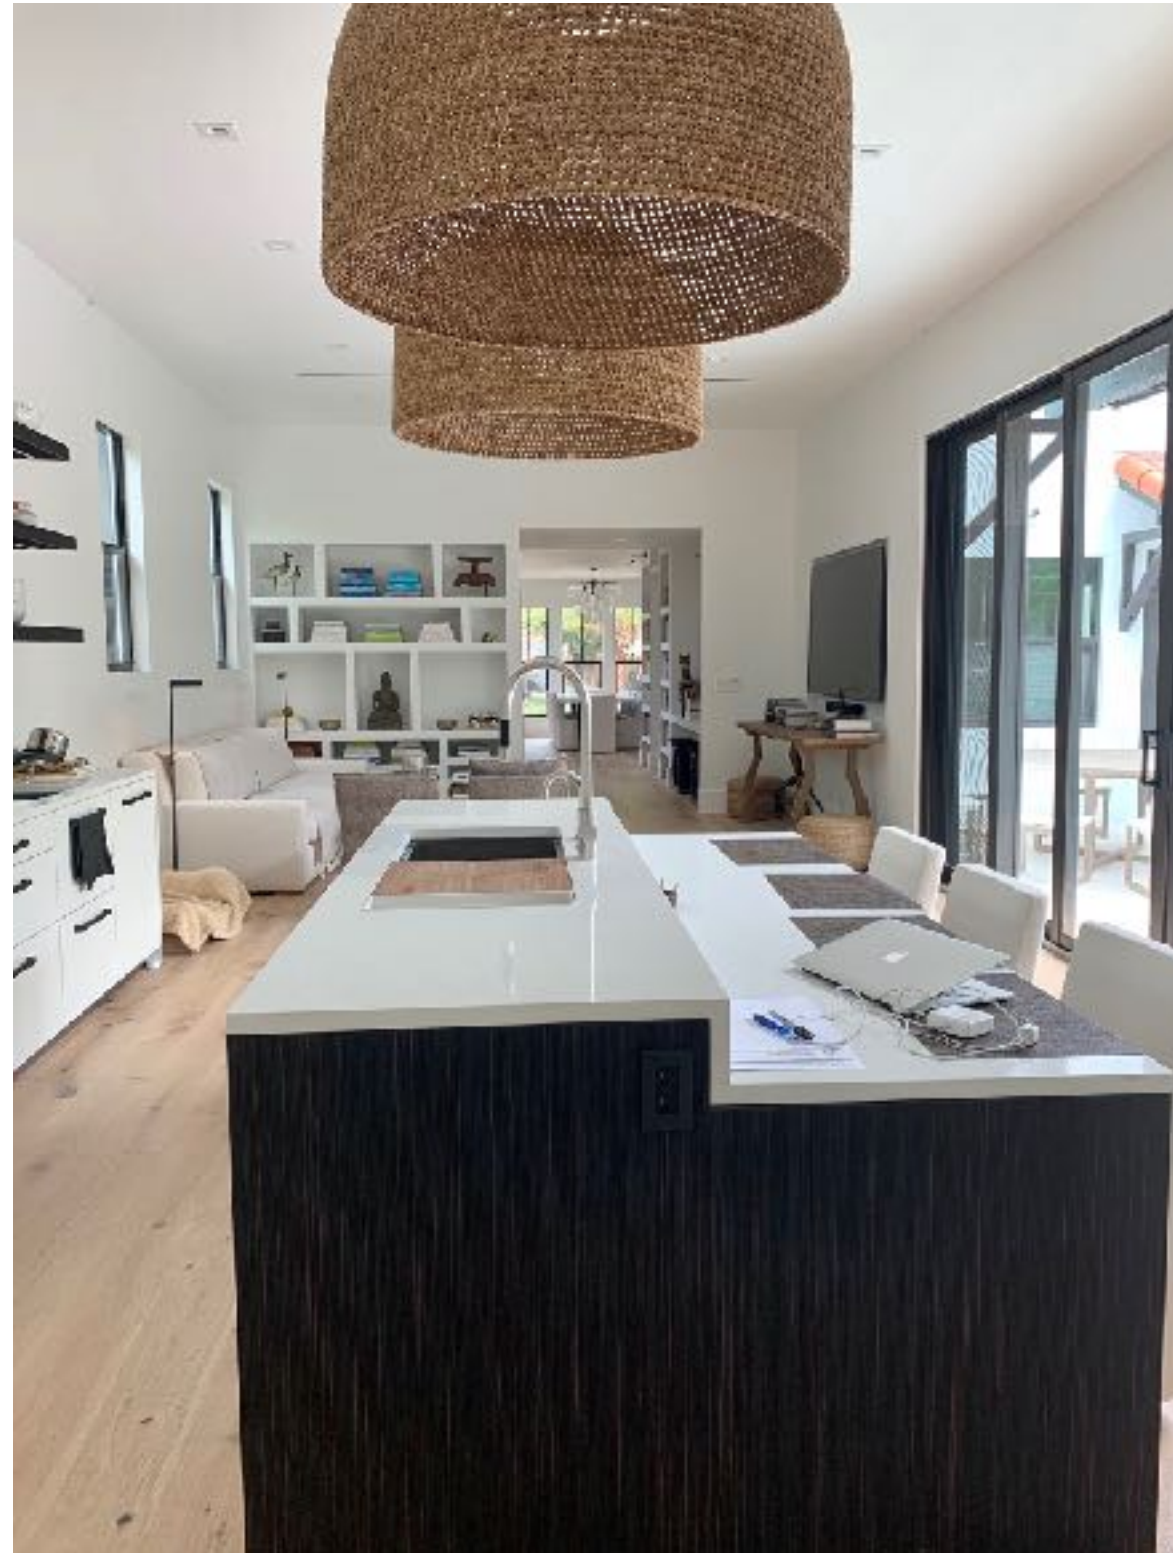
SAME VIEW AFTER

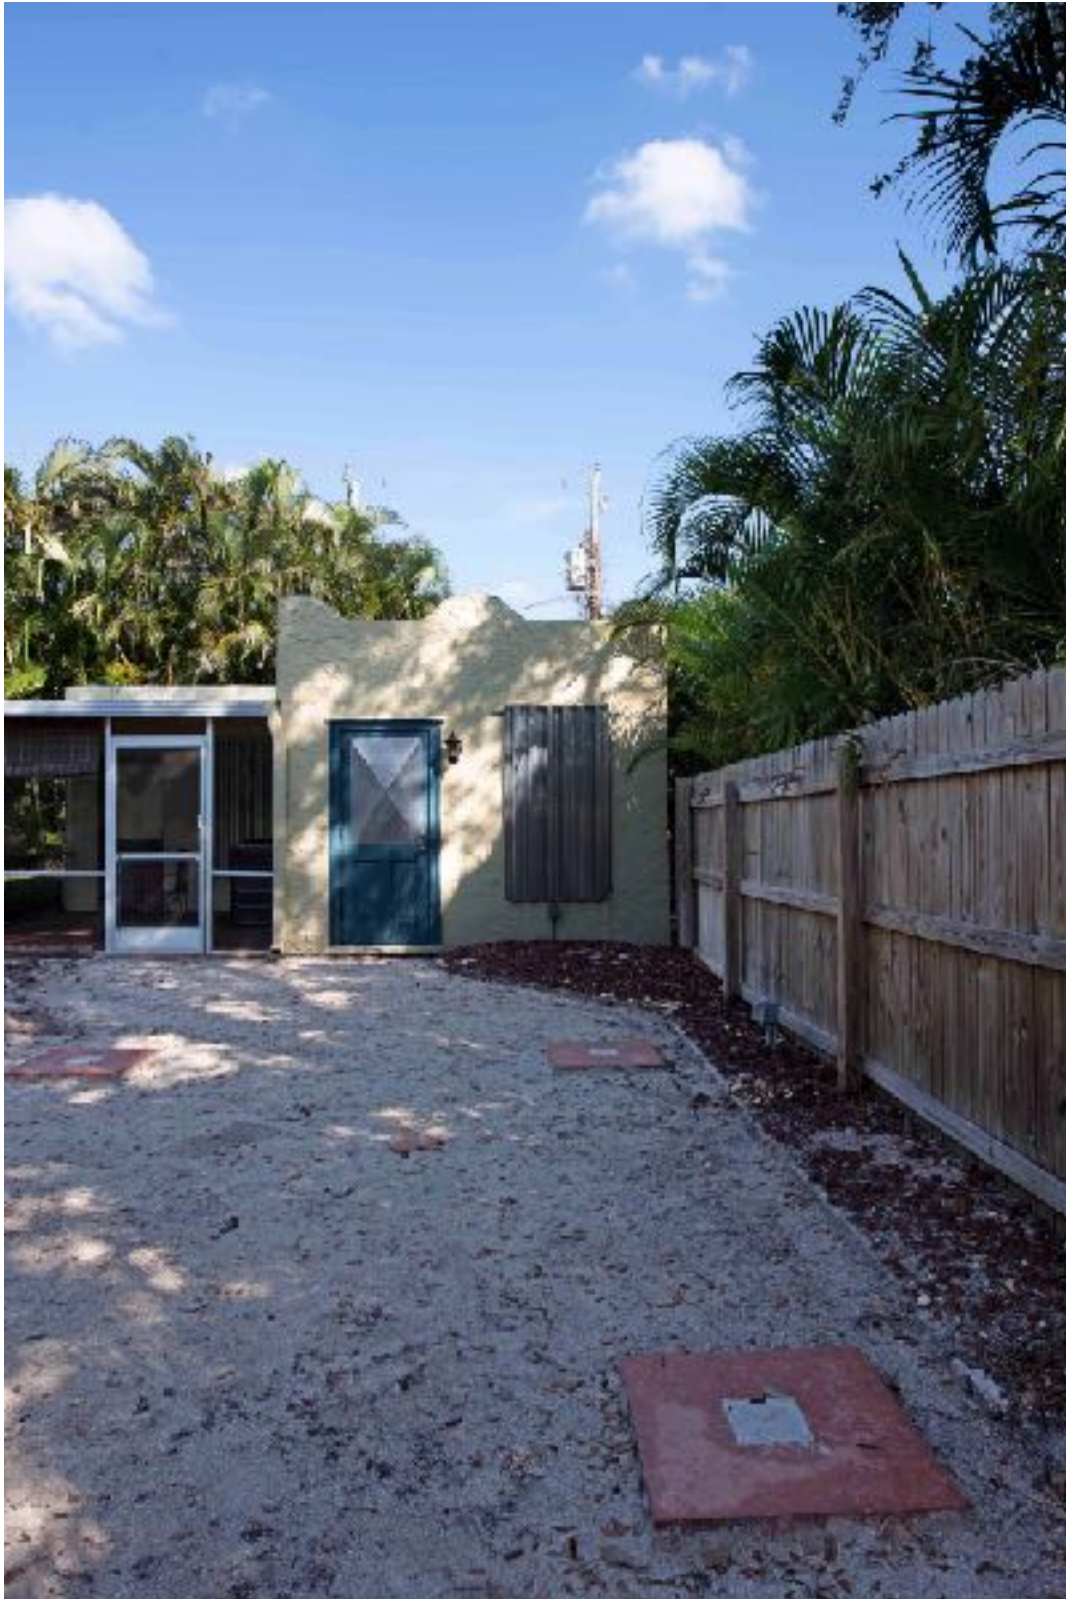
EAST ELEVATION BEFORE/
VIEW OF REAR COTTAGE

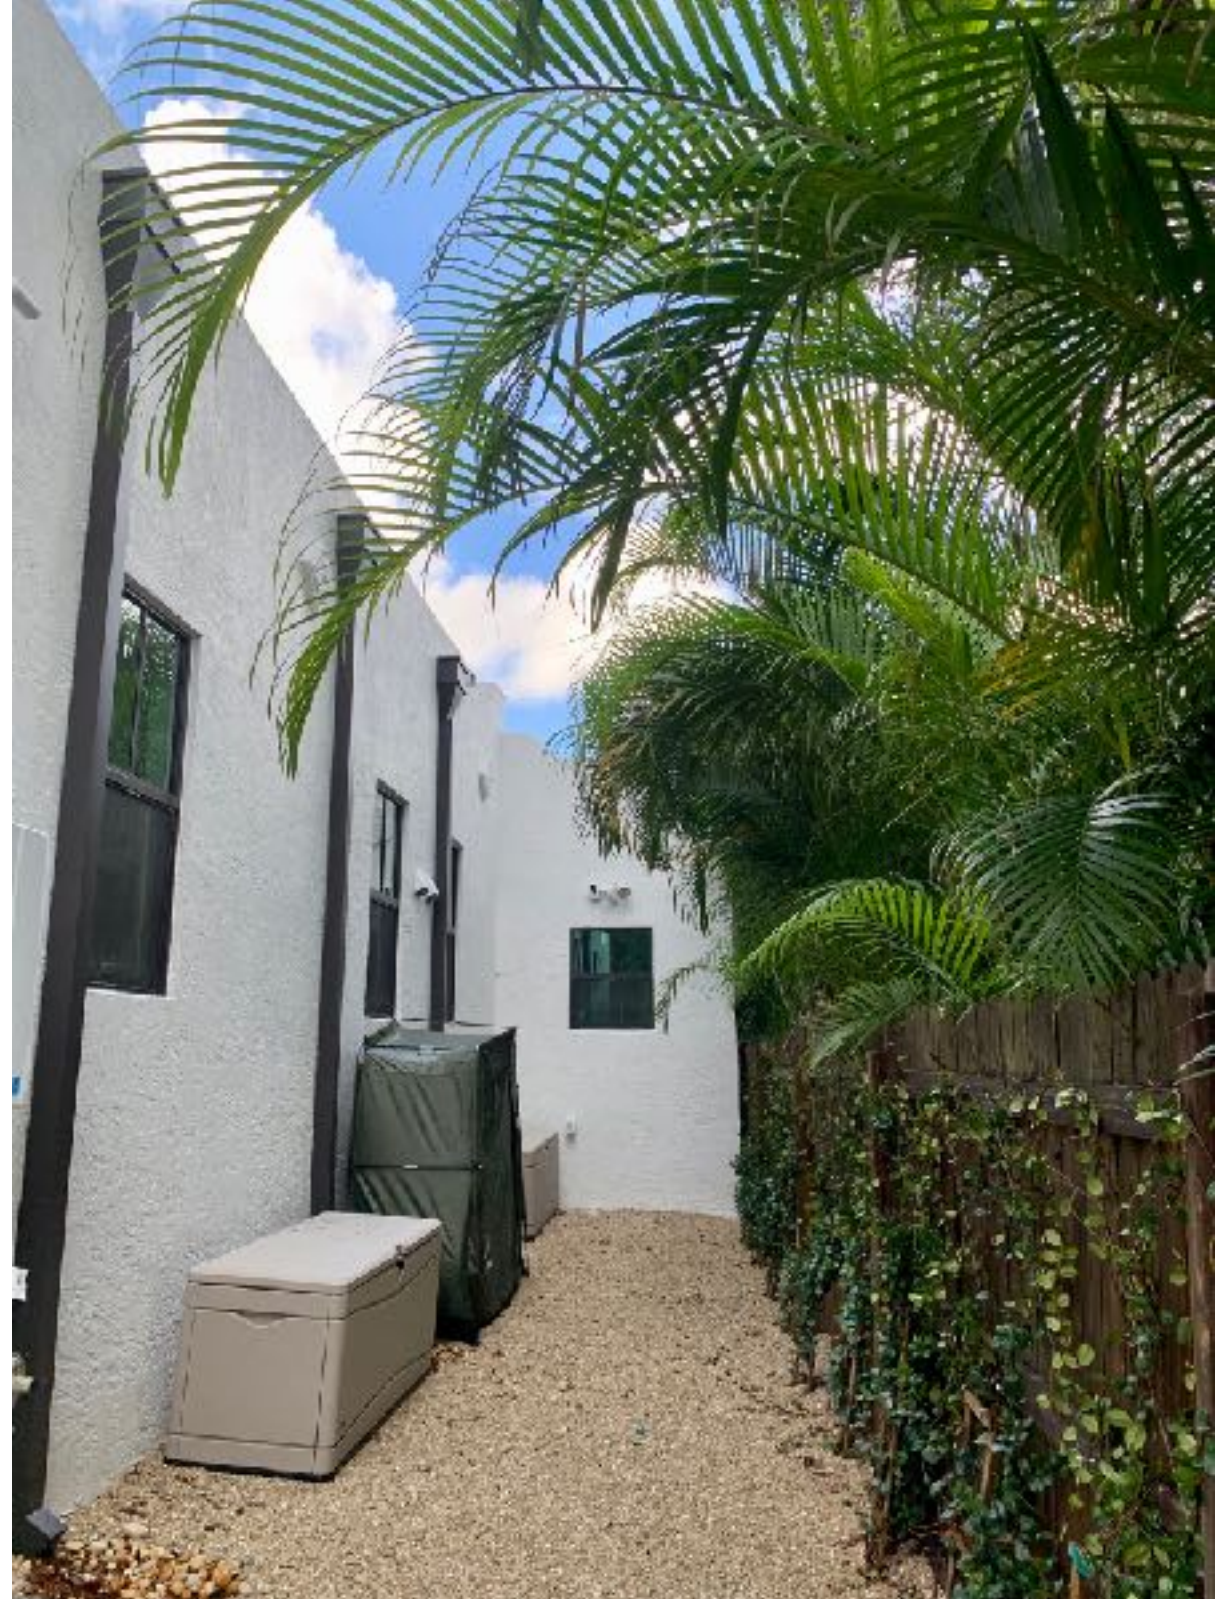
EAST ELEVATION AFTER/
VIEW OF VISIBLE PORTION OF FORMER REAR COTTAGE
AND NORTH ELEVATION

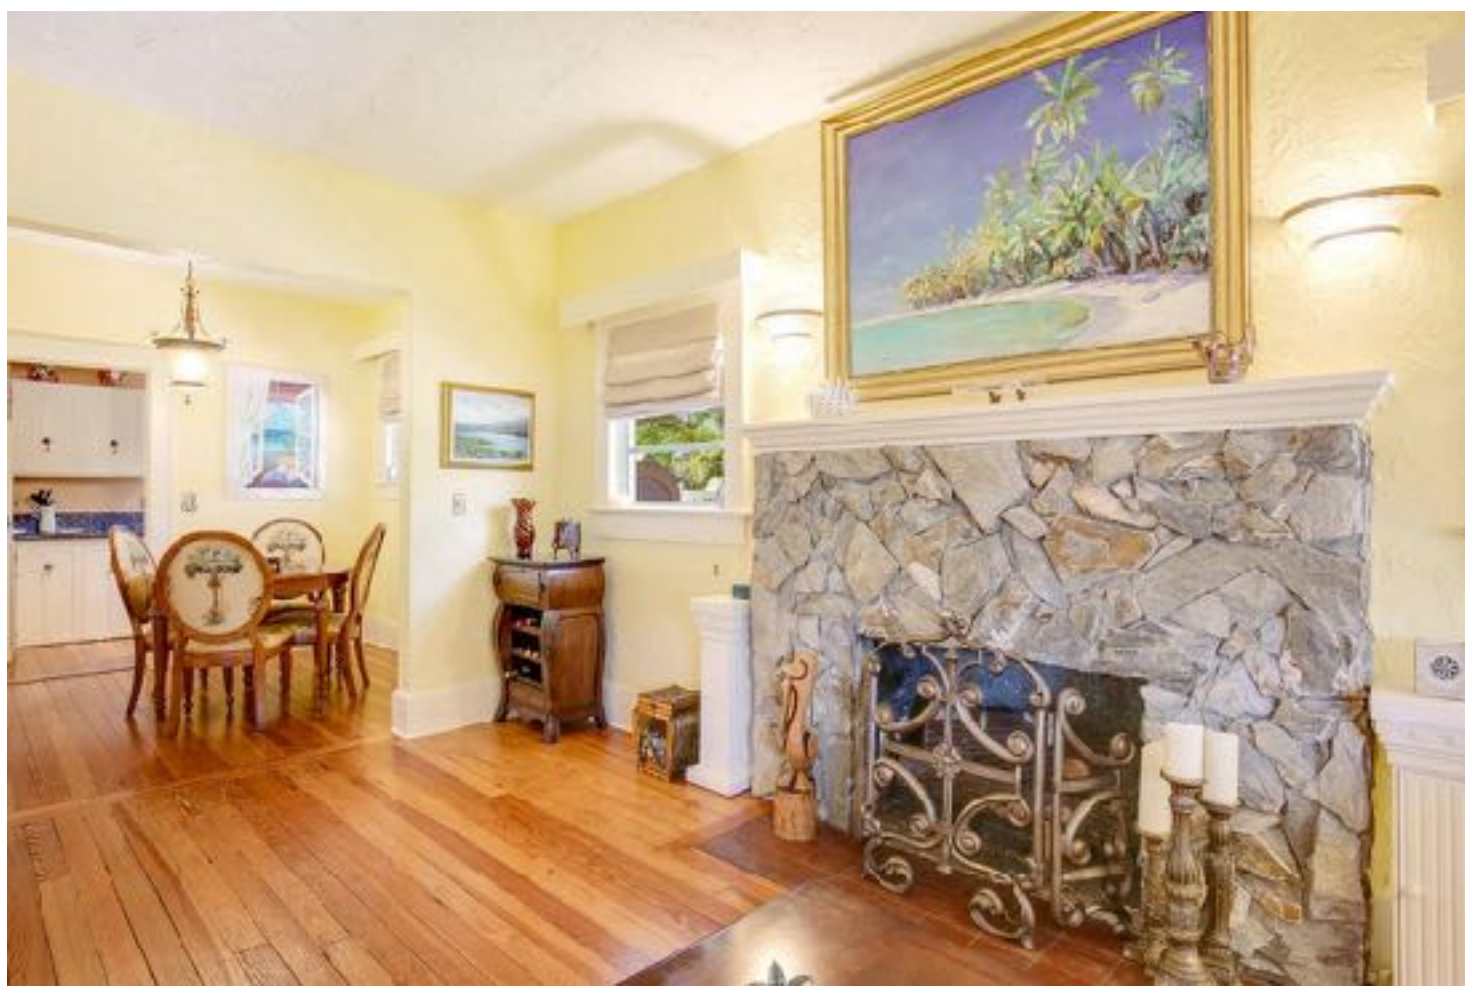
DINING ROOM BEFORE

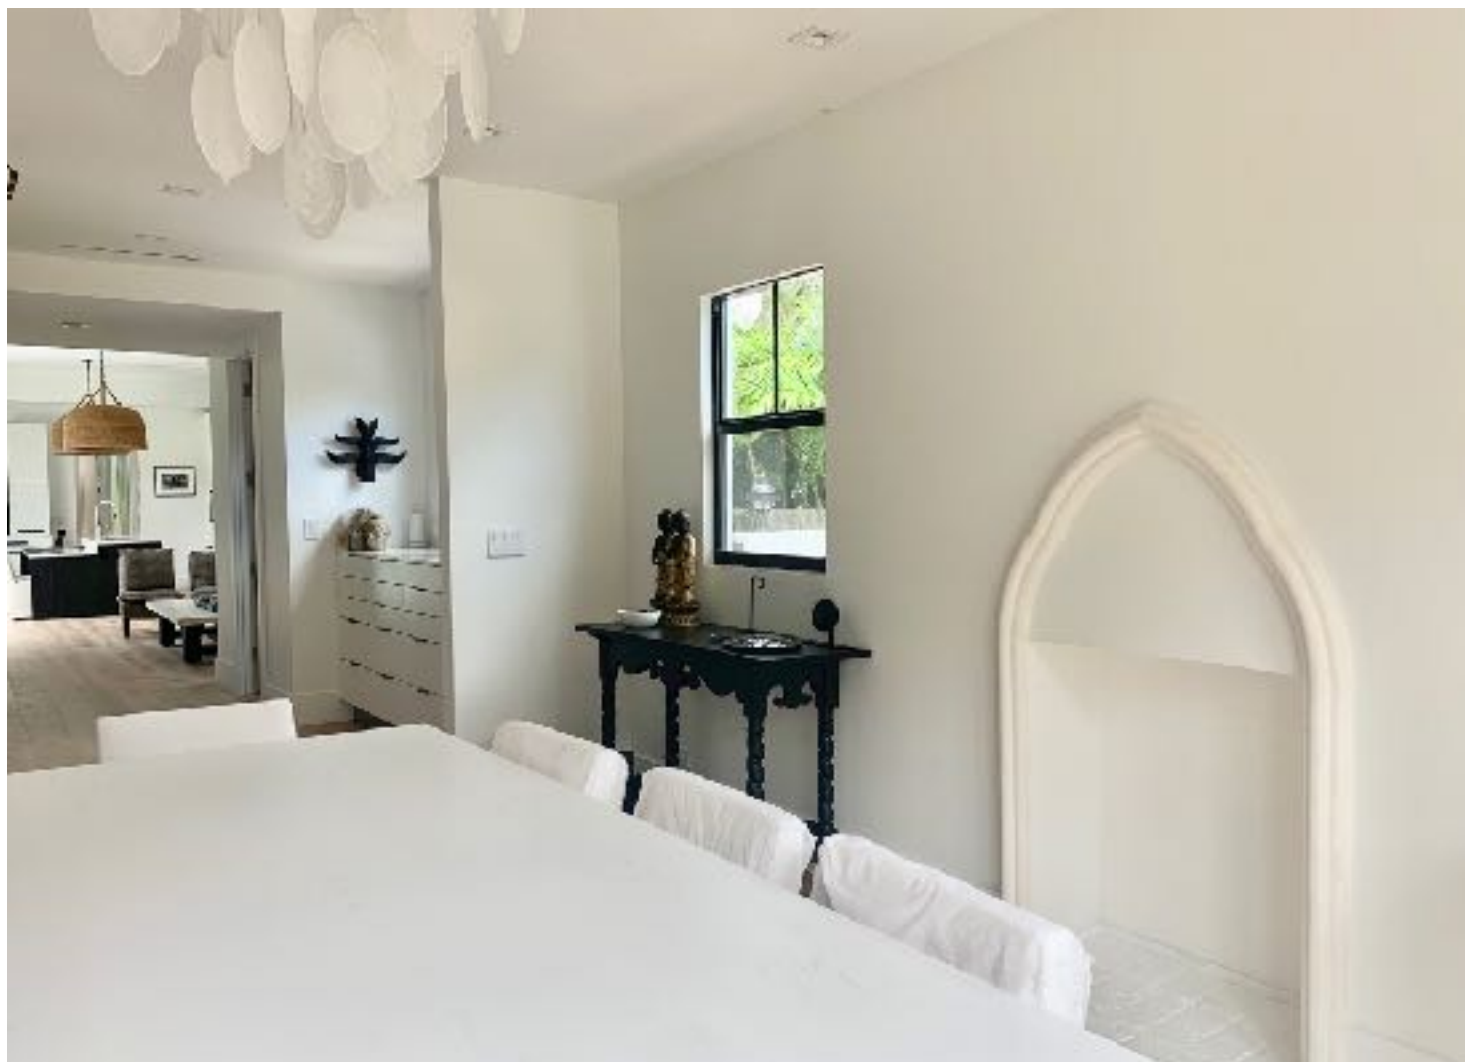
DINING ROOM AFTER

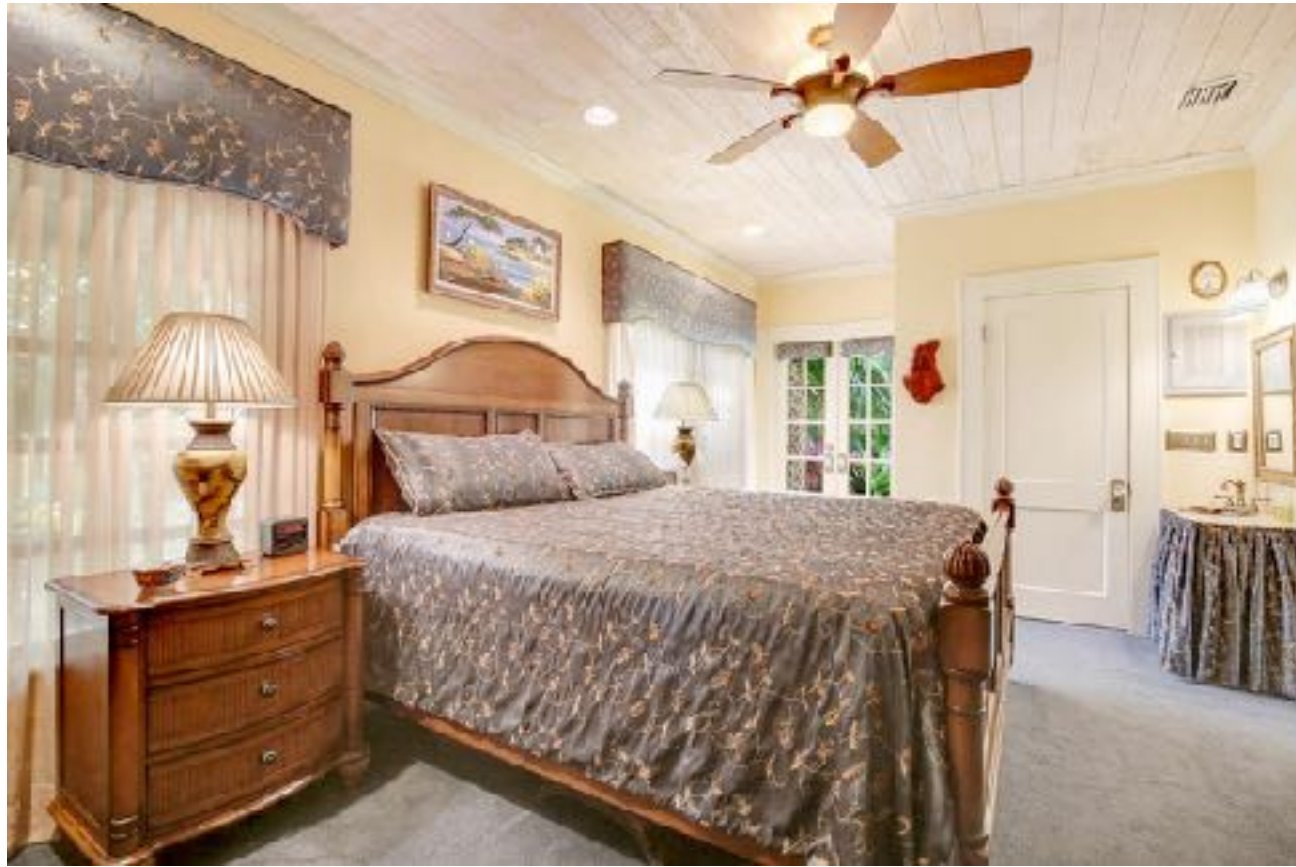
MASTER BEDROOM BEFORE/
LOOKING WEST

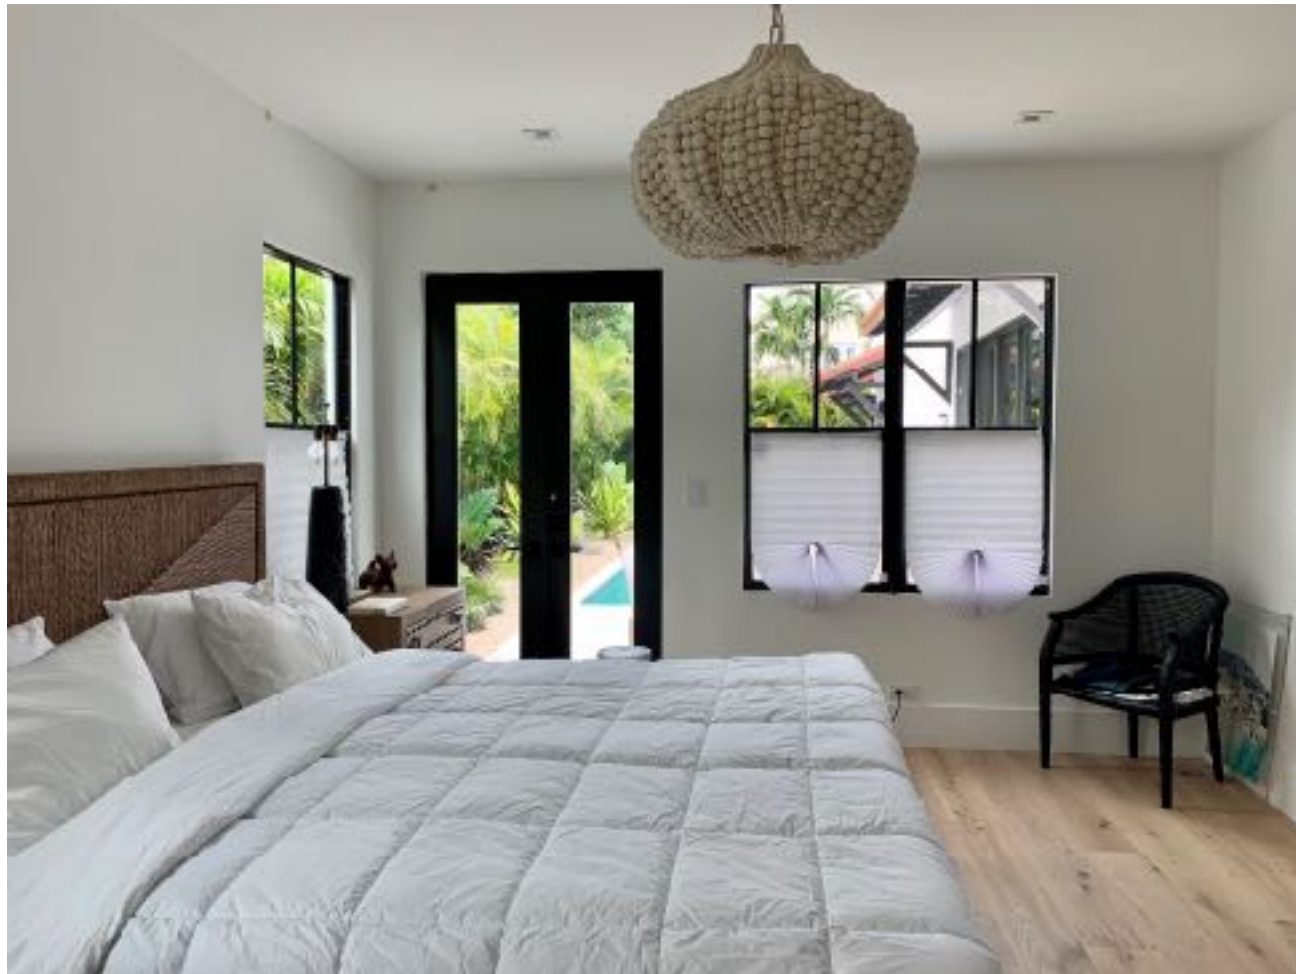
MASTER BEDROOM AFTER/
LOOKING WEST
