19 N Dixie Blvd

History

Site Before/Exterior Appearance Before

Site After/Exterior renovations

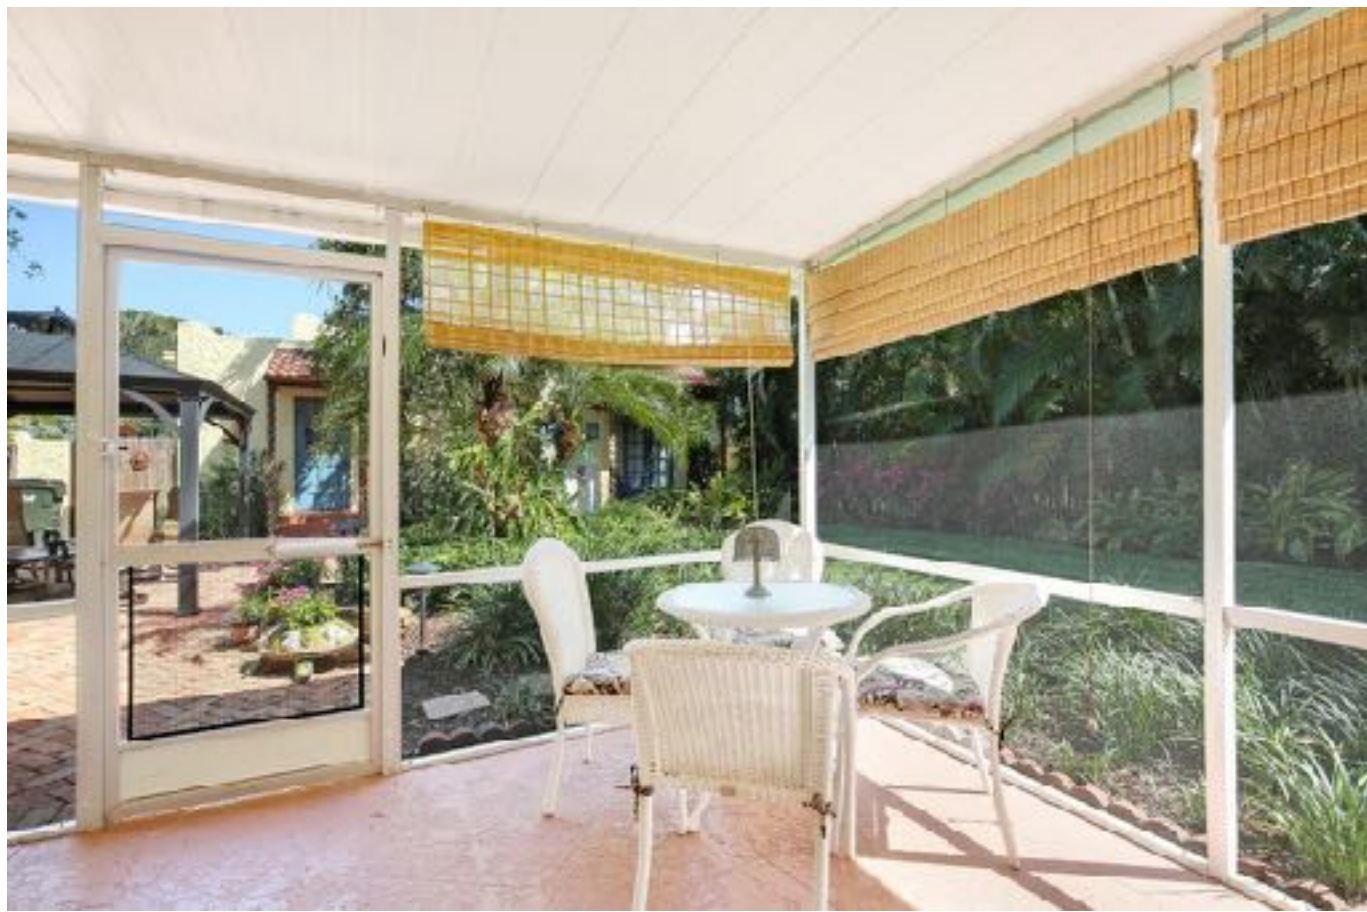
REAR COTTAGE PORCH/LAUNDRY BEFORE

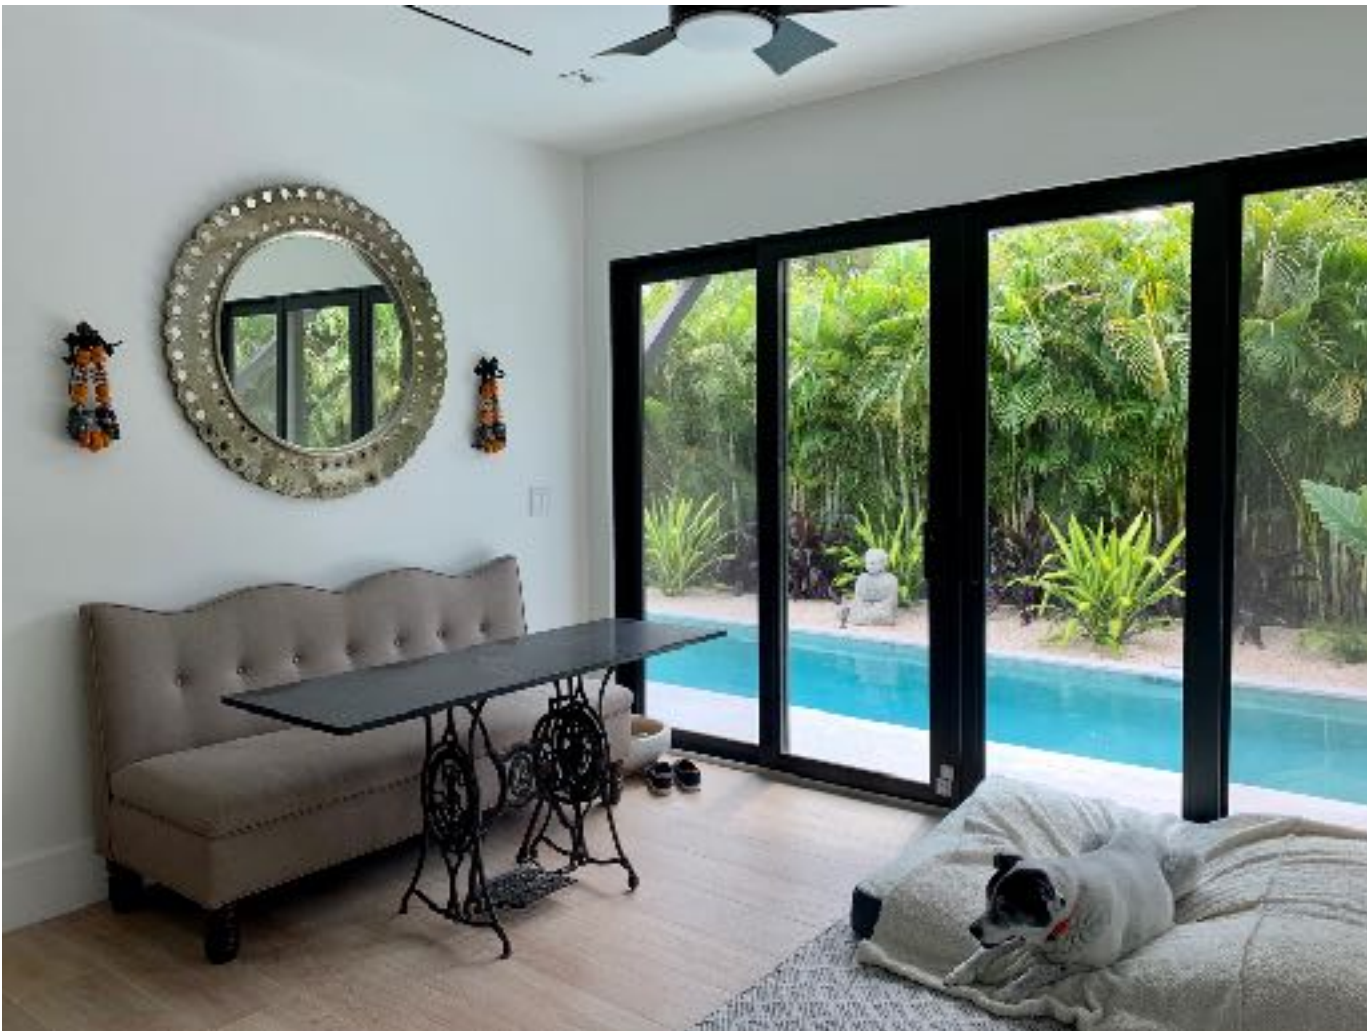
SAME VIEW AFTER-STUDIO
