Historic Banyan Tree – Southeast Corner of Clubhouse

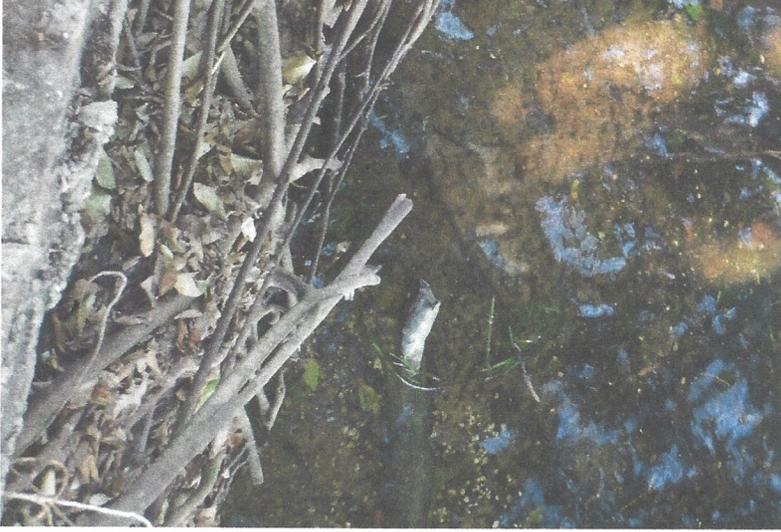
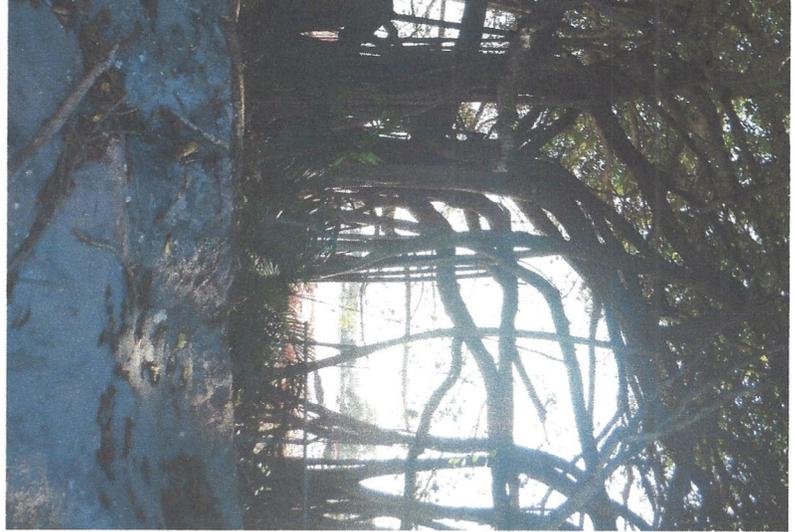
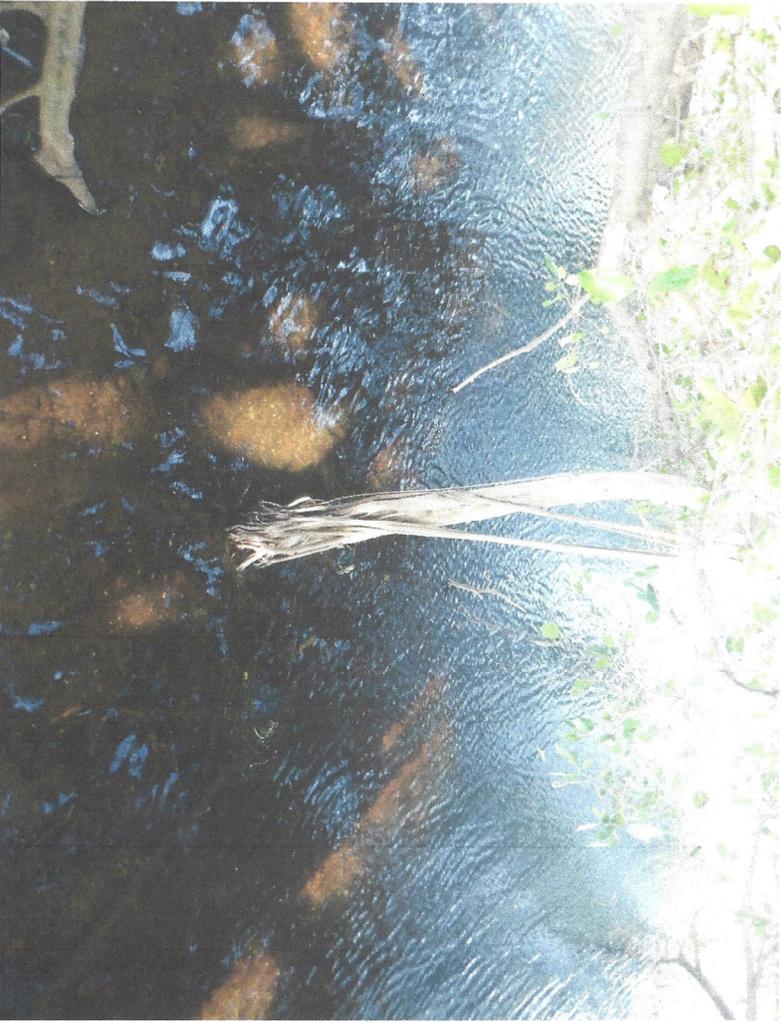
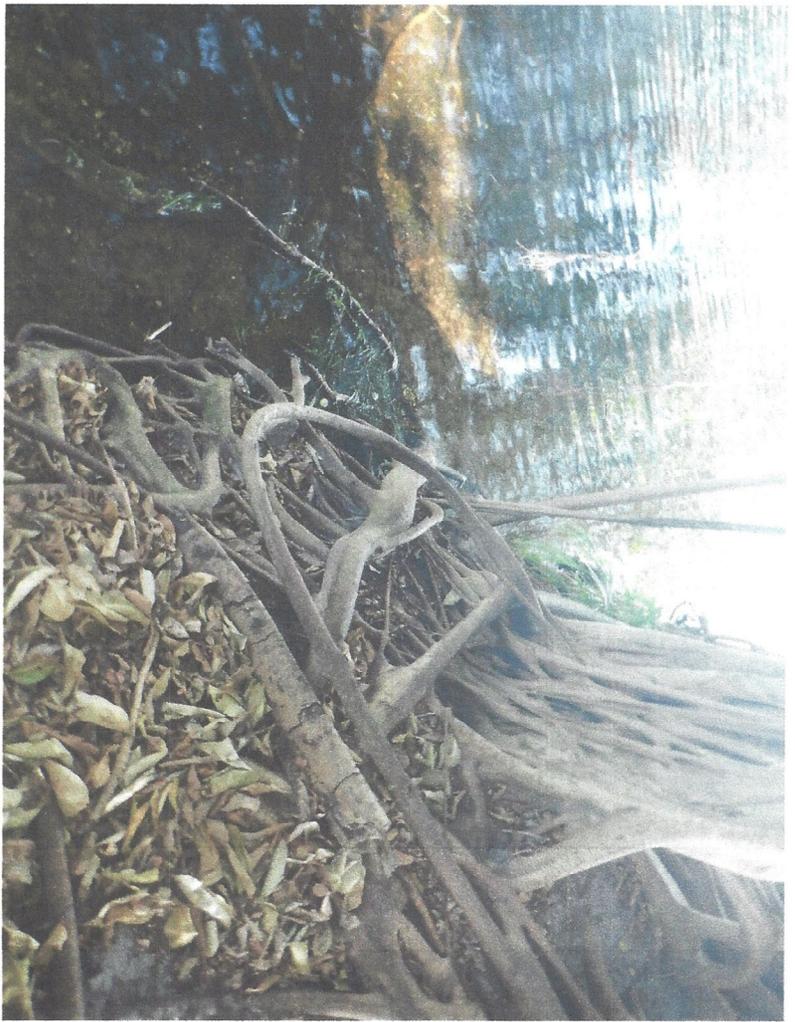
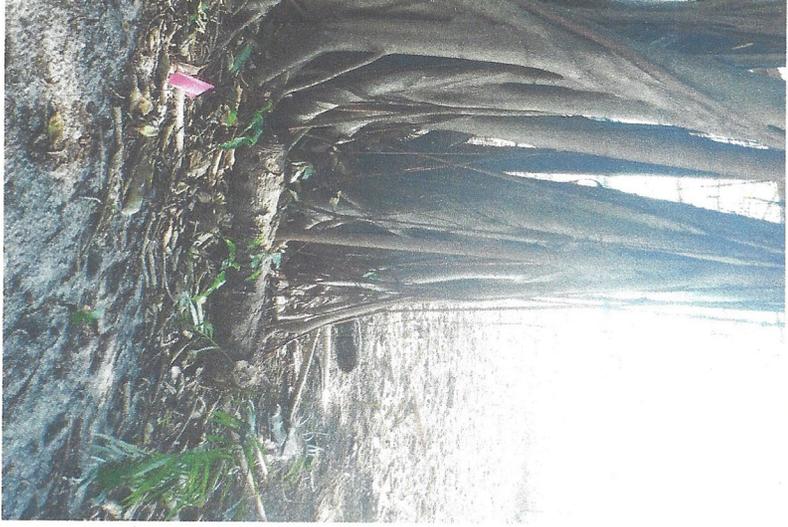
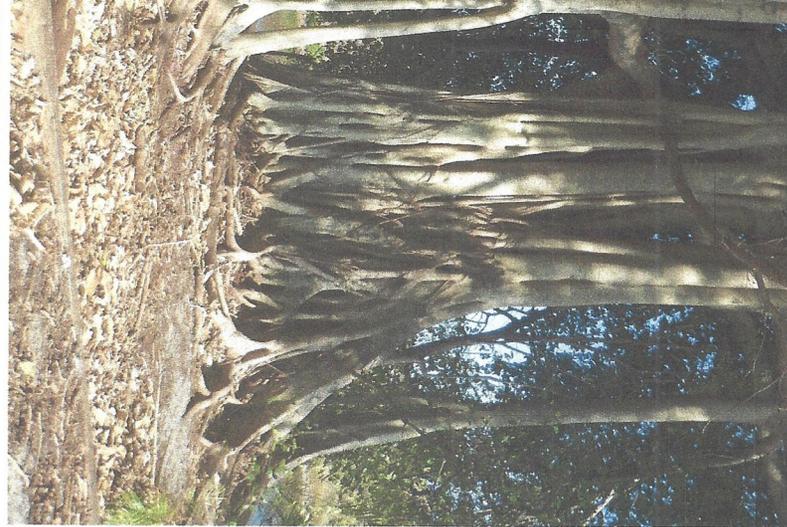
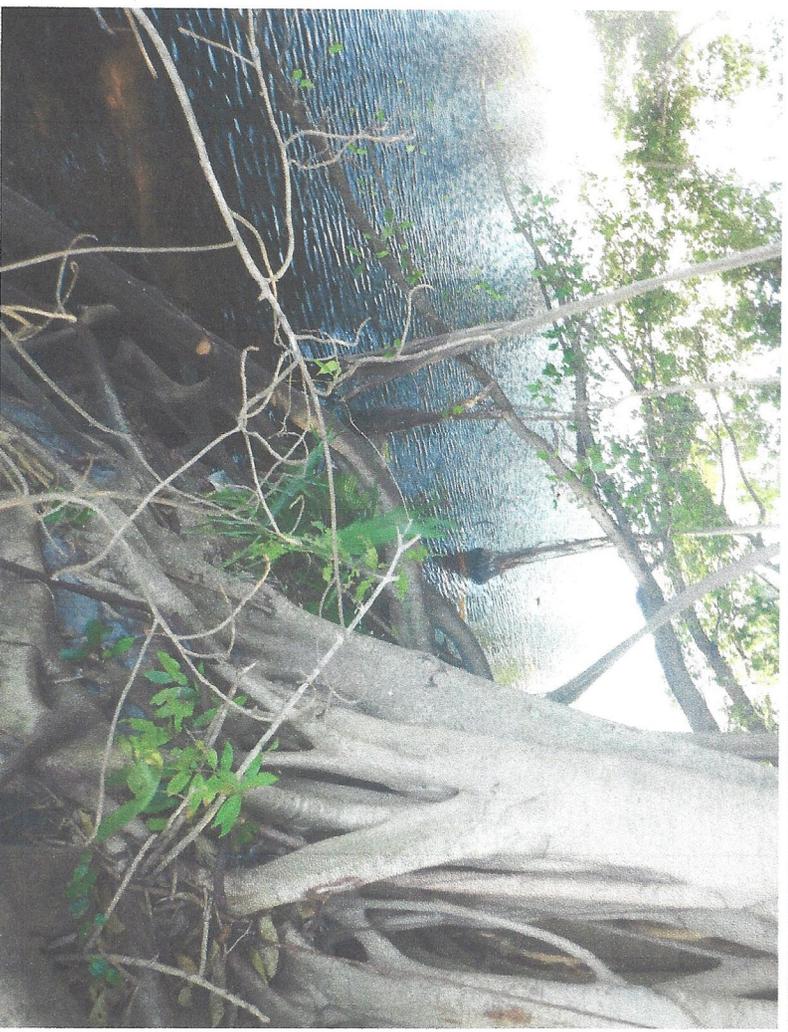
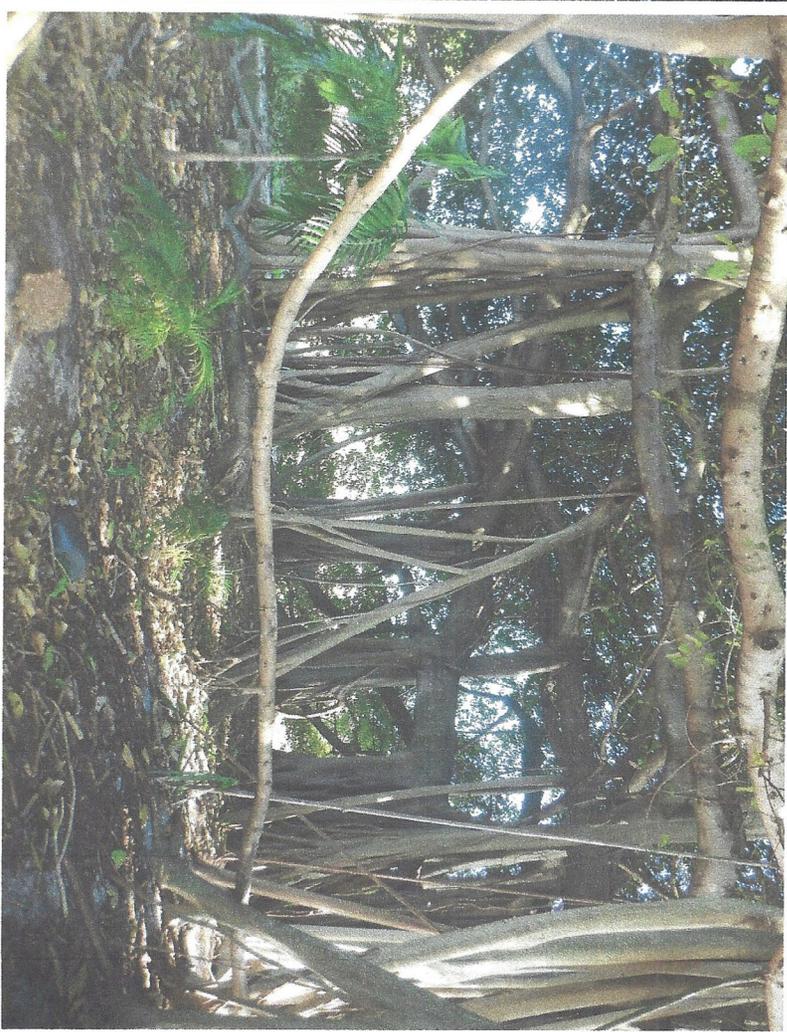
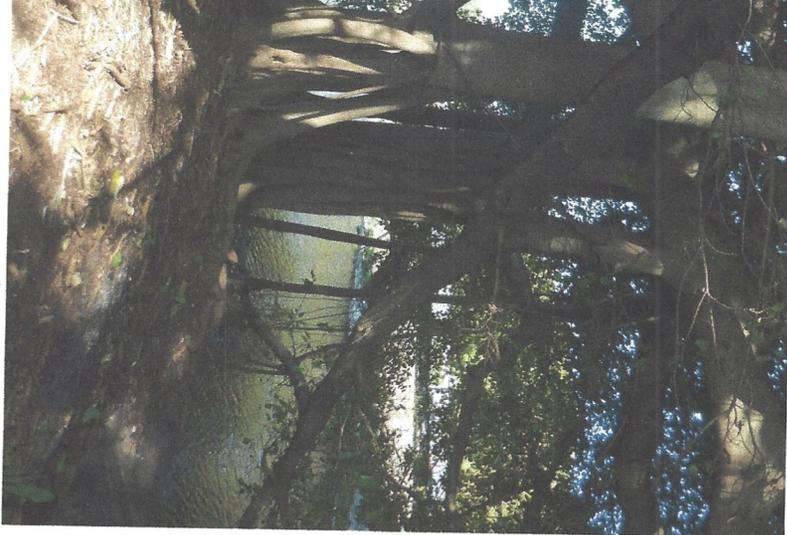
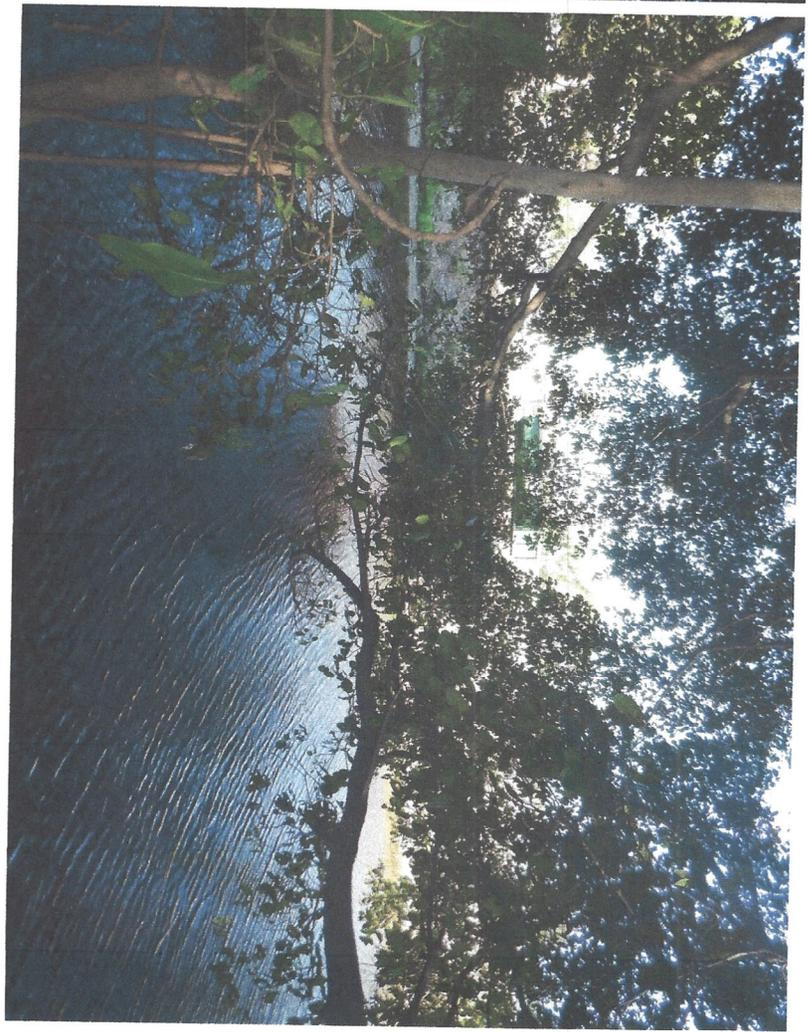
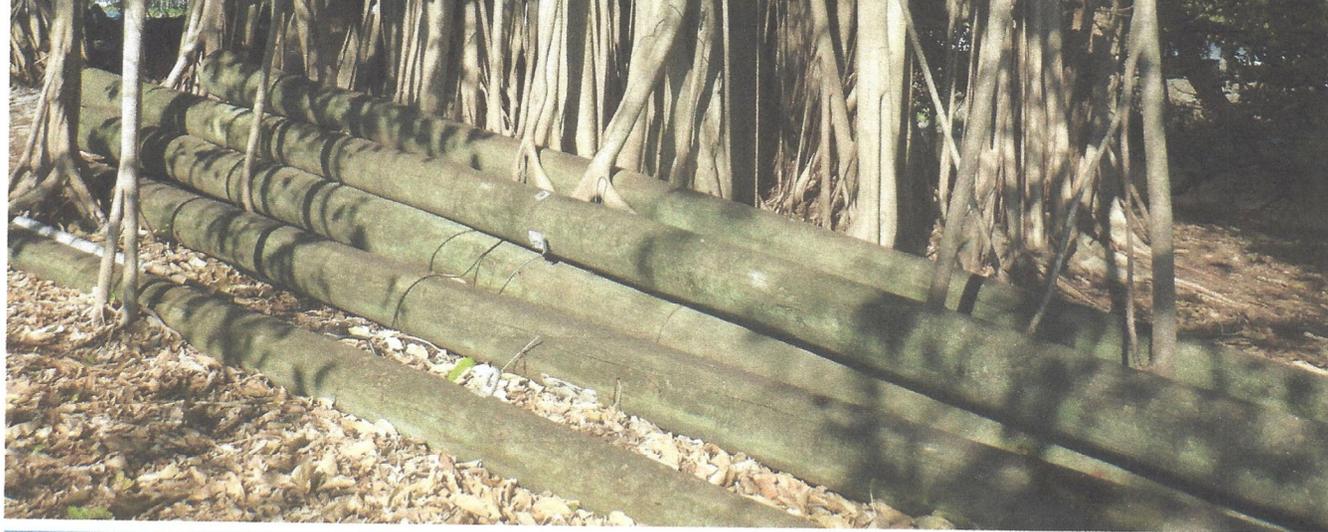
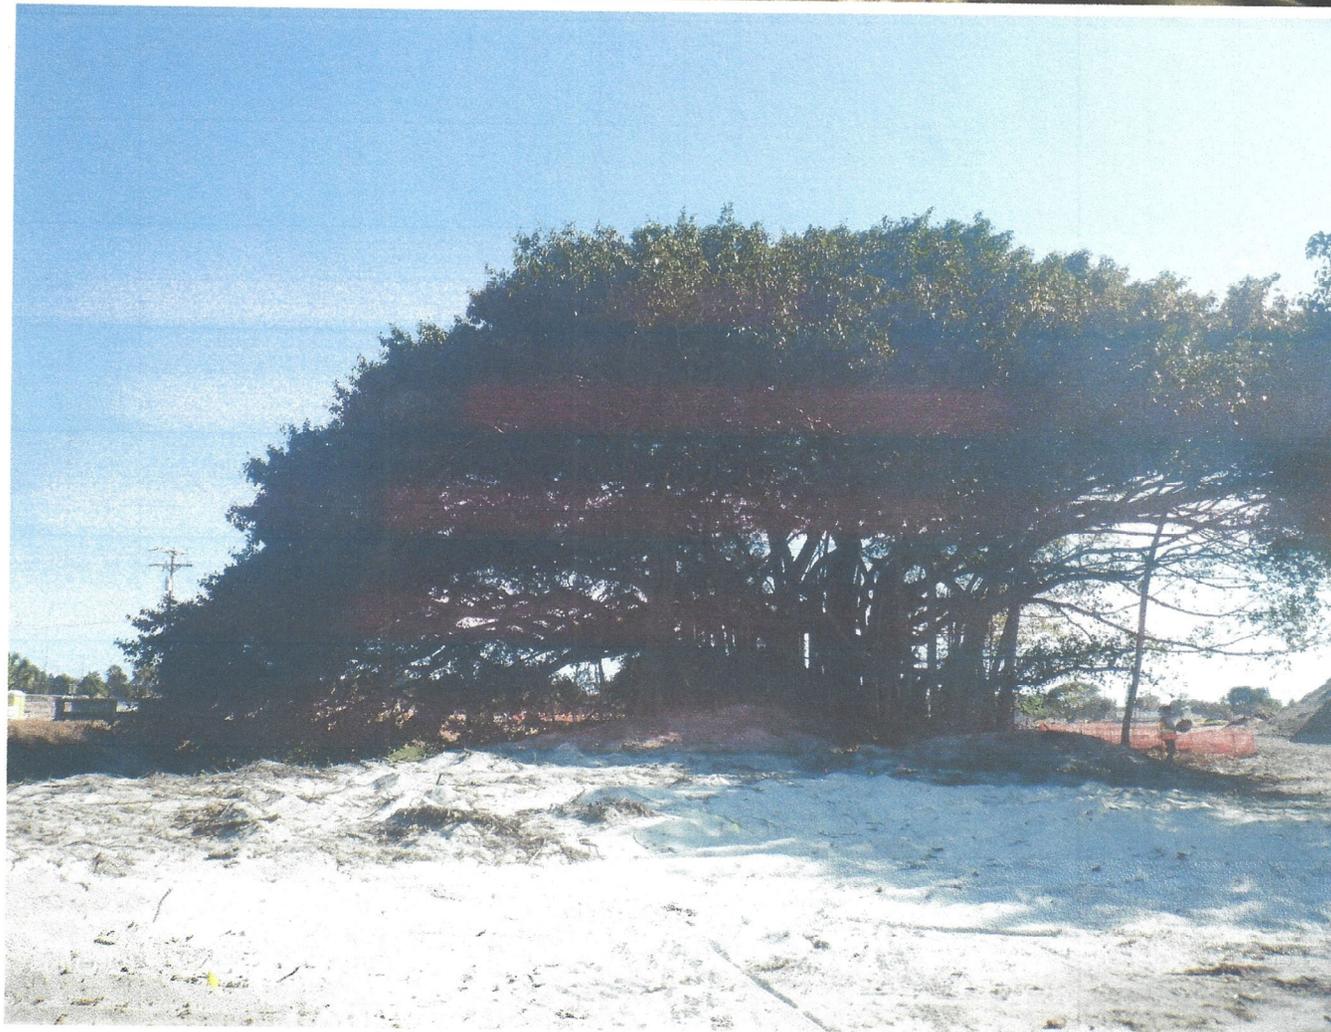
1. Approximately 98% of the tree is located within the LWDD easement.
2. The canopy extends significantly over the drainage canal, limiting maintenance access.
3. The mature root mass has expanded into the canal, seeking water sources and establishing growth within the canal bank managed by LWDD (see attached photos).

Based on the photographs and site assessment, the original trunk appears to have been approximately 30 feet from the canal's edge. Over the decades, aerial roots have established themselves, expanding the overall footprint of the tree. In addition to the primary trunk, there are approximately seven to eight secondary trunks formed from aerial roots, each now functioning as independent structural supports, with trunk diameters (DBH) ranging from approximately 8 to 14 feet.

- Remove the canopy portions that overhang and obstruct access to the canal for maintenance.
- Remove the root mass and appendage growth encroaching into the canal bank and waterway.
- Selectively remove appendages extending from the main trunk to allow for safe excavation of the root mass without compromising the primary structure of the tree.
- Create sufficient clearance to allow proper equipment access for ongoing LWDD canal maintenance.

This process would likely involve removing approximately 45–55% of the tree’s secondary growth. Following this structural reduction, I would implement corrective and restorative pruning in accordance with ANSI A300 standards.
