JANUARY 16, 2026

CREST THEATRE
CONCEPT DESIGN AND ASSESSMENT

DRAFT

PREPARED BY:
MILLS + SCHNOERING ARCHITECTS,LLC

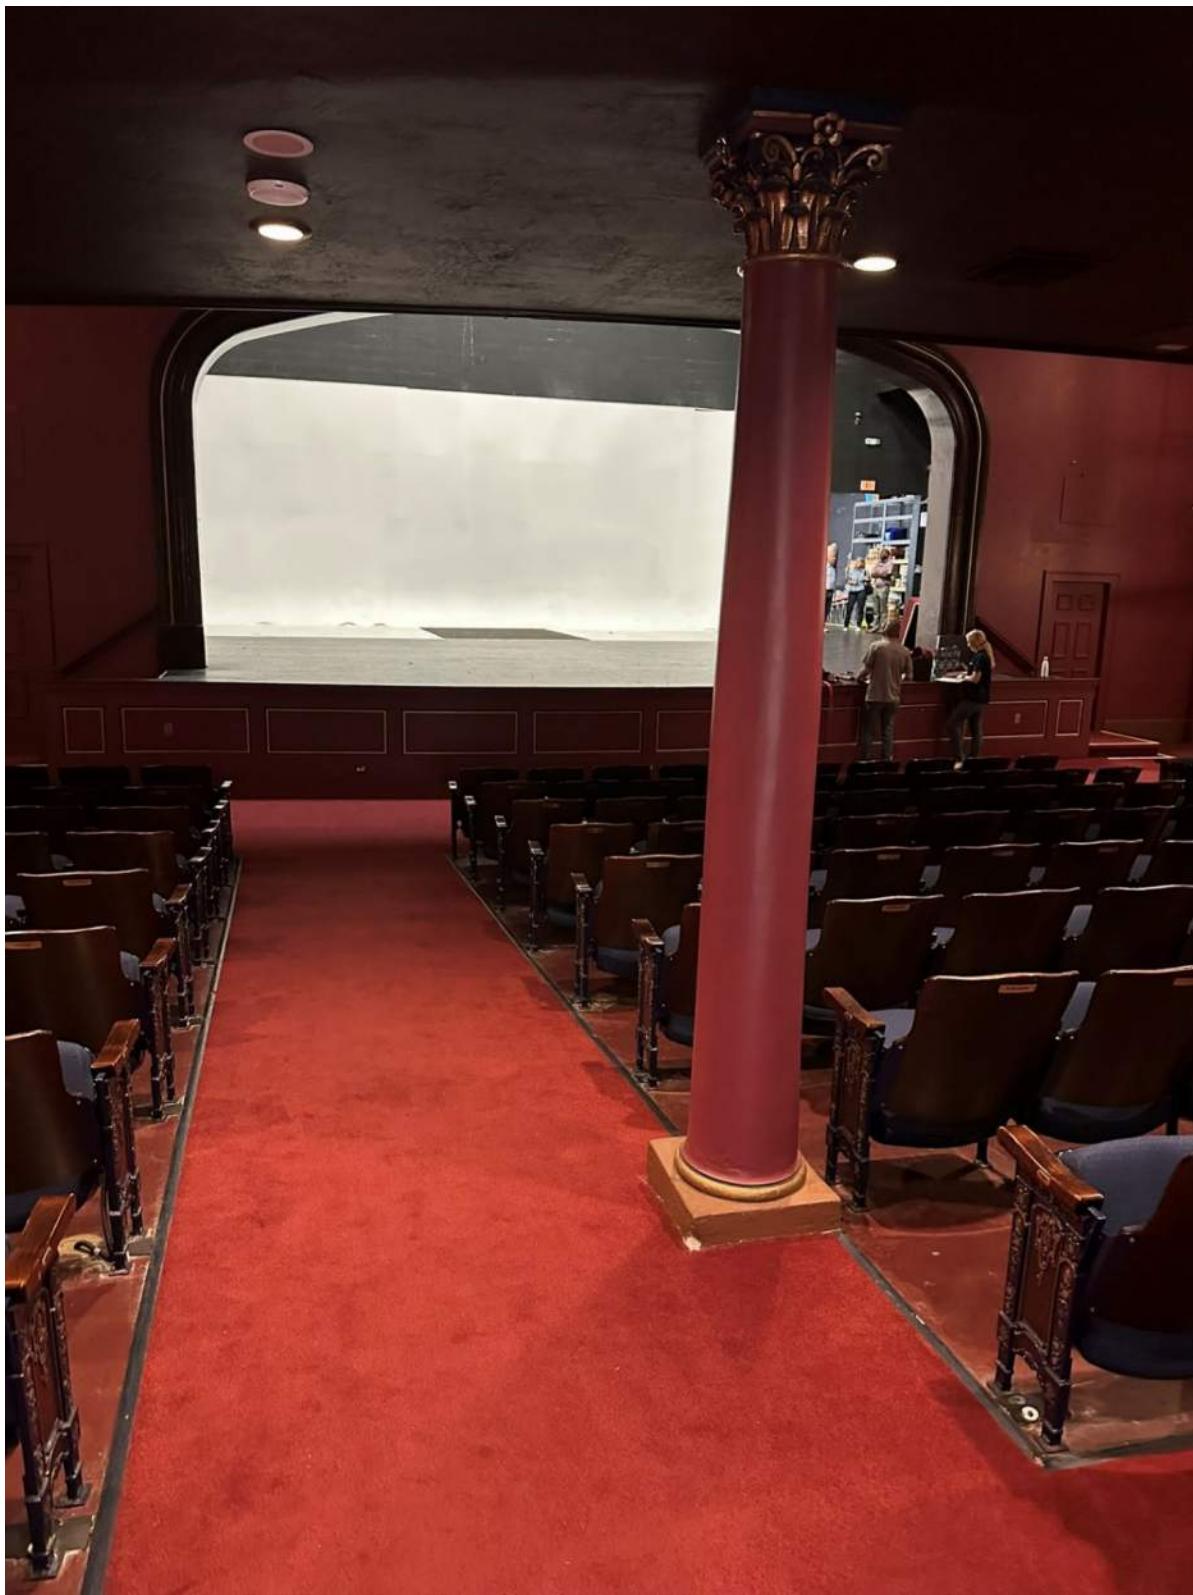
Conditions: **Fair condition**

There is evidence of water infiltration at the side doors from the roof leaders which direct drainage towards the door in the case of the north and into an enclosure in the case of the south.

The seats do not spring back in several locations which becomes an egress issue.

Figure 5. View of Auditorium looking towards stage.

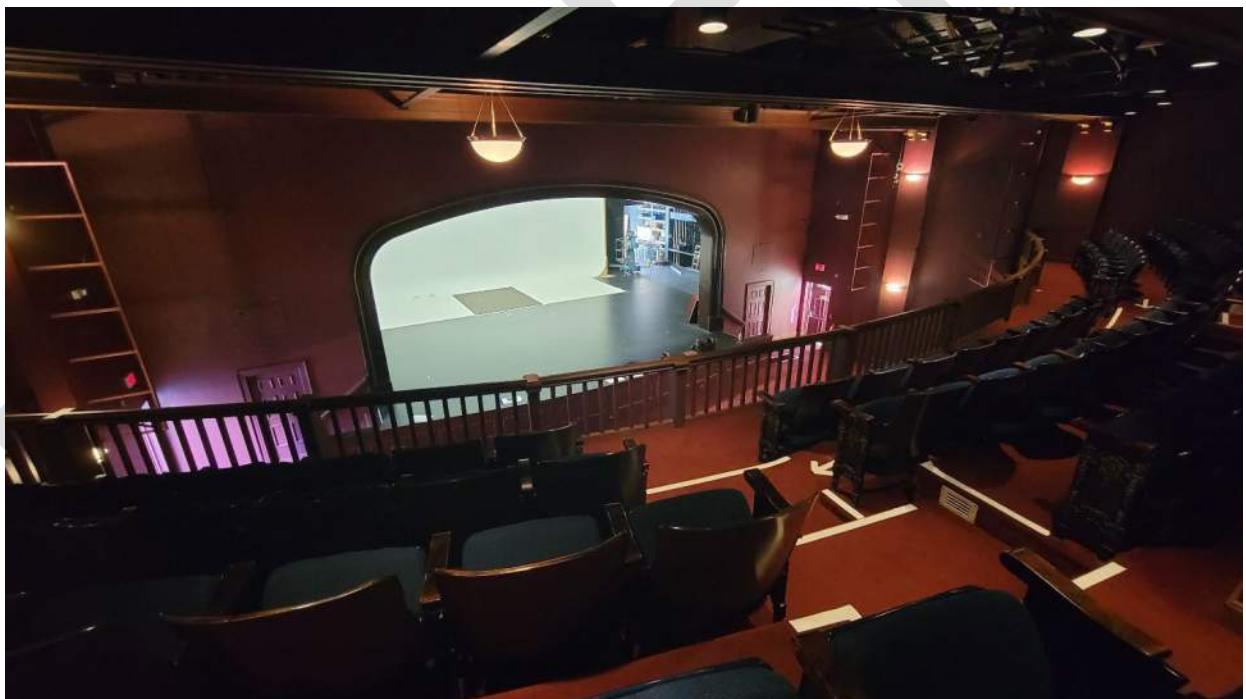
Conditions: **Fair condition**

Control booth windows are in poor condition.

Control rooms to remain require level access.

Figure 8. View of balcony looking towards Stage.

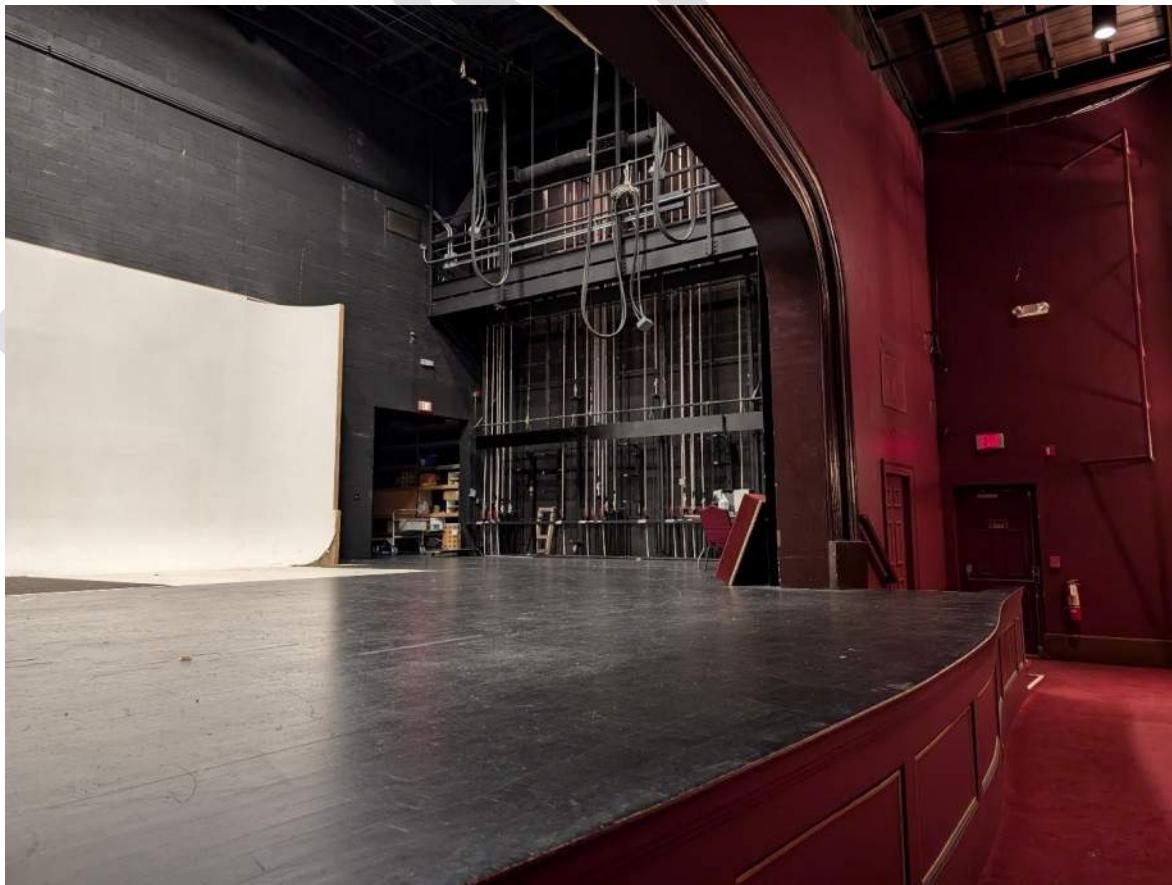
Conditions: **Fair condition**

Figure 12. Stage looking toward stage left and arbor tree.

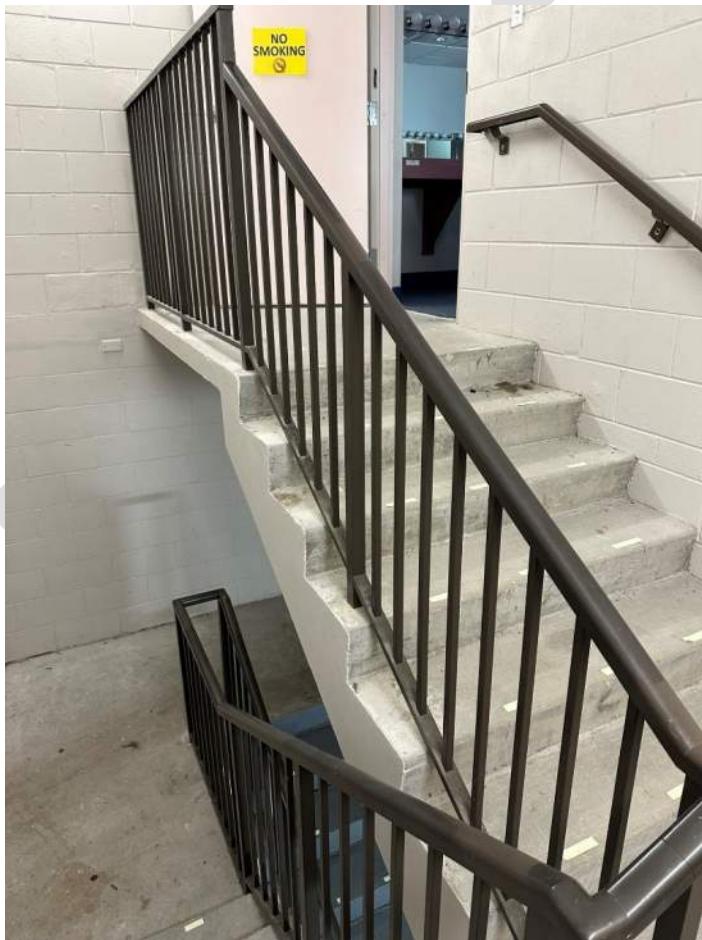
Figure 15. Stair 001

Conditions: **Fair condition.** Spalled CMU at building joint and minor finish conditions.

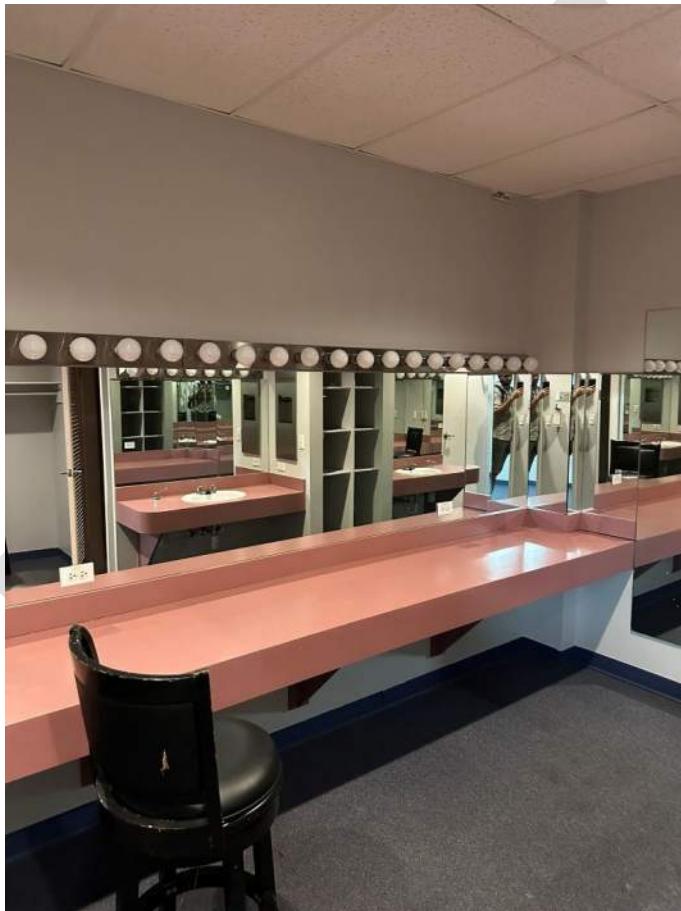
Conditions: **Fair condition.** Worn carpeting and dated finishes.

Figure 16. Typical first floor dressing room.

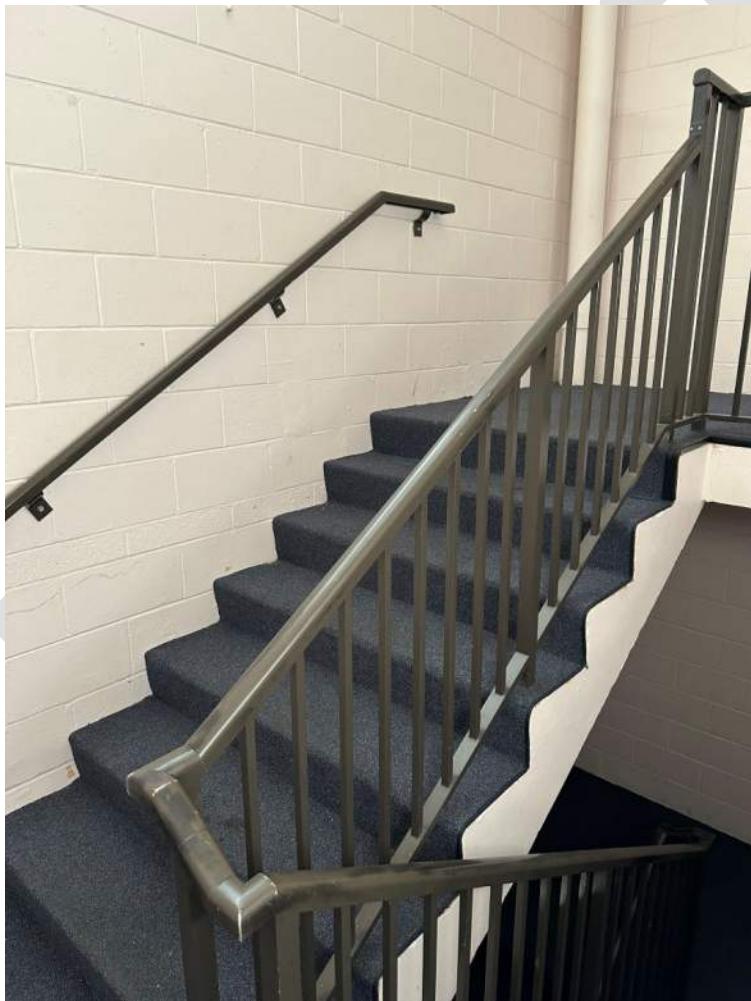
Figure 17. Stair 002

Conditions: Fair condition.

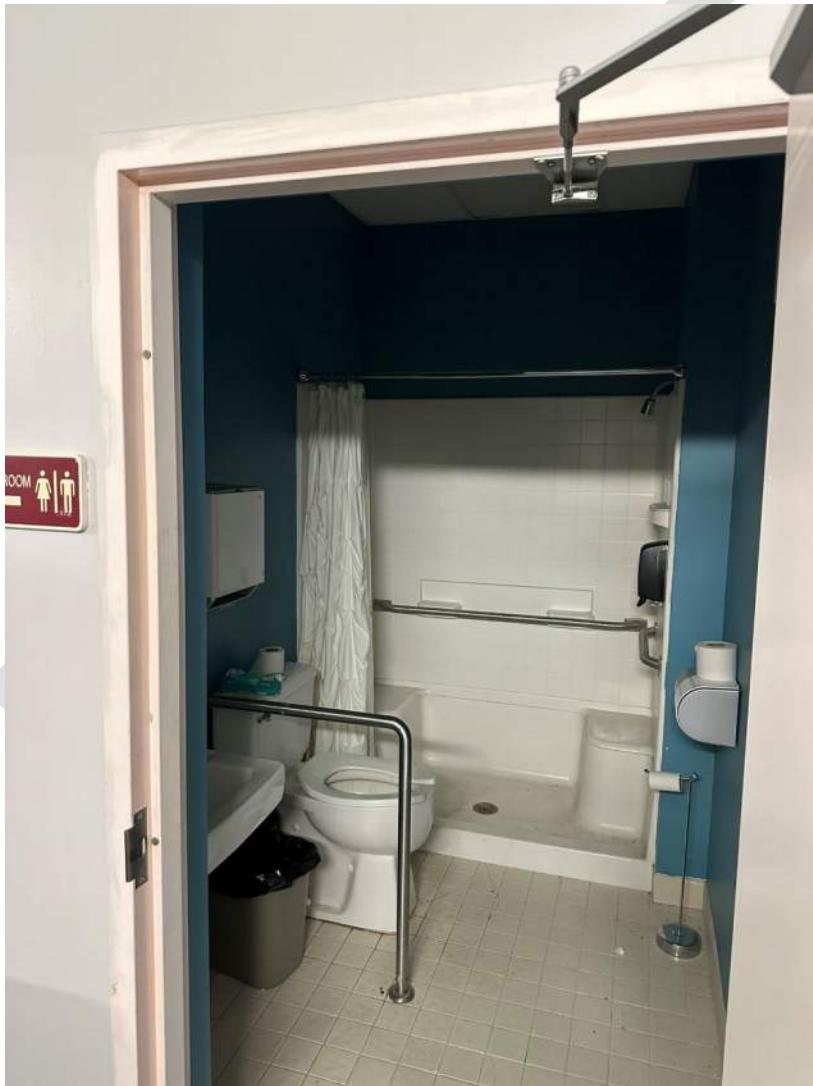
Figure 18. Toilet Room 003

Conditions: **Fair condition.** Stains at ceiling tiles.

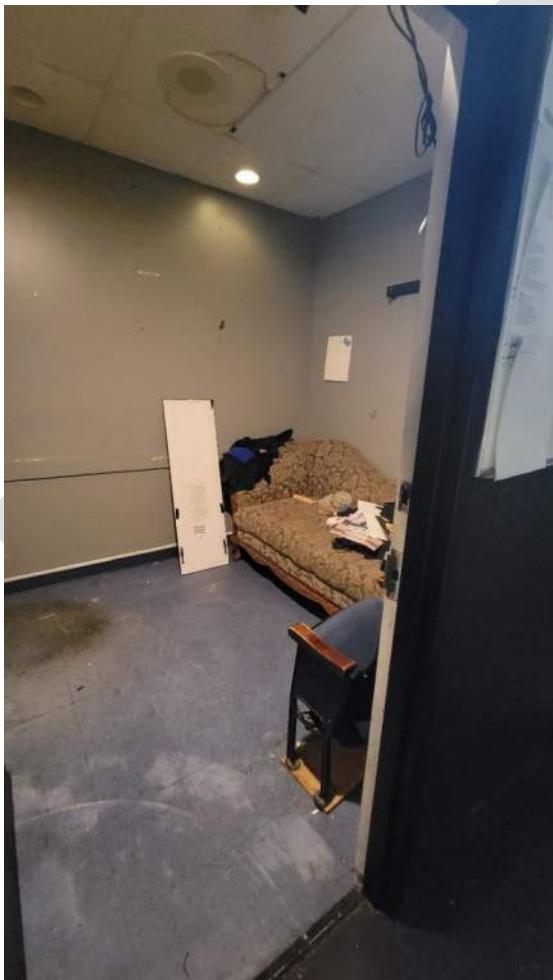
Figure 19. Back of House office

Conditions: **Poor condition.** Stains at ceiling tiles and floor.

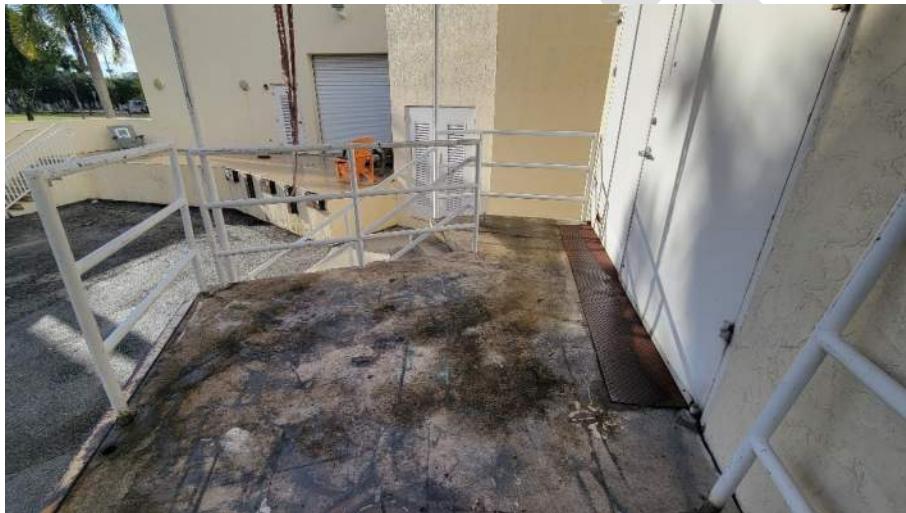
Conditions: The metal elements on the loading dock, including the lift are rusted and in need of replacement. Some of the stair railings have corroded and missing elements. The canopy is tattered and in need of replacement.

Figure 20. Loading dock looking towards loading dock for the adjacent Pavilion.

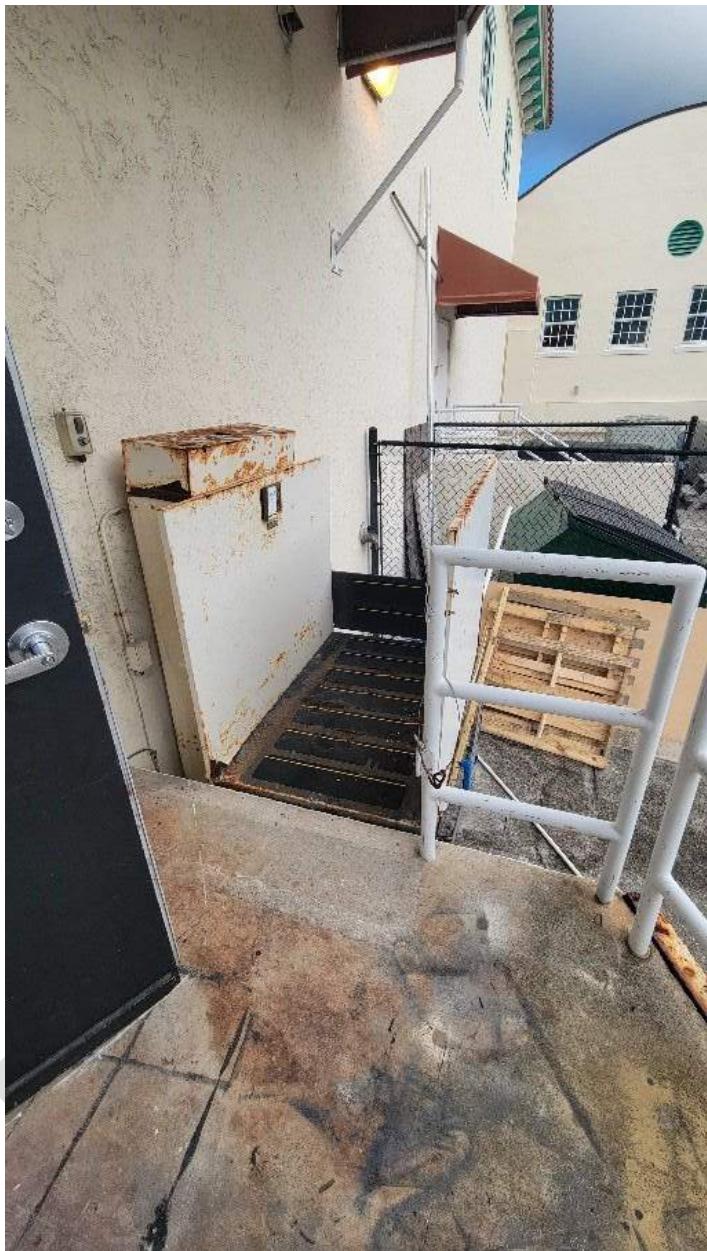
Figure 21. The existing lift at the loading dock is in poor condition.

The base option includes a replacement of the existing wheelchair lift at the loading dock. Exterior wheelchair lifts are not preferred because of their maintenance and longevity concerns due to exposure to the elements. Replacement of the exterior canopy at the loading dock is included in the base option and will provide better cover for the lift. A new egress door out of the loading and stage area is provided along with a new overhead rolling door for loading.

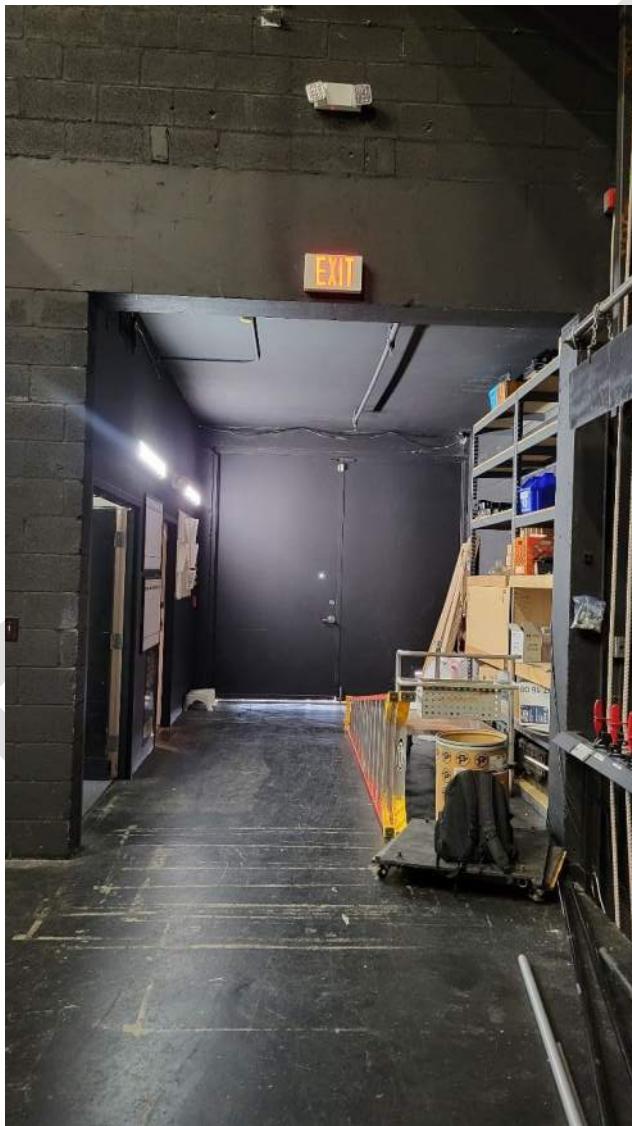
Condition: Fair condition

Figure 22. View of loading doors and loading area at the behind the stage.

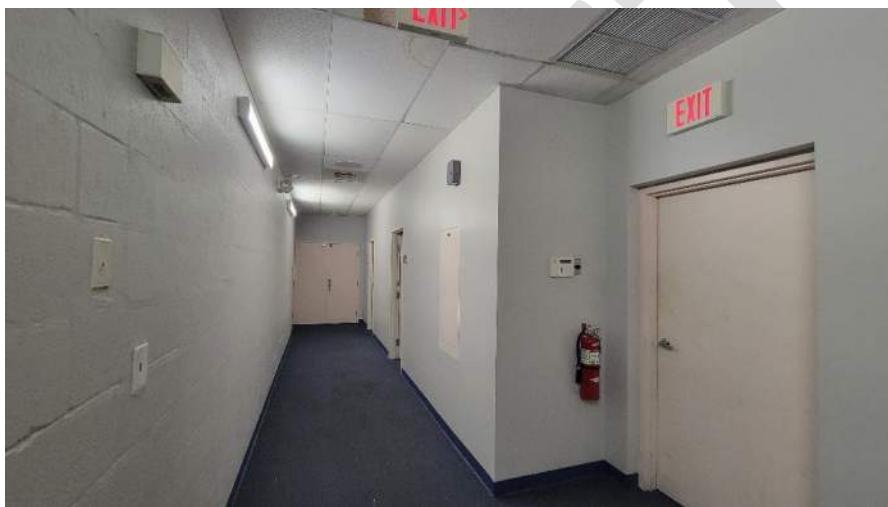
Condition: Fair condition; Carpet is stained.

Figure 23. Crossover hallway looking north.

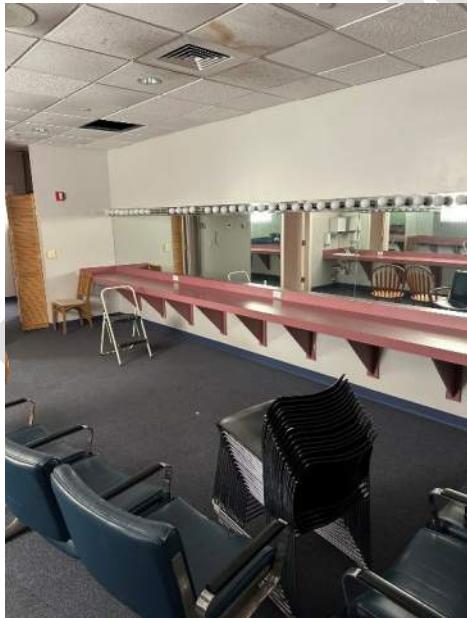
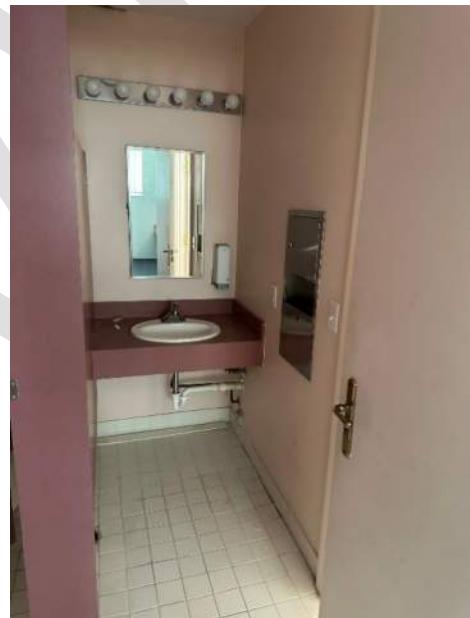
Condition: Fair condition; Ceiling tiles are stained. Wallboard ceilings in toilet rooms show mold growth.

Figure 25. Existing second floor dressing room and toilet room.

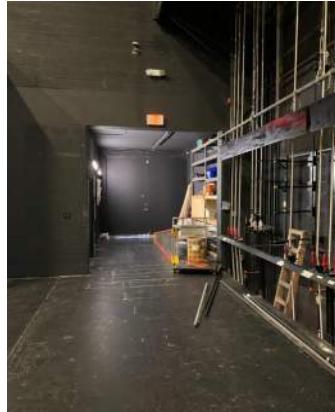
- 1. Stage Load-In Door:** There is currently a single door (pair) between loading dock and upstage left, and has a separate “pass-through door” to allow cabling to run from outside to inside. The door and pass-through door is not equipped with sound seals at perimeter and bottom, allowing light and sound from exterior to bleed into the performing area.

- 2. Stage Load-In Door: See photo above.** Raw opening in upstage wall leading to load-in corridor provides a potential light and sound issue, including access to stage level dressing room corridor/crossover during performances, unless blocked by stage draperies.

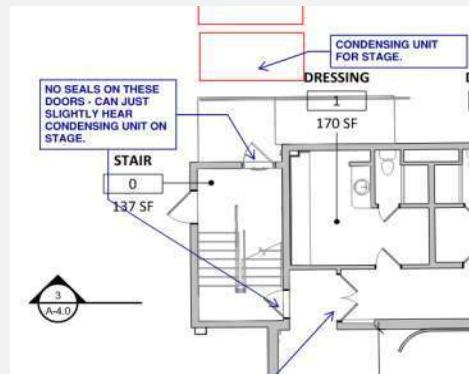
4. **Stair "0" Exterior Door USR:** Door opens directly to condensing unit for stage. Noise audible on stage through stairwell. Doors do not have perimeter sound gasketing.

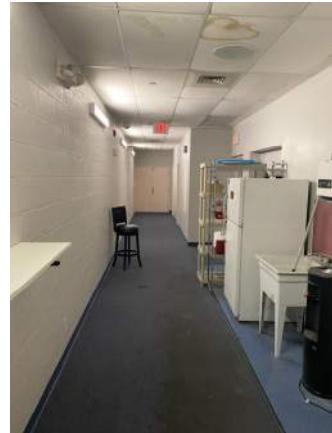
5. **BOH Dressing Areas:** Areas are served by in-ceiling and closet-type fan coil units that have been recently replaced/installed per discussion with DPW employees. Noise from these units, particularly in the hallway on level 2, is evident (not problematic), but may be deemed acceptable given the nature of these spaces. Noticeable vibration from rooftop air handler unit serving stage, but vibration (low frequency rumble) appears to be confined to the BOH area and does not appear to be affecting stage or theater spaces. First floor corridor opens on both sides directly onto the stage and can be problematic from a light and sound bleed aspect if doors are left open during performances (as we expect they do).

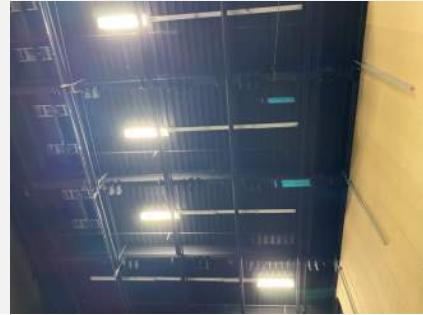
6. Stage Smoke Hatches: Shown to left of photo. Review of rigging report (9/24/24) indicates these hatches do not have hatch release cables connected to fire protection systems and are reported to have light intrusion, indicating some loss of weather protection (not observed). Systems should be fully inspected.

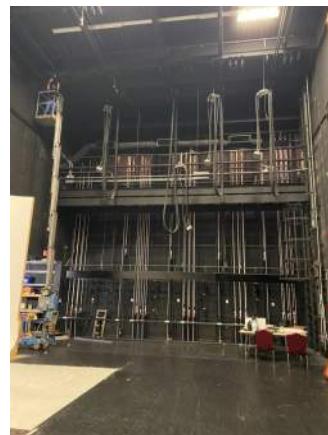
7. Stage Supply and return systems: Systems are provided at high level sides (supply), with two return grilles at upper Up-Stage wall. Systems was in operation at time of visit and appear to be working appropriately and sufficiently quiet. Verification with earlier drawings (1992) shows these systems having appropriate noise control features including silencers and internally lined ductwork.

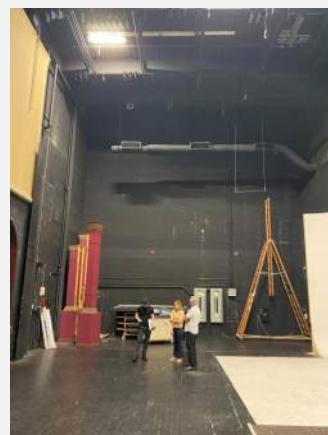
8. Stagehouse: CMU construction and appears to be sufficient to protect from outside noises (doors are weak links however). Roof construction was not verified at time of visit and not possible to assess adequate protection from rain noise. Stage in it's raw condition is reverberant, and this reverberation bleeds into the house and can lead to difficulty in audio clarity in the house. Use of stage draperies will reduce this effect. Permanent installation of sound absorbing materials at underside of roof deck and upper wall surfaces can also reduce this effect with or without use of stage draperies.

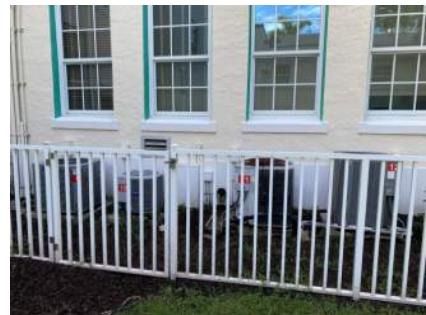
Condensers located adjacent to house left theater door. These serve other areas of the building and are currently protected by open fencing – this does not prevent noise transmission into the theater through the door.

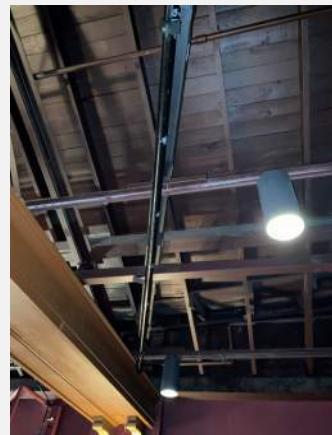
**12. Theater Roof:** the ceiling over the theater audience seating is exposed wood plank, supported by the structural roof system. Roof construction has not been identified/confirmed, nor has it been identified when the roof has undergone any significant repair or replacement. It is currently unknown if there are any negative issues related to rain noise into the theater, and these should be identified through further investigation, and addressed in concert with any future roof improvements.

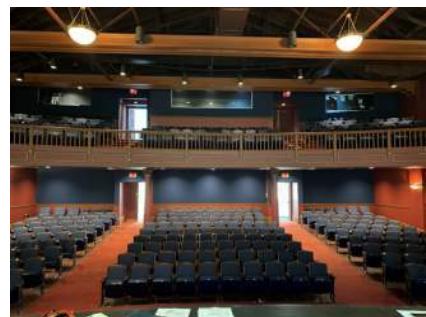
**13. Theater Interior:** Theater walls appear to be gypsum board with no insulation in cavity (hollow when thumped) and most likely furred out from CMU or concrete structural substrate. Flooring is painted/stained concrete under seating areas with carpeting in main circulation aisles, front and rear. 1" thick acoustic panels are installed on upper half of rear walls on both main and balcony levels and are in good condition. The room feel is intimate and sounds

appropriately controlled with the current finishes with no excessive reverberation other than that emanating from the empty stagehouse. It should be noted that some seating areas in the balcony do have compromised sightlines to all parts of the stage, even with open balcony rail.

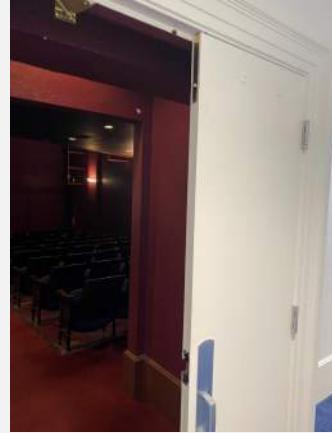
15. Theater Entry Doors from Lobby: Entry to the theater from Lobby is through one set of double doors (two entry points at each level). Entry doors do not have perimeter sound/light gasketing. This combination can lead to significant light and noise issues between the theater and lobby. Each entry point does appear to lead to a small vestibule before entering the theater – an additional set of doors or curtain may be explored to reduce sound/light bleed. The need for panic hardware on all entry doors also increases risk of noticeable noise and annoyance in the theater during performances.

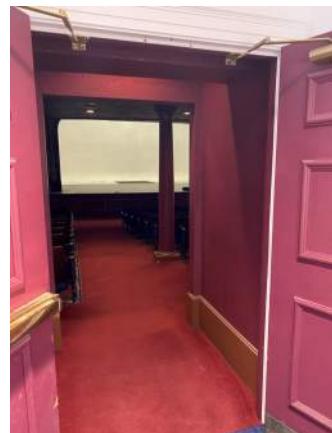
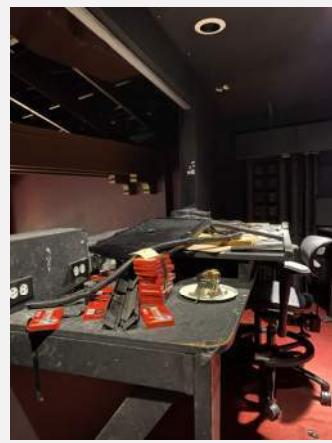
16. Control Rooms (House Left/Right): These rooms are small but functional for single users. Windows to the theater are currently single pane $\frac{1}{4}$ " glass in what appears to be a medium duty operable (sliding) track system. All glazing is installed vertically in the wall. Thickness of glass is typically not appropriate to block operator voices from audience members seated nearby. Door to balcony level is not equipped with sound gasketing, making conversations by operators potentially audible in the audience area.

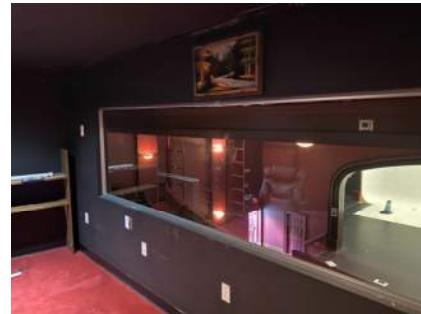
17. Followspot Room: Appropriate size and condition. Door to balcony level is not equipped with perimeter sound gasketing making conversations by operators potentially audible in the audience area. Glazing is single layer $\frac{1}{4}$ " glass in aluminum frame, installed vertically in wall opening. Thickness, type and angle of glass may not be appropriate to reduce light reflection from followspots nor audience members from hearing operator conversations.

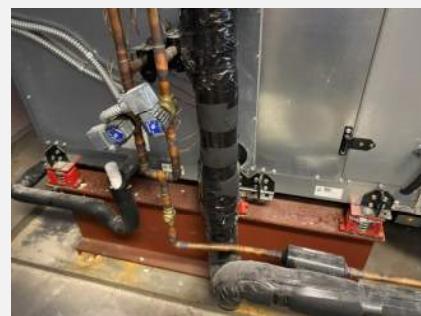
18. Theater Air Handling Room: Supply air handler serving the Theater audience area is located in a dedicated room within the Electrical Room remote from, but adjoining, the Theater. As such there is no noise impact to the theater from this unit, nor from the supply ductwork system which appears to be properly equipped with lined ductwork and silencers. This unit is installed on top of plenum systems with steel rails and external spring isolators.
