**LISA H. HAMMER, RCA**  
*Horticultural Consultant*

March 23, 2022  
(Rev. May 28, 2022)

RE: 408 S.E. 2<sup>nd</sup> Street  
Delray Beach, Florida

**PHOTOGRAPHS OF EXISTING TREES**

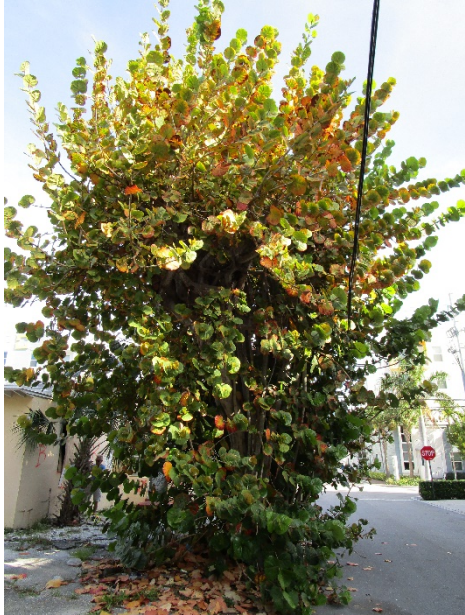
Tree #1 – Seagrape

| Tree # | Common Name | Scientific Name | Trunk Diameter (in) | Overall Height (ft) | Crown Spread (ft) | Condition (%) | Disposition | Comments |
|---|---|---|---|---|---|---|---|---|
| 1 | Seagrape | <i>Coccoloba uvifera</i> | 16+7+7+12+8+5+5 | 30 | 26 | 60 | Retain or Remove | topped at 4' above grade; all leaders are suckers; roots cut by street; crown in powerlines |

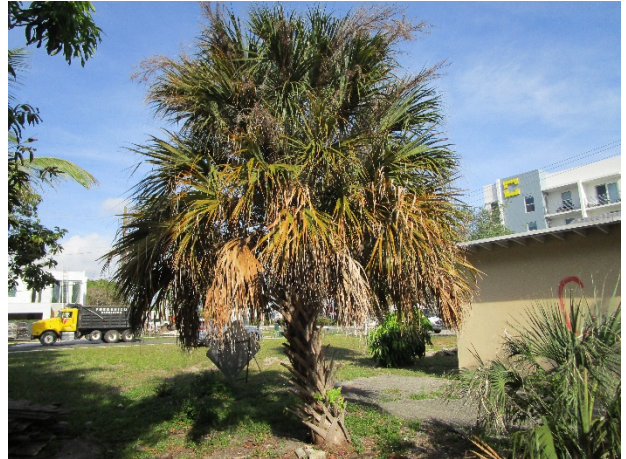
Tree #2 – Cabbage Palm

| Tree # | Common Name | Scientific Name | Trunk Diameter (in) | Overall Height (ft) | Crown Spread (ft) | Condition (%) | Disposition | Comments |
|---|---|---|---|---|---|---|---|---|
| 2 | Cabbage Palm | <i>Sabal palmetto</i> | 14 | 22 | 12 | 75 | Retain, Remove, or Relocate | curved trunk; minor nutritional deficiencies |

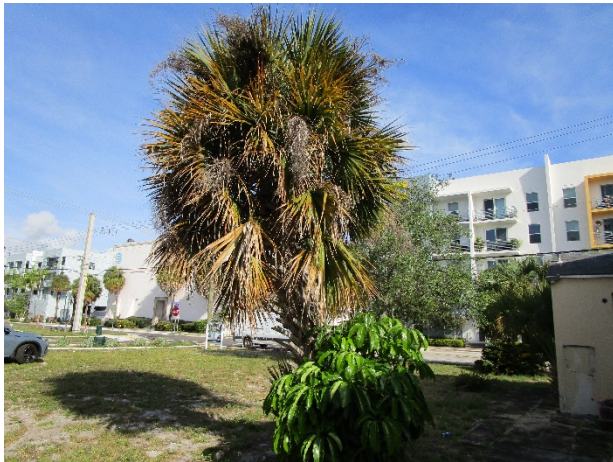
Tree #3 - Cabbage Palm and  
Tree #11 – Queensland Umbrella

| Tree # | Common Name | Scientific Name | Trunk Diameter (in) | Overall Height (ft) | Crown Spread (ft) | Condition (%) | Disposition | Comments |
|---|---|---|---|---|---|---|---|---|
| 3 | Cabbage Palm | <i>Sabal palmetto</i> | 15 | 22 | 12 | 75 | Retain, Remove, or Relocate | curved trunk; minor nutritional deficiencies |
| 11 | Queensland Umbrella | <i>Schefflera actinophylla</i> | stump - 18 | 5 | 8 | 5 | Remove | stump with suckers; Category I invasive species |

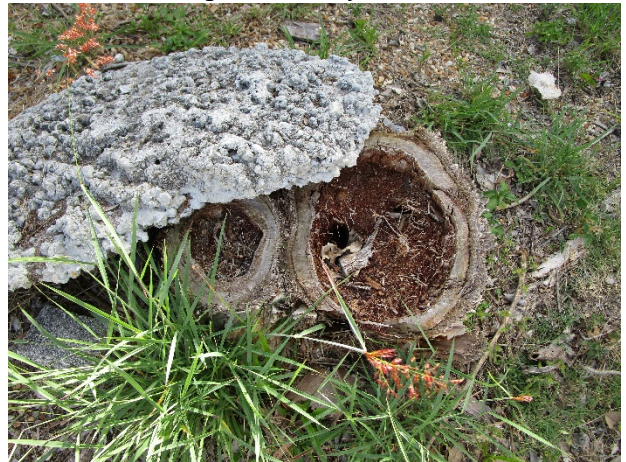
Tree #4 – Stump – Possibly Melaleuca

| Tree # | Common Name | Scientific Name | Trunk Diameter (in) | Overall Height (ft) | Crown Spread (ft) | Condition (%) | Disposition | Comments |
|---|---|---|---|---|---|---|---|---|
| 4 | Unknown | <i>Unknown</i> | 10 + 6 | 0 | 0 | 0 | Remove | Stump. Possibly Melaleuca Tree, a Category I invasive species |

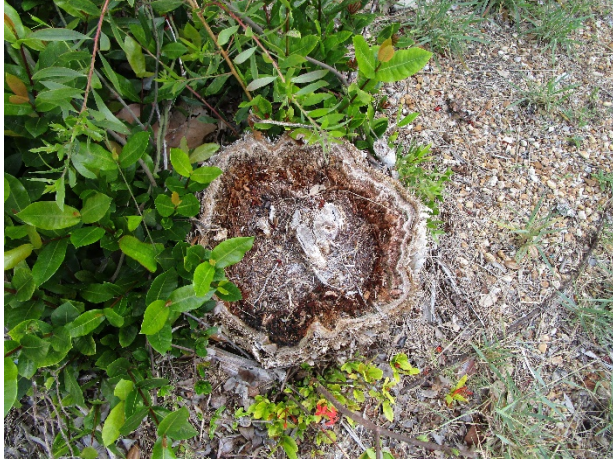
Tree #5 – Stump – Possibly Melaleuca

| Tree # | Common Name | Scientific Name | Trunk Diameter (in) | Overall Height (ft) | Crown Spread (ft) | Condition (%) | Disposition | Comments |
|---|---|---|---|---|---|---|---|---|
| 5 | Unknown | <i>Unknown</i> | 12 | 0 | 0 | 0 | Remove | Stump. Possibly Melaleuca Tree, a Category I invasive species |

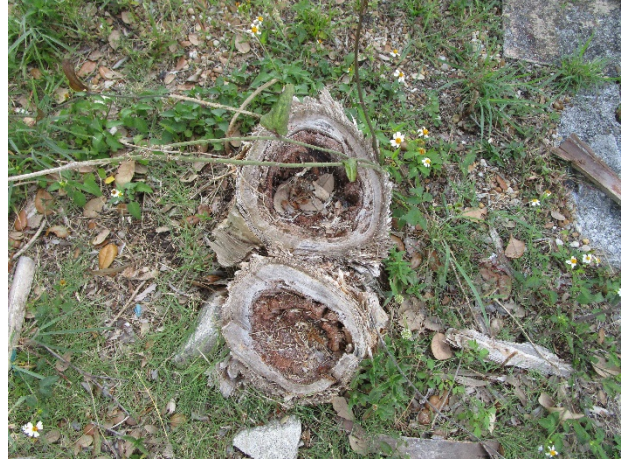
Tree #6 – Stump – Possibly Melaleuca

| Tree # | Common Name | Scientific Name | Trunk Diameter (in) | Overall Height (ft) | Crown Spread (ft) | Condition (%) | Disposition | Comments |
|---|---|---|---|---|---|---|---|---|
| 6 | Unknown | <i>Unknown</i> | 7 + 8 | 0 | 0 | 0 | Remove | Stump. Possibly Melaleuca Tree, a Category I invasive species |

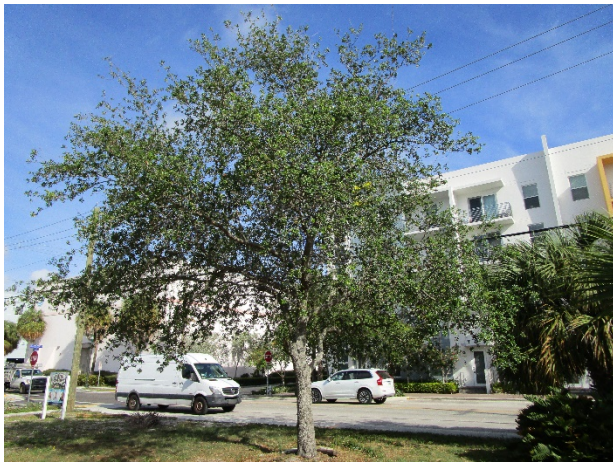
Tree #7 – Live Oak

| Tree # | Common Name | Scientific Name | Trunk Diameter (in) | Overall Height (ft) | Crown Spread (ft) | Condition (%) | Disposition | Comments |
|---|---|---|---|---|---|---|---|---|
| 7 | Live Oak | <i>Quercus virginiana</i> | 11 | 25 | 28 | 80 | Retain or Relocate | root-pruned |

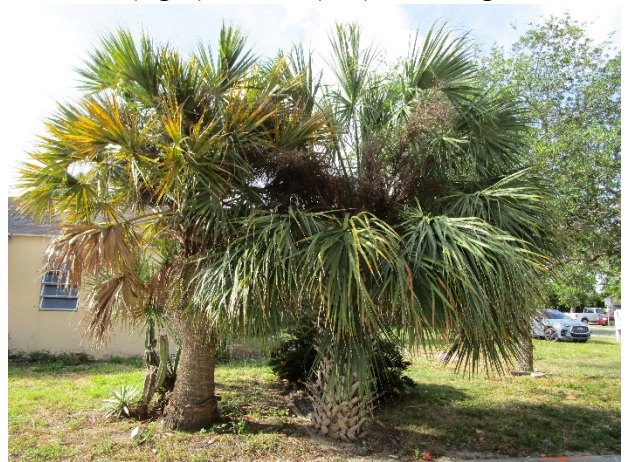
Trees #8 (right) and #9 (left)– Cabbage Palms

| Tree # | Common Name | Scientific Name | Trunk Diameter (in) | Overall Height (ft) | Crown Spread (ft) | Condition (%) | Disposition | Comments |
|---|---|---|---|---|---|---|---|---|
| 8 | Cabbage Palm | <i>Sabal palmetto</i> | 18 | 18 | 12 | 85 | Retain, Remove, or Relocate | |
| 9 | Cabbage Palm | <i>Sabal palmetto</i> | 14 | 18 | 12 | 80 | Retain, Remove, or Relocate | |

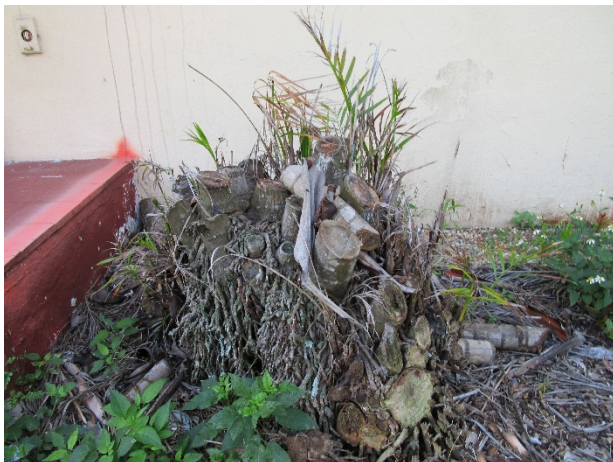
Tree #10 – Areca Palm

| Tree # | Common Name | Scientific Name | Trunk Diameter (in) | Overall Height (ft) | Crown Spread (ft) | Condition (%) | Disposition | Comments |
|---|---|---|---|---|---|---|---|---|
| 10 | Areca Palm | <i>Dypsis lutescens</i> | 15 @ 2-3 | 2 | 0 | 5 | Remove | Stems all cut down to base |

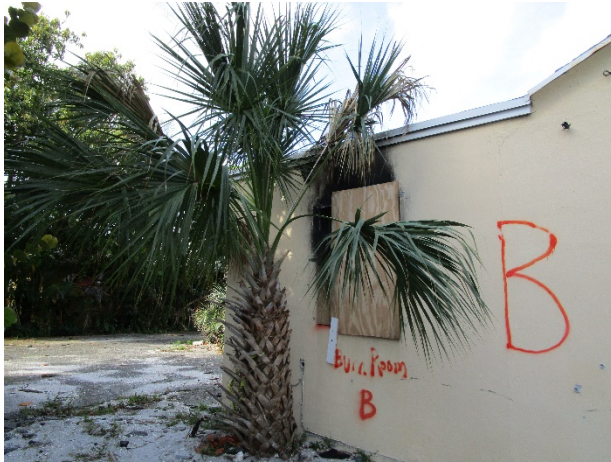
Tree #12 – Cabbage Palm

| Tree # | Common Name | Scientific Name | Trunk Diameter (in) | Overall Height (ft) | Crown Spread (ft) | Condition (%) | Disposition | Comments |
|---|---|---|---|---|---|---|---|---|
| 12 | Cabbage Palm | <i>Sabal palmetto</i> | 16 | 12 | 12 | 75 | Retain, Remove, or Relocate | add to survey on east side of existing house |
