**Steve Siebert Architecture**  
466 N. Federal Hwy.  
Boynton Beach, Florida 33435  
ph. 561.880.7894  
*AR 0017834*

### **DEMOLITION JUSTIFICATION STATEMENT**

For the Accessory use garage structure located in the “rear-yard” located at:  
131 SE 7<sup>th</sup> Avenue

### Damage report.

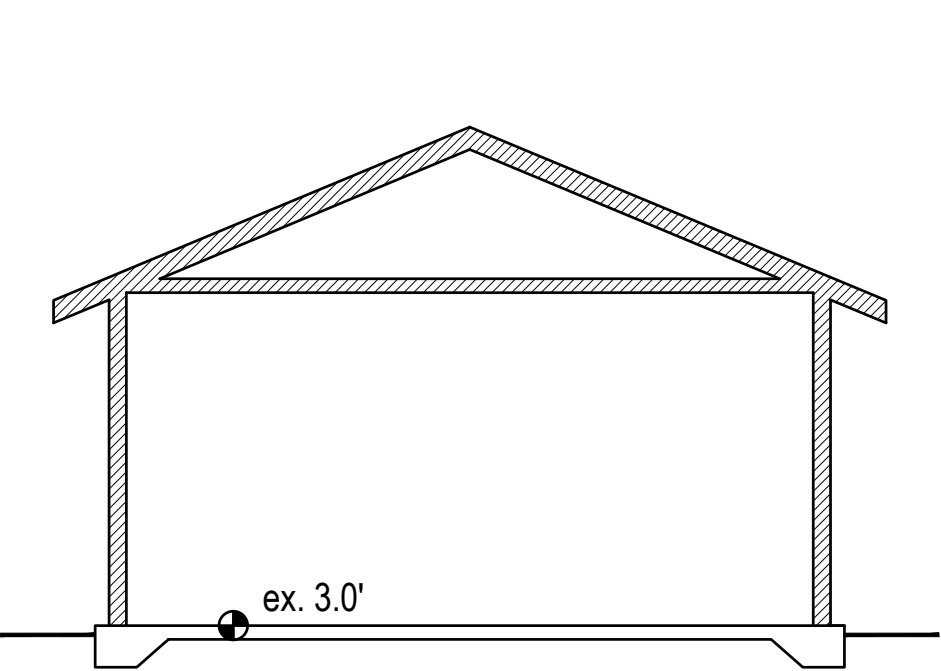
Existing Garage (as is) in flood zone

As noted on the survey the garage is currently 2.5' in flood zone AE-6. The minimum required base floor elevation, in-this-zone, for a wood-frame structure (per FEMA) is  $5.0' + 1' = 6.0'$ . This requires us to raise the existing wood structure a minimum of 3.5' to comply.

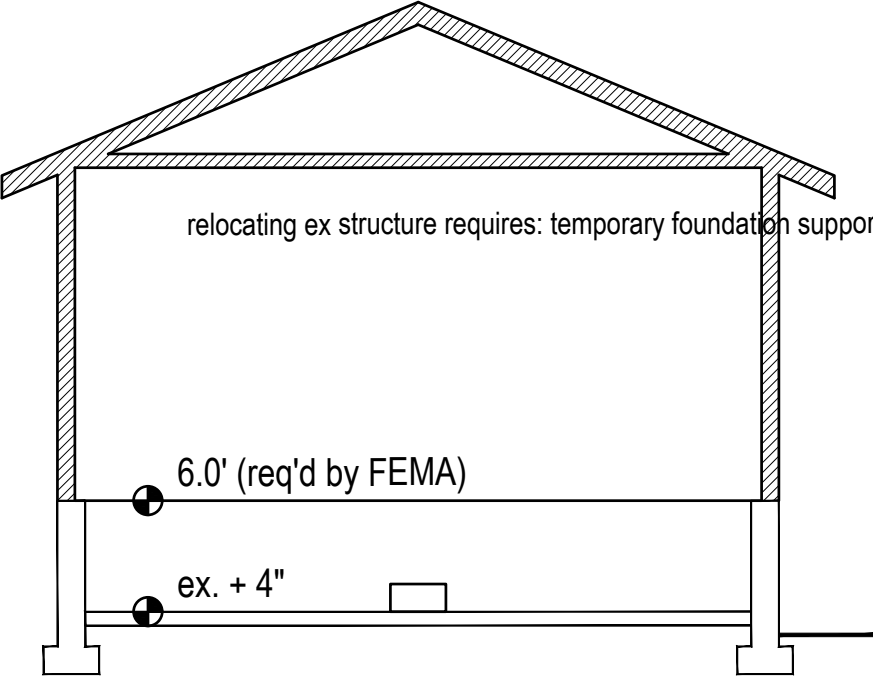
Repair OPTION #1  
replace current foundation with new poured concrete (elevation walls) include flood vents as req'd.

option #1 (estimated \$20,000) includes moving structure

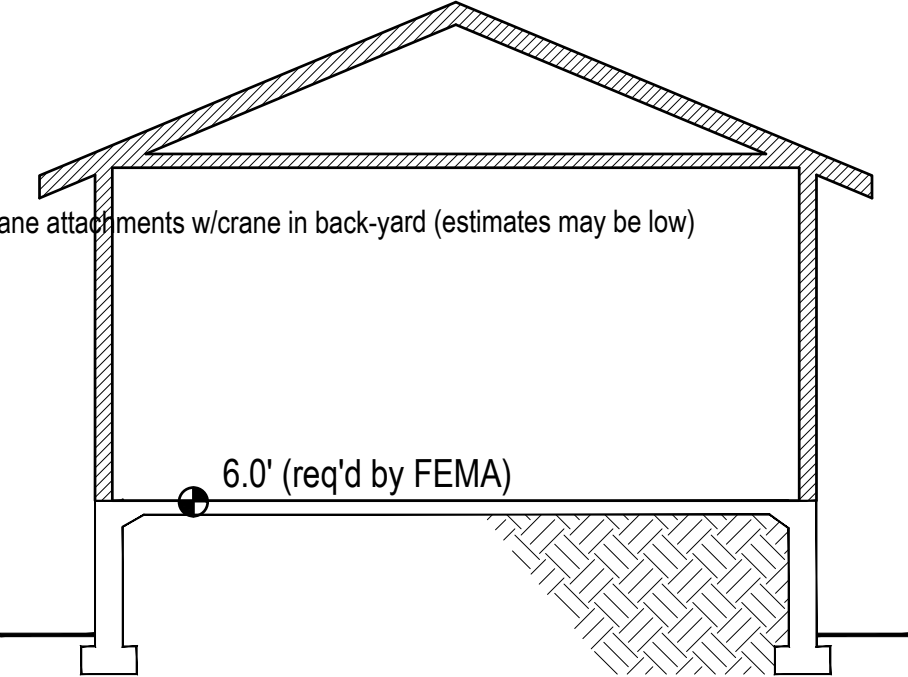
Repair OPTION #2  
replace current foundation with foundation set at required flood elevation 5'-0" = 1' = 6.0'

option #2 (estimated \$23,500) includes moving structure (excludes ramp to provide access)\* not feasible
