# **INSPECTION REPORT**

**145 NE 6TH AVE  
DELRAY BEACH, FL 33483**

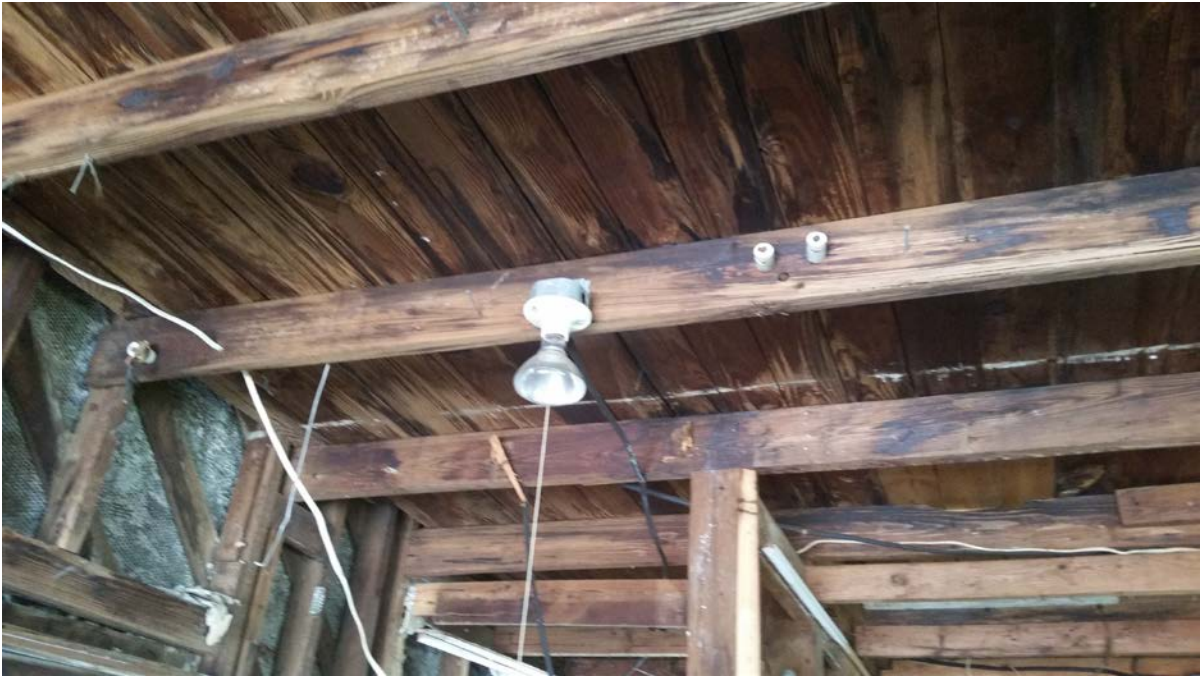
Exhibit 3. Water damaged roof joist, decking and ledger board

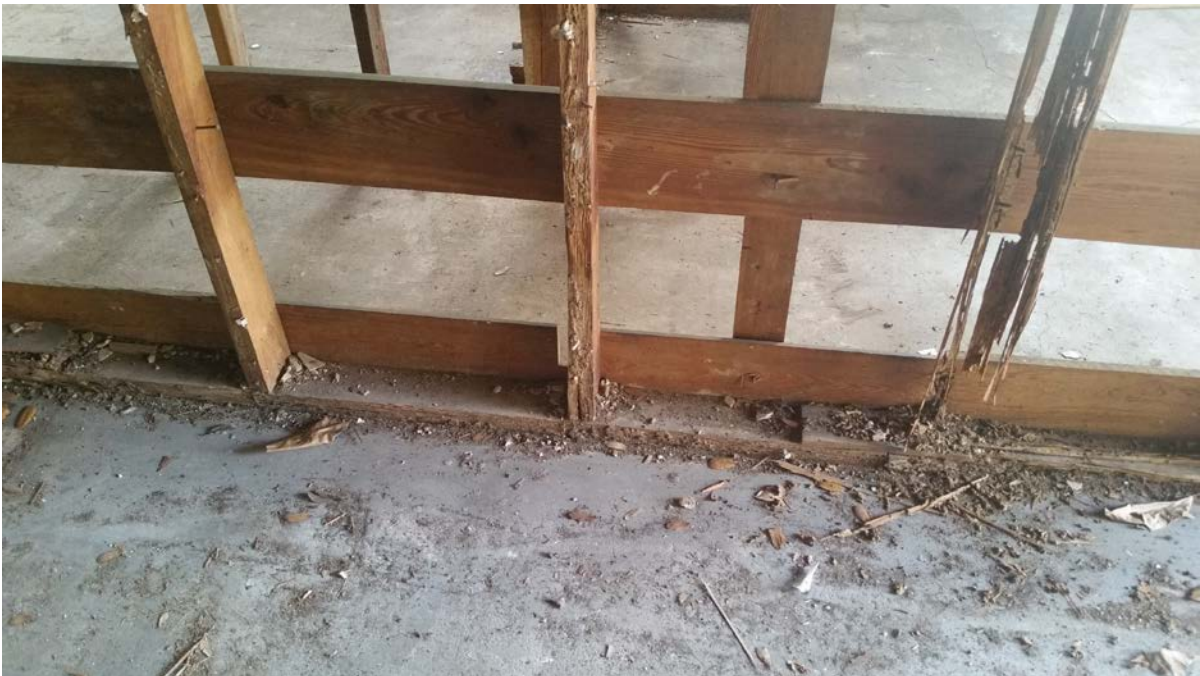
Exhibit 4. Typical missing/eroded wood wall studs

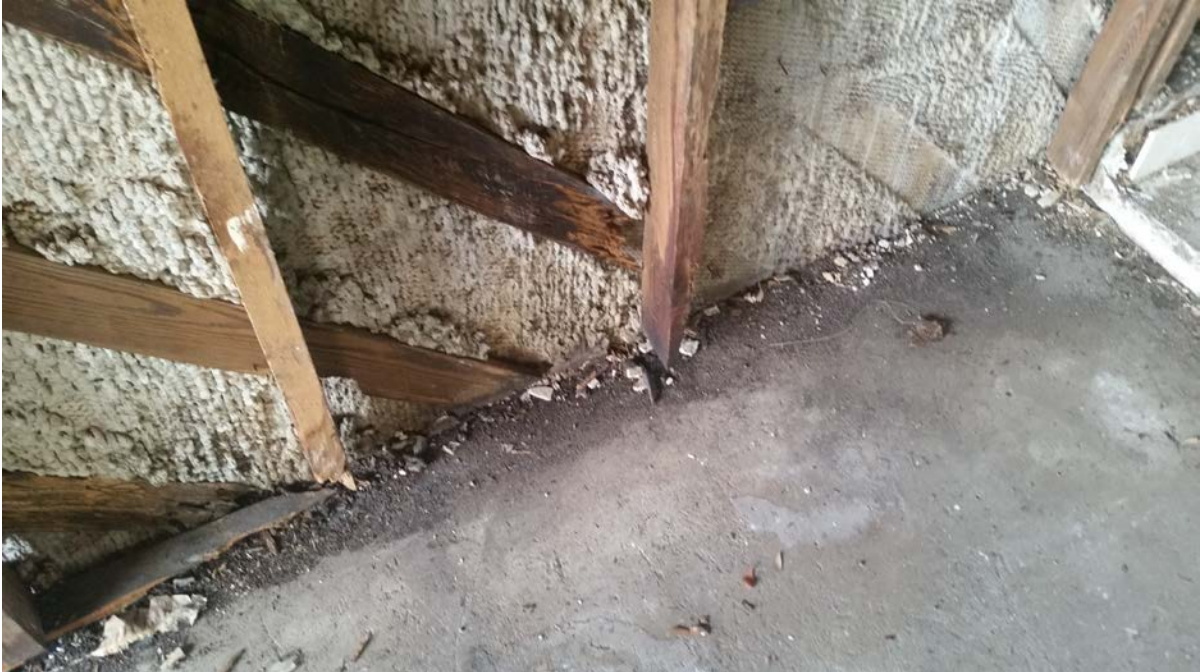
Exhibit 5. Typical Missing/eroded base plate of exterior wood frame walls

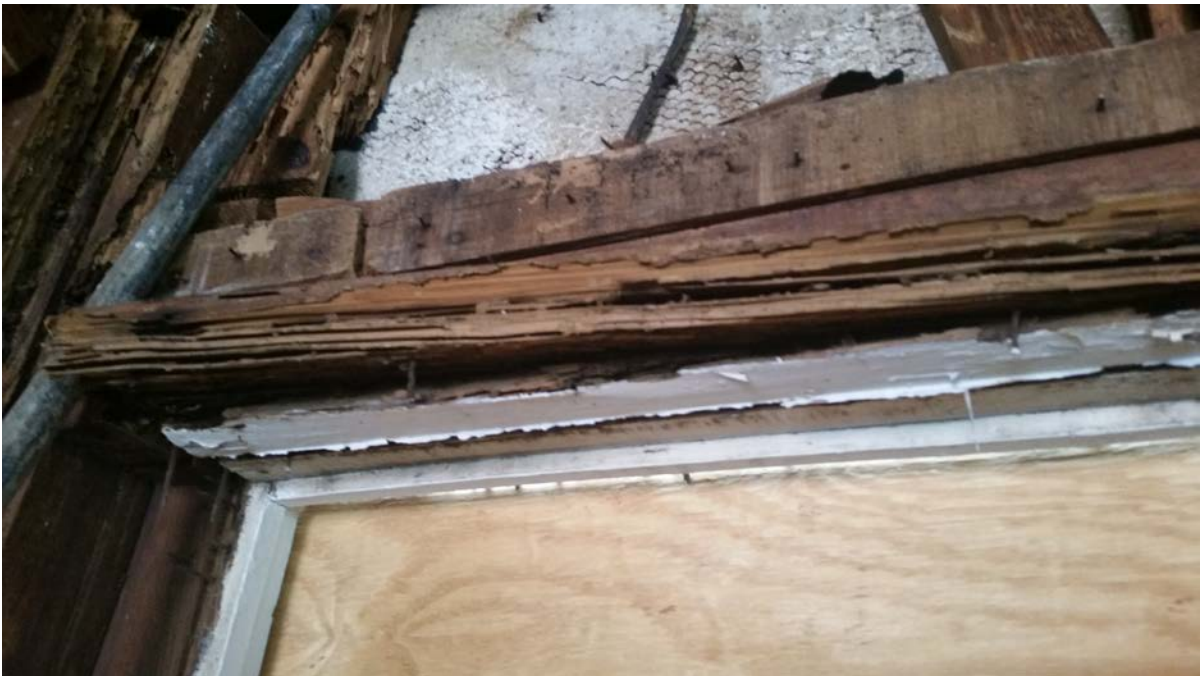
Exhibit 6. Typical rooted wood header/jamb at exterior openings

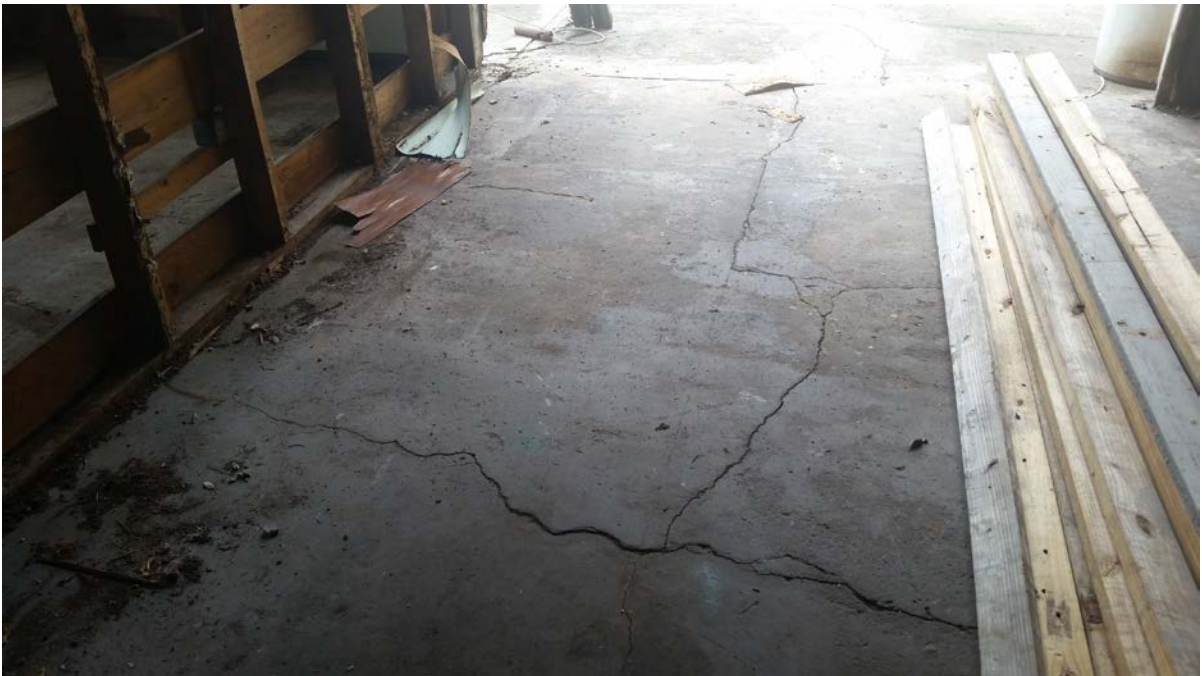
Exhibit 8. Typical Continuous Concrete slab cracks

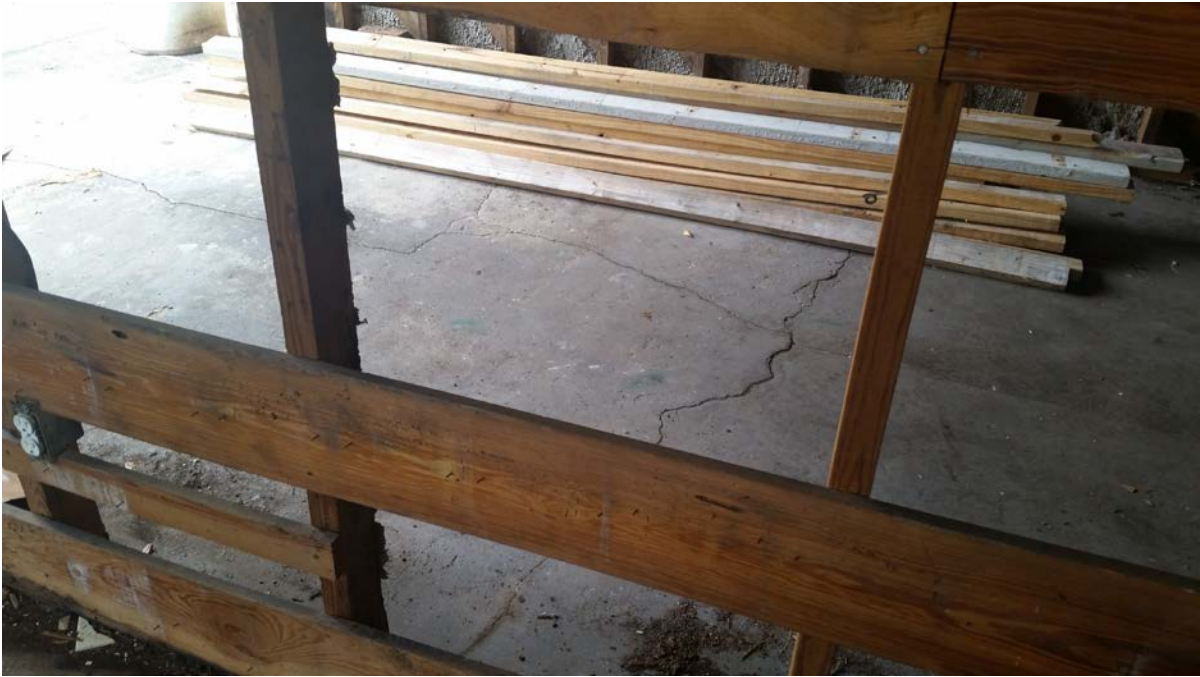
Exhibit 9. Typical Continuous Concrete slab cracks at garage area

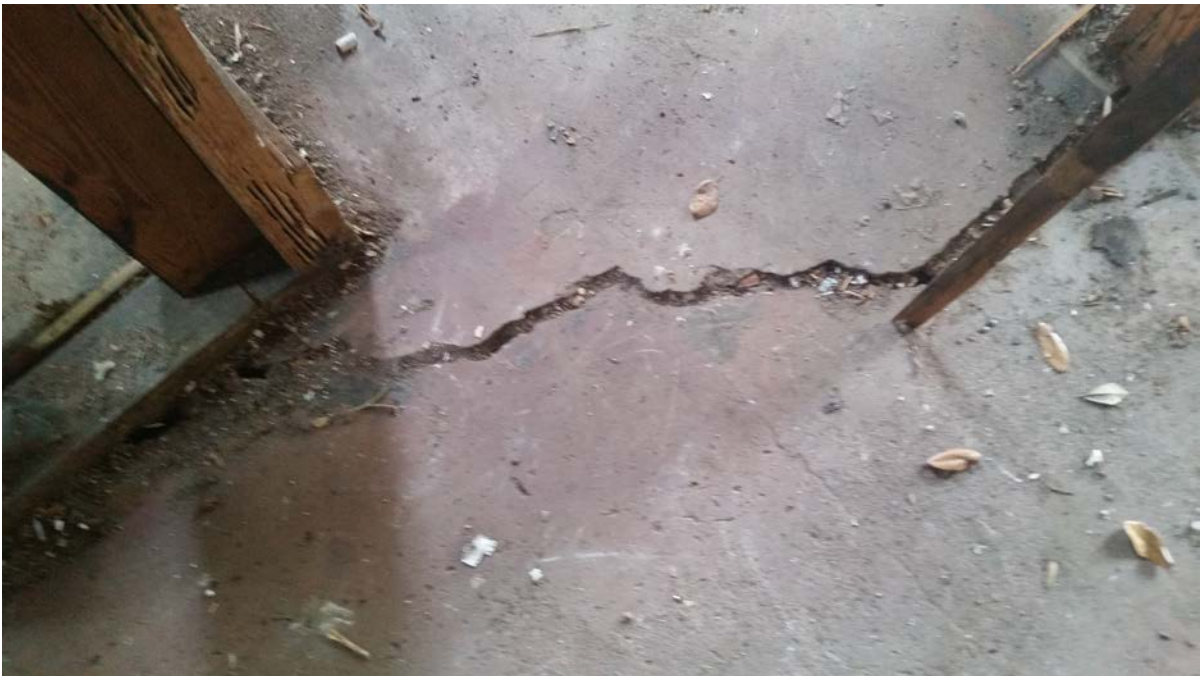
Exhibit 10. Typical Continuous Concrete slab cracks

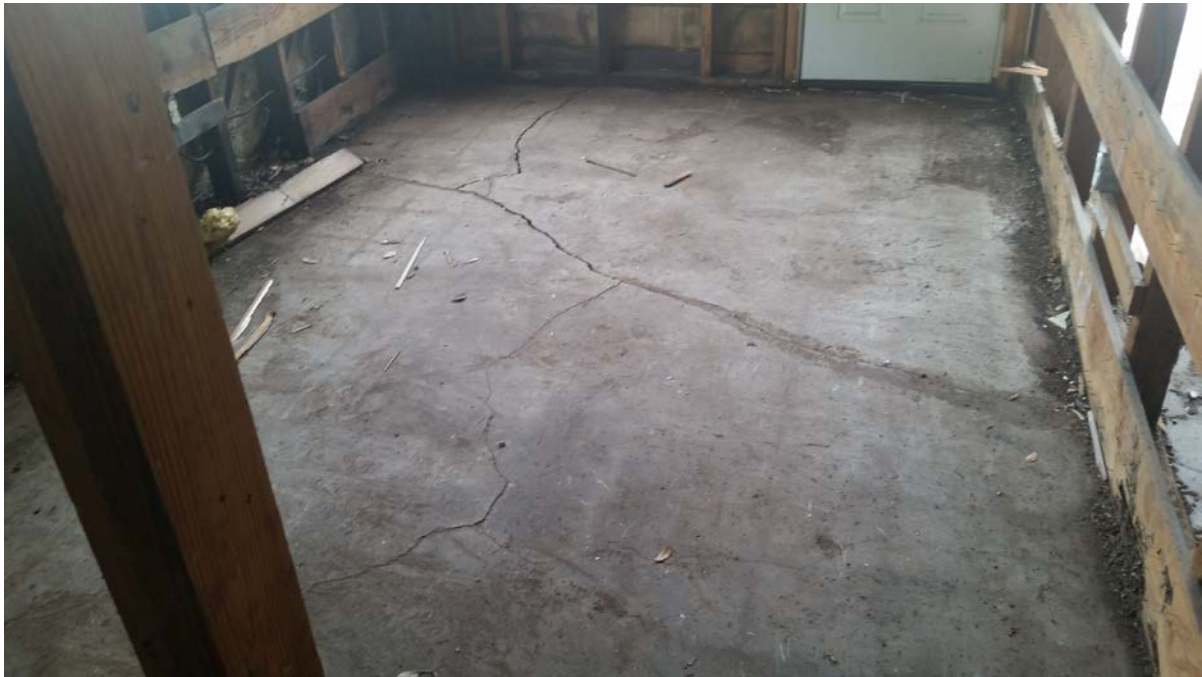
Exhibit 11. Typical Continuous Concrete slab cracks at room

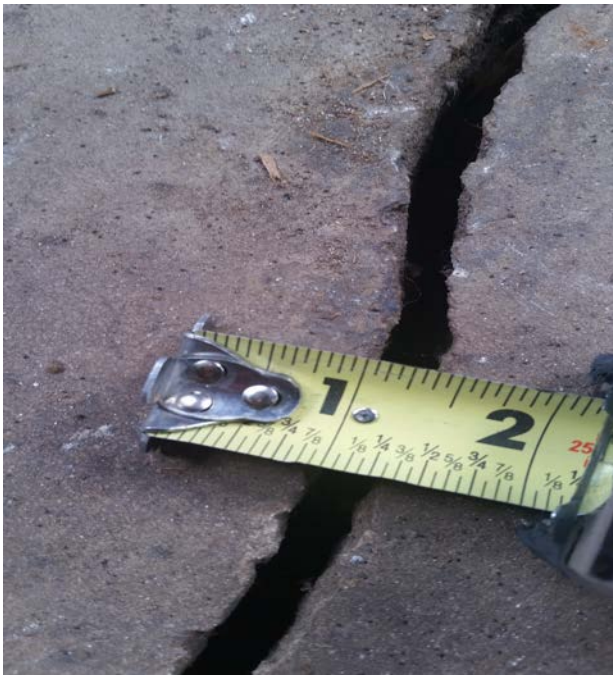
Exhibit 12. Typical Crack separation

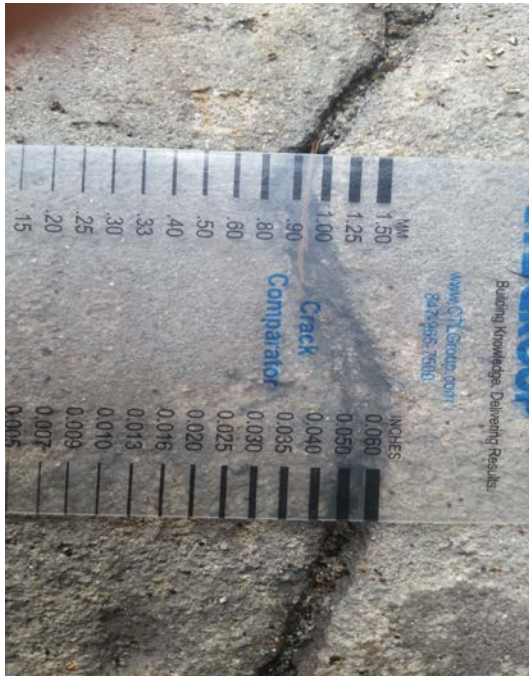
Exhibit 13. Typical Crack separation
