## Arboriculture Tree Report

2419-2613 N Federal Hwy, Delray Beach

**Name:** JC Planning Solutions  
**Attn.:** Jeffery Costello  
**Address:** Delray Beach, FL

**Date:** March 21, 2025  
**Phone:** (561)573-1486  
**Email:** jcostello@jcplanningsolutions.com

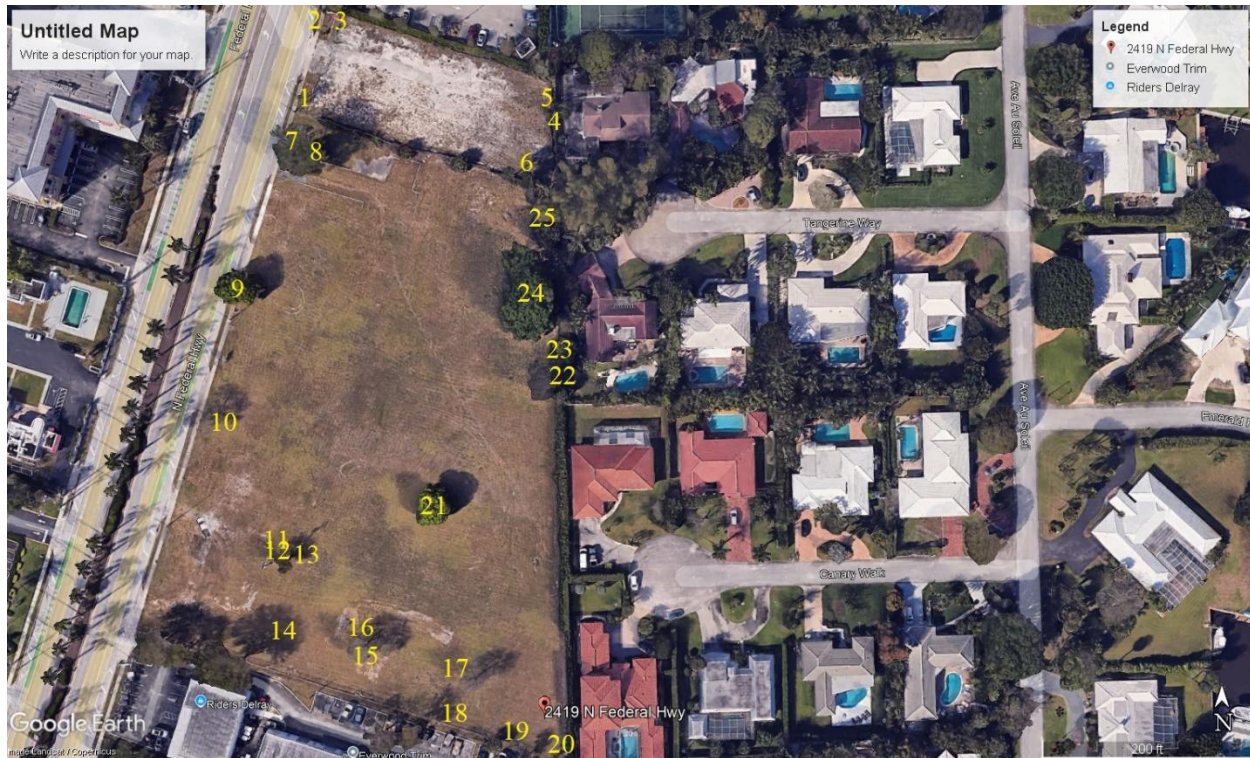
Please see Google Earth picture with tree locations, individual tree specifics and pictures below.
