# Kimley»Horn

**RE: *Delray Beach DDA Christmas Tree Evaluation***

Kimley-Horn and Associates, Inc. ("Kimley-Horn") is pleased to submit this report to Delray Beach Downtown Development Authority ("Delray Beach DDA") for the preliminary structural evaluation of the steel frame of the 100 foot tall steel framed Christmas tree that the DDA displays over the holidays at Old School Square.

# Delray Beach DDA Christmas Tree Frame

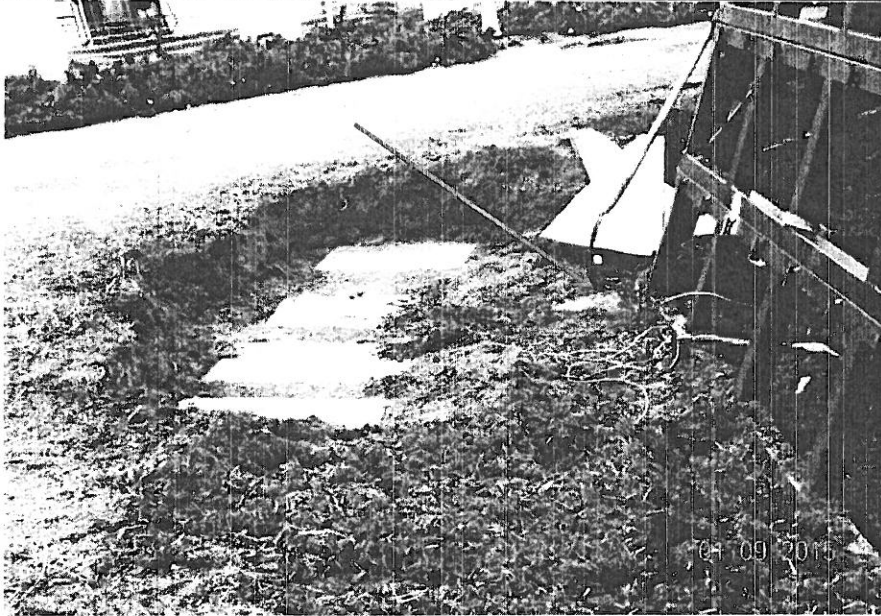
Photo No. 11

Remarks: View of concrete foundation ring below bottom section. Note foundation is sunken relative to grade.

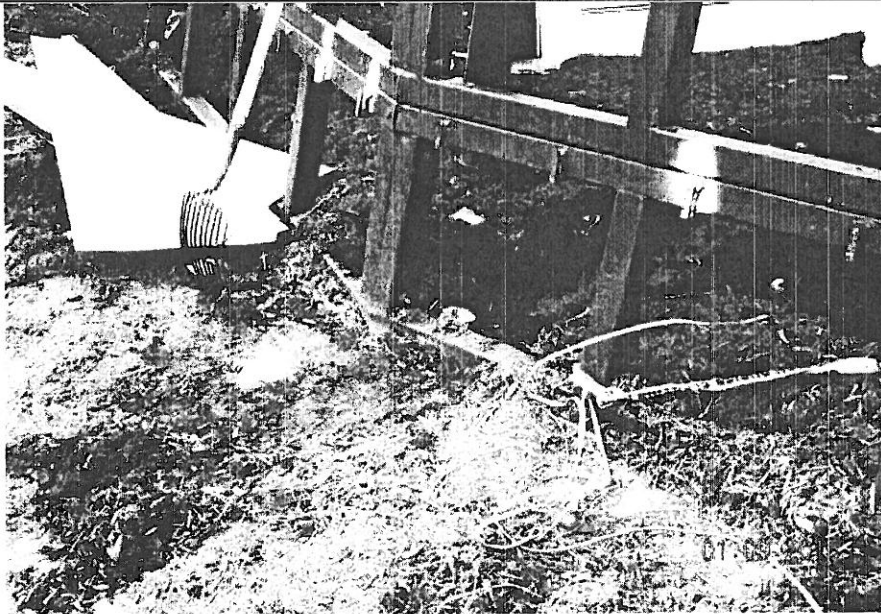
Photo No. 12

Remarks: Close up view of foundation area indicated by red arrow in Photo 11 above.

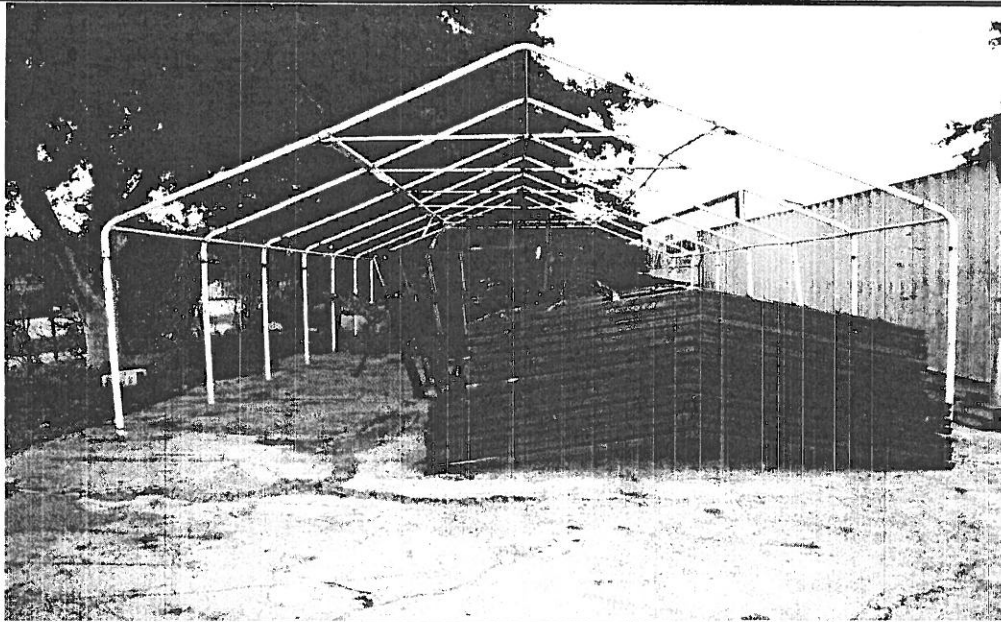
Photo No. 19

The partially connected frames are transported and stacked in the back of the Public Works yard facility in an area that used to have a framed canopy. The frame is still visible, but the tarp is no longer in place. The condition of the canopy frame indicates that the tarp has been missing for several years. The overall plan size of the framed canopy is approximately 20 feet by 30 feet.

The frames are placed directly on the pavement, with some frames connected with bolted fasteners still in place.

5. Develop a rack system for storage that holds the frames vertical, elevated off the floor, thereby minimizing trapped water intrusion.
6. Continue to remove any loose rust and patch, weld or replace severely corroded sections as needed.

9. Construct or install an insulated closed shed-type structure for storage and protection of the frames.
