SUPPLEMENTAL DEMOLITION TIMELINE AND PHOTO DOCUMENTATION

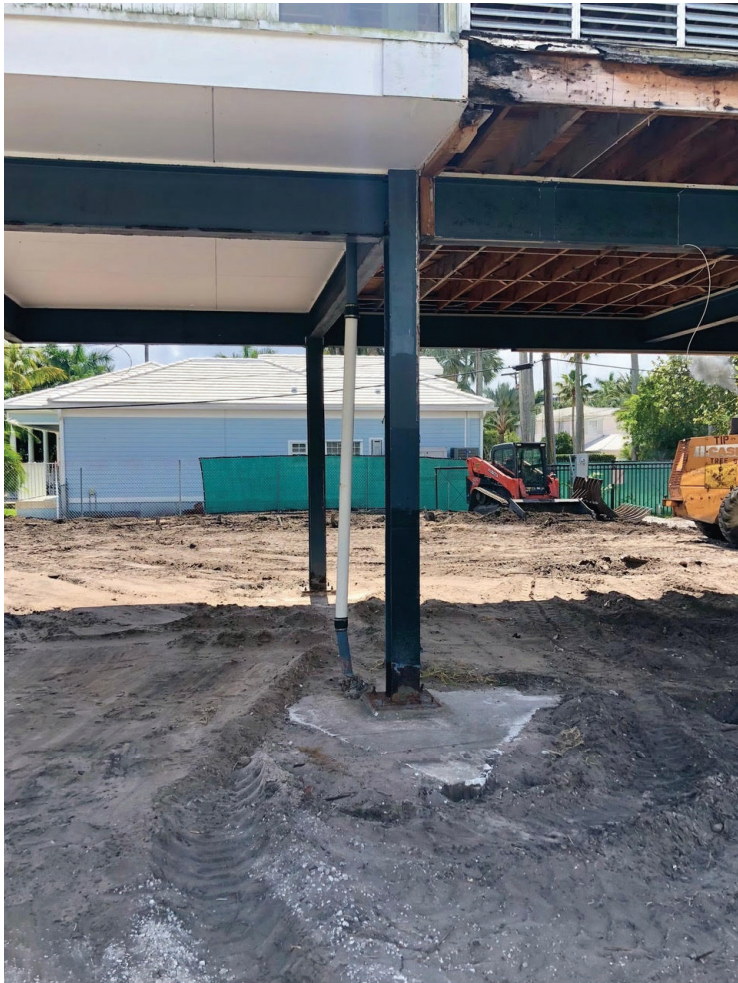
February 28, 2020 Building permit approved. Base of existing steel columns and pile cap plates excavated and severe corrosion discovered.

CORRODED STEEL COLUMN EXPOSED FEB 28, 2020

March 5, 2020 Structural engineer inspects corrosion and recommends corroded steel be cut out and replaced by new steel. **See Engineer's report.**

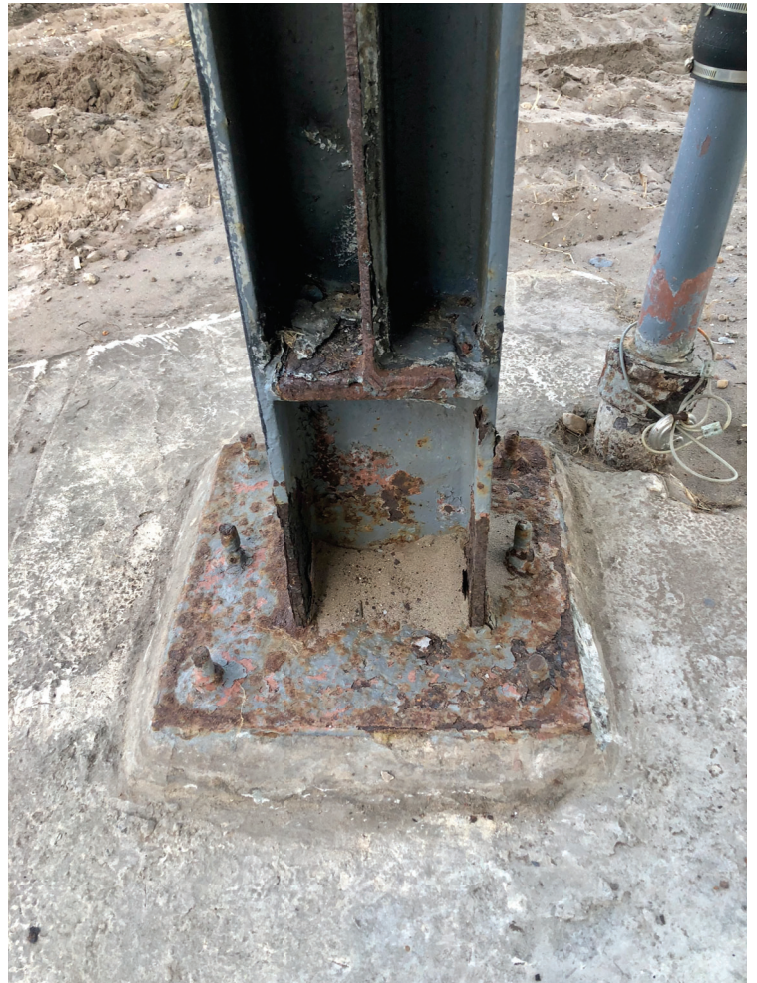
CORRODED STEEL COLUMN AND PLATE MARCH 5, 2020

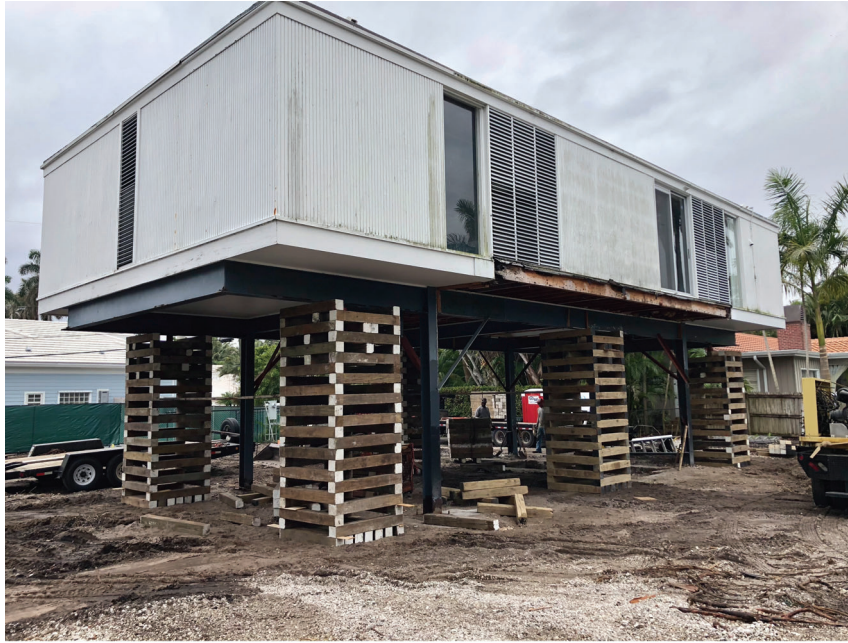
CRIBBING TO SUPPORT HOUSE DURING STEEL REPAIR MARCH 10, 2020

March 10, 2020 The existing house is stabilized and supported by cribbing in order to cut out the damaged steel at the base.

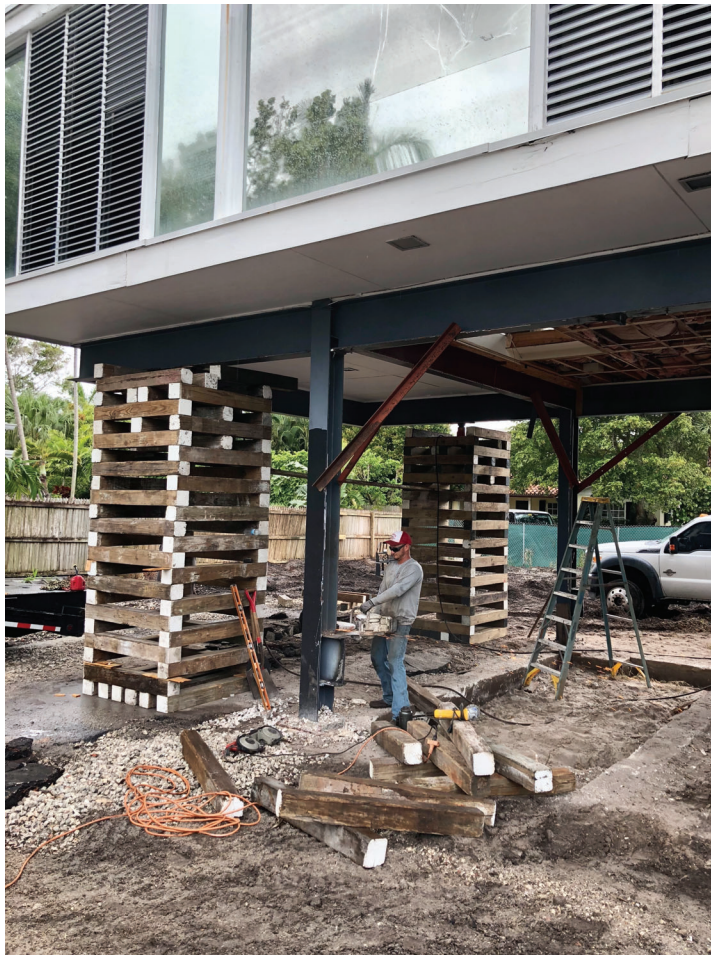
CUTTING OUT CORRODED STEEL MARCH 10, 2020

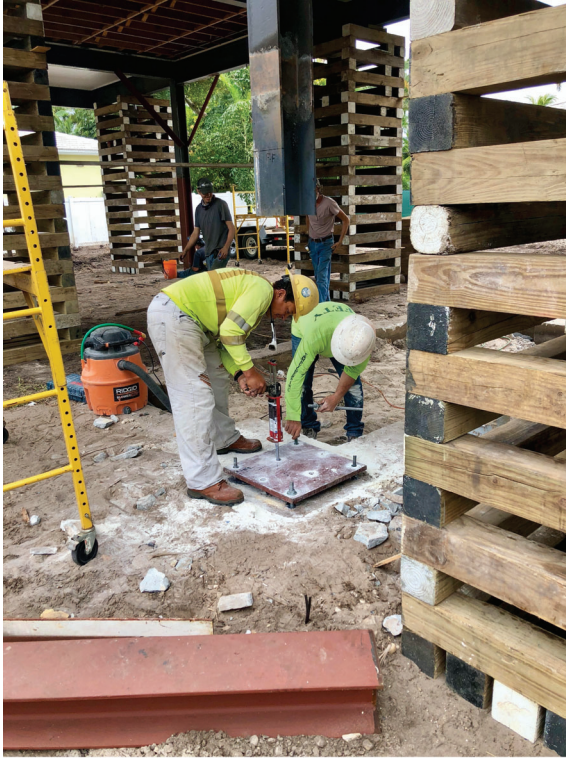
REPLACE STEEL COLUMN SECTION & PILE CAP PLATE MARCH 11, 2020

March 11, 2020 The existing corroded steel column sections and pile cap plates are cut out and replaced. The elevation of the finish first floor is raised to 7' NAVD by cutting out and replacing the corroded steel column sections at the base while the house is supported by the cribbing. **The elevation change was not approved in advance by the HPB. See Justification Statement.**

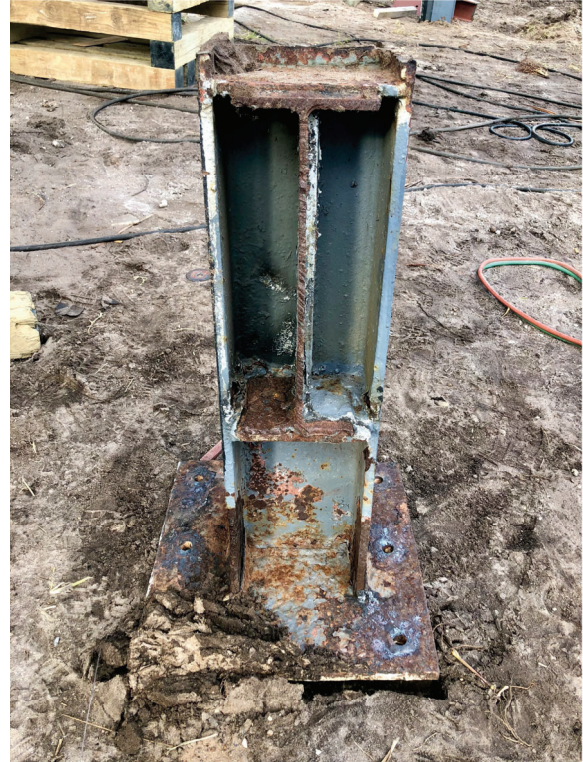
CORRODED STEEL COLUMN AND PLATE REMOVED MARCH 11, 2020

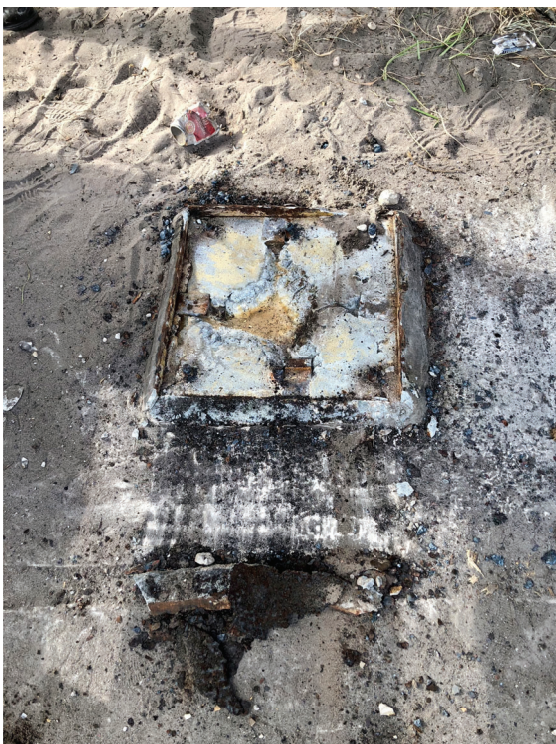
CORRODED STEEL PILE CAP PLATE MARCH 11, 2020

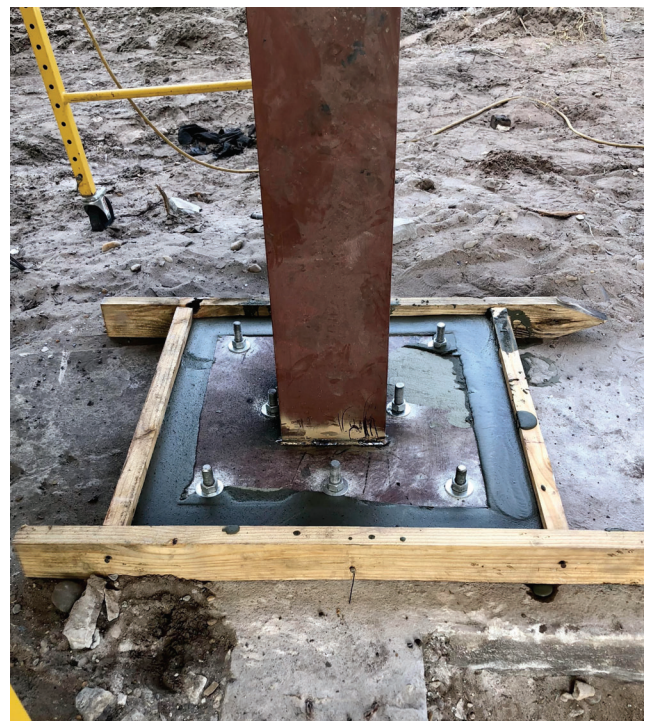
NEW STEEL PILE CAP PLATE & COLUMN SECTION MARCH 11, 2020

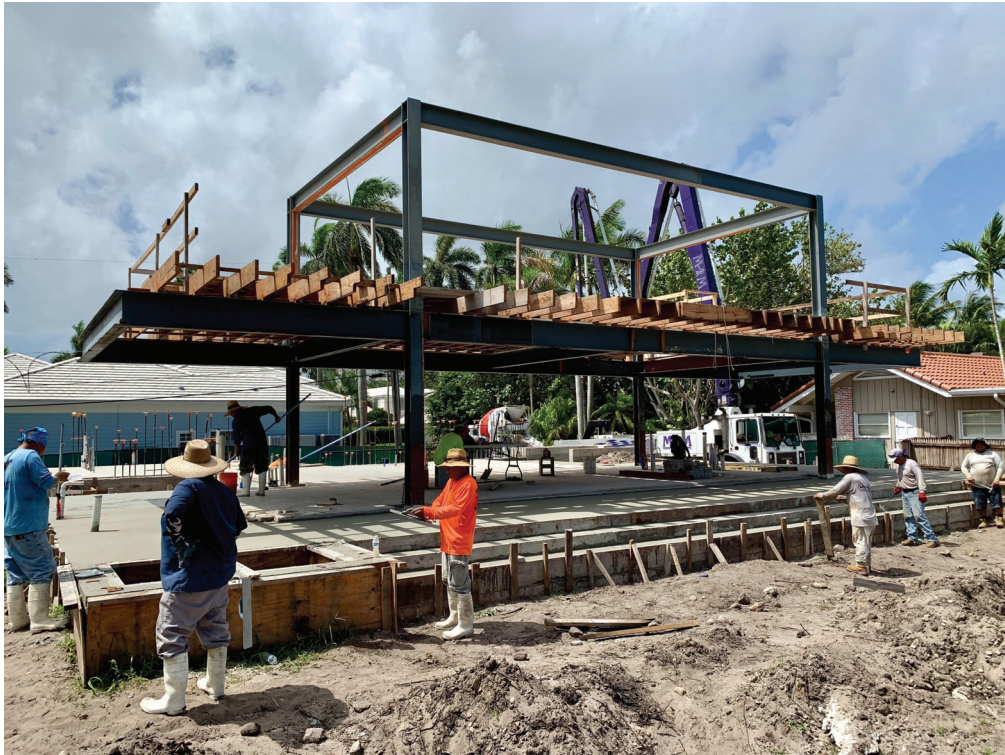
August 5, 2020 Stop Work Order issued by the building department due to the change in elevation and the demolition of more than 25% of the historic structure without HPB approval. Work on the concrete foundation and the existing steel structure repair and preservation were allowed to be completed.

STEEL STRUCTURE AFTER DEMO & ELEV CHANGE AUGUST 24, 2020

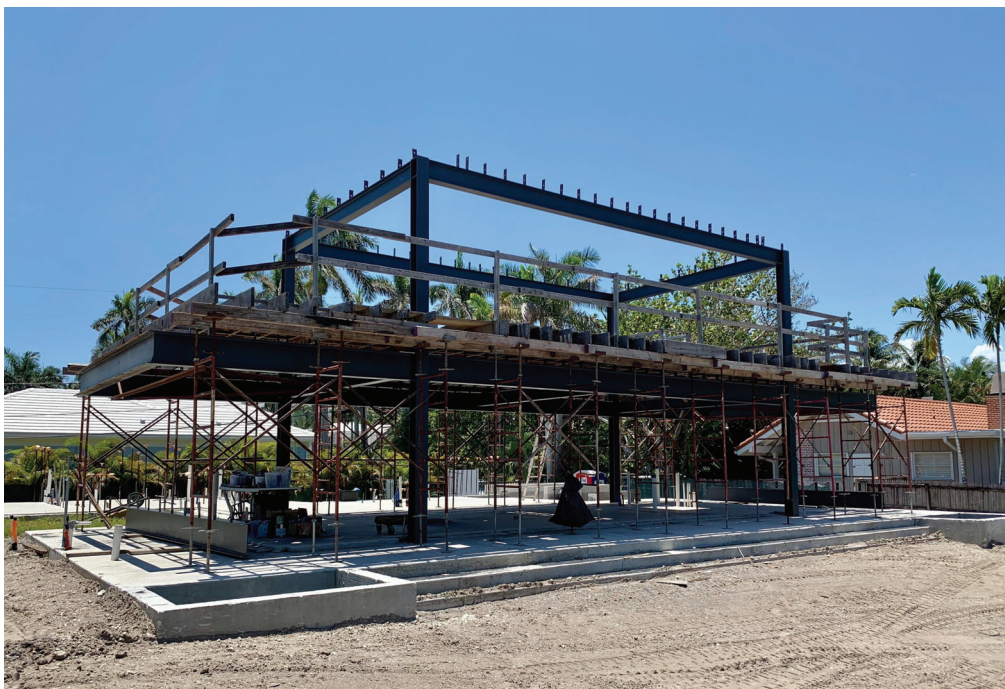
EXISTING STRUCTURE AFTER ELEV CHANGE, DEMO & STEEL PRESERVATION MAY 5, 2021
