**INSPECTION REPORT**  
**EVALUATION OF EXISTING BUILDING STRUCTURE**  
**FOR**

**212 SEABREEZE AVENUE**  
**DELRAY BEACH, FL 33483**

Investigation and evaluation of existing two-story standing alone wood and steel frame building structure with deep foundation system, at the aforementioned address

**INSPECTION REPORT**  
**EVALUATION OF EXISTING FLOOR SYSTEM**  
**FOR**

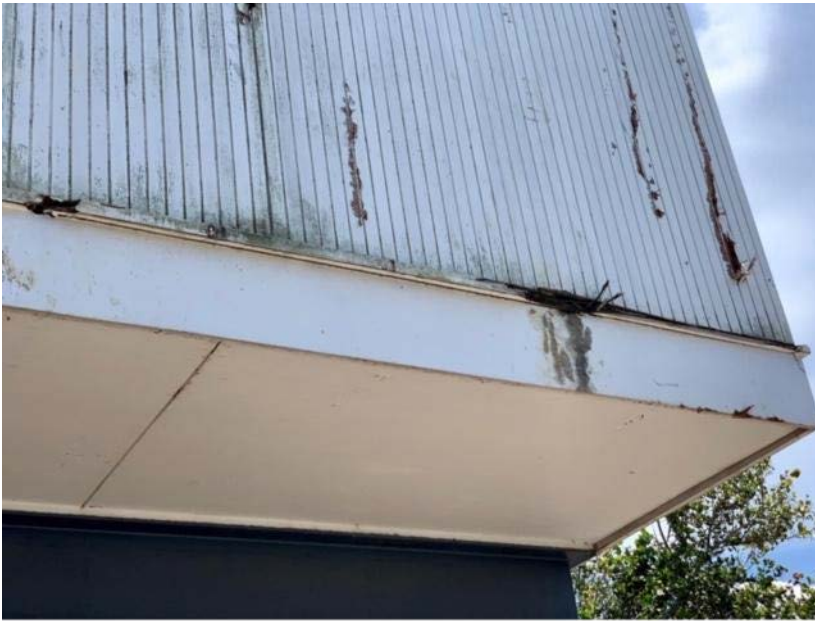
EXISTING FRONT PLYWOOD SIDING WEST

Exhibit 5. General view of Exterior of the Building

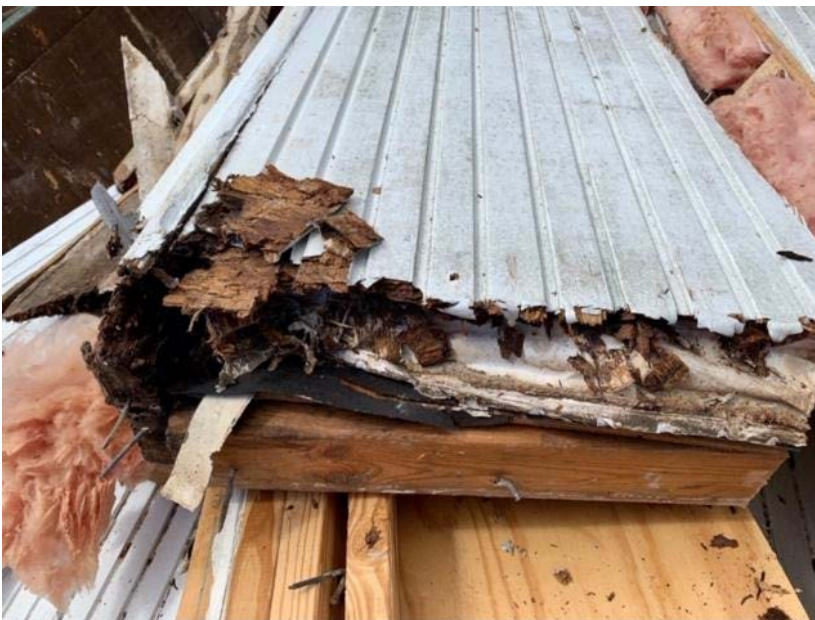
EXISTING ROTTED PLYWOOD SIDING

Exhibit 6. Typical rotted plywood siding at exterior wood frame walls

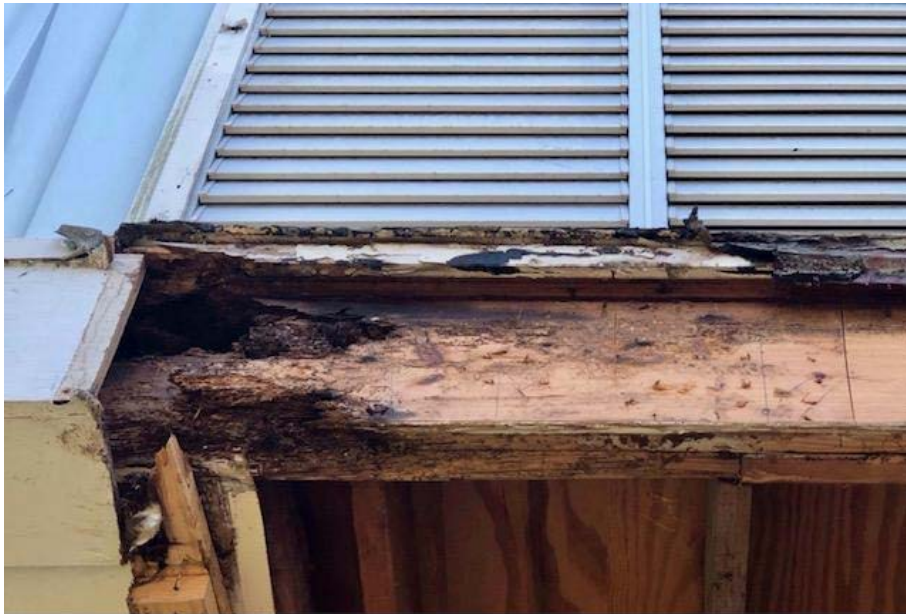
EXISTING 2ND FLOOR WOOD DAMAGE

Exhibit 7. Typical rotted wood beam/header at exterior load bearing walls

Since the damage at structural wood members at roof level and second floor (roofing, rafters, roof sheathing, wall studs, fascia, sub fascia, sills, headers, jambs and rim and wall sheathing) at excessive levels where total section losses and loss of strength are observed, I recommend total removal of the damaged roof and second floor wall system and rebuild the structure as per permit plans issued by City Delray Beach Building Department. The construction methods and materials are outlined in detail on sheets **S-2, S-3, S-4, S-6 & S-7** sheet of these plans. Necessary installation and attachment details are provided in order for this building to meet requirements of current Florida Building Code and to be structurally sound and safe.

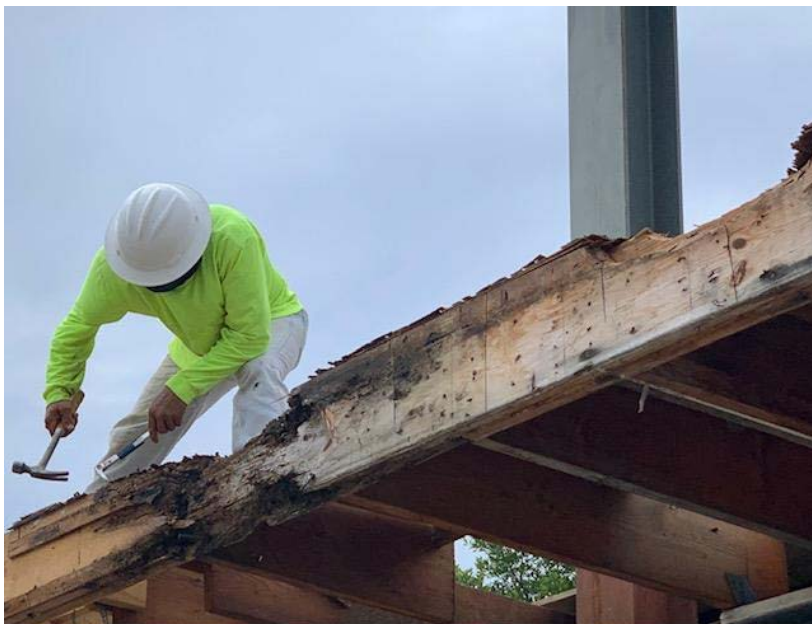
EXTENSIVE WOOD DAMAGE 2ND FLOOR

Exhibit 8. Typical rotted wood beam/header at exterior load bearing walls

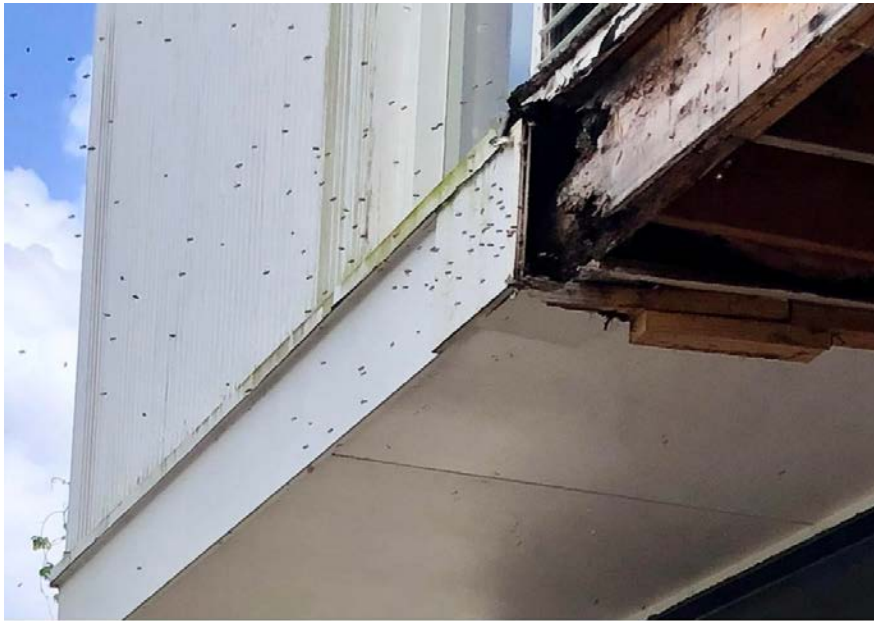
DAMAGE TO 2ND FLOOR WOOD DUE TO TERMITES/INSECTS

Exhibit 9. Typical termite damage at structural wood members

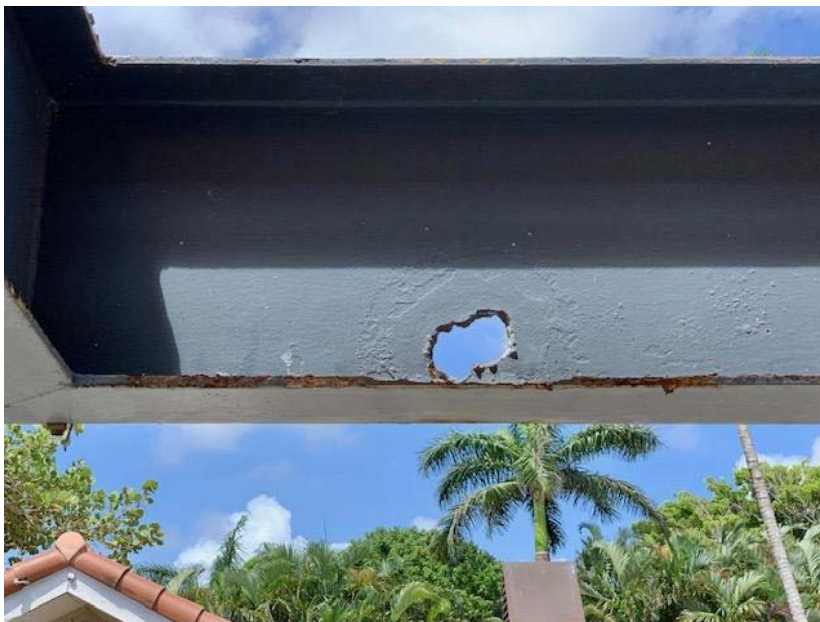
EXISTING STEEL BEAM DAMAGE

Exhibit 10. Typical structural damage and section loss at load bearing steel members

Until necessary demolition is performed on the upper level of the building the damaged steel structure cannot be fully accessed. Appropriate steel structure repairs shall be applied on the existing steel beams as per repair details provided and repairs shall be executed by certified welders.

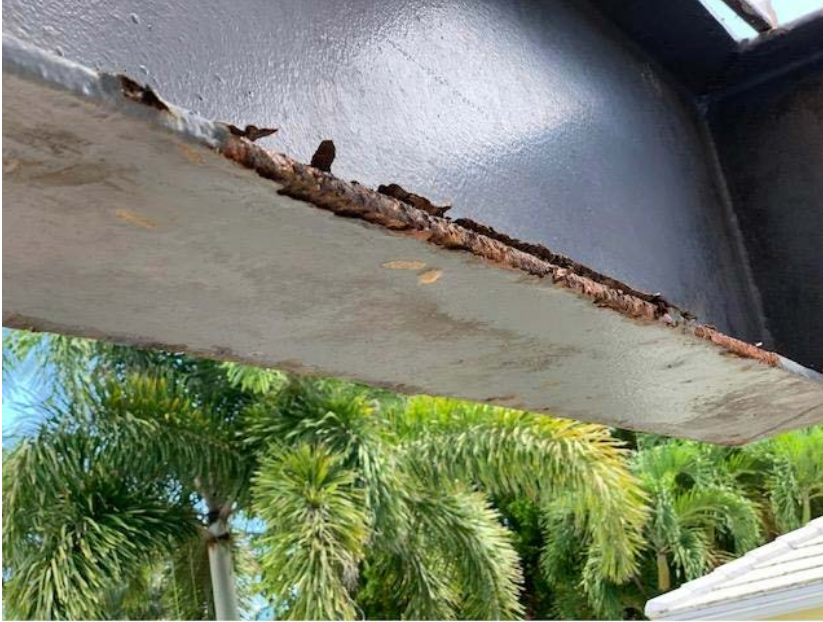
STEEL BEAM CORROSION

Exhibit 11. Typical structural damage and section loss at load bearing steel members

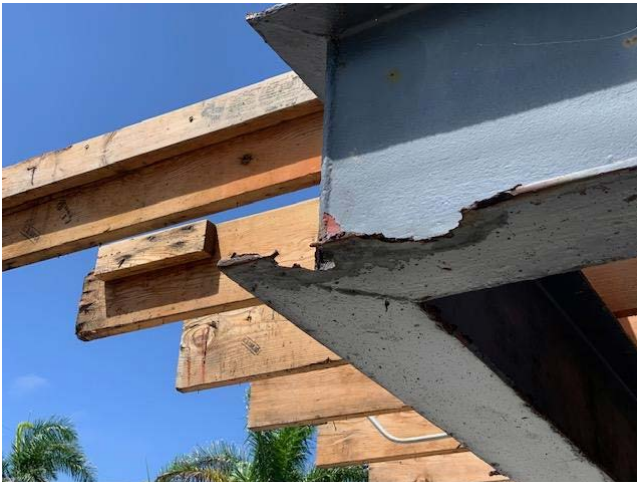
STEEL BEAM CORROSION

Exhibit 13. Typical structural damage and section loss at load bearing steel members

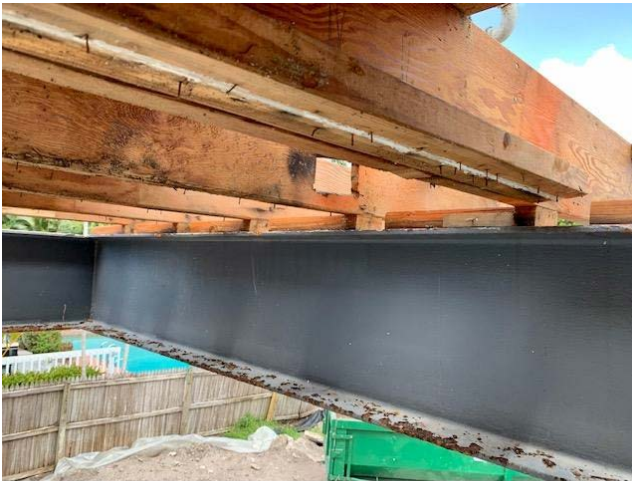
EXISTING 2ND FLOOR JOISTS

Exhibit 13. There were no forms of fastening or nailing at wood members to main structure (typical at perimeter). There was no continuous load path from roof to foundation

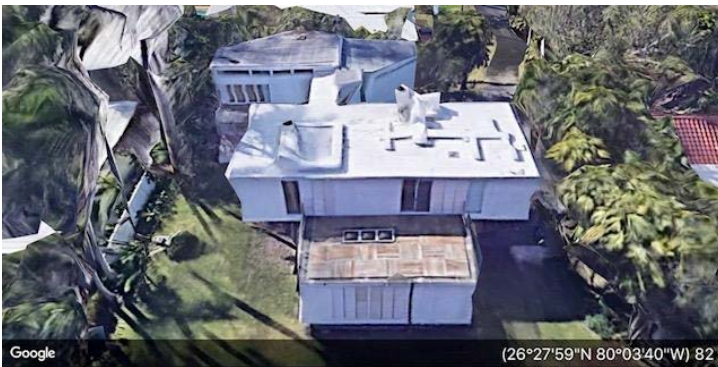
- iv. Severe existing roofing deterioration is observed throughout the building. Excessive deflection of roof rafters and sheathing indicate improper design of existing roof structure to carry the superimposed weight of AC equipment that were installed on the roof top. Active water damage and seepage observed from the numerous locations at roof top equipment and ductwork/pipe penetration locations. The roofing was not built and fastened as per Florida Building code requirements.

AC EQUIPMENT ON ROOF OF EXISTING HOUSE PRIOR TO ROOF REMOVAL

Exhibit 14. Birdseye view of existing roof

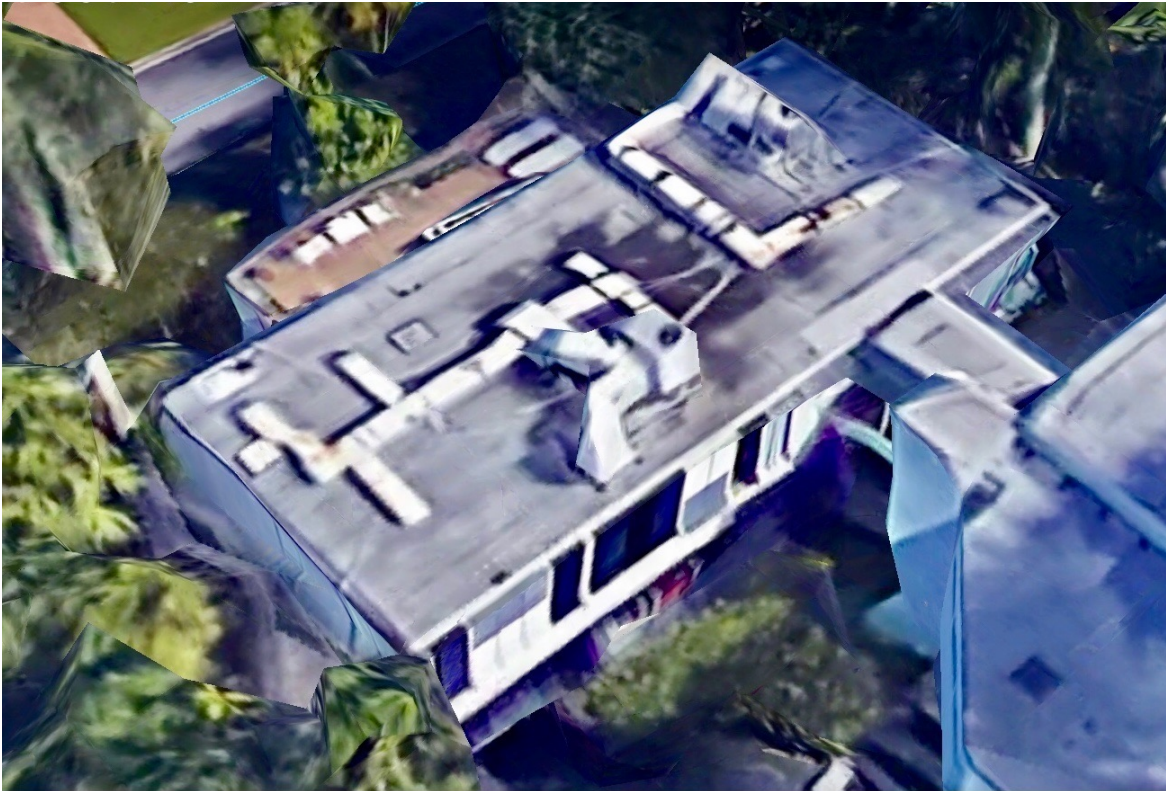
EXISTING HOUSE WITH AC EQUIPMENT ON ROOF APRIL 18, 2018

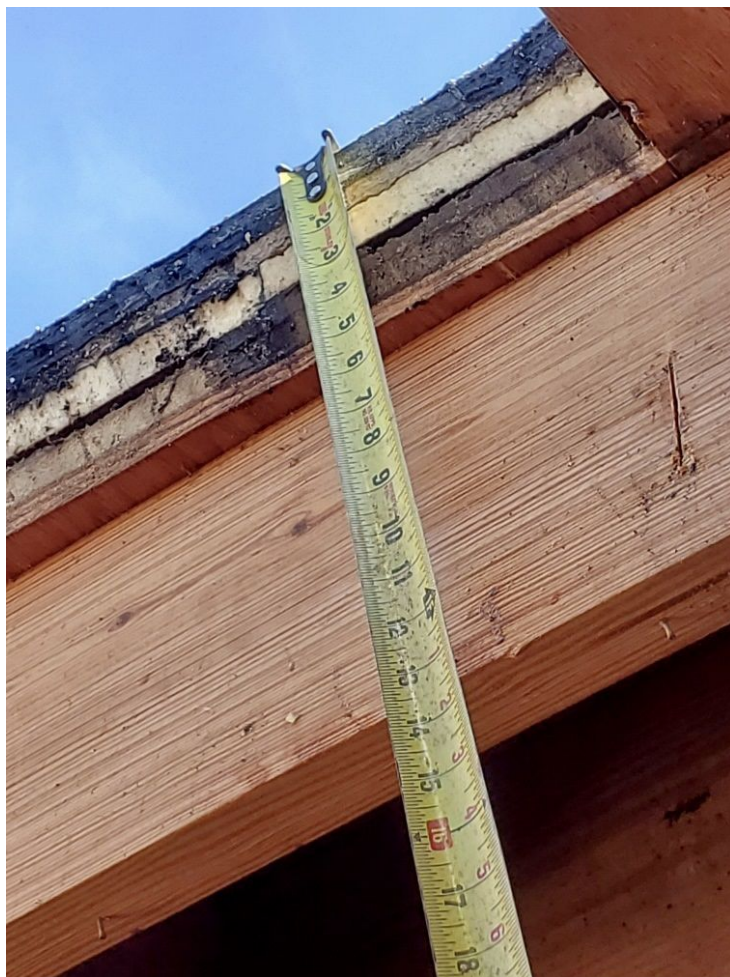
EXISTING 4 LAYER ROOF BEFORE REMOVAL

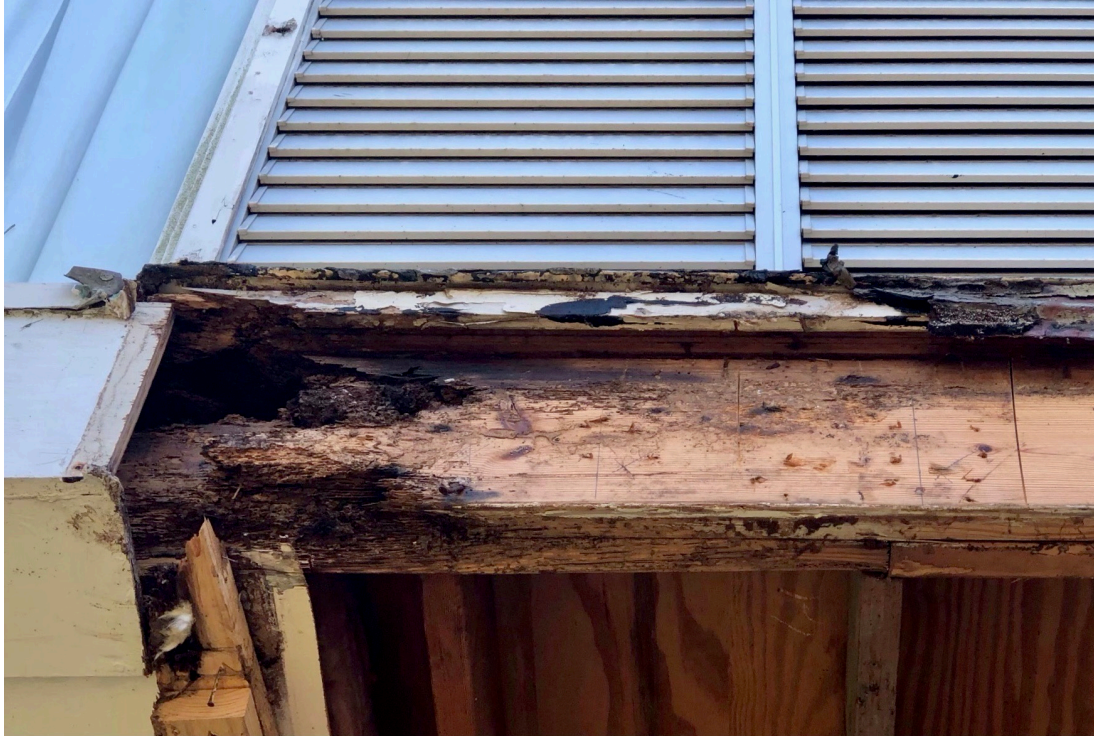
EXISTING 2ND FLOOR WOOD ROT JANUARY 15, 2019

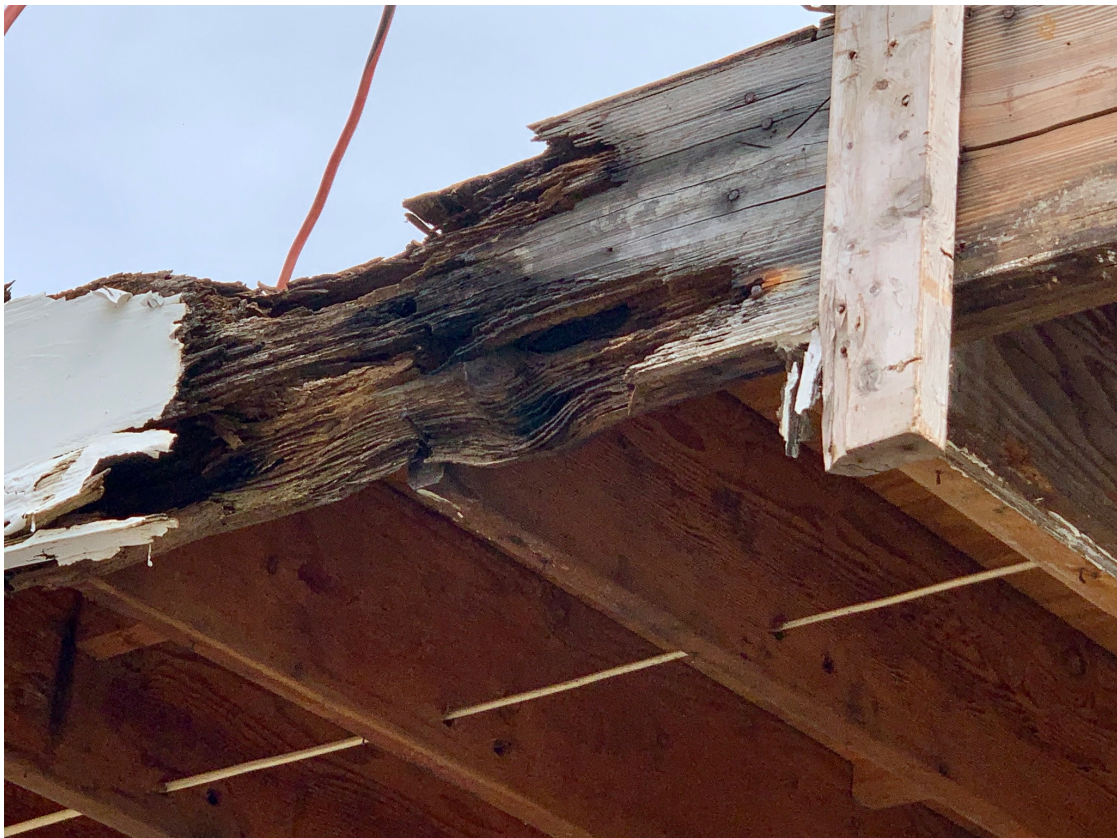
EXISTING ROTTEN WOOD 2ND FLOOR JULY 21, 2020

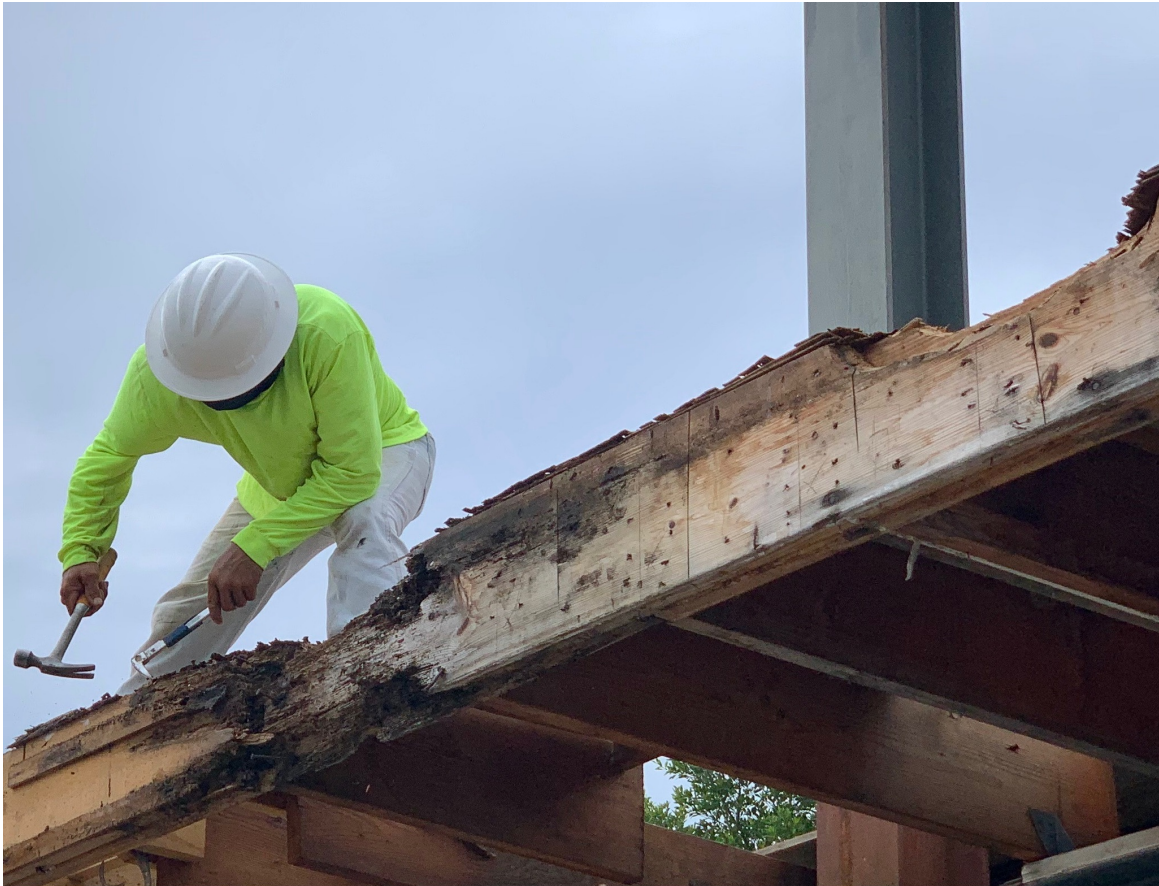
EXTENSIVE WOOD DAMAGE 2ND FLOOR JULY 21, 2020

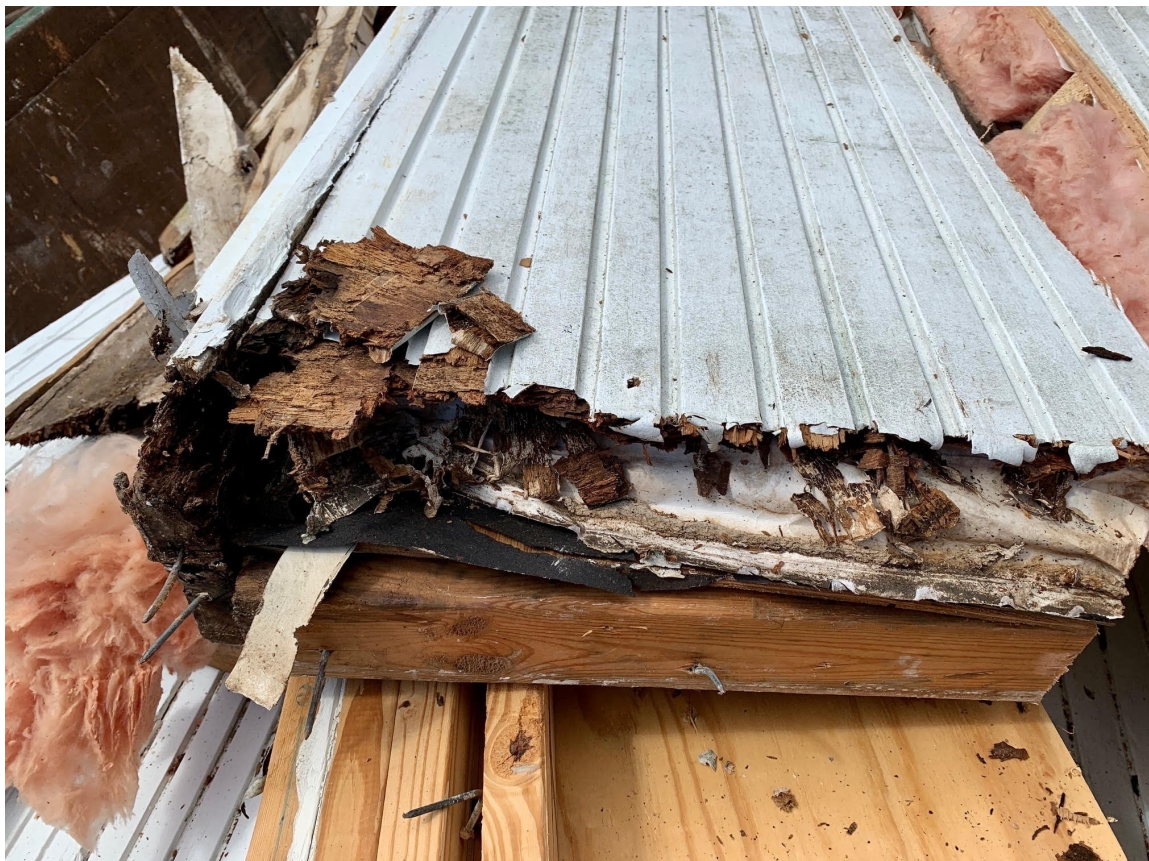
EXISTING ROTTED PLYWOOD SIDING JULY 20, 2020

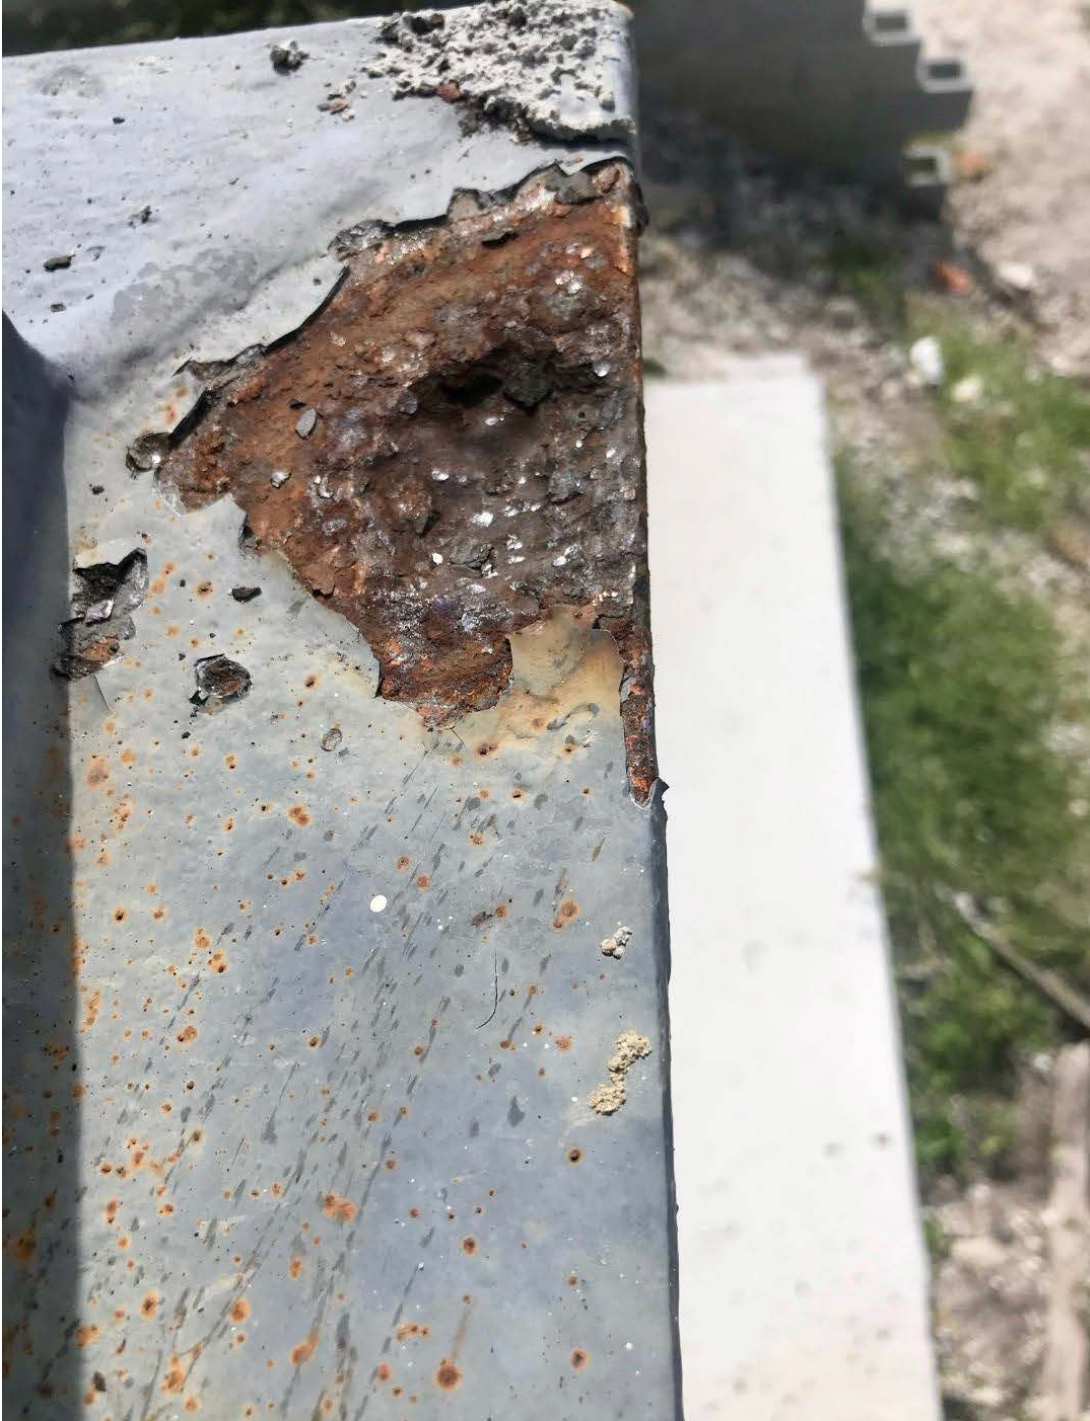
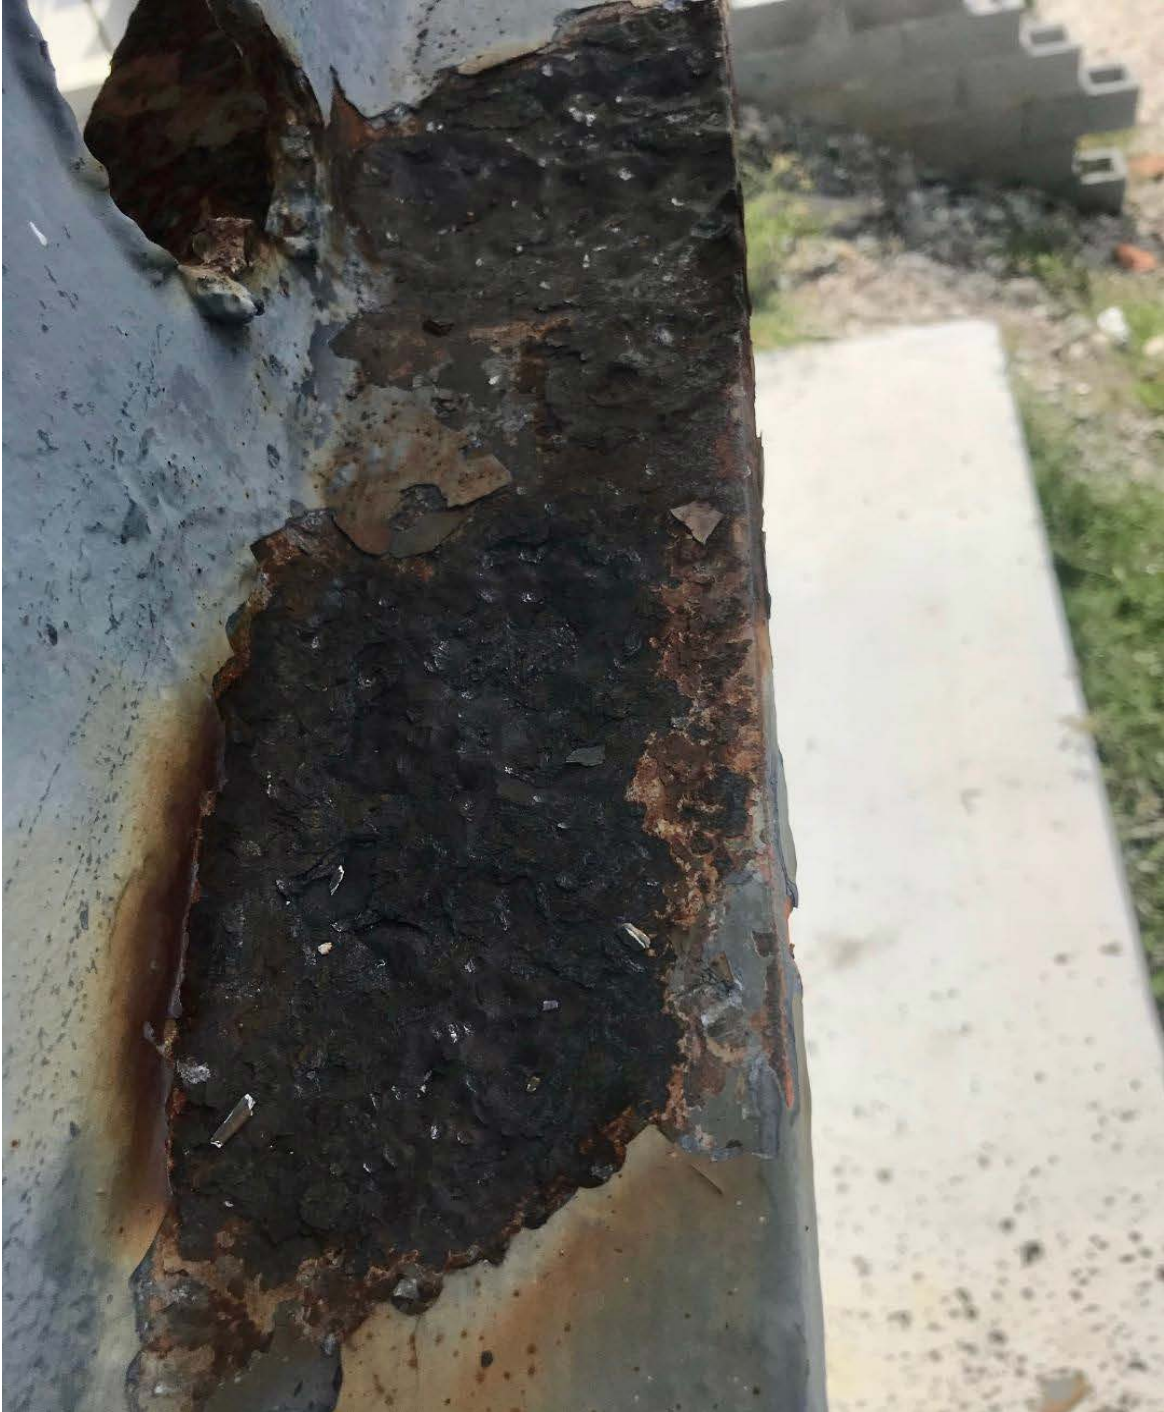
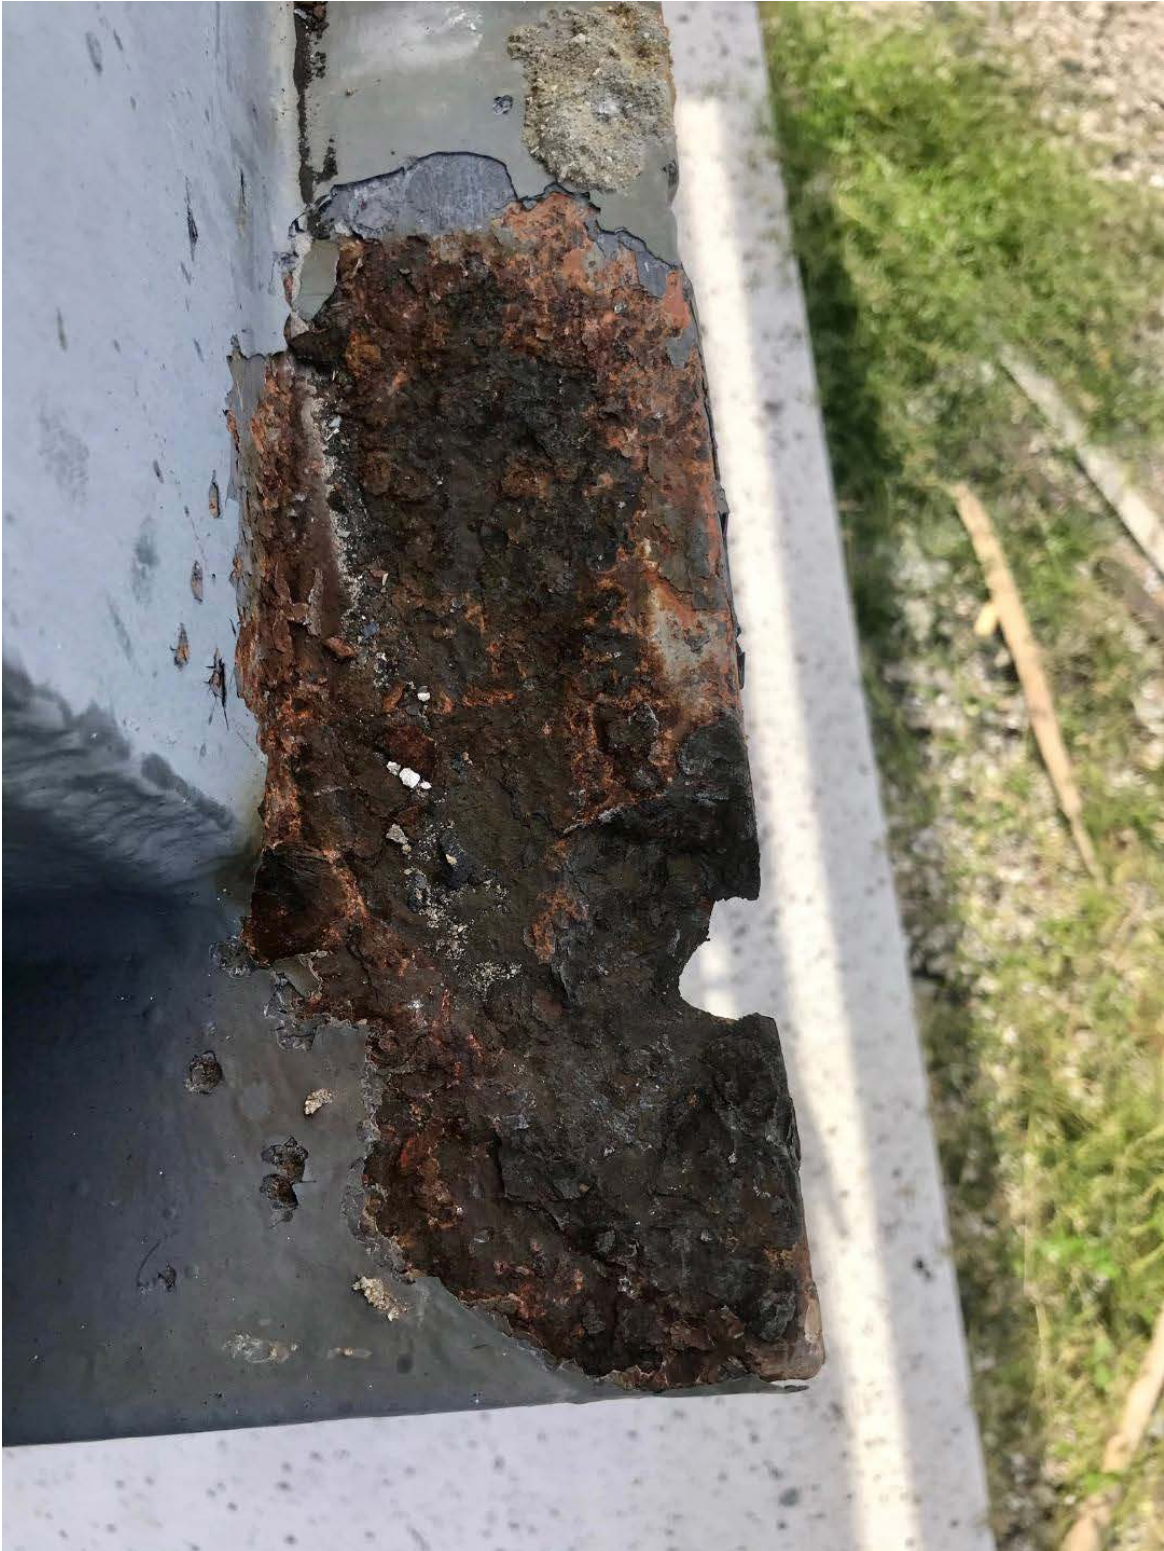
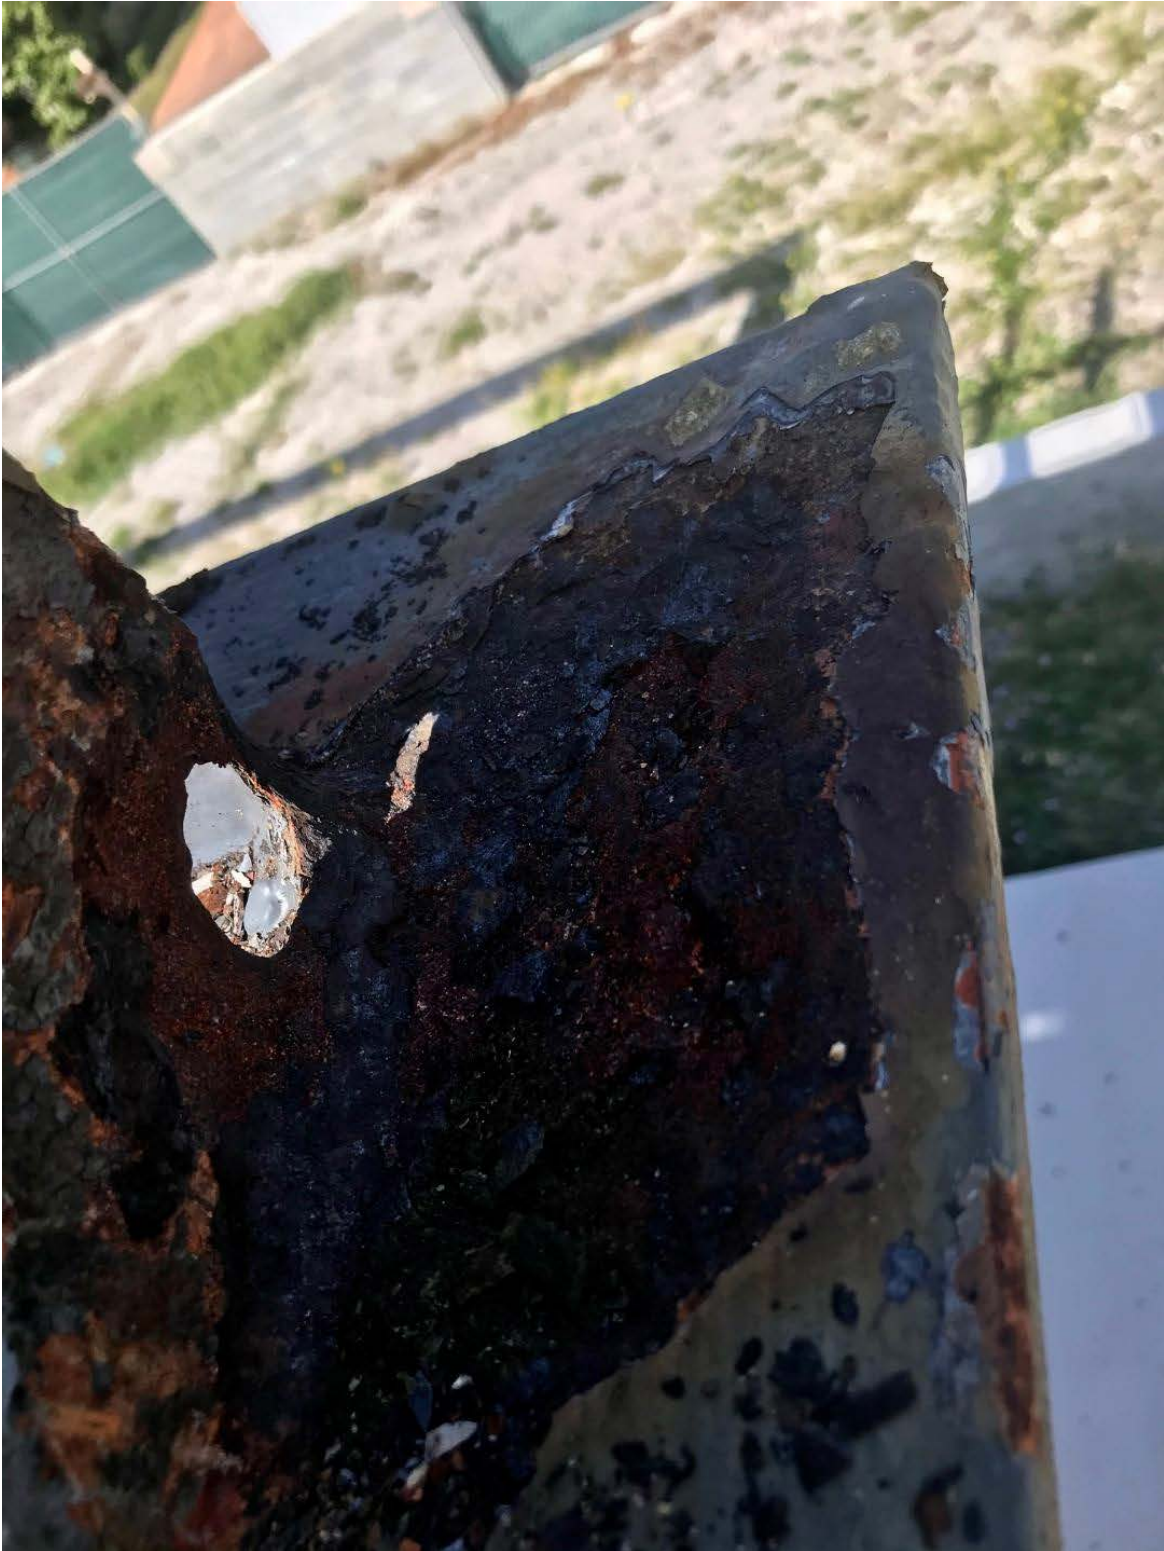
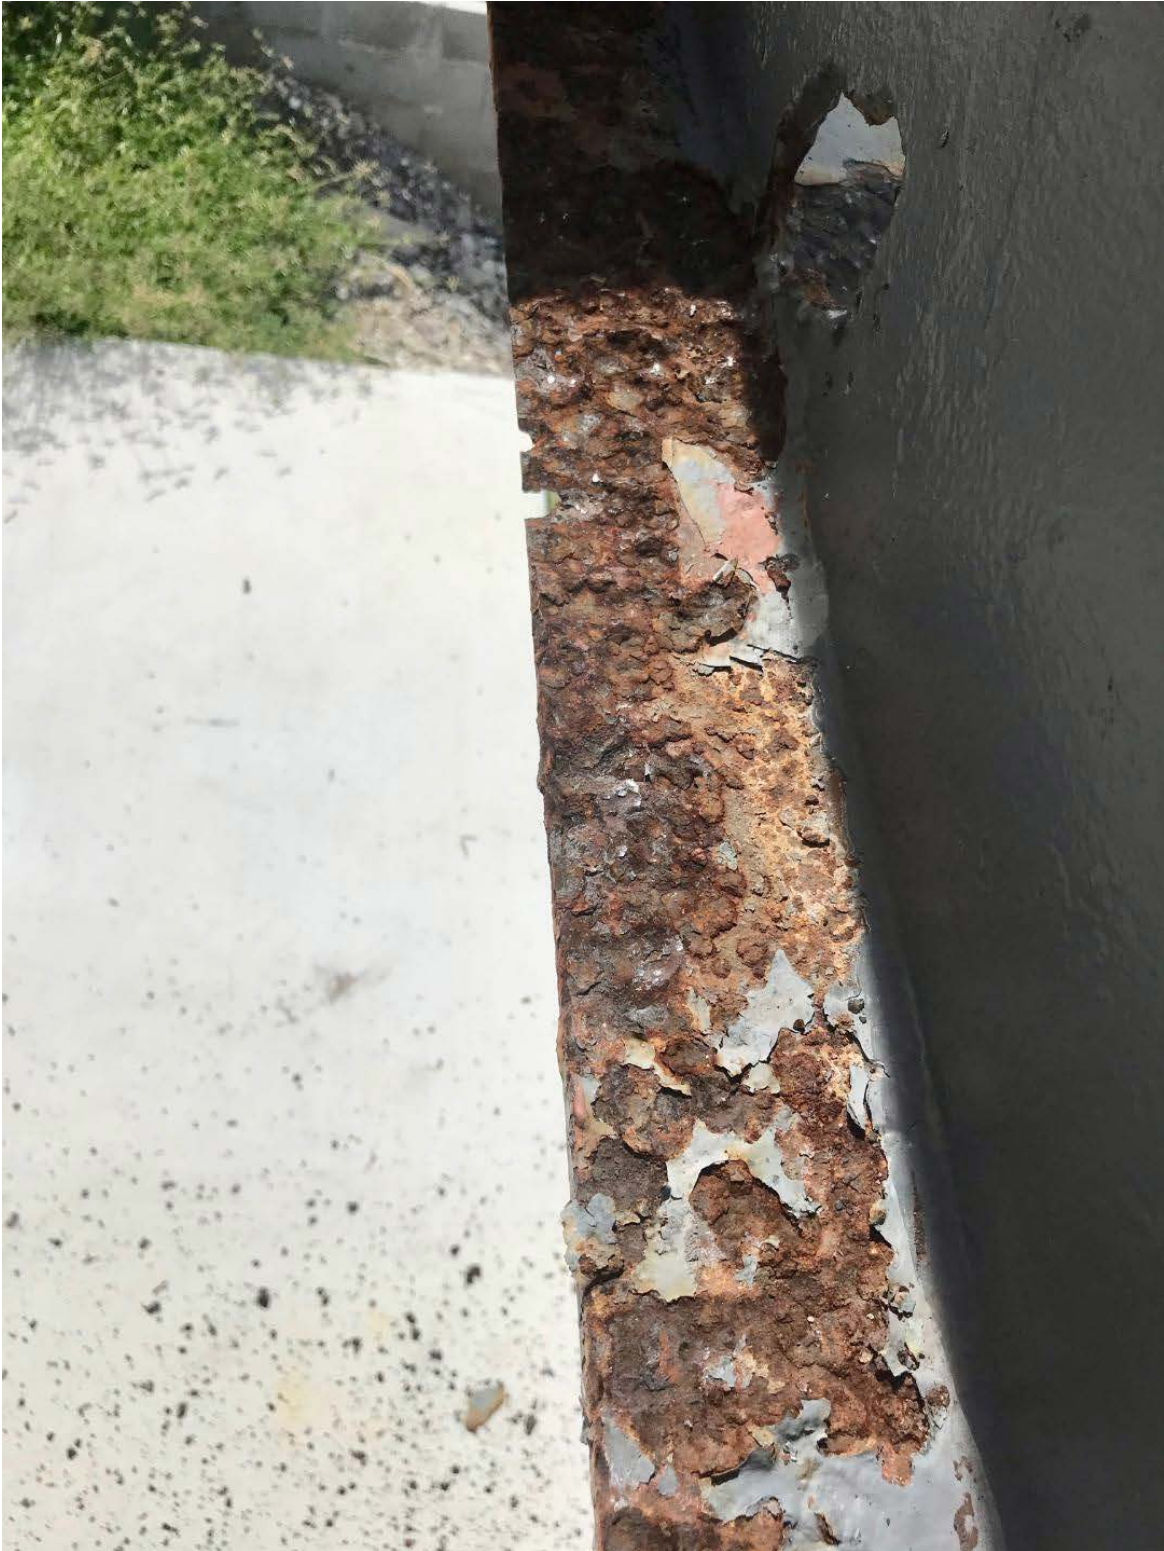
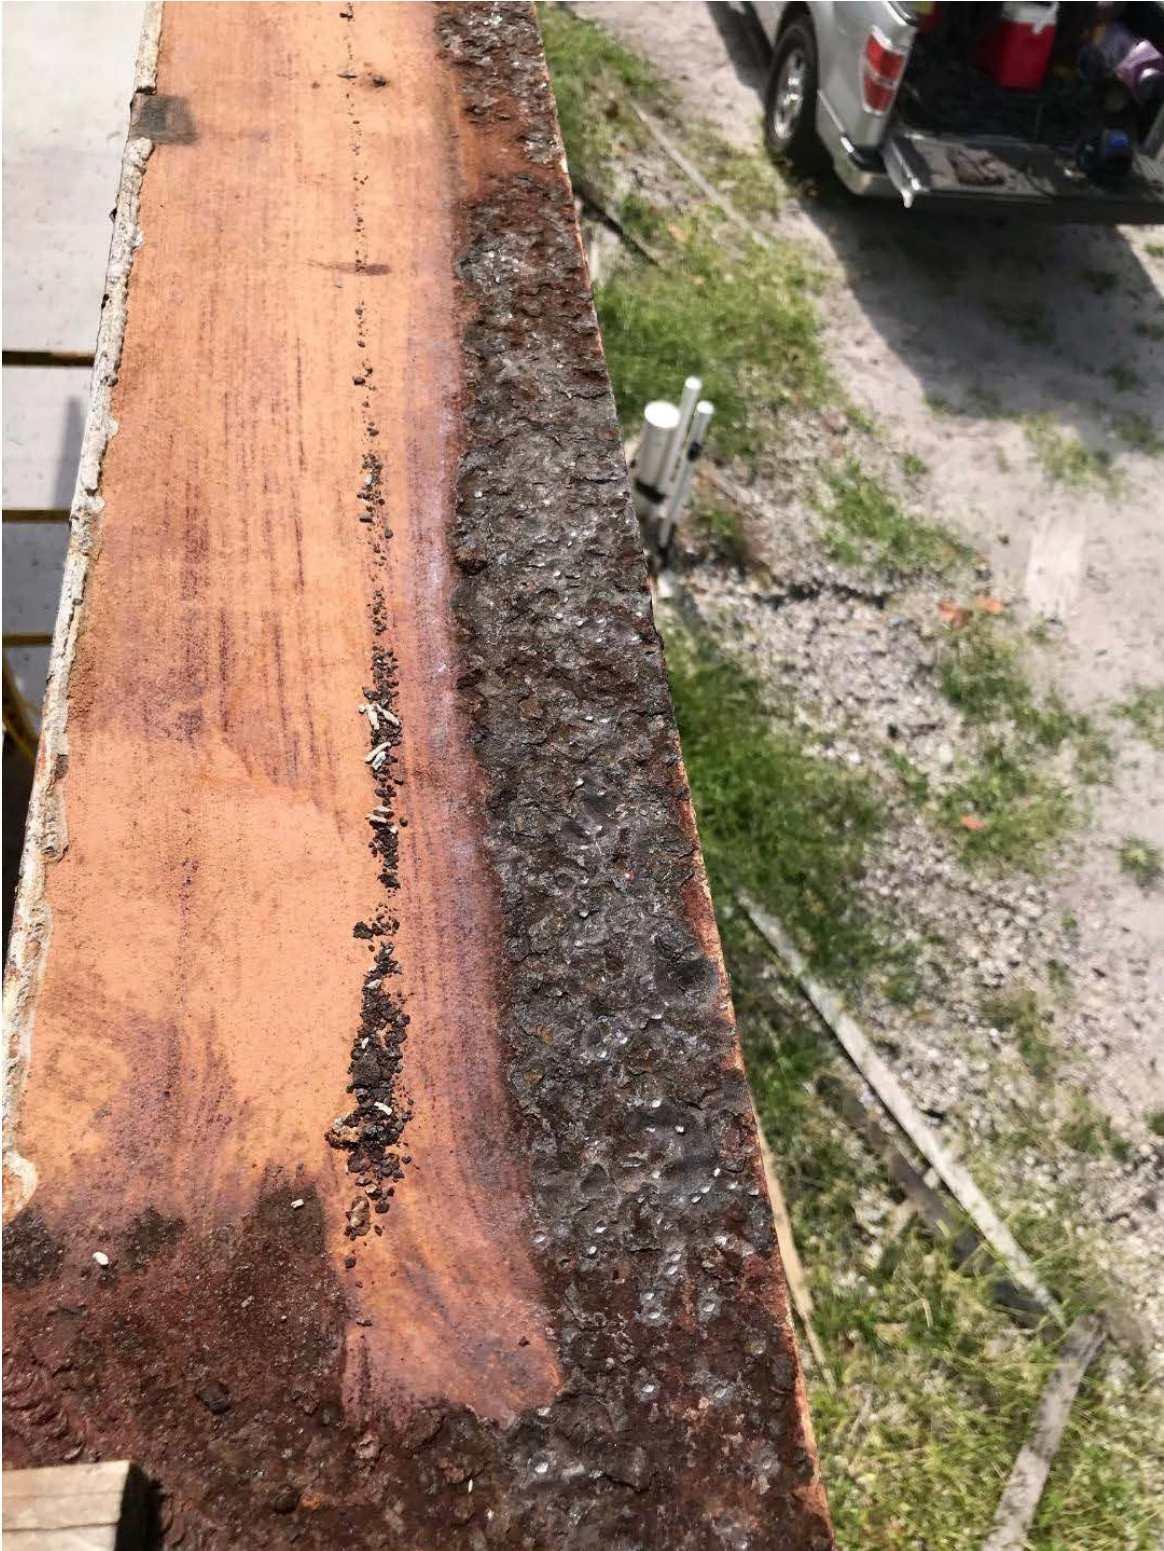
During the existing steel beam repair process, it has been discovered that existing steel beams located at East & West sides of existing house steel frame system are deteriorated beyond safe and structurally sound repair due to excessive section losses. Any attempt to patch, reweld or sectional replacement will not successfully achieve regaining original structural strength.

**Attachment 1:** Photos of deteriorated existing steel beams located at East & West Side of the existing house steel frame (Total 6 photos)

**I recommend replacement of existing steel beam located at East & West Side of the existing house steel reframe to be replaced with new steel beam with matching structural speciation's as existing steel beam**

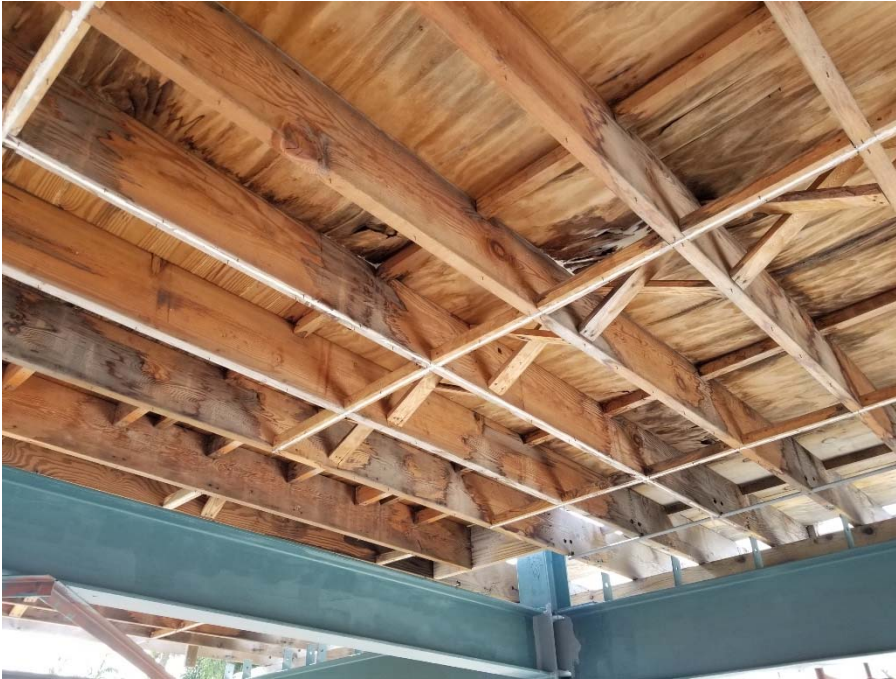
Exhibit 1. General view of Damaged Floor System

Since the damage at structural wood members of floor level (including floor rafters and sheathing) at excessive levels due to total section losses and loss of strength, **I recommend removal of the existing floor system in entirety and rebuild the floor structure with new wood members designed with the current Florida Building Code requirements.** New structural component of the floor system shall be properly erected and connected as per permitted structural plans approved by Delray Beach Building Department in order for this building to meet requirements of current Florida Building Code and to be structurally sound and safe

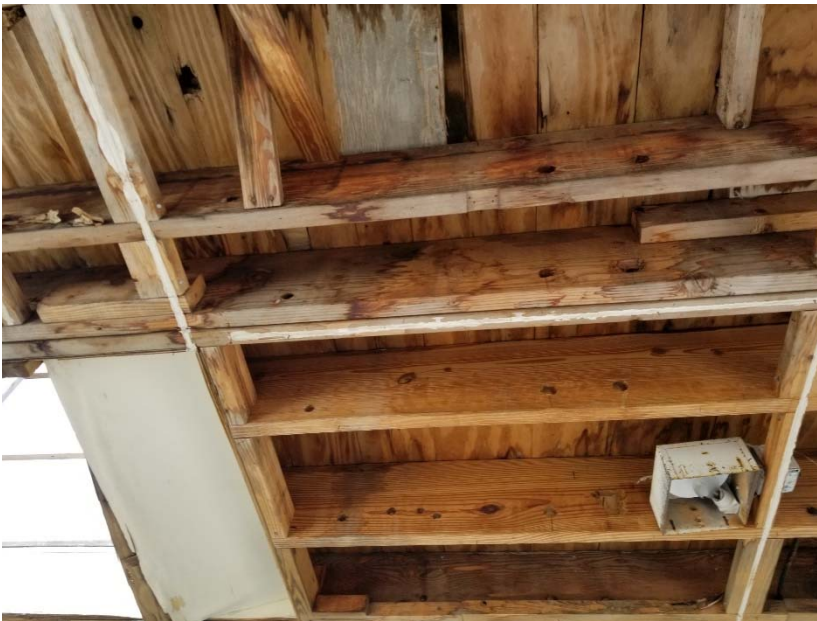
Exhibit 2. General view of Damaged Floor System
