**INSPECTION REPORT**  
**EVALUATION OF EXISTING BUILDING STRUCTURE**  
**FOR**

**212 SEABREEZE AVENUE**  
**DELRAY BEACH, FL 33483**

Investigation and evaluation of existing two-story standing alone wood and steel frame building structure with deep foundation system, at the aforementioned address

**INSPECTION REPORT**  
**EVALUATION OF EXISTING FLOOR SYSTEM**  
**FOR**

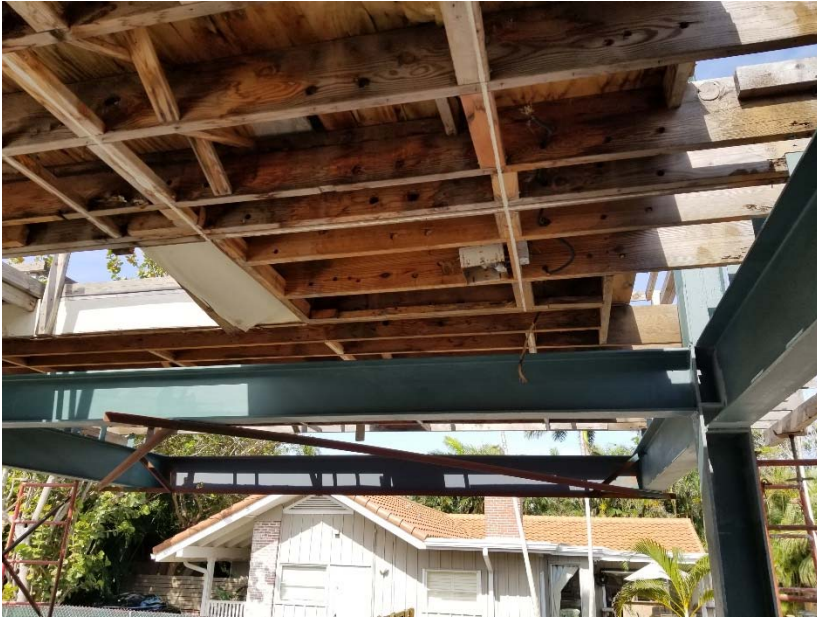
Exhibit 3. General view of Damaged Floor System

Since the damage at structural wood members of floor level (including floor rafters and sheathing) at excessive levels due to total section losses and loss of strength, **I recommend removal of the existing floor system in entirety and rebuild the floor structure with new wood members designed with the current Florida Building Code requirements.** New structural component of the floor system shall be properly erected and connected as per permitted structural plans approved by Delray Beach Building Department in order for this building to meet requirements of current Florida Building Code and to be structurally sound and safe

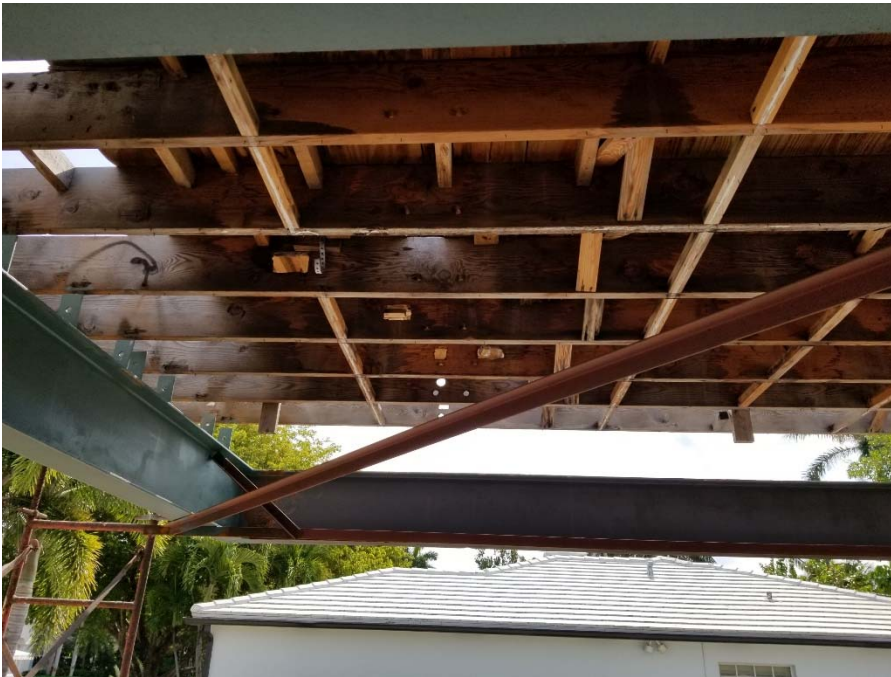
Exhibit 4. General view of Damaged Floor System oversized bored holes and notches

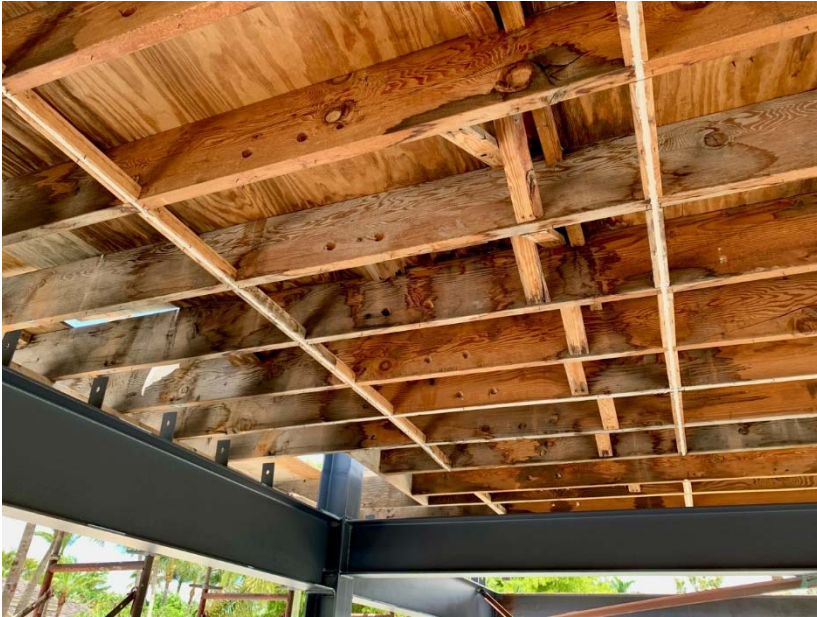
Exhibit 5. General view of Damaged Floor System

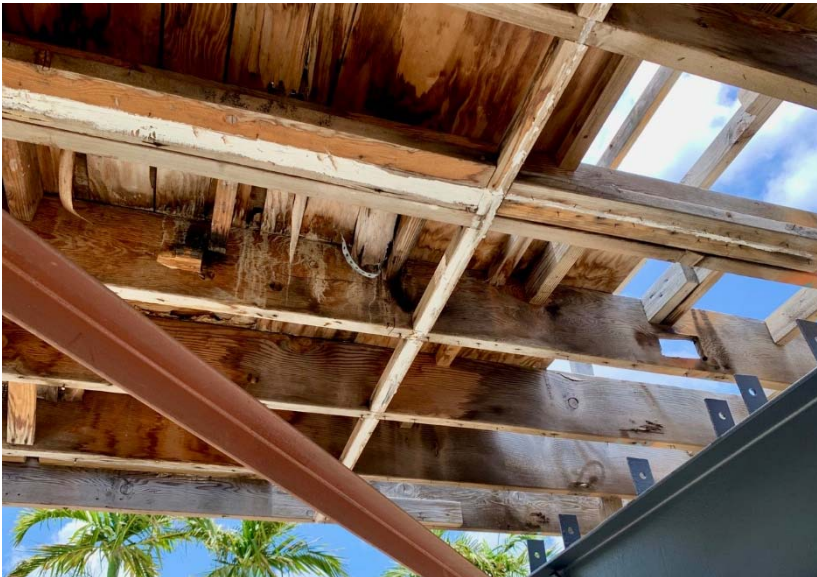
Exhibit 6. General view of Damaged Floor System

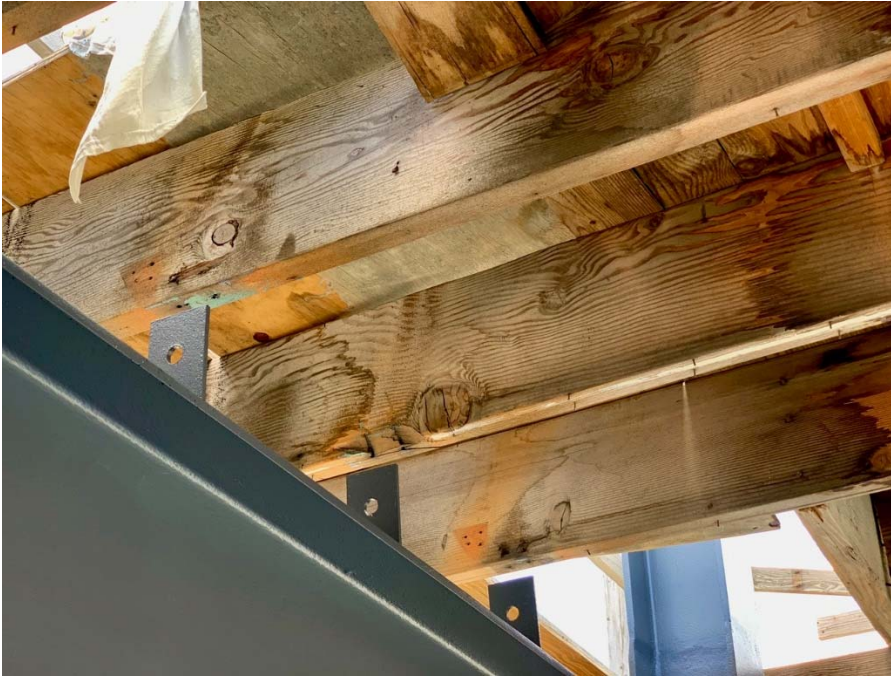
Exhibit 7. General view of Damaged Floor System
