Appraisal of the Existing Structure Prior to Demolition

File No. 21-1980 Prior to Demo

**INSPECTION REPORT**  
**EVALUATION OF EXISTING BUILDING STRUCTURE**  
**FOR**  
**212 SEABREEZE AVENUE**  
**DELRAY BEACH, FL 33483**

Investigation and evaluation of existing two-story standing alone wood and steel frame building structure with deep foundation system, at the aforementioned address

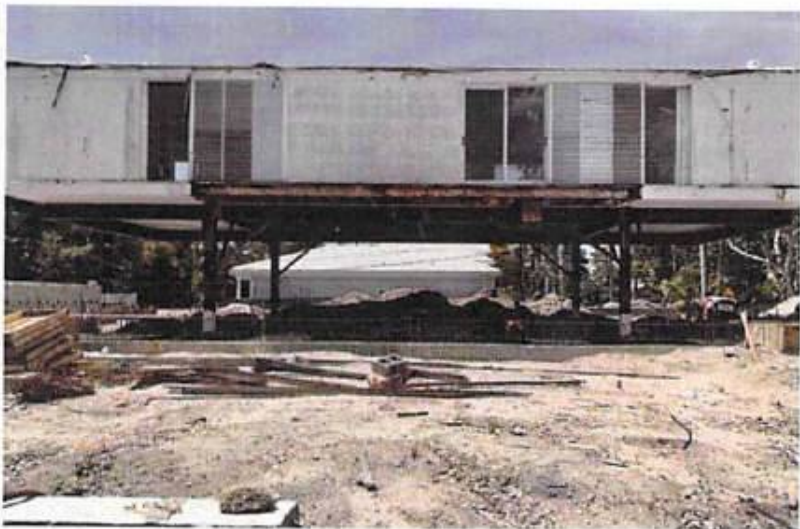
Exhibit 1. General view of Exterior of the Building

EXISTING FRONT FACADE BEFORE WALLS REMOVED

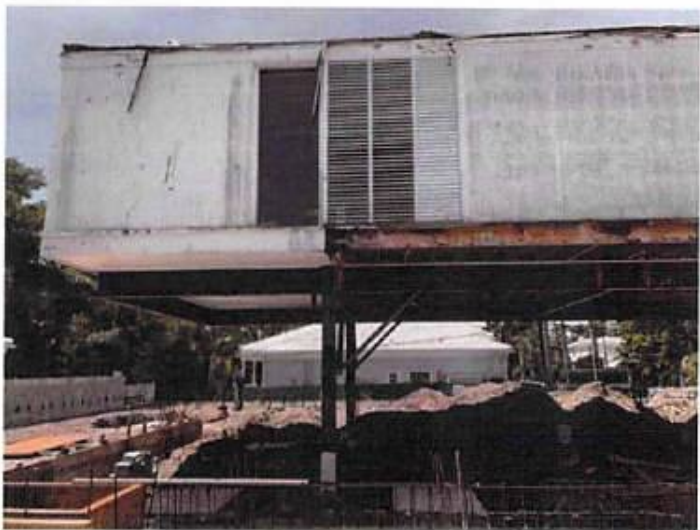
Exhibit 2. General view of Exterior of the Building

EXISTING FRONT FACADE EAST SIDING

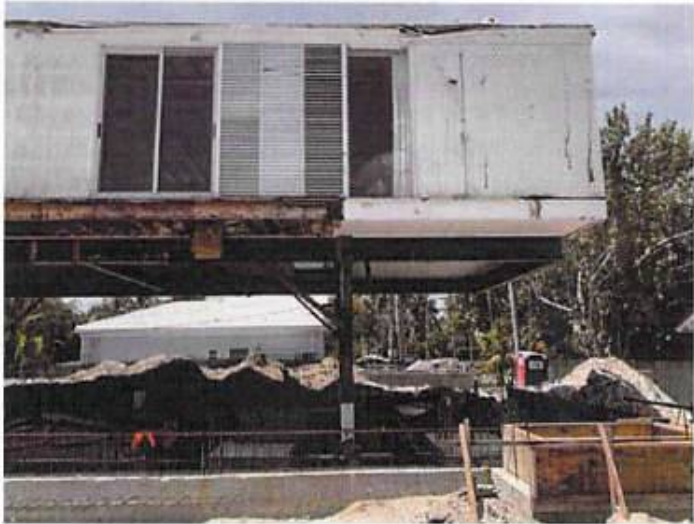
Exhibit 3. General view of Exterior of the Building

EXISTING FRONT FACADE WEST SIDING

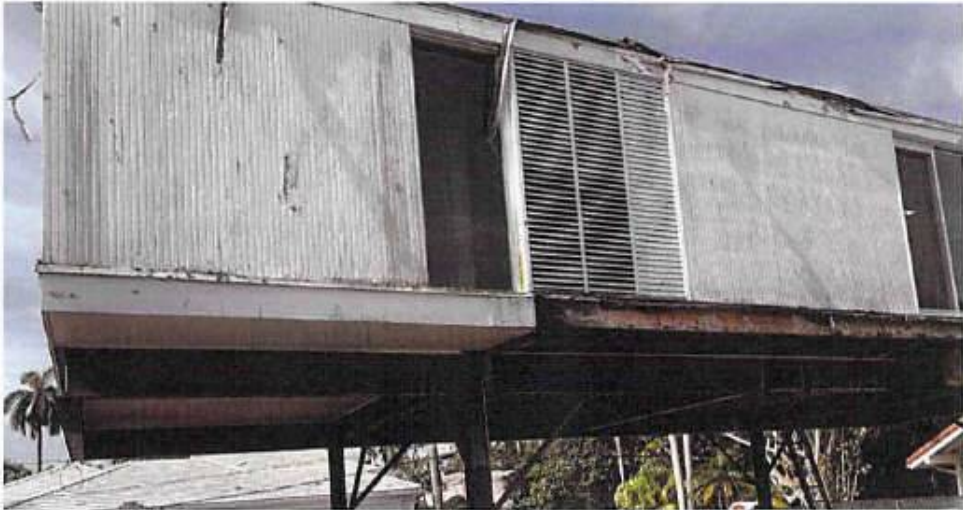
Exhibit 4. General view of Exterior of the Building

EXISTING PLYWOOD SIDING

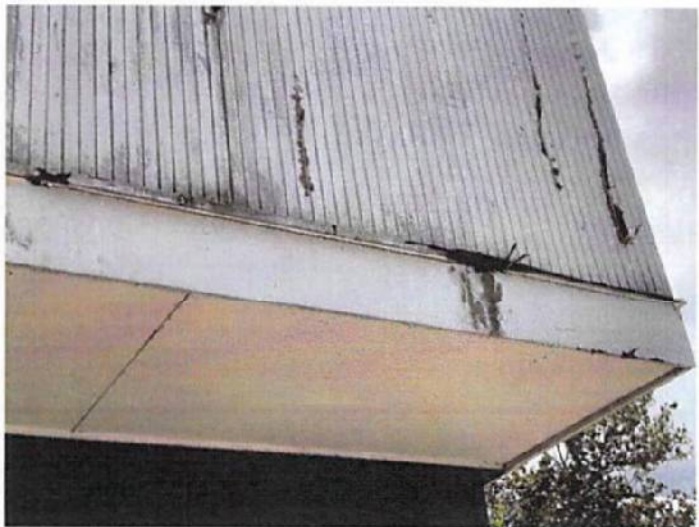
Exhibit 5. General view of Exterior of the Building

EXISTING FRONT PLYWOOD SIDING WEST

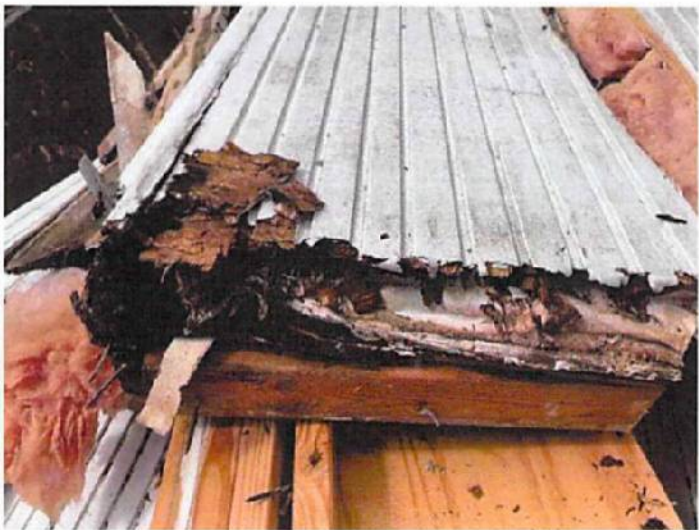
- i. Excessive moisture, stain, rotting, section loss and fully decayed wood members were encountered throughout roof rafters and exterior wall structure members that spread throughout the entire building
- ii. Wood Beams and Headers were severely rotted and deteriorated throughout the entire building
- iii. Existing wood fascia, sub fascia and sills were totally damaged and rotted
- iv. Missing exterior wood wall base plates and their connections throughout the entire structure
- v. All exterior Wood Siding, Jams and Bucks around window/door openings were severely damaged from constant water intrusion.
- vi. Excessive Deflection observed at flat roof rafter.

EXISTING ROTTED PLYWOOD SIDING

Exhibit 6. Typical rotted plywood siding at exterior wood frame walls

Since the damage at structural wood members at roof level and second floor (roofing, rafters, roof sheathing, wall studs, fascia, sub fascia, sills, headers, jambs and rim and wall sheathing) at excessive levels where total section losses and loss of strength are observed, I recommend total removal of the damaged roof and second floor wall system and rebuild the structure as per permit plans issued by City Delray Beach Building Department. The construction methods and materials are outlined in detail on sheets S-2,S-3,S-4,S-6 & S-7 sheet of these plans. Necessary installation and attachment details are provided in order for this building to meet requirements of current Florida Building Code and to be structurally sound and safe.

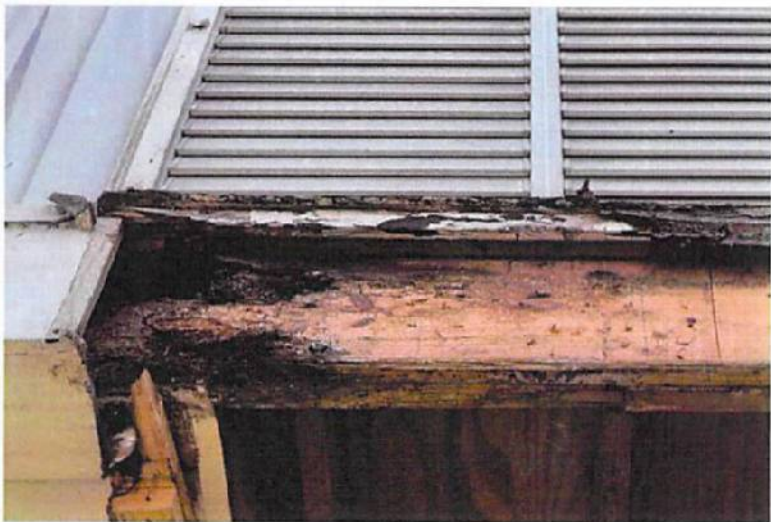
EXISTING 2ND FLOOR WOOD DAMAGE

Exhibit 7. Typical rotted wood beam/header at exterior load bearing walls

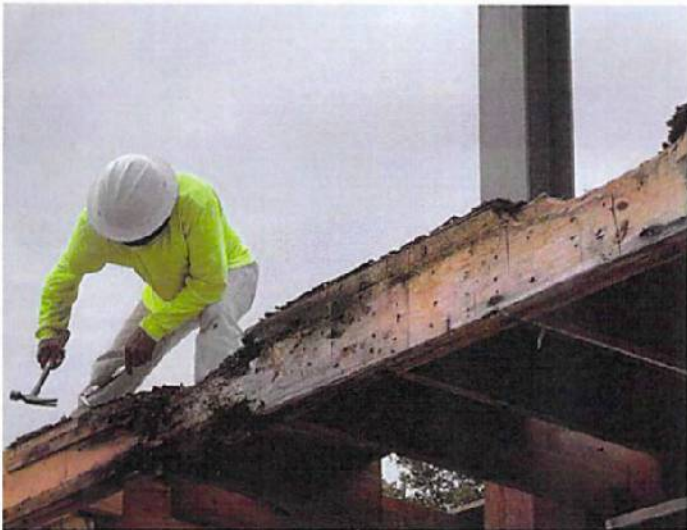
EXTENSIVE WOOD DAMAGE 2ND FLOOR

Exhibit 8. Typical rotted wood beam/header at exterior load bearing walls

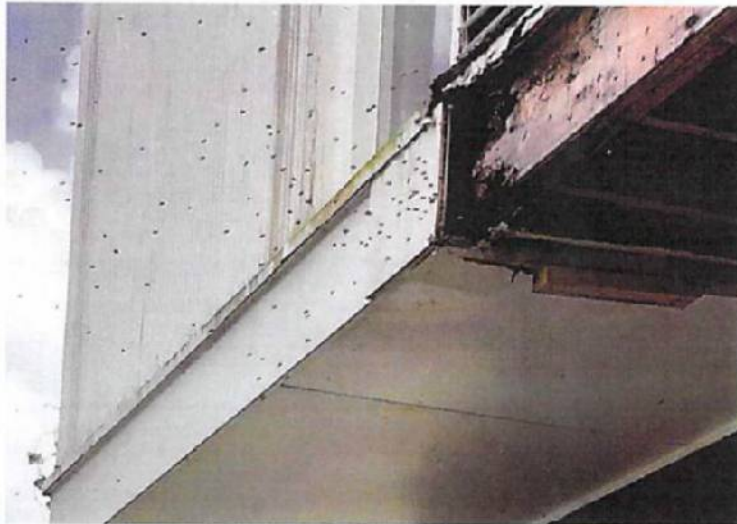
- i. Water damage was seemed active throughout the building
  - ii. There were traces of active termite damage at wood members
  - iii. All structural load bearing steel beams had structural damage/section loss and weakened connections.

DAMAGE TO 2ND FLOOR WOOD DUE TO TERMITES/INSECTS

Exhibit 9. Typical termite damage at structural wood members

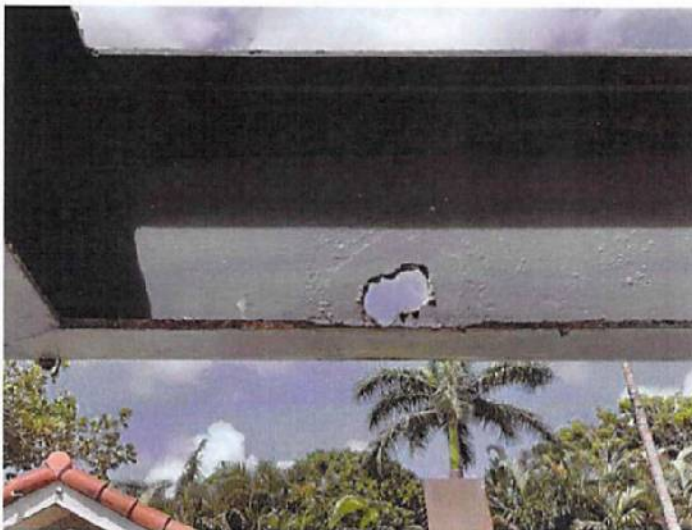
EXISTING STEEL BEAM DAMAGE

Exhibit 10. Typical structural damage and section loss at load bearing steel members

Until necessary demolition is performed on the upper level of the building the damaged steel structure cannot be fully accessed. Appropriate steel structure repairs shall be applied on the existing steel beams as per repair details provided and repairs shall be executed by certified welders.

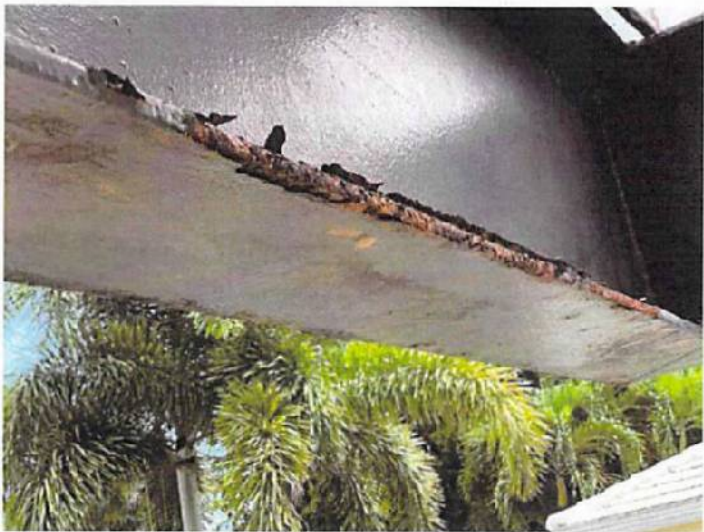
STEEL BEAM CORROSION

Exhibit 11. Typical structural damage and section loss at load bearing steel members

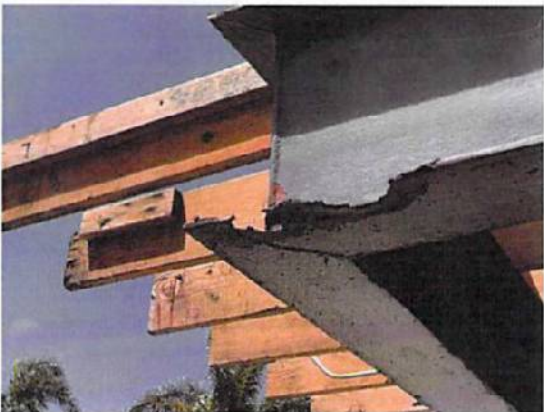
STEEL BEAM CORROSION

Exhibit 13. Typical structural damage and section loss at load bearing steel members

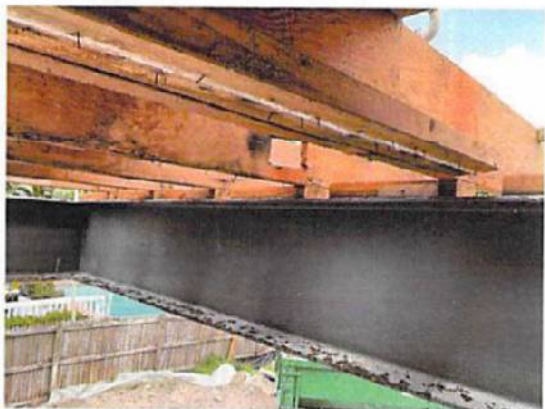
- vii. There were no forms of fastening or nailing at wall to roof rafter and wall connections (typical at perimeter). There was no continuous load path provided to resist wind forces.

EXISTING 2ND FLOOR JOISTS

Exhibit 13. There were no forms of fastening or nailing at wood members to main structure (typical at perimeter). There was no continuous load path from roof to foundation

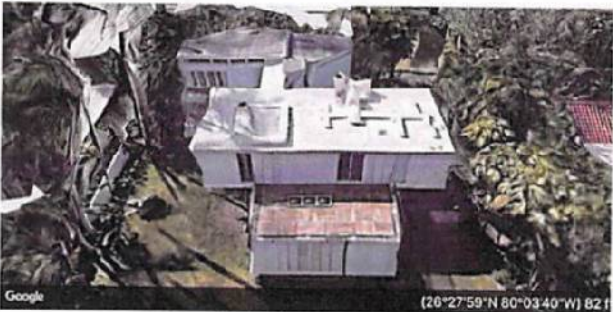
Exhibit 14. Birdseye view of existing roof

- iv. Severe existing roofing deterioration is observed throughout the building. Excessive deflection of roof rafters and sheathing indicate improper design of existing roof structure to carry the superimposed weight of AC equipment that were installed on the roof top. Active water damage and seepage observed from the numerous locations at roof top equipment and ductwork/pipe penetration locations. The roofing was not built and fastened as per Florida Building code requirements.

AC EQUIPMENT ON ROOF OF EXISTING HOUSE PRIOR TO ROOF REMOVAL
