RE: Arboricultural Consulting for Entrance Located at 2001 South Ocean Boulevard, Delray Beach, FL

Overview

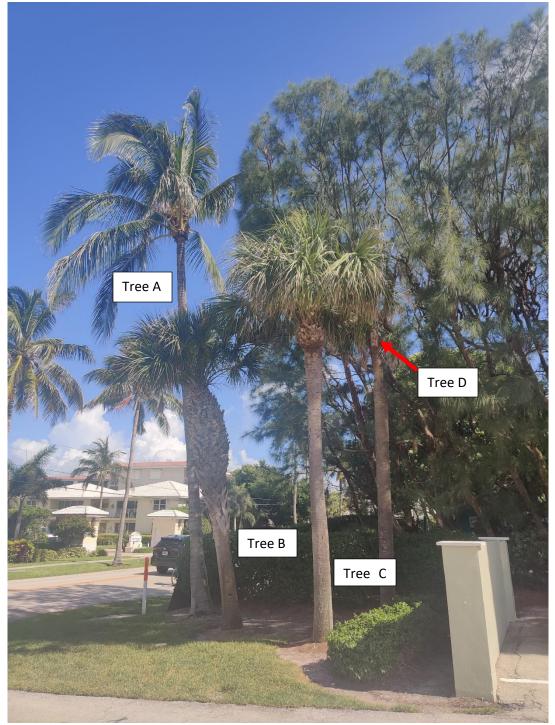
Tree D indicated above with declining crown rubbing on adjacent tree

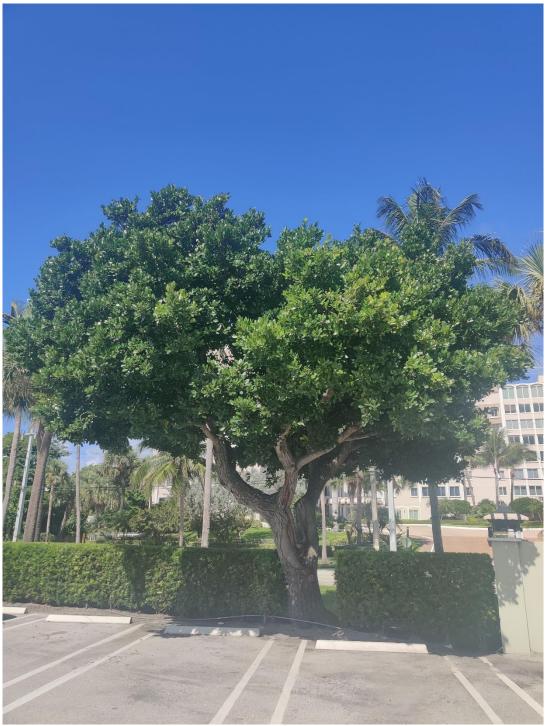
Brazilian Beautyleaf, Calophyllum Brasiliense view looking west

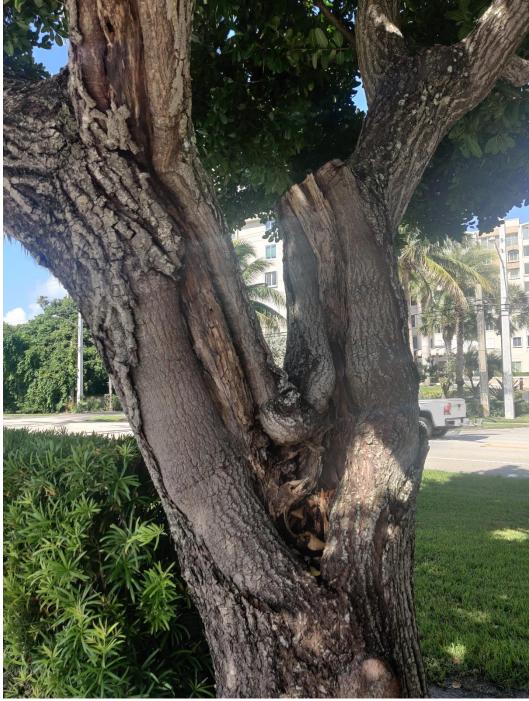
Closer view of Brazilian beautyleaf showing codominant trunks with extensive damage that is more than 50% of the trunk area with decay present

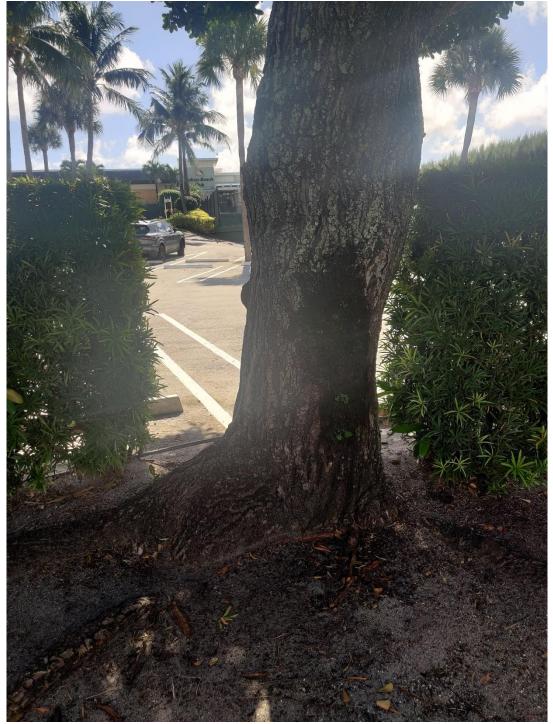
View of Brazilian beautyleaf showing limited root space and deflected roots

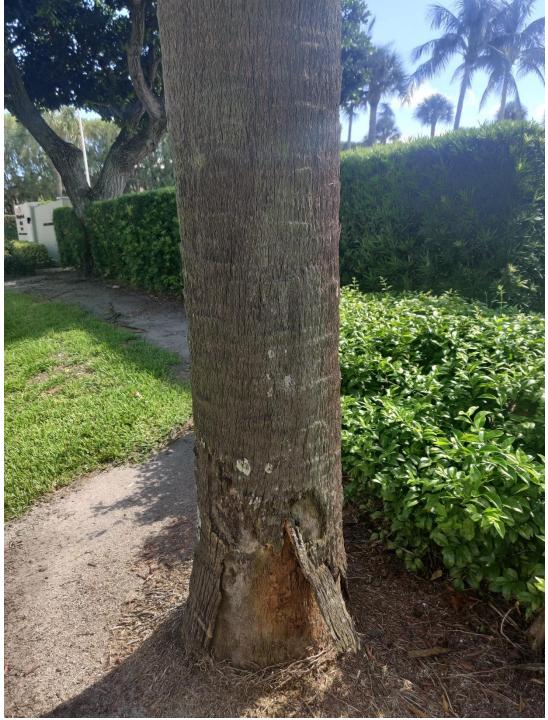
View of trunk damage on Tree T, Cabbage Palm

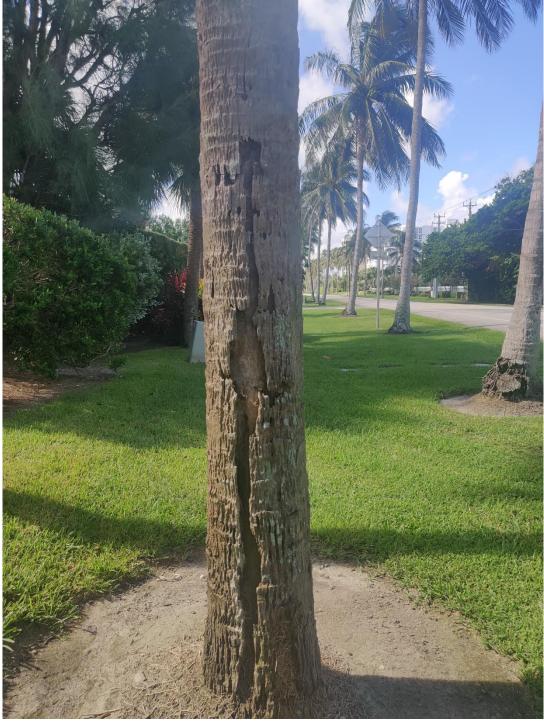
Trunk damage Tree AA, Cabbage Palm

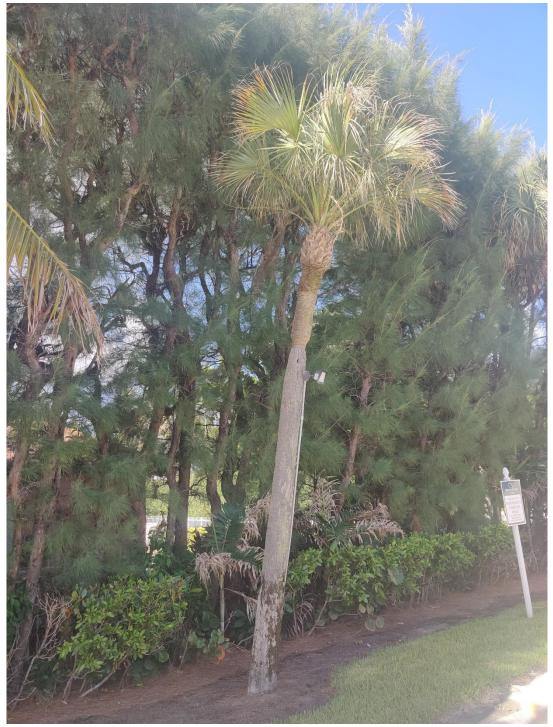
Tree AE, Cabbage Palm with poor trunk taper, undersized crown with low nutrition

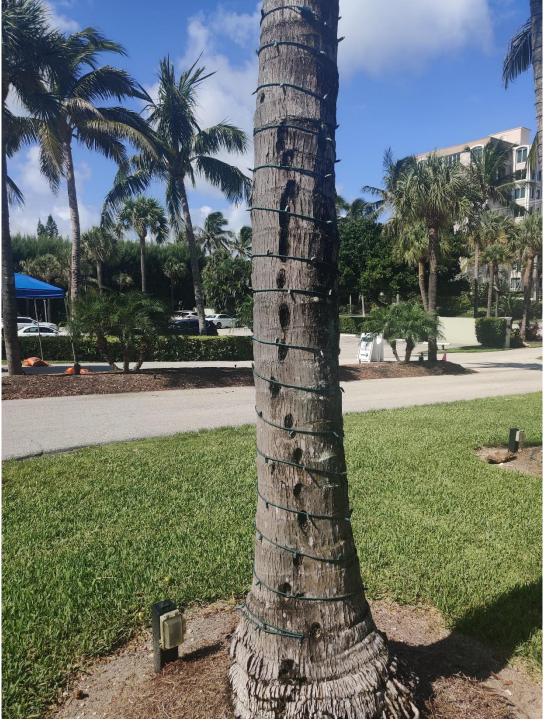
Tree AY, Coconut Palm with spiked trunk
