**LISA H. HAMMER, RCA**  
*Horticultural Consultant*

RE: 917 NE 8 Avenue  
Delray Beach, Florida

**PHOTOGRAPHS OF EXISTING TREES AS OF MAY 24, 2022**

**917 NE 8 Avenue  
Delray Beach, Florida**

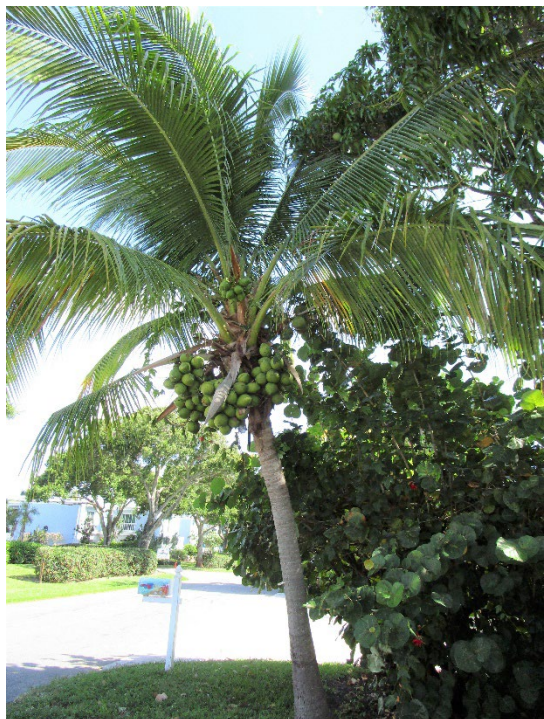
Tree #1 – Coconut Palm

Tree #	Common Name	Scientific Name	Trunk Diameter (in)	Overall Height (ft)	Clear Trunk Palms (ft)	Crown Spread (ft)	Condition (G,F,P)	Condition (%)	Disposition Recommendation	Comments
1	Coconut Palm	<i>Cocos nucifera</i>	8	20	10	16	Excellent	90	Retain, Remove, or Relocate	
2	Frangipani	<i>Plumeria obtusa</i>	5 + 6	20	N/A	18	Excellent	90	Retain, Remove, or Relocate	
3	Christmas Palm - dbl	<i>Adonidia merrillii</i>	4 & 4	20 & 20	12 & 12	8 & 8	Good	80	Retain, Remove, or Relocate	
4	Queen Palm	<i>Syagrus romanzoffianum</i>	6.5	25	12	16	Fair-Good	75	Retain, Remove, or Relocate	
5	Queen Palm	<i>Syagrus romanzoffianum</i>	8	30	24	16	Fair-Good	75	Retain, Remove, or Relocate	
6	Royal Poinciana	<i>Delonix regia</i>	24	30	N/A	65	Good	80	Retain	Not a good candidate for relocation due to species and size; few small dead branches
7	Jacaranda	<i>Jacaranda mimosifolia</i>	20	30	N/A	55	Fair	60	Retain or Remove	Large decay cavity on 1 leader into trunk; little storm damage; not a good candidate for relocation

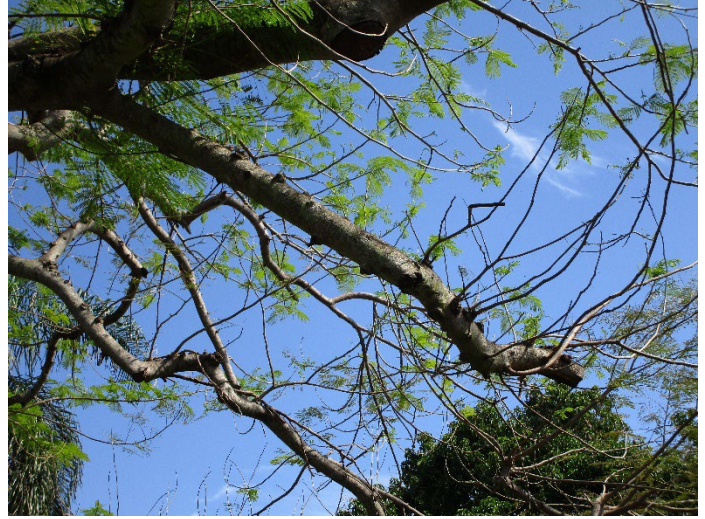
Tree #6 – Note a few small dead branches

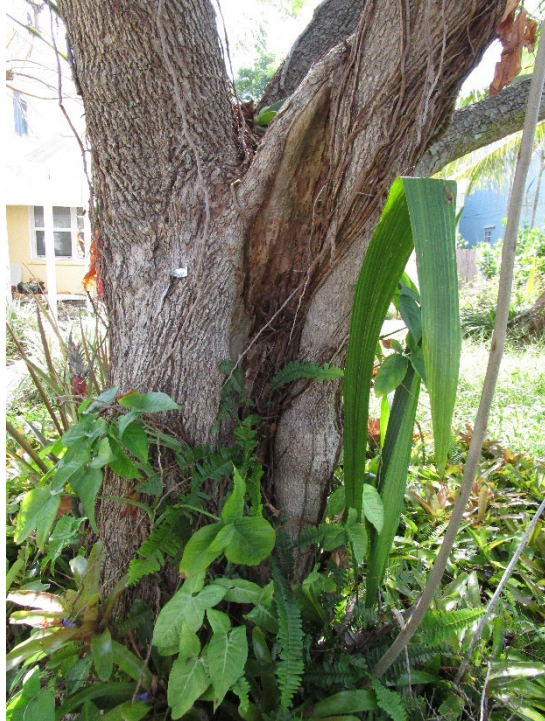
Tree #7 – Decay cavity on leader and trunk

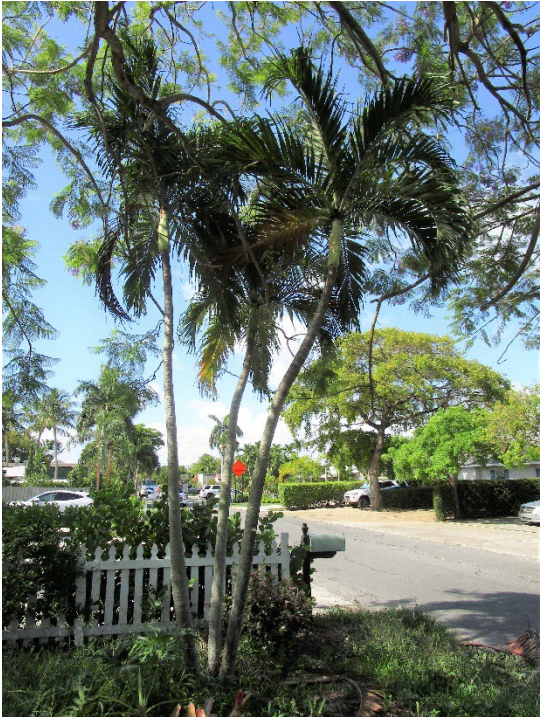
Tree #8 – Christmas Palm – triple

8	Christmas Palm - trpl	<i>Adonidia merrillii</i>	4 & 4 & 4	20 & 18 & 20	12 & 10 & 12	6 & 6 & 6	Fair-Good	75	Retain, Remove, or Relocate	Slightly thin trunk
9	Coconut Palm	<i>Cocos nucifera</i>	7	20	10	18	Good	80	Retain, Remove, or Relocate	Little trunk damage
10	Loquat	<i>Eriobotrya japonica</i>	6	25	N/A	20	Fair-Good	75	Retain, Remove, or Relocate	Not a good candidate for relocation due to species
11	Mango	<i>Mangifera indica</i>	13	35	N/A	30	Good	80	Retain or Remove	Possibly a volunteer seedling, not worthy of relocation
12	Mango	<i>Mangifera indica</i>	32	35	N/A	50	Good	80	Retain	Not a good candidate for relocation due to size
13	Coconut Palm	<i>Cocos nucifera</i>	9	25	12	16	Fair	60	Retain or Remove	Significant trunk wound
14	Coconut Palm	<i>Cocos nucifera</i>	15	25	4	22	Excellent	90	Retain, Remove, or Relocate	Large, robust palm
15	Coconut Palm	<i>Cocos nucifera</i>	16	35	25	20	Good	80	Retain, Remove, or Relocate

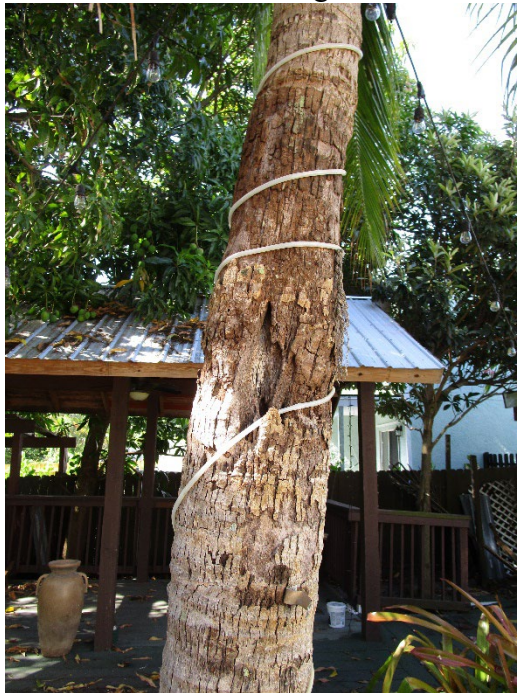
Tree #13 – Trunk Damage

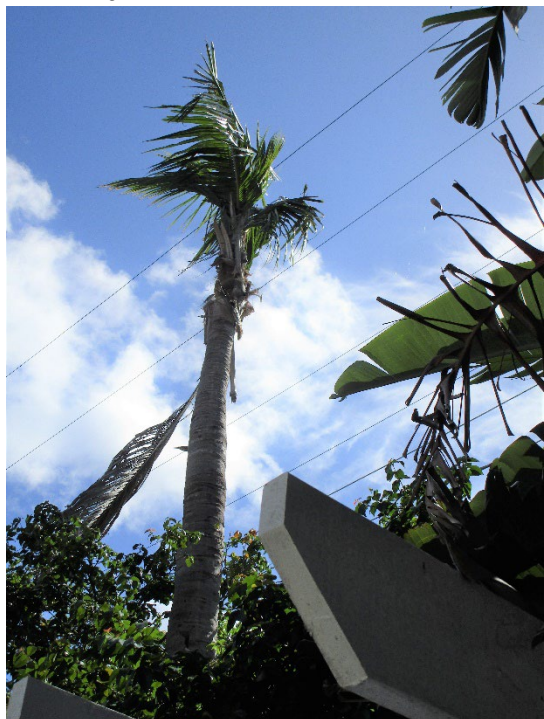
Tree #16 – Coconut Palm

16	Coconut Palm	<i>Cocos nucifera</i>	11	28	22	3	Poor	35	Remove	Over-pruned many times for line-clearing. Nutritional deficiencies.
17	Cabbage Palm	<i>Sabal palmetto</i>	14	30	22	10	Good	80	Retain, Remove, or Relocate
