RE: *Delray Beach DDA Christmas Tree Evaluation*

Kimley-Horn and Associates, Inc. ("Kimley-Horn") is pleased to submit this report to Delray Beach Downtown Development Authority ("Delray Beach DDA") for the preliminary structural evaluation of the steel frame of the 100 foot tall steel framed Christmas tree that the DDA displays over the holidays at Old School Square.

Delray Beach DDA Christmas Tree Frame

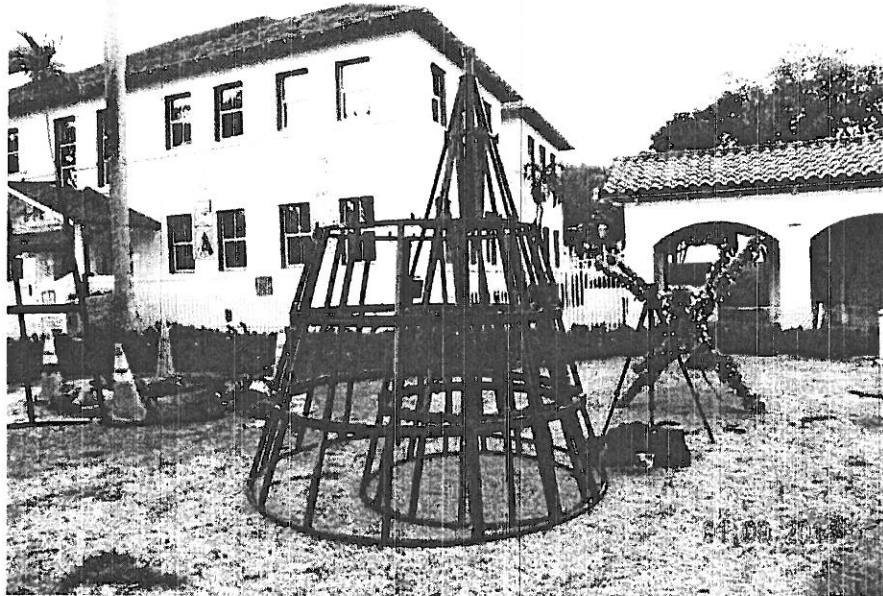
Photo No. 7

Remarks: View of upper portion of top tree section on site during removal. This section was recently refurbished.

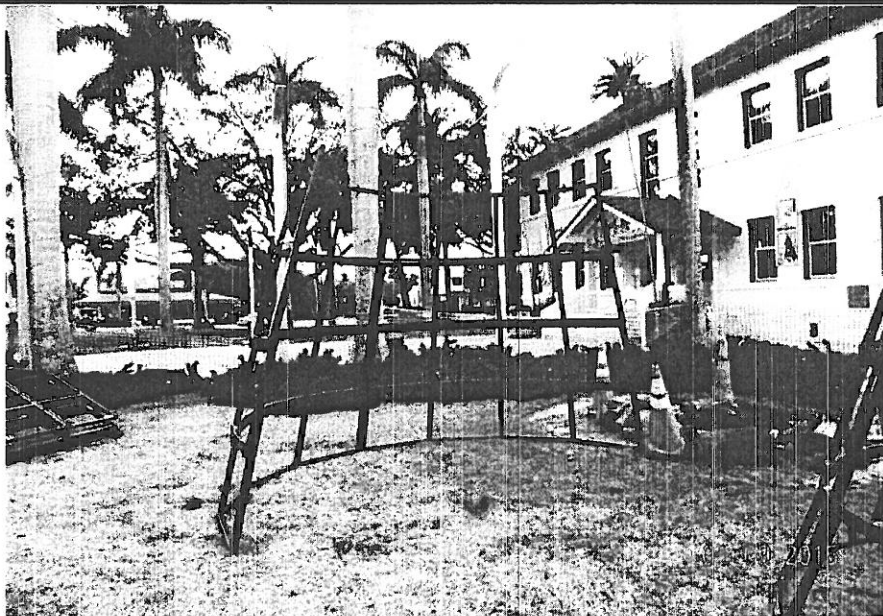
Photo No. 8

Remarks: View of lower portion of top tree section on site during removal. This section is in fairly good condition.

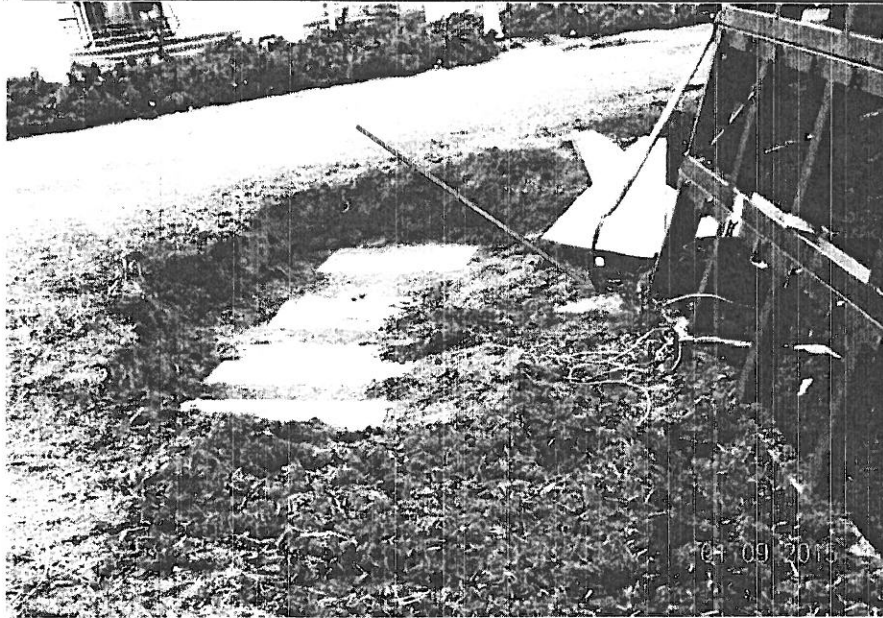
Photo No. 11

Remarks: View of concrete foundation ring below bottom section. Note foundation is sunken relative to grade.

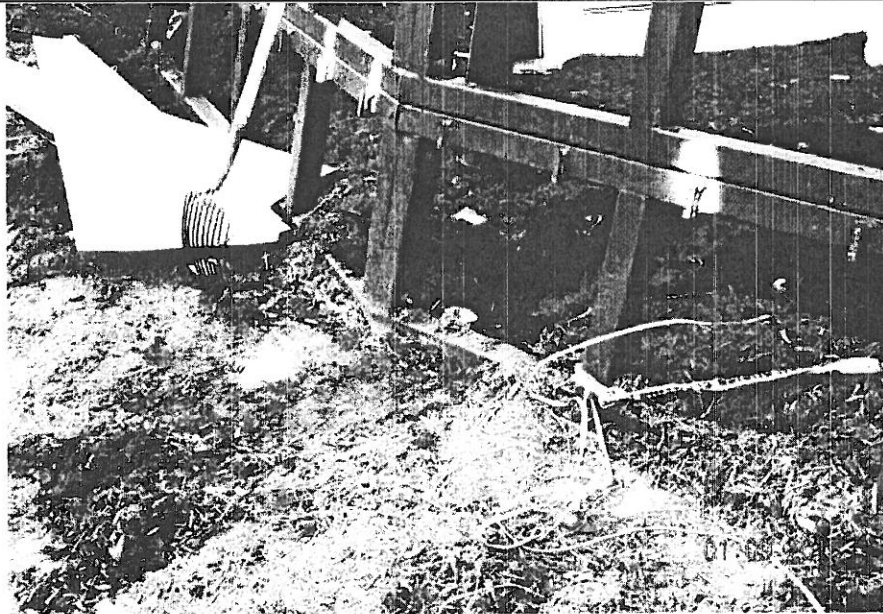
Photo No. 12

Remarks: Close up view of foundation area indicated by red arrow in Photo 11 above.

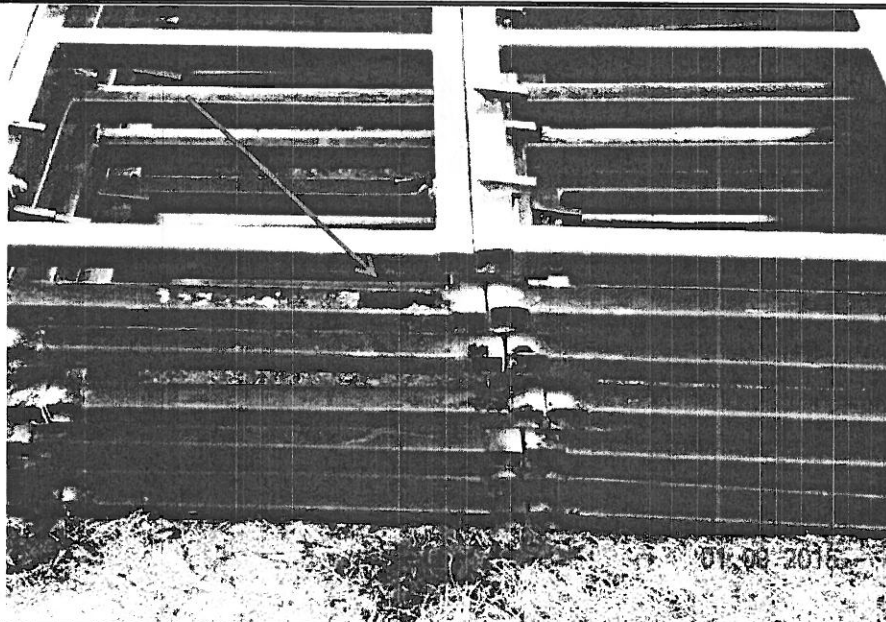
Photo No. 13

The primary cause of the deterioration of the frame is due to the existing frame configuration that does not allow for proper ventilation/drying of the interior of the tubular members. Water gets trapped inside the tubular members.

Remarks: View of end of frames stacked on site. Note corrosion near connections.

5. Develop a rack system for storage that holds the frames vertical, elevated off the floor, thereby minimizing trapped water intrusion.
6. Continue to remove any loose rust and patch, weld or replace severely corroded sections as needed.

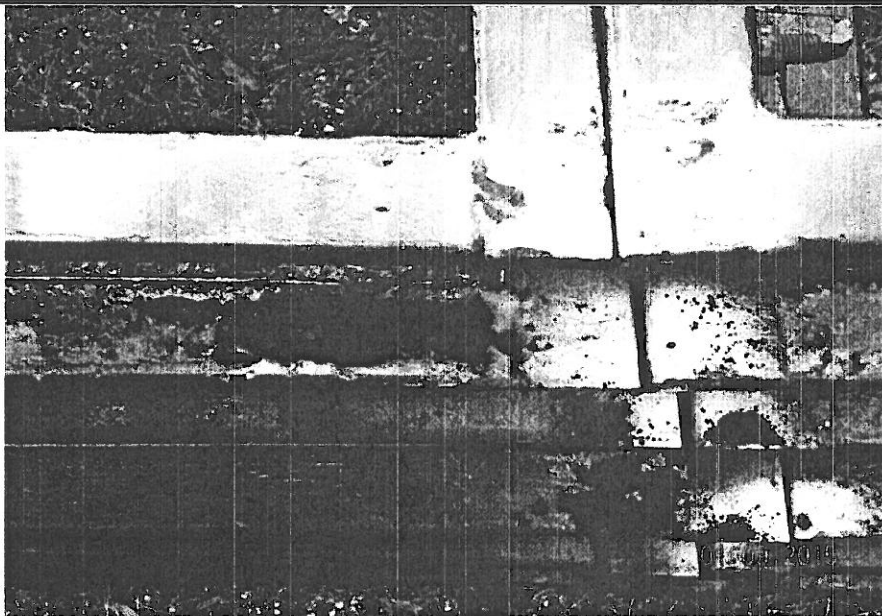
Photo No. 14

Remarks: Close-up view of corroded connection points indicated by red arrow in Photo 13 above.

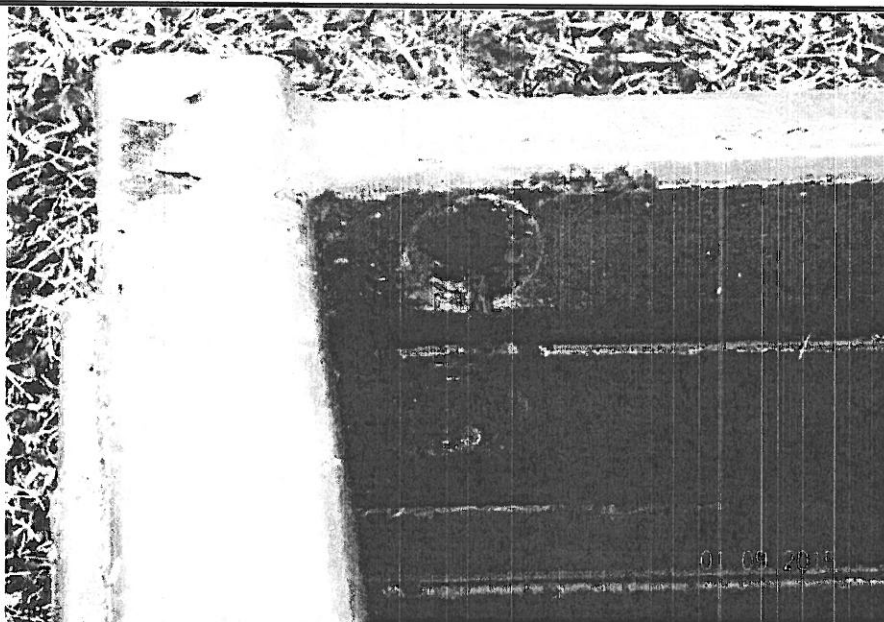
Photo No. 15

The orientation in which the frames are stacked (horizontally) allows rainwater to enter the bolt holes in the vertical legs, where it gets trapped because the vertical legs do not have drains. The only openings in the vertical legs are the bolt holes.

Remarks: Typical view of corrosion around bolt hole in vertical leg of frame.

1. Drill drain holes in the closed vertical leg sections of the frames to prevent trapping water.
2. Replace all fastener components (bolts, washers and nuts) with non-corrosive galvanized or stainless steel assemblies.

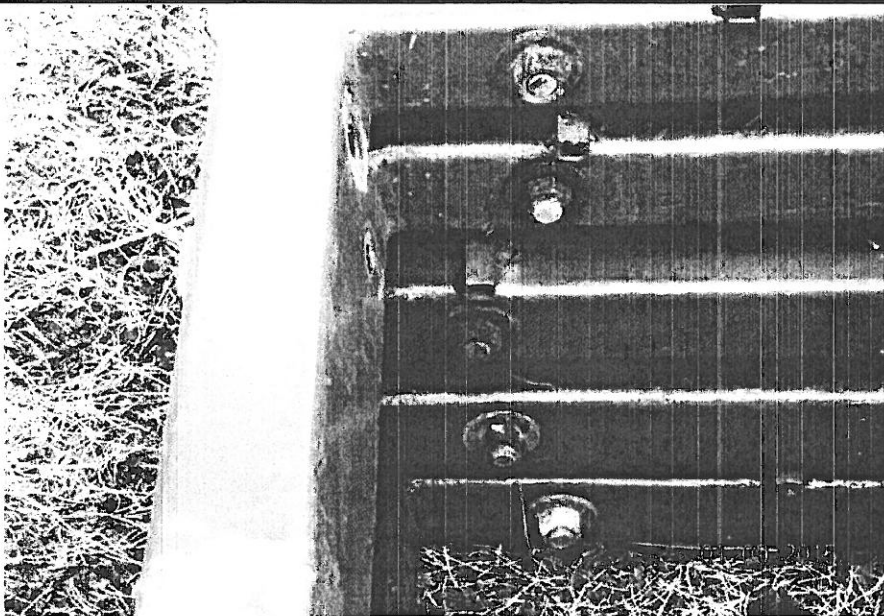
Photo No. 16

Remarks: Typical view of corroded fasteners.

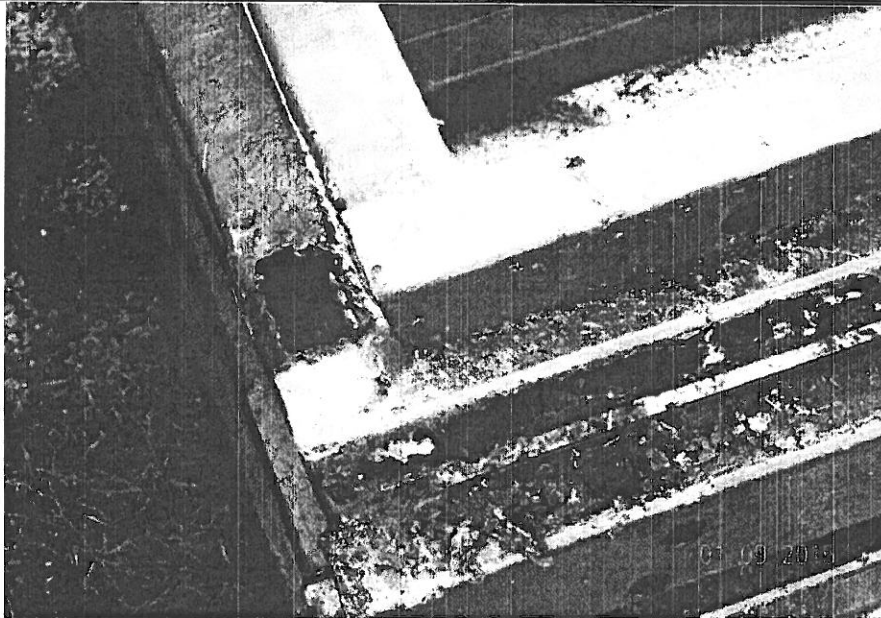
Photo No. 17

Remarks: Close-up view of corner of frame subject to corrosion damage.
