Delray Beach Golf Clubhouse, Delray Beach, FL Emergency Operation Center Feasibility Report

Jeffrey Bergmann, P.E.
FL PE No. 50159
Wantman Group, Inc.
Cert. No. 6091-LB No. 7055
561-839-1721
Job # 41011004.22
May, 2017

Introduction

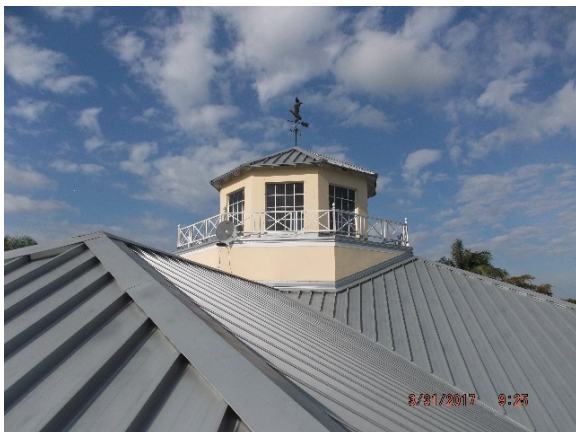
Octagonal Cupola

No structural plans for the octagonal cupola could be obtained. Based on visual inspection the structure appears to be constructed of timber framing. The cupola is open to below with windows on each side. Due to its height and configuration, the cupola is at risk of being damaged during a hurricane event. Damage to either the cupola's roof or walls will jeopardize the structure's resistance to hurricane force winds. Without having the ability to verify the anchorage and construction of the cupola before the building is used as an EOC this structure should be removed to enhance the roof's integrity. The proceeding evaluation of the building will be completed assuming the removal of the cupola.

- All the trees within the lay-down range of the building should be removed,
- All exterior doors should be replaced with hurricane rated doors,
- The octagonal cupola at the top of the roof should be removed,
- Roof top equipment should be strapped down to the roof, and
- Roof overhangs should be cut back closer to the walls with the eaves refinished.

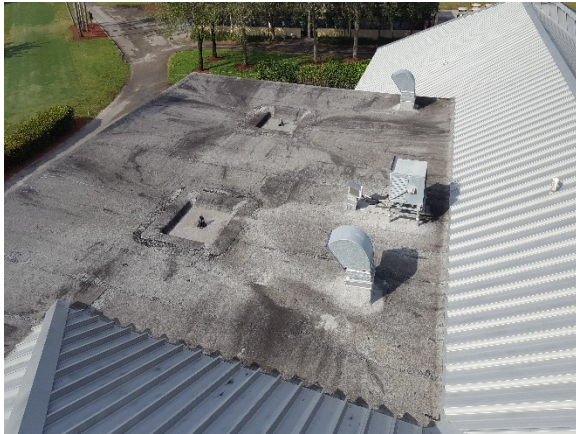
Several roof mounted air handling units and vents were observed without hurricane resistant restraints. Unanchored roof appendages will lead to the roof being classified as non-compliant.

Unsecured Roof Mount Air Handling Units

*4 – Removing part of the roof eaves and securing roof top appendages will lead to a compliant building.

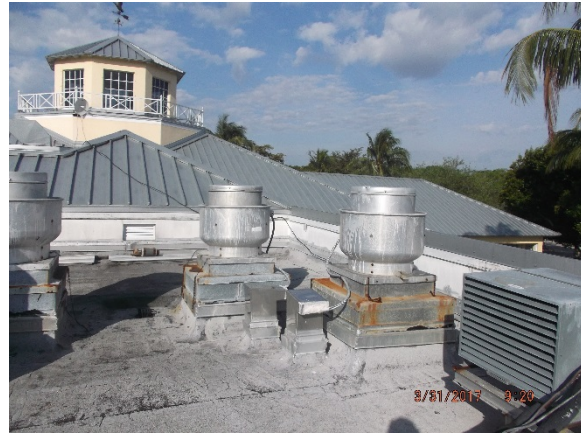
Unsecured Roof Mount Air Handling Units

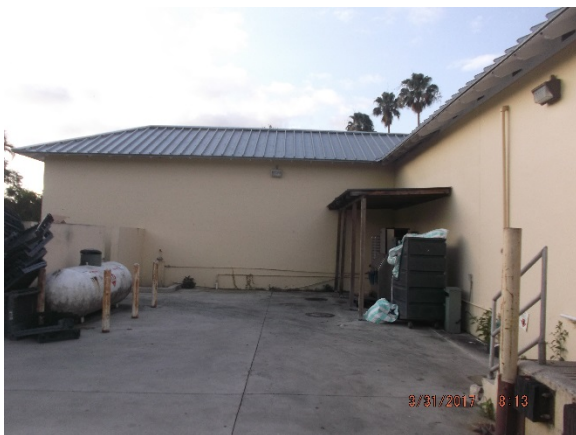
Several air conditioning units installed on the ground were observed to not be adequately secured for hurricane force winds. It has been our experience that the units themselves are not designed to withstand hurricane wind forces. In addition to the air conditioner units several other unsecured items were located adjacent to or below the club house. These items include a fuel tank, ice machines, patio furniture, dumpsters, and golf carts. If these items are not secured they can become wind borne debris during hurricane events. We recommend that these items be either strapped down or relocated prior to any hurricanes.

Unsecured Fuel Tank and Ice Machine

- Replace all windows in the meeting/ballroom area,
- Strap down air conditioning units on the ground,
- Secure unsecured items on the building exterior (i.e. fuel tank, ice machines, patio furniture, dumpsters, and golf carts), and
- Remove canvas canopy prior to hurricane events

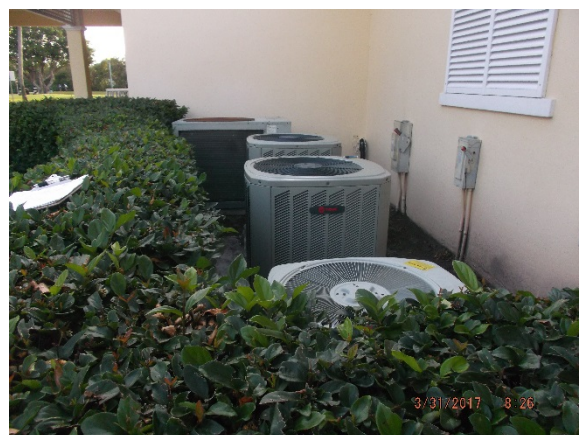
Unsecured Air Conditioning Units

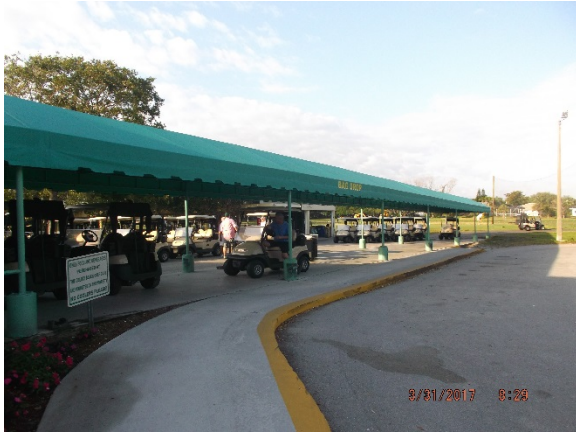
On the west side of the clubhouse a canvas covered canopy is attached to the walls of the building. This canvas canopy needs to be removed prior to a high wind event.

Canvas Canopy to be Removed

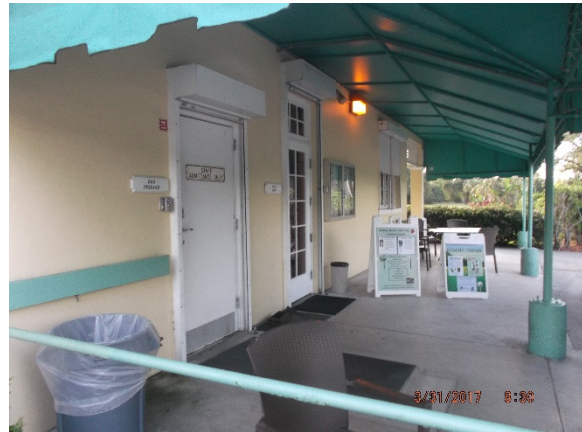
Canvas Canopy to be Removed
