February 18, 2019

Re: Shade Tree Health Evaluation and Report for 1009 and 1023 Casuarina Road, Delray Beach, Florida

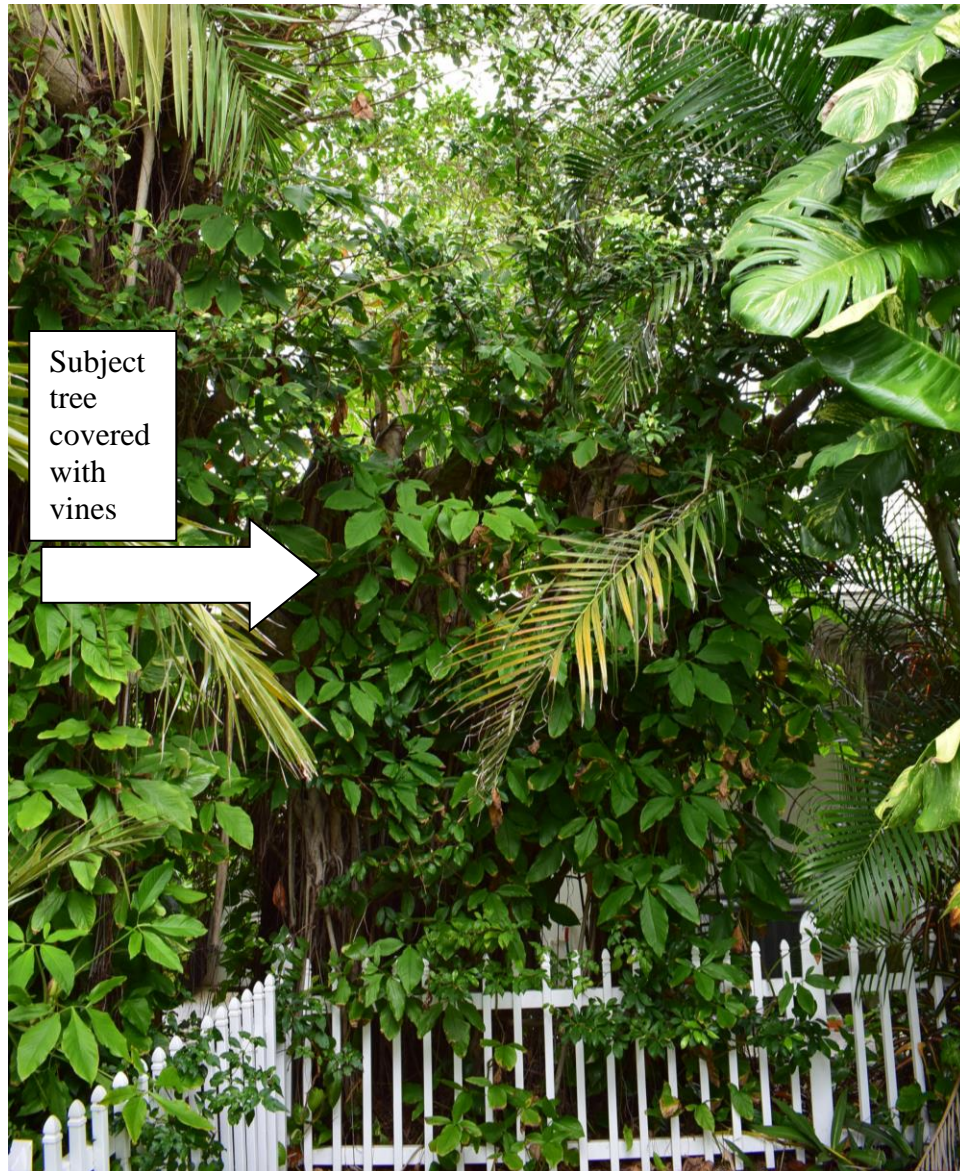
Tree Three

Tree Three: Weeping fig, *Ficus microcarpa*, approximately 10 feet tall, six feet wide. The trees trunk diameter was 50 inches. The tree has very poor health and structure since it has been hatracked (headed) with very few leaves remain. The tree is a stump covered with vines and located immediately beneath the overhead powerlines. The trees health condition is very poor with a 15% health condition percentage.

View looking north

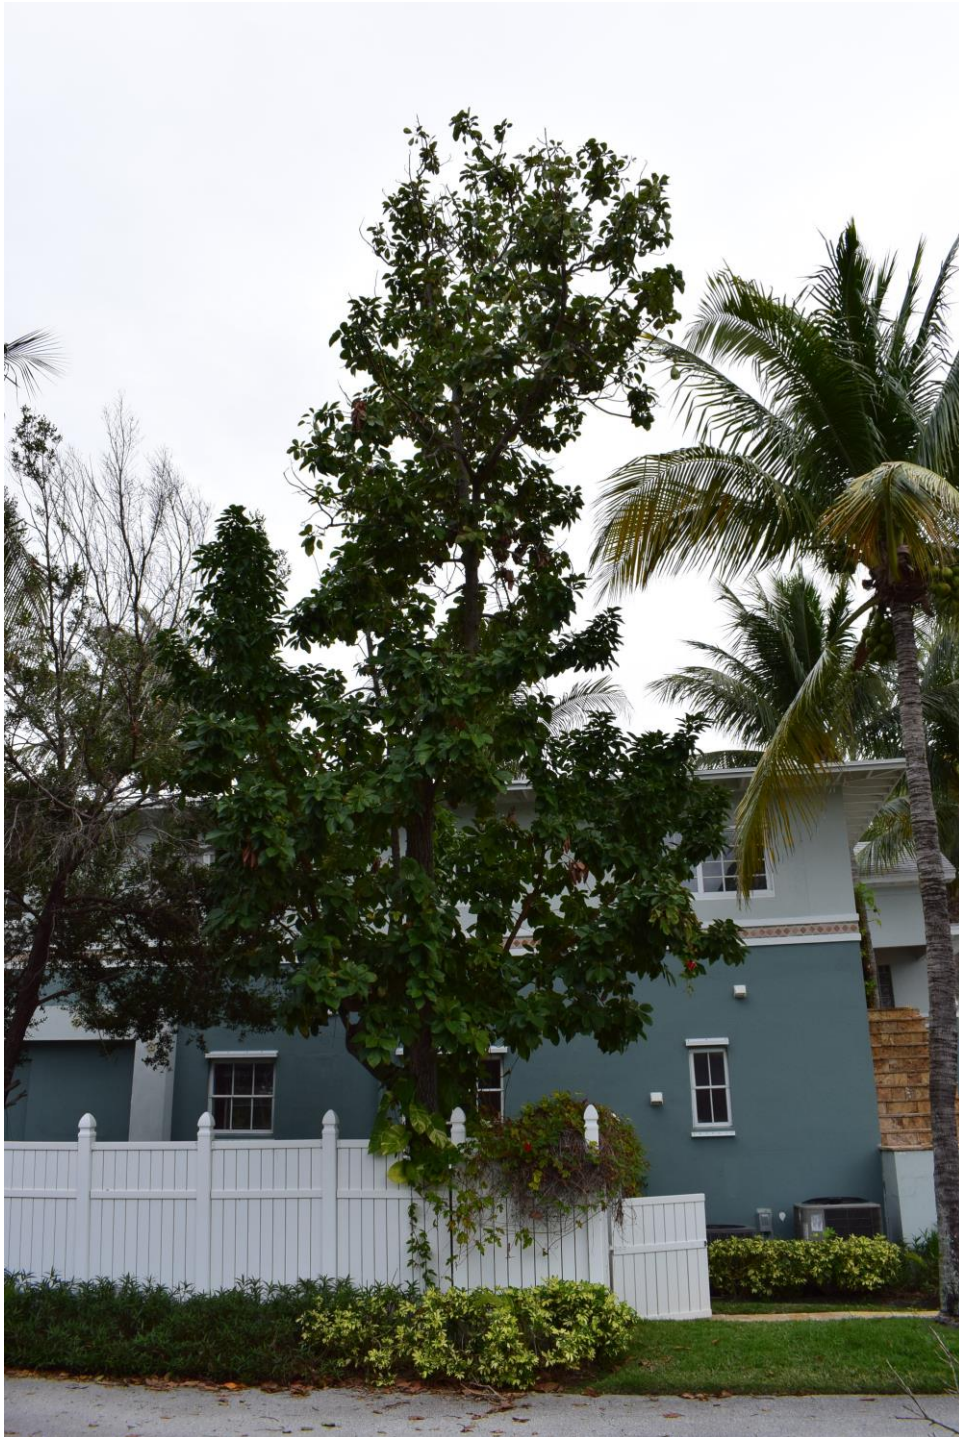
Tree Nine

Tree Nine: *Persea americana*, Avocado approximately 30 feet tall, 15 feet wide, the tree was measured at breast height (dbh), 54 inches above ground level and was 13 inches in diameter. The tree has significant storm damage resulting in trunk wounds with cavities. The tree is in poor condition with a 30% health condition.

View looking east at Avocado

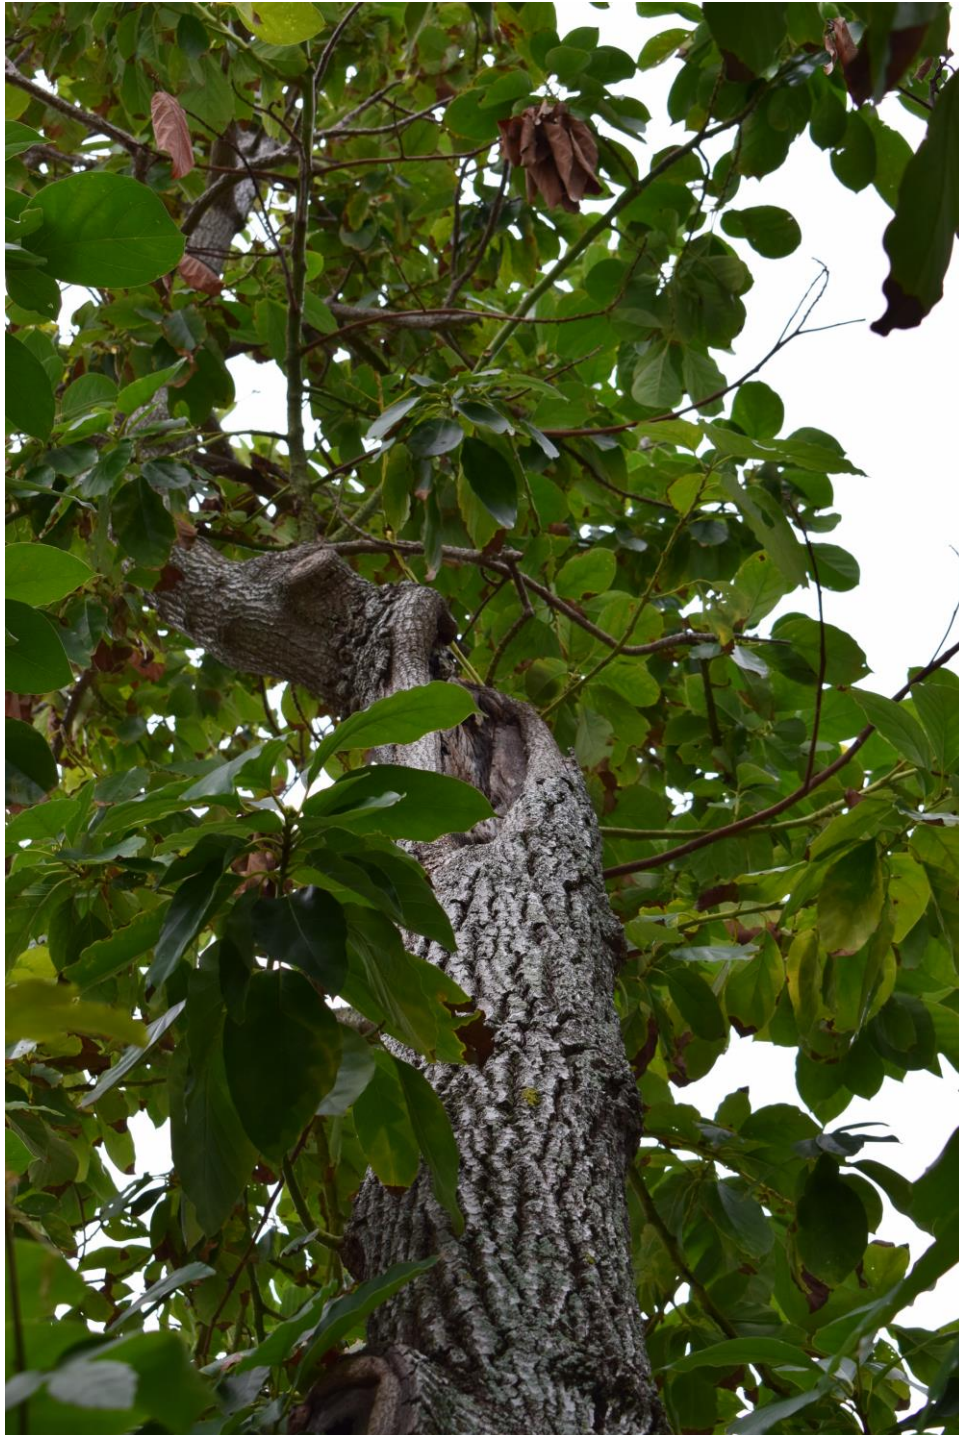
Large wound with cavity where top was broken out of Avocado

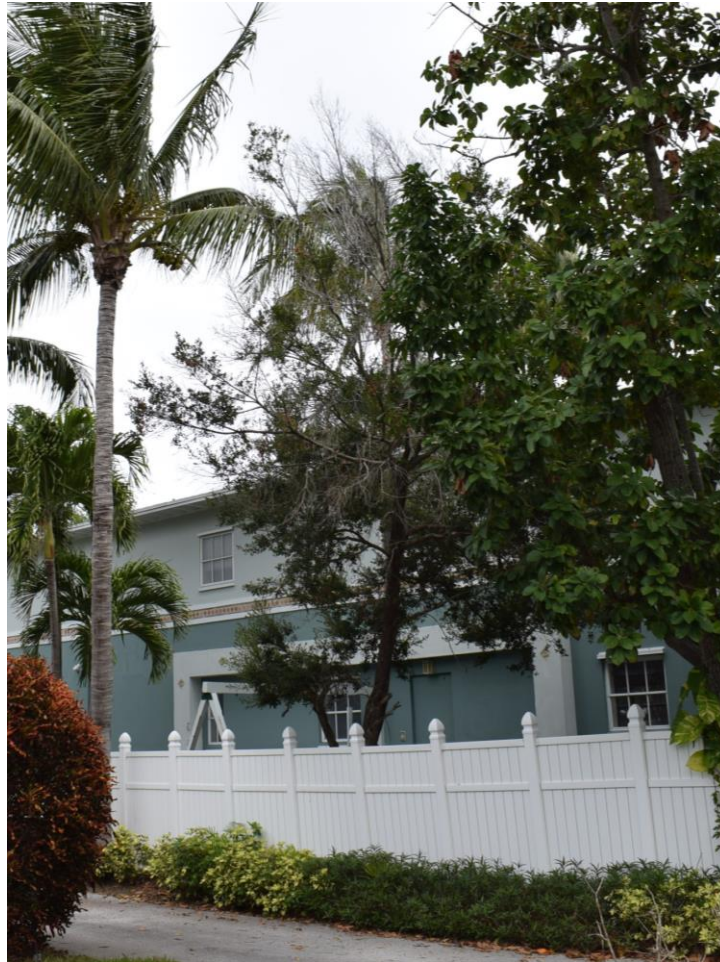
Tree 10

Tree 10: *Eugenia spp*, Stoppers 15 feet tall with a canopy of 15 feet the trunk of the tree was measured at dbh and was nine inches in diameter. The tree is declining with extensive dieback of twigs and the entire upper half of the tree. The tree is in poor health condition with a 30% health rating.

View looking northeast at Stopper, note dead top

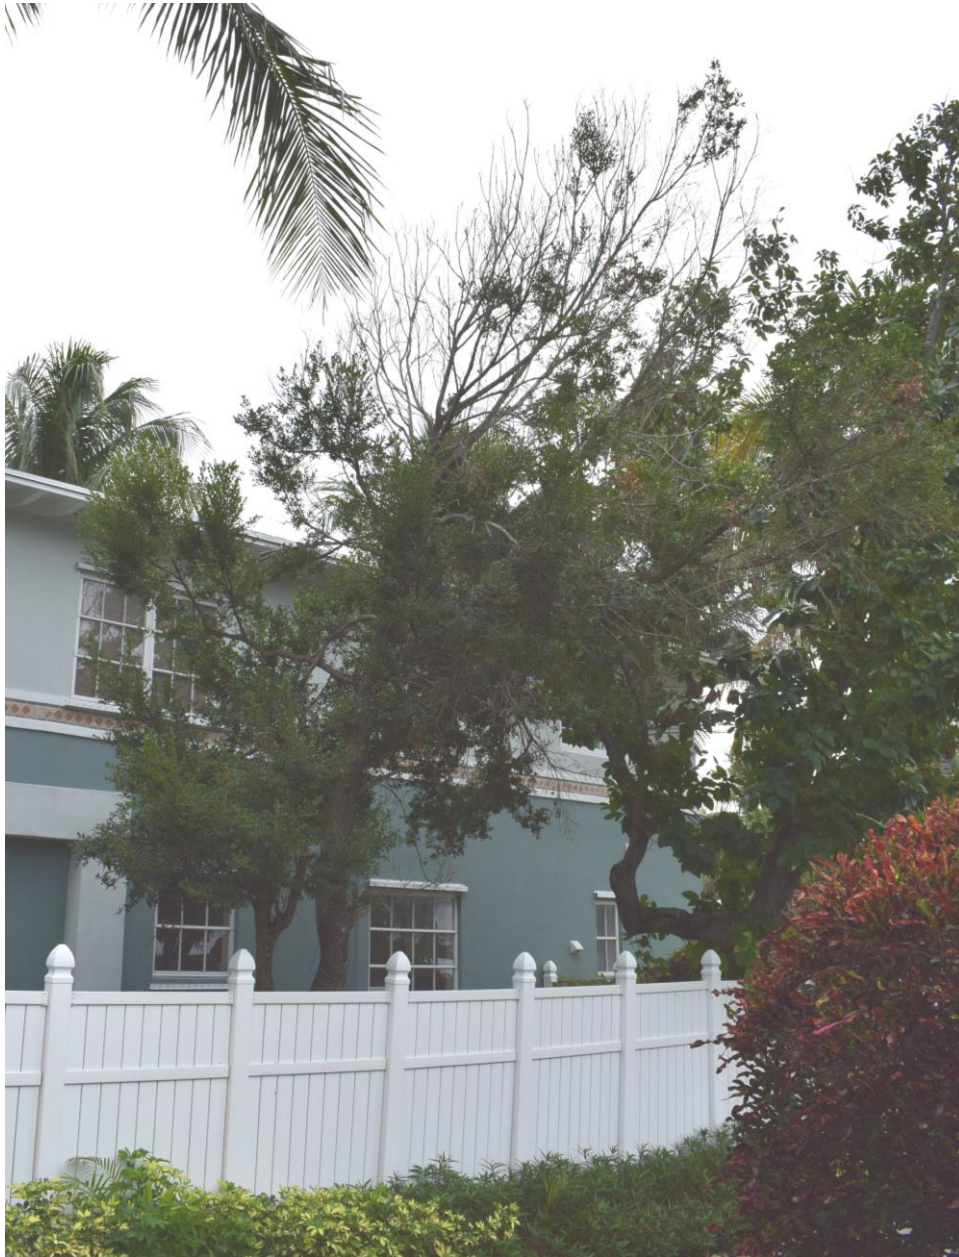
View looking southeast at *Eugenia* spp demonstrating dieback and decline

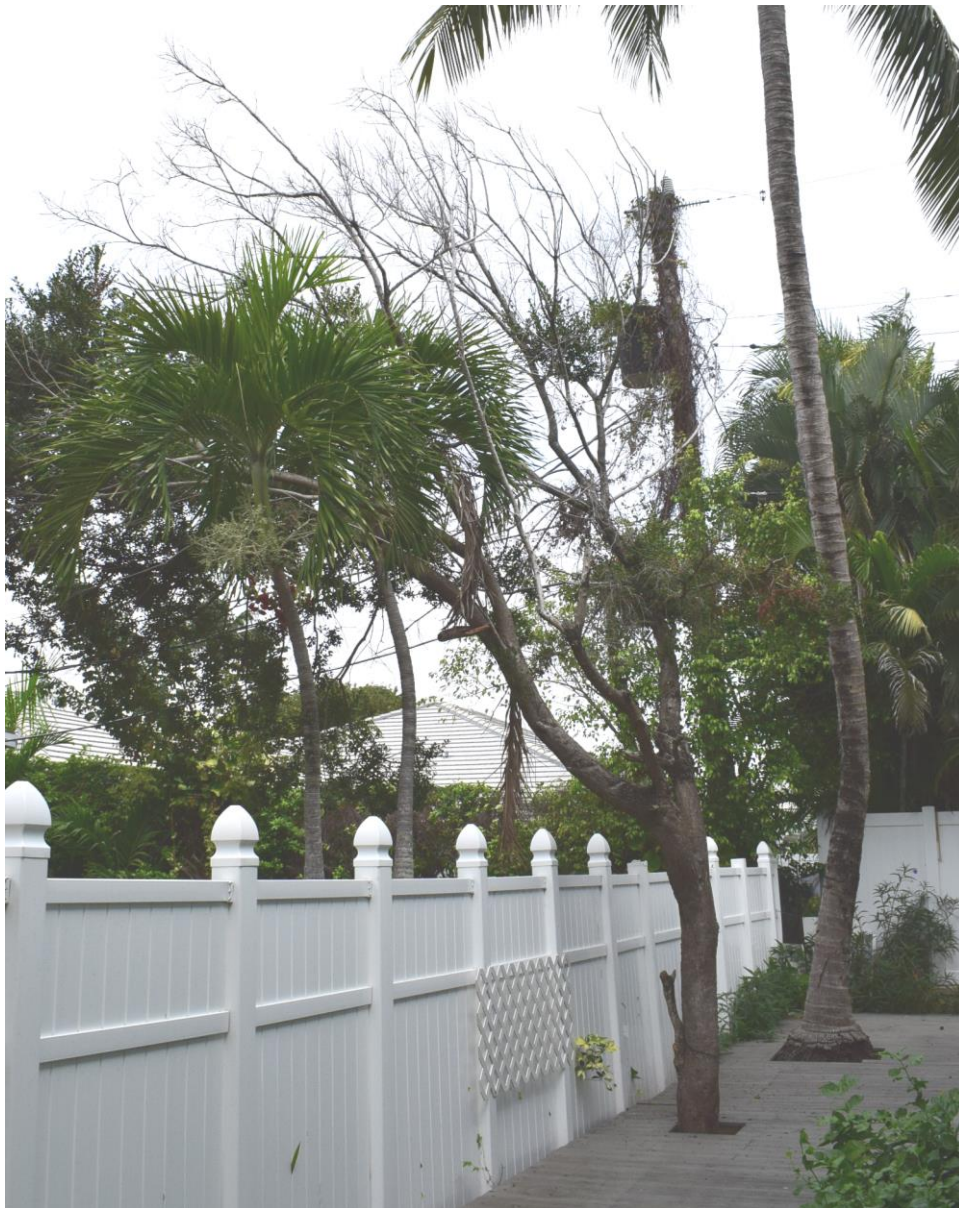
Tree 13

Tree 13: *Eugenia spp*, Stoppers 15 feet tall with a canopy of 15 feet the trunk of the tree was measured at dbh and was eight inches in diameter. The tree is declining with extensive dieback of twigs the eastern half of the tree is dead. The tree is in very poor health condition with a 15% health rating.

View looking north at Eugenia spp extensive decline with dead limbs throughout canopy

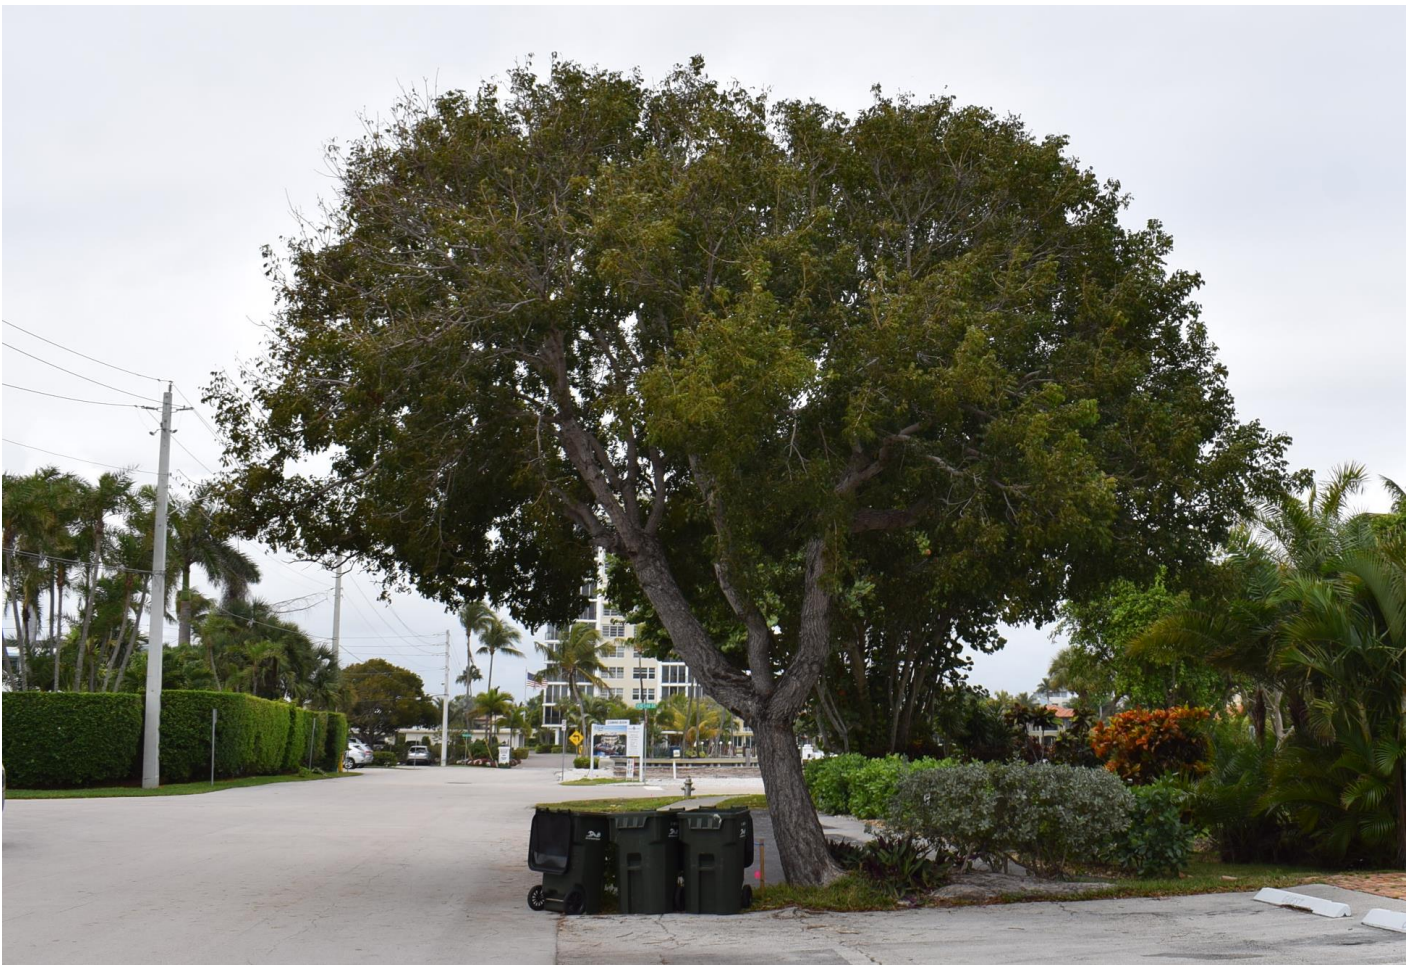
Tree 24

Tree 24: *Swietenia mahagoni*, Mahogany 25 feet tall with a canopy of 32 feet the trunk of the tree was measured at dbh and was 18 inches in diameter. The tree has good vitality and fair structure. The tree has codominant stems that formed seven above the ground level with a minor lean towards the south. The tree has very limited root space, having been confined within a five feet wide planting island. The tree has deflected its roots along the island towards the north. There are large surface roots visible. These roots should not be pruned since it may destabilize the tree. The tree has a health condition of 60%.

View looking west at Mahogany

If preservation of this tree is desired then utilizing the guidelines in the *ANSI A300 (Part 5) - 2012: Management of Trees and Shrubs During Site Planning, Site Development, and Construction* and the companion Best Management Practices shall be utilized.

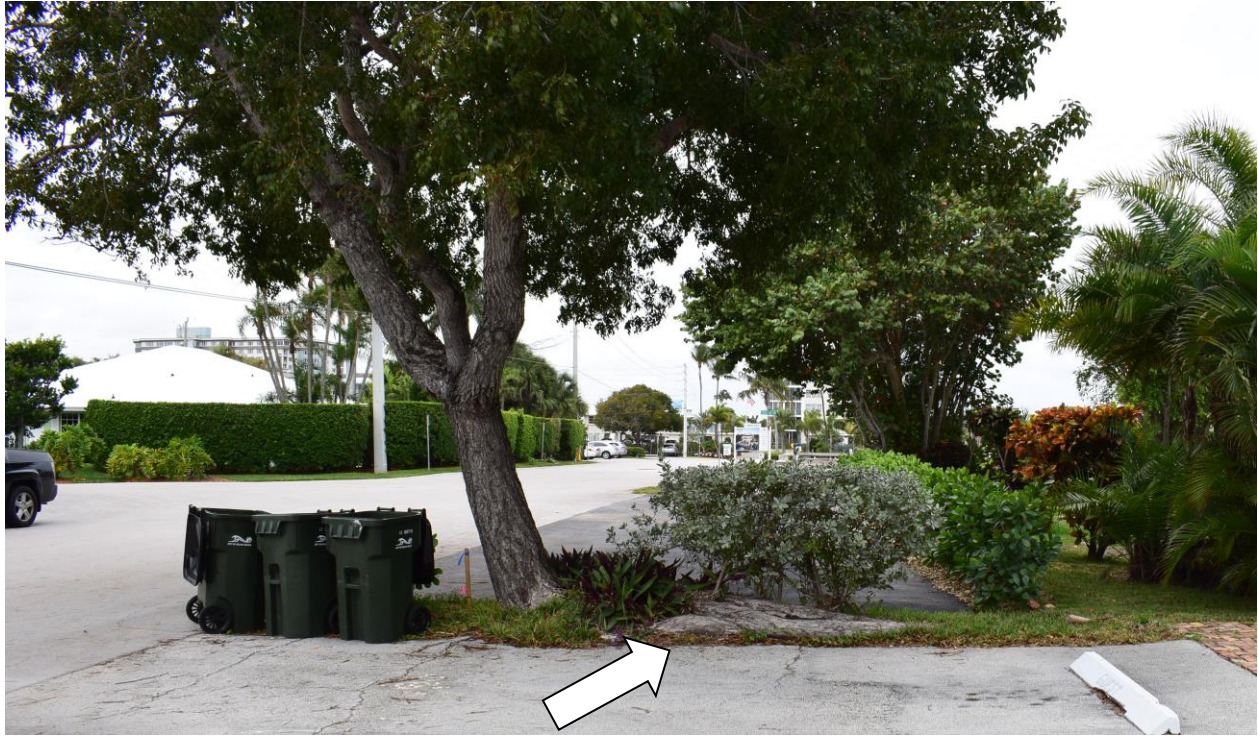
Surface roots indicated by white arrow

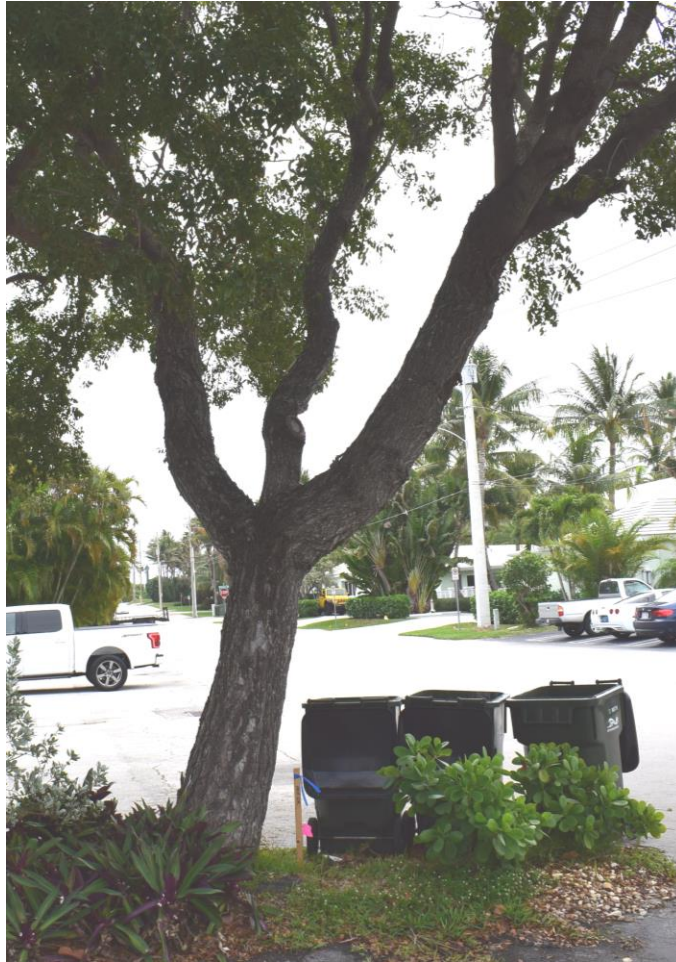
View looking east of Mahogany, note codominant stems and minor lean
