### **DEMOLITION JUSTIFICATION STATEMENT**

For the Accessory use garage structure located in the “rear-yard” located at:  
131 SE 7<sup>th</sup> Avenue

### Damage report.

### **Certified Report**

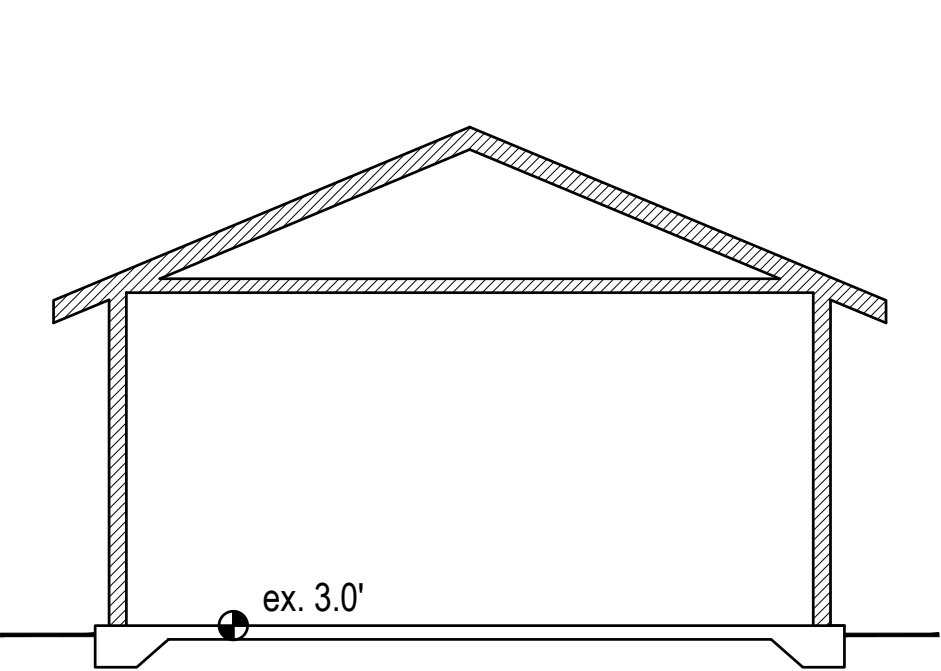
Existing Garage (as is) in flood zone

As noted on the survey the garage is currently 2.5' in flood zone AE-6. The minimum required base floor elevation, in-this-zone, for a wood-frame structure (per FEMA) is  $5.0' + 1' = 6.0'$ . This requires us to raise the existing wood structure a minimum of 3.5' to comply.

Our professional recommendation is to replace the structure entirely with an aesthetically pleasing one that continues the function this property owner currently enjoys. Please review the Architectural drawings included in this presentation.

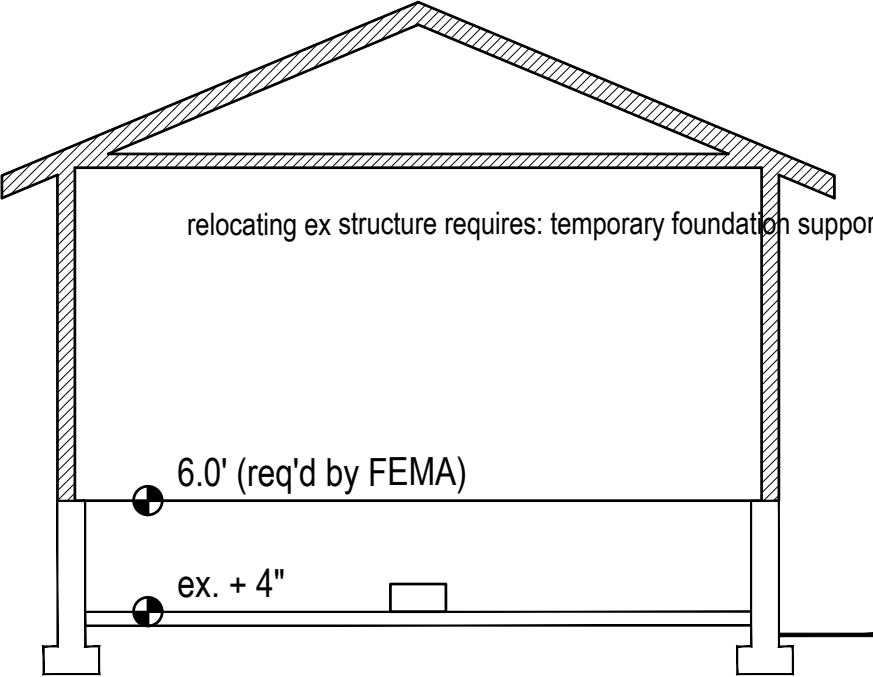
Repair OPTION #1  
replace current foundation with new poured concrete (elevation walls) include flood vents as req'd.

One acceptable alternative would be to construct the FEMA approved concrete base at the existing floor elevation and raise the wood-frame building to 6.0' (see OPTION #1). FEMA allows non-water permeable structures below the minimum flood-elevations (6.0) if the proper flood vents are installed. We also recommend raising the existing slab 4 more inches to better direct water run-off from the existing drive if this OPTION is used. Our "best-guess" estimate for this option is \$20,000-plus; to temporarily remove the structure, construct a concrete base & new slab, then relocate the wood structure at the minimum elevation.

option #1 (estimated \$20,000) includes moving structure

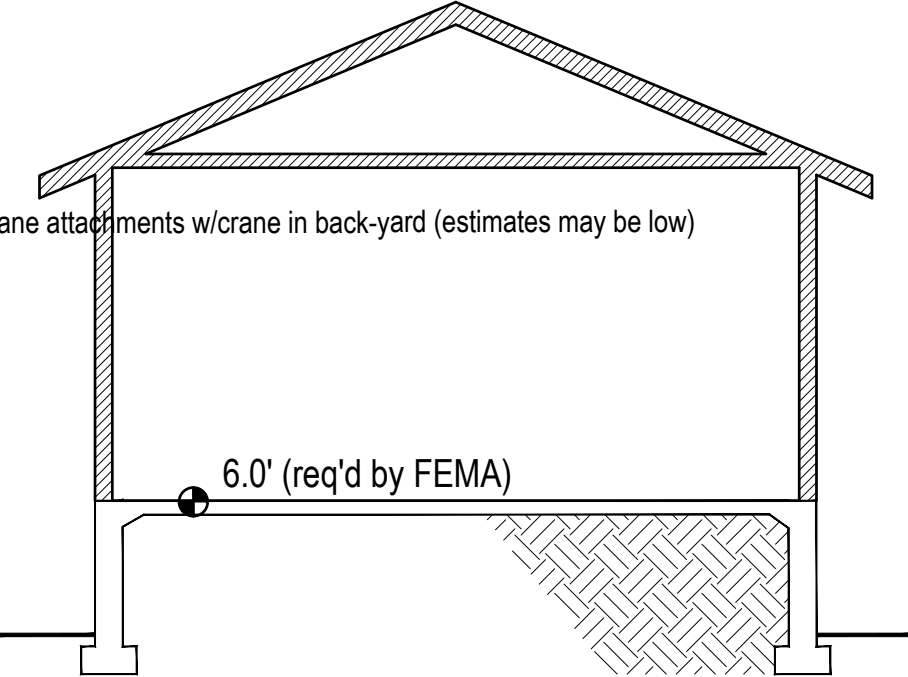
Repair OPTION #2  
replace current foundation with foundation set at required flood elevation 5'-0" = 1' = 6.0'

We do NOT think it's feasible to temporarily remove the building – raise the slab, ramp the driveway and add stairs to access the yard as shown on the attached sketch (OPTION #2)

option #2 (estimated \$23,500) includes moving structure (excludes ramp to provide access)\* not feasible

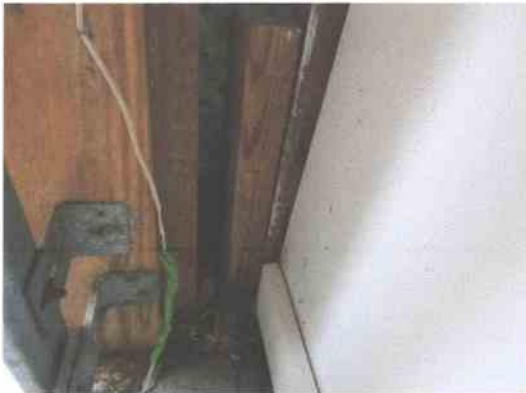
While this structure may-be “contributing”, years of repair have replaced much of the original material and we estimate there is less than 50% of original original/historic material. The steel overhead door is not original, the interior wall covering is not original, a visual inspection of the roof deck shows that over 30% has been replaced with plywood to support the non-original asphalt shingles. And most of the studs were replaced due to rot.

ALL WOOD STUDS (IN-THIS-EXPOSED-VIEW) ARE “NON-ORIGINAL” ALL EXISTING (HISTORIC) FRAMING HAS BEEN REPLACED – TYPICAL AT EXPOSED LOCATIONS.

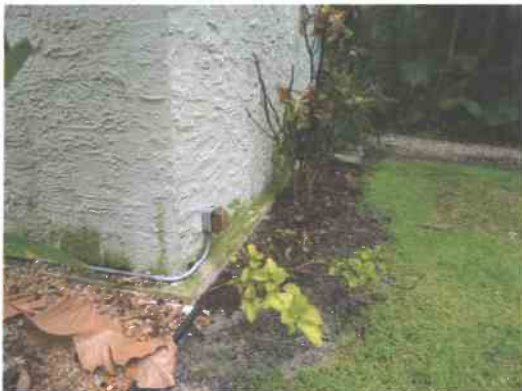
The Garage Floor elevation is less than 3.0' NAVD, and subject to flooding multiple times per year. The Concrete slab extends beyond the exterior walls 4" on all 4-sides; this architectural detail catches water and allows it to erode the wood sill-plate.

GARAGE FLOOR SLAB EXTENDS OUTSIDE FRAME WALL – DETAIL OF THIS “LEDGE” PERMITS WATER-DAMAGE TO THE EXISTING SILL-PLATE AND STUDS (SUGGEST REPLACEMENT WITH MASONRY OF CONCRETE TO PREVENT FUTURE DAMAGE)

We recommend (strongly) that the wood be removed from the ground floor and replaced with masonry as a sustainable solution to this location. (the Floor can not be raised above the flood elevation.) The proposed block replacement will contain the required flood vents, and the non-contributing details, can be installed with a pleasing appearance to IMPROVE the current structure.

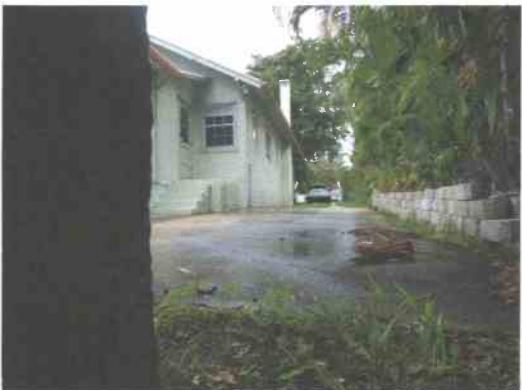
EXISTING GARAGE IS AT LOW-POINT OF LOT – PAVED DRIVEWAY DIRECTS RAIN WATER TO FRONT OF STRUCTURE – PROPOSE SETTING REPLACEMENT STRUCTURE 4” MINIMUM (HIGHER) TO DIRECT SURFACE FLOW AROUND PROPOSED MASONRY STRUCTURE.

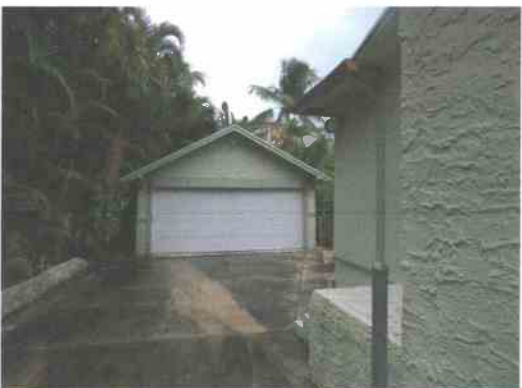
VIEW OF EXISTING WOOD-STUCCO GARAGE. (HISTORIC DETAIL LIMITED TO SMALL “CORBEL”) – METAL DOOR & STUCCO TRIM-DETAIL ADDED, ASSUME AT TIME OF FRAMING REPAIR? STRUCTURE SHOULD BE REPLACED WITH ONE SUITABLE FOR THE OCCASIONAL SUBMERSION WITHOUT STRUCTURE IMPACT – WOOD IS NOT ACCEPTABLE.
