Photographs of “wood-frame” garage  
131 SE 7<sup>th</sup> Avenue

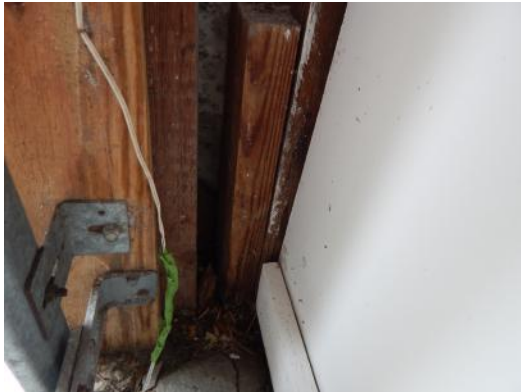
ALL WOOD STUDS (IN-THIS-EXPOSED-VIEW) ARE “NON-ORIGINAL” ALL EXISTING (HISTORIC) FRAMING HAS BEEN REPLACED – TYPICAL AT EXPOSED LOCATIONS.

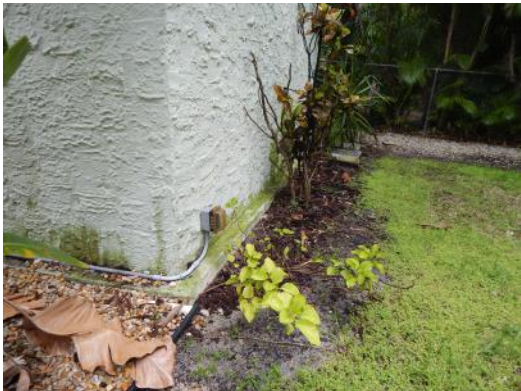
GARAGE FLOOR SLAB EXTENDS OUTSIDE FRAME WALL – DETAIL OF THIS “LEDGE” PERMITS WATER-DAMAGE TO THE EXISTING SILL-PLATE AND STUDS (SUGGEST REPLACEMENT WITH MASONRY OF CONCRETE TO PREVENT FUTURE DAMAGE)

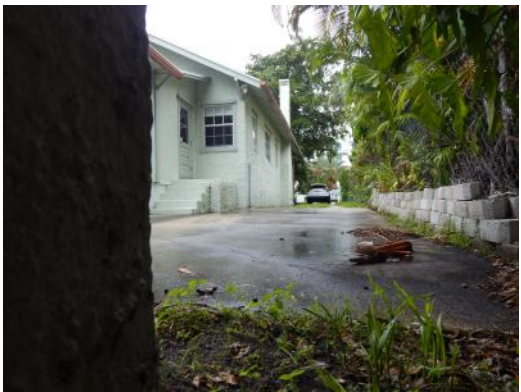
EXISTING GARAGE IS AT LOW-POINT OF LOT – PAVED DRIVEWAY DIRECTS RAIN WATER TO FRONT OF STRUCTURE – PROPOSE SETTING REPLACEMENT STRUCTURE 4” MINIMUM (HIGHER) TO DIRECT SURFACE FLOW AROUND PROPOSED MASONRY STRUCTURE.

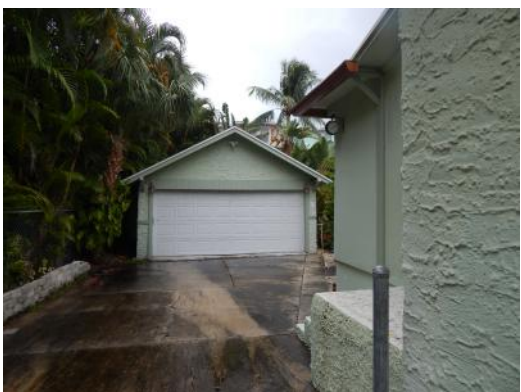
VIEW OF EXISTING WOOD-STUCCO GARAGE. (HISTORIC DETAIL LIMITED TO SMALL “CORBEL”) – METAL DOOR & STUCCO TRIM-DETAIL ADDED, ASSUME AT TIME OF FRAMING REPAIR? STRUCTURE SHOULD BE REPLACED WITH ONE SUITABLE FOR THE OCCASIONAL SUBMERSION WITHOUT STRUCTURE IMPACT – WOOD IS NOT ACCEPTABLE.
