**RE: Unsafe Structures – Block 70 Building H
Delray Beach, Florida
Mc/Sal Project N° 19446.002**

McNamara Salvia visited the project site to observe the existing conditions of Building H and Block 70. The enclosed is a summary of our findings as it specifically pertains to the structure.

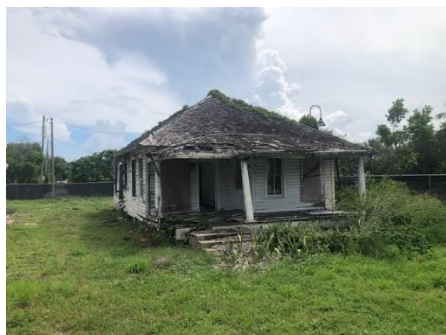
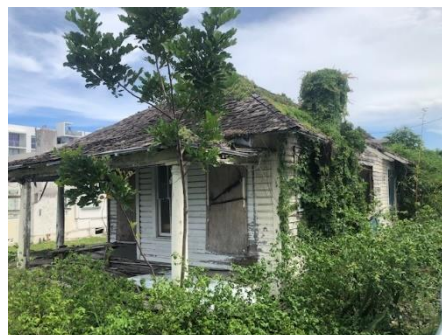
The following are a few images of the outside of the structure overall:

Overall, the home is in very poor condition with local collapse throughout the structure and dangerous to occupy even to investigate.

In conclusion, this is entirely an unsafe structure and has been in this condition for a significant period of time; also evidenced by the vegetation growing on the roof and into the interior of the structure. We recommend immediate demolition and removal of the entire building, but utilize any salvageable materials that may remain in good condition for the re-use of a re-build. Please let us know if you have any further questions.

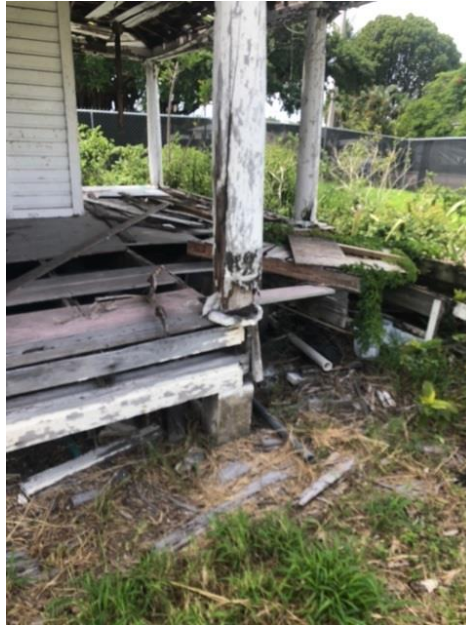
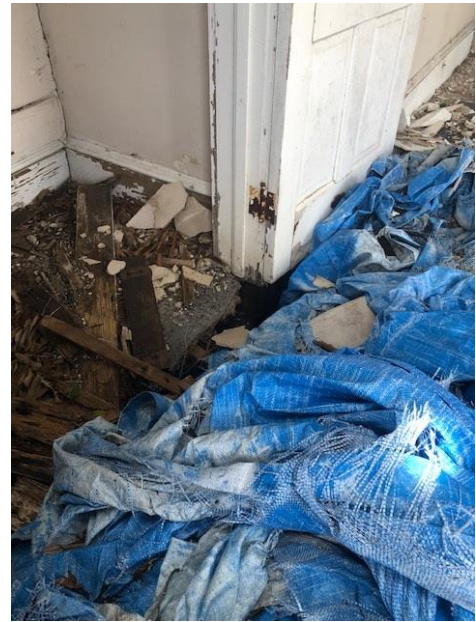
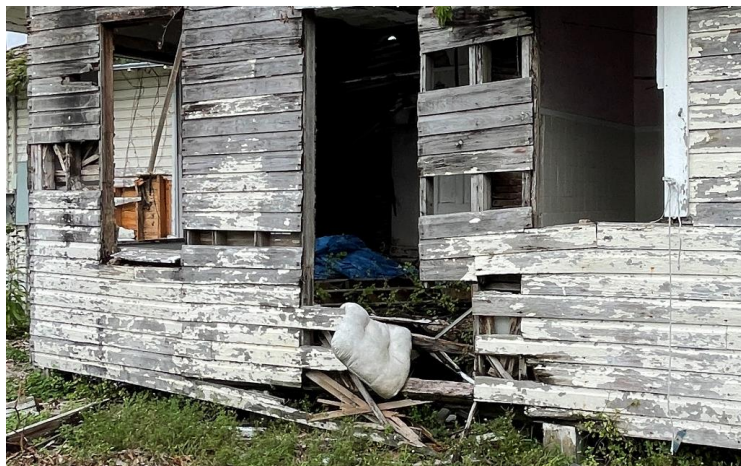
The home is entirely wood framed bearing on concrete piers that bear on foundations that cannot be observed. The concrete piers are out of plumb / leaning, have settled and some appear to be replaced with loose concrete blocks as a remedial repair.

The floor is out of level due to the foundation conditions but also due to wood rot and collapse. There are holes to the ground both inside the structural and on the front porch.

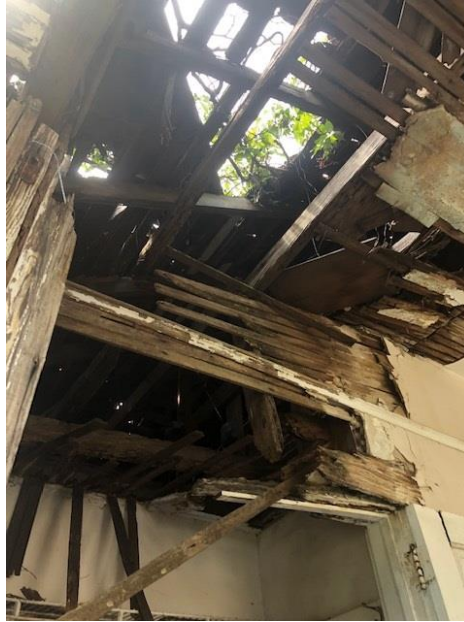
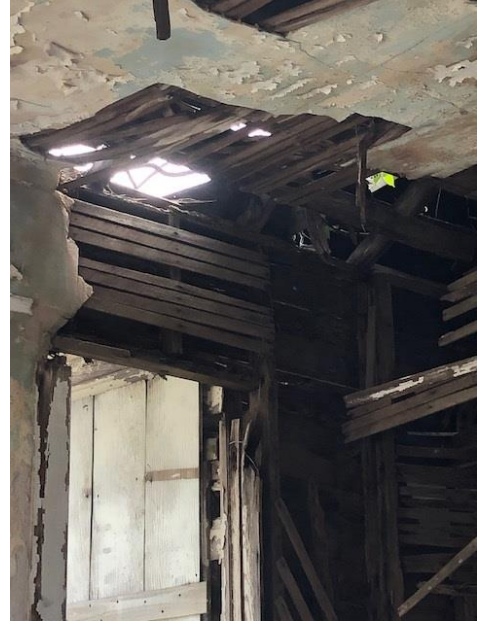
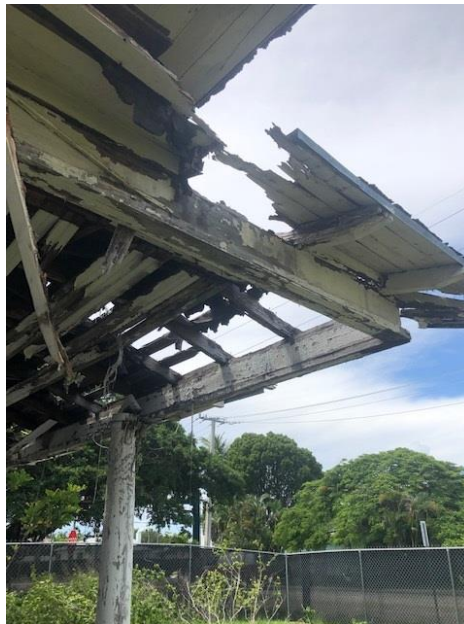
The roof framing is in exceptionally poor condition with local collapses throughout the home leaving the entire structure open to the elements. The roof framing members are rotted and are splitting even at locations that have not yet collapsed. In addition, there are several areas where the eaves have collapsed.

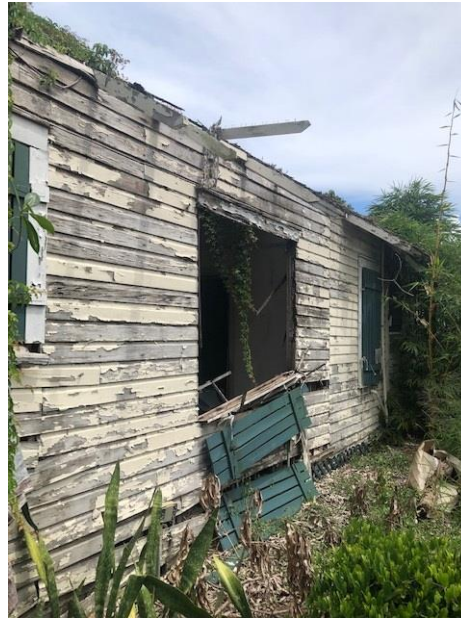
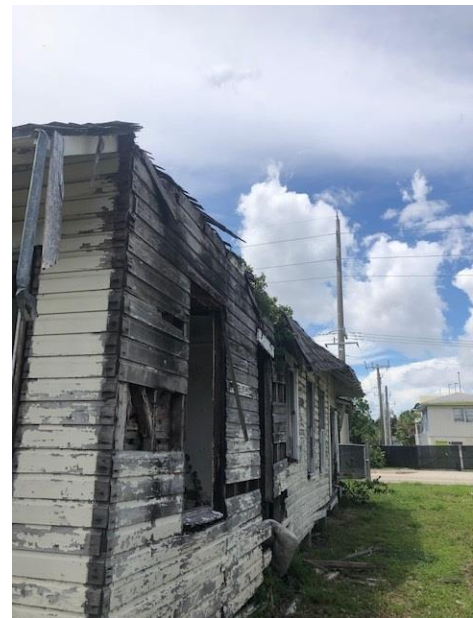
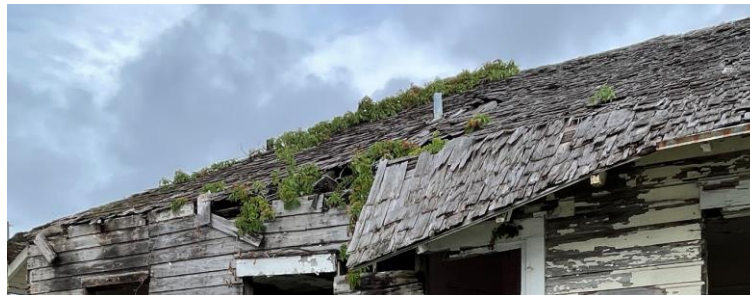
Most of the exterior windows and doors are breached, broken or removed entirely leaving the entire home open to the elements. The siding is also dilapidated with missing sections.
