RE: Unsafe Structures – Block 69 Building Z Delray Beach, Florida Mc/Sal Project No 19446.002

McNamara Salvia visited the project site to observe the existing conditions of Building Z and Block 69. The enclosed is a summary of our findings as it specifically pertains to the structure.

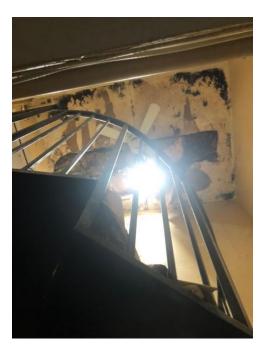
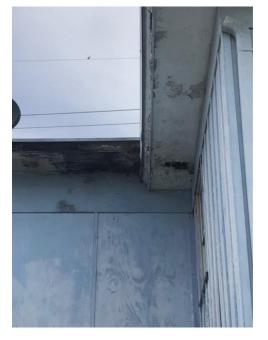
The enclosed photos are from the west, two-story home and illustrates holes in the roof directly allowing rain into the interior space both upstairs and downstairs.

In conclusion, based on the above, we recommend the immediate demolition and removal of the connection between the original two home structures and the removal of the home to the west. Upon demolition and removal, those areas should be reevaluated for structural integrity as partial demo may compromise the structural integrity of the remaining building. Please let us know if you have any further questions.
