Rimkus Building Consultants, L.L.C.
The Flatiron Building
927 E. New Haven Avenue, Suite 315
Melbourne, FL 32901

Claim No.: GC2020096996
Asset No.: 092001
Address: 80 Depot Avenue, Delray Beach, FL 33444
Rimkus File No: 100042144
Subject: Report of Findings

The City of Delray Beach City, Florida reported that on February 25, 2020 the Delray Train Depot was damaged by fire. The Delray Train Depot is located at 80 Depot Avenue, Delray Beach, FL.

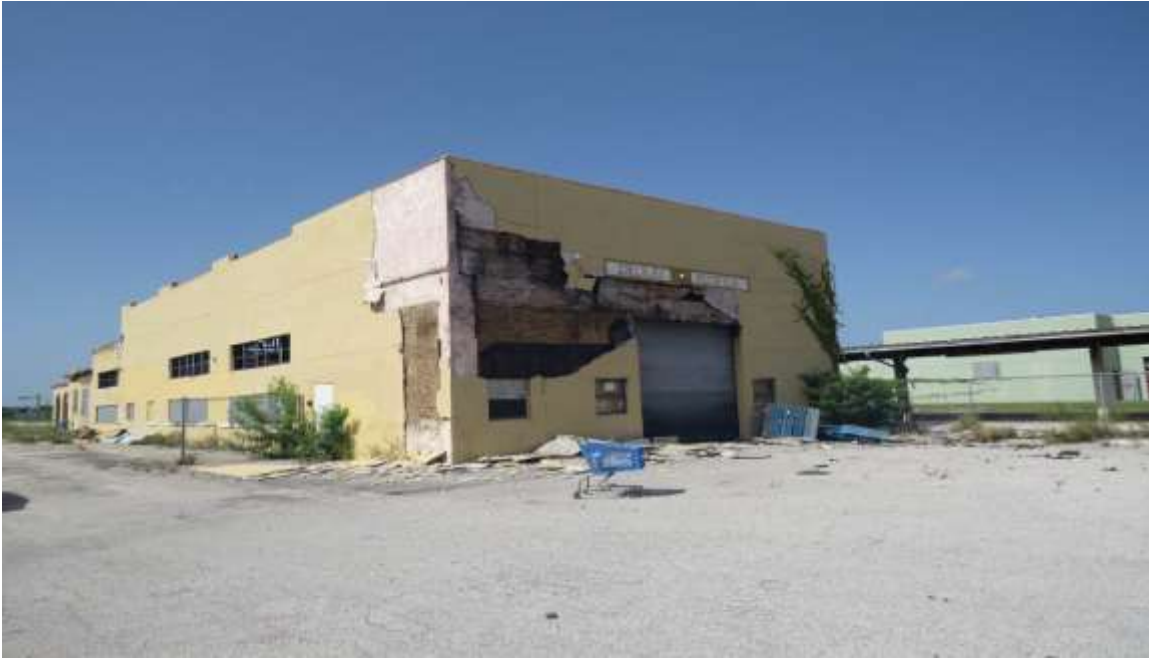
Photograph 1

The Delray Train Depot was a one-story masonry, concrete and wood structure (**Photograph 1**). The building was constructed over a concrete slab-on-grade foundation. The exterior walls of the building were clad with stucco. The roof was covered with terracotta tiles and was framed with one wooden truss and four metal trusses. The interior walls were constructed of wood and covered with gypsum board.

A view of the north (front) and east elevations of the Delray Train Depot building.

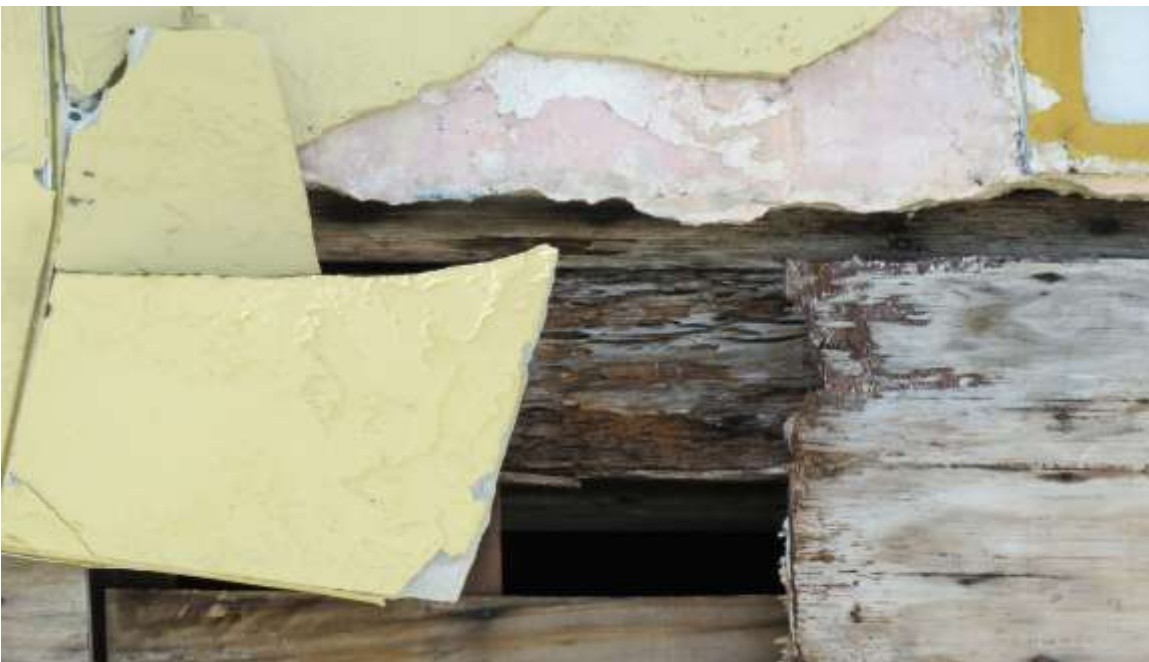
Photograph 2

The Delray Train Depot was inspected to evaluate the fire damage reported to the building. The stucco on the exterior of the building was cracked and displaced in various locations (**Photographs 2, 3, and 4**). The brick parapet wall was broken on the east side of the building, consistent with damage caused by displacement of the roof framing (**Photograph 5**).

A view of broken and displaced stucco on the north elevation of the building.

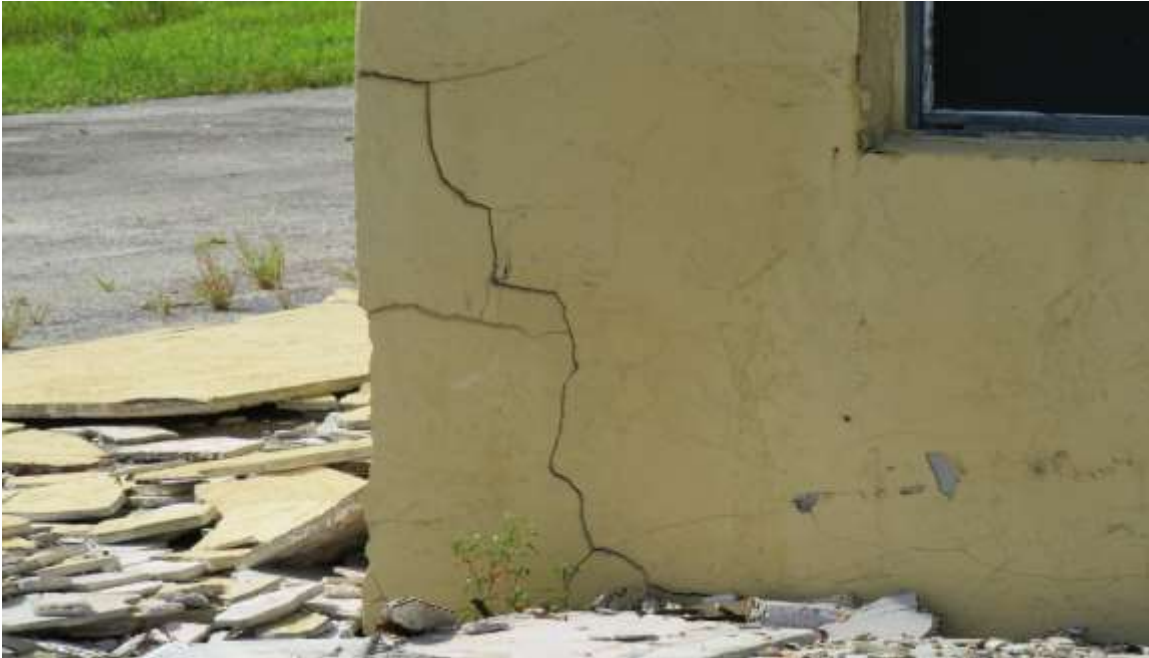
Photograph 3

There were cracks in the stucco at the northeast corner of the building.

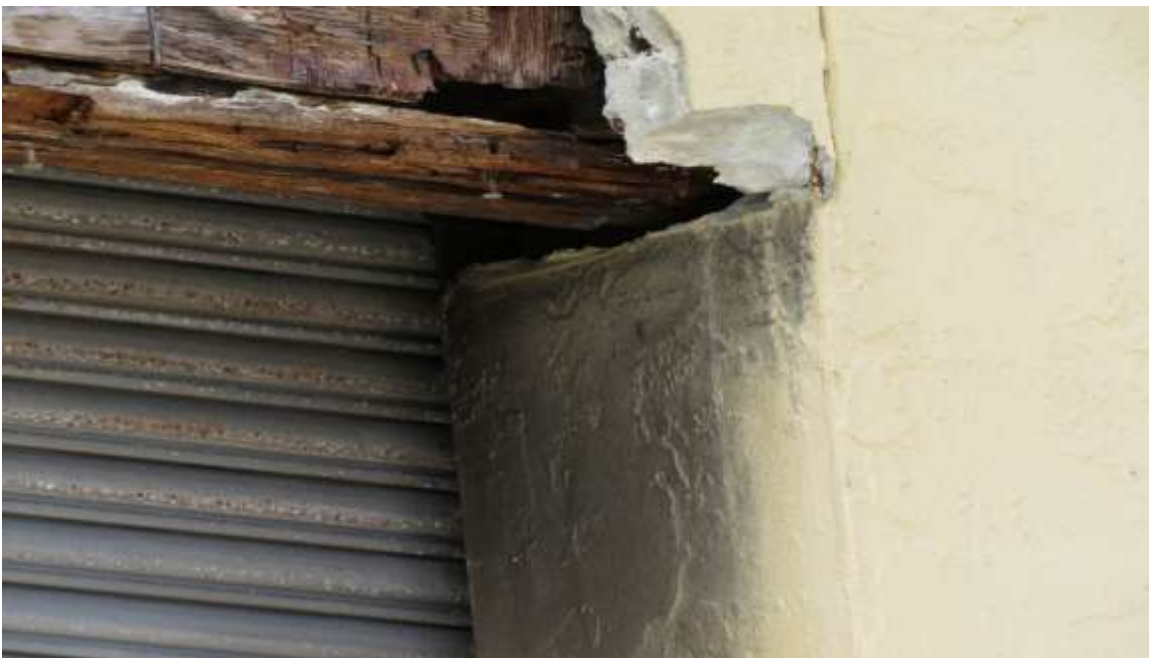
Photograph 4

There was broken and displaced stucco above a door on the east side of the building. Note soot on the stucco at this location.

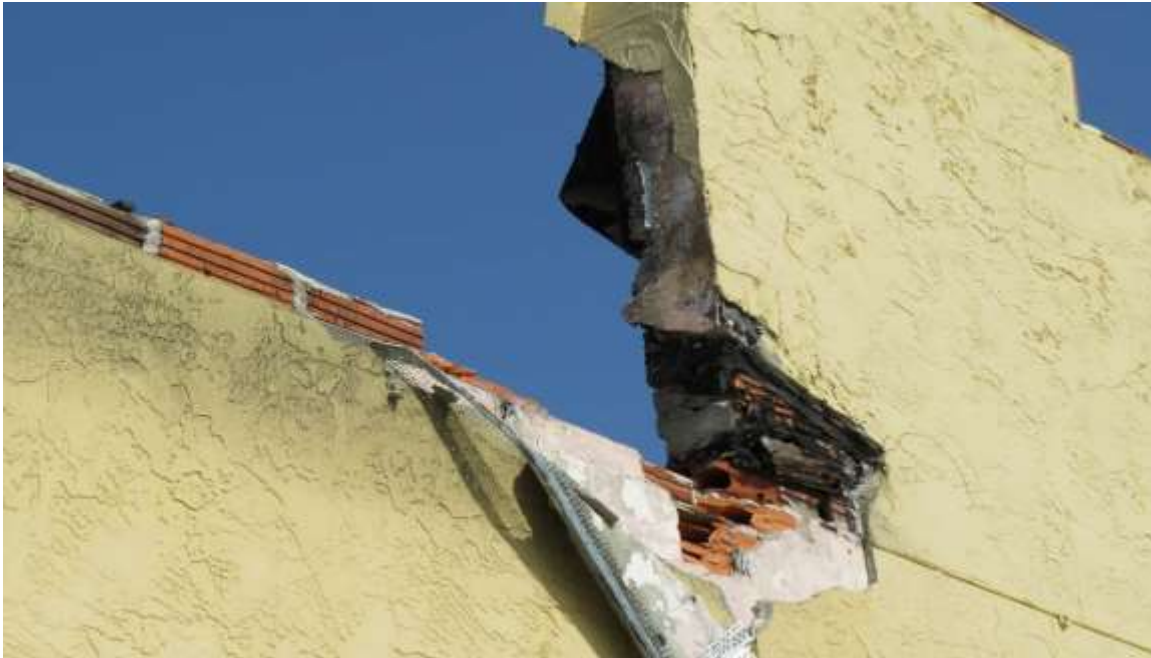
Photograph 5

The brick parapet wall was broken on the east side of the building.

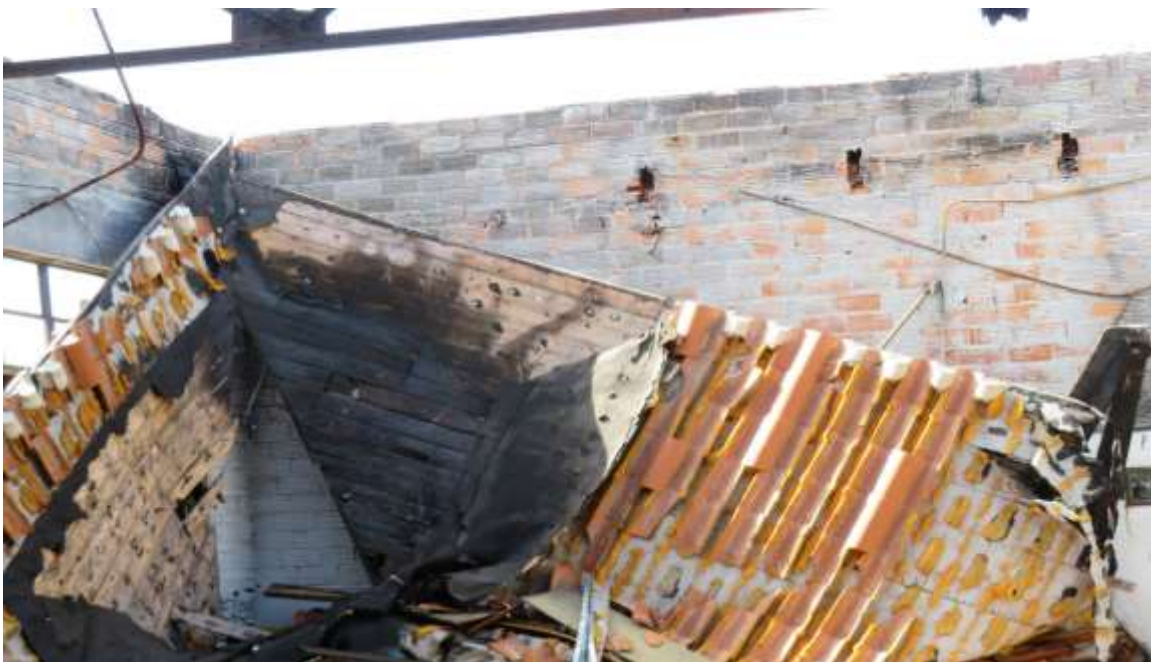
Photograph 6

The roof over the south section of the building and the south end of the north section of the building had collapsed (**Photograph 6**). A portion of the roof framing remained in place above the north section of the building. The remaining roof framing was covered in soot and partially charred (**Photograph 7**). The wooden truss at the middle of the north section of the building was partially charred and a portion of a wood member was newly exposed indicating that a portion of the member had been dislodged. (**Photograph 8**). As wood burns, it is progressively converted to char above the charred-uncharred interface (or char base) temperature of 550 degrees Fahrenheit. Char is the ashed or "alligatored" remains of the burned wood that are considered to have negligible strength, i.e., no allowable mechanical properties. Thus, reduction in the strength of wood framing members, caused by fire and heat, does not generally occur until the temperature of the wood fibers reaches the heat threshold for charring. Therefore, structural elements with char should be reinforced or replaced in order to restore the integrity of the elements to their pre-damaged condition.

The roof over the south section of the building and the south end of the north section of the building had collapsed.

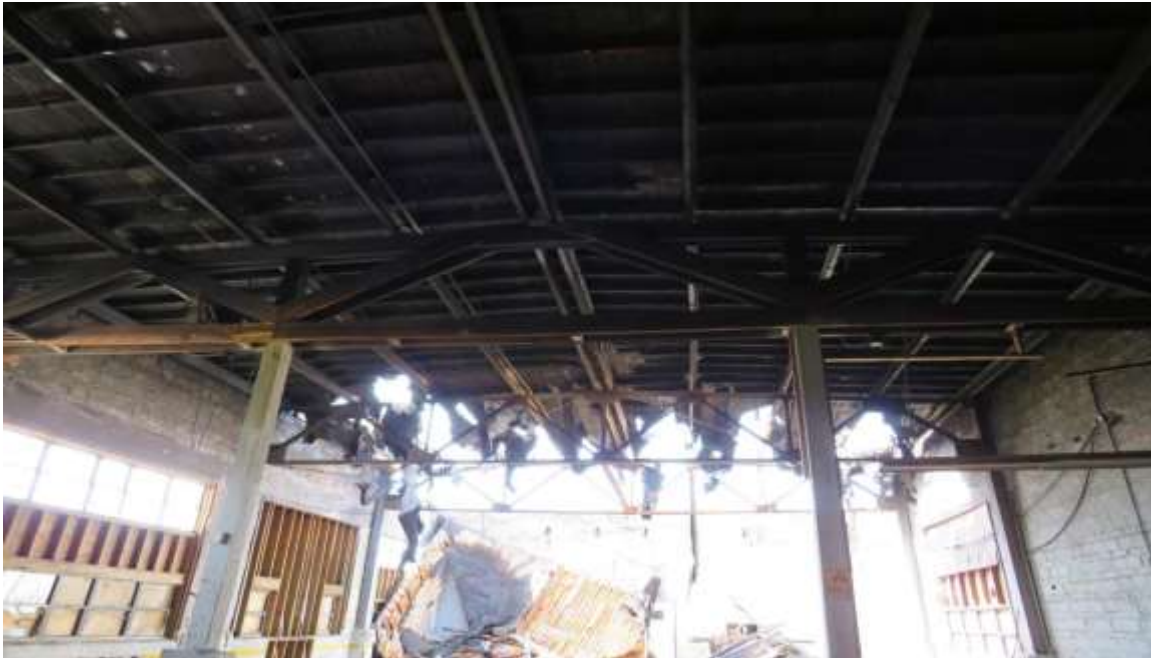
Photograph 7

A portion of the roof framing remained in place above the north section of the building. The remaining roof framing was covered in soot and partially charred.

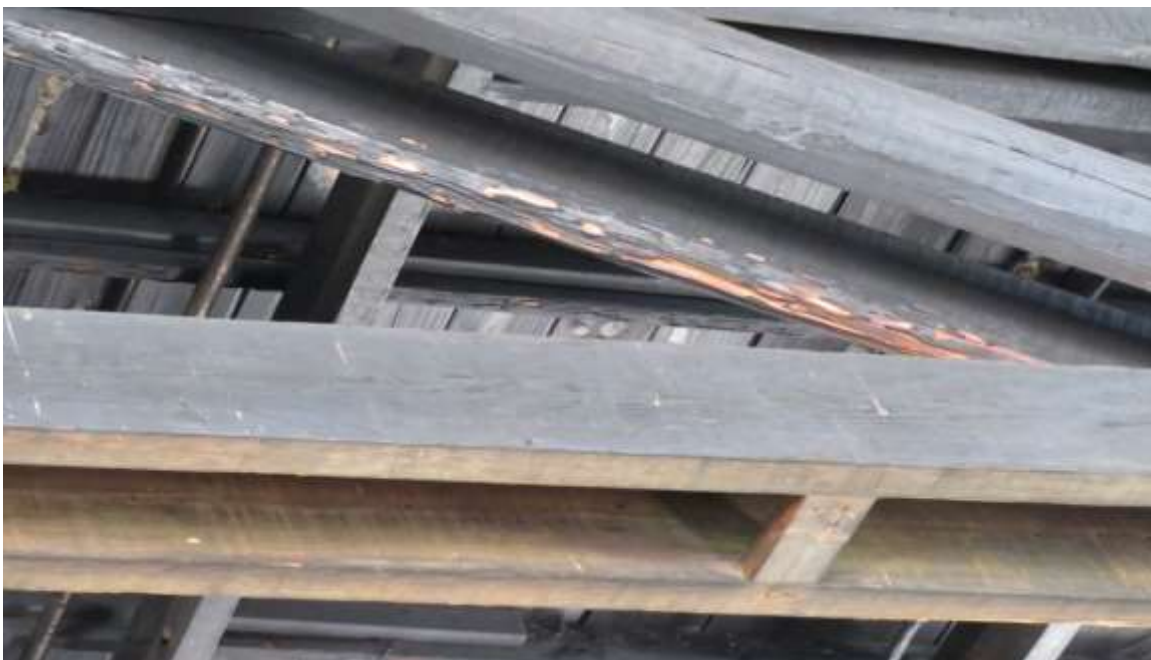
Photograph 8

The wooden truss at the middle of the north section of the building was partially charred and a portion of a wood member was newly exposed.

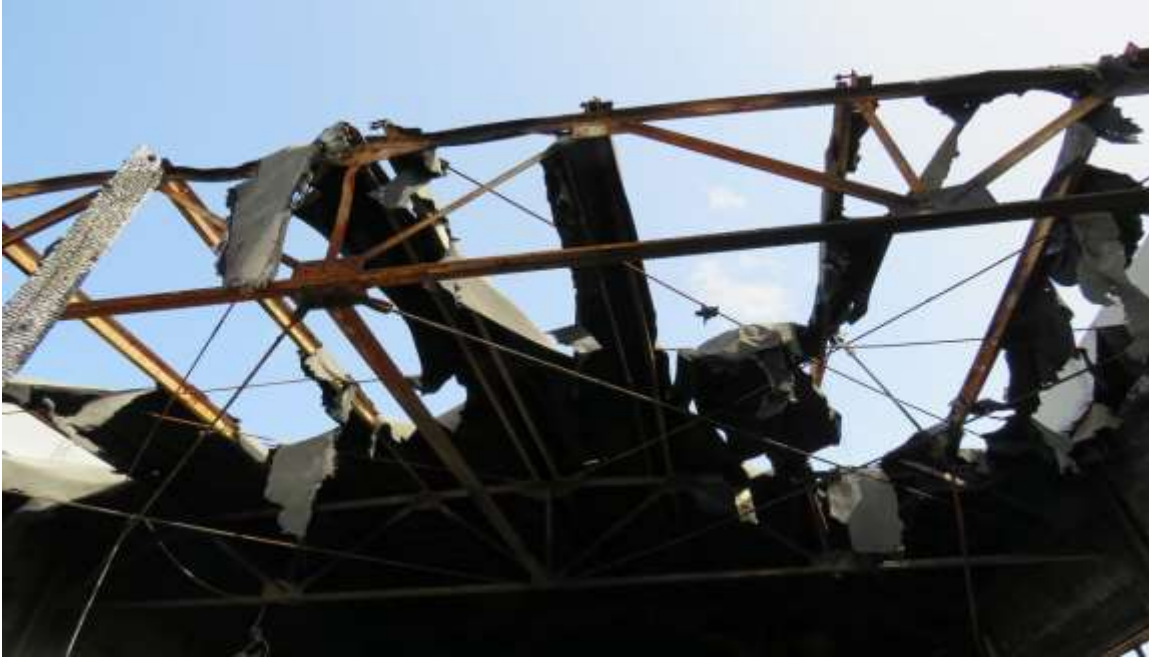
Photograph 9

The southernmost steel truss above the north section of the building was warped and was no longer suitable for support of the roof framing (**Photograph 9**).

The southernmost steel truss above the north section of the building was warped.

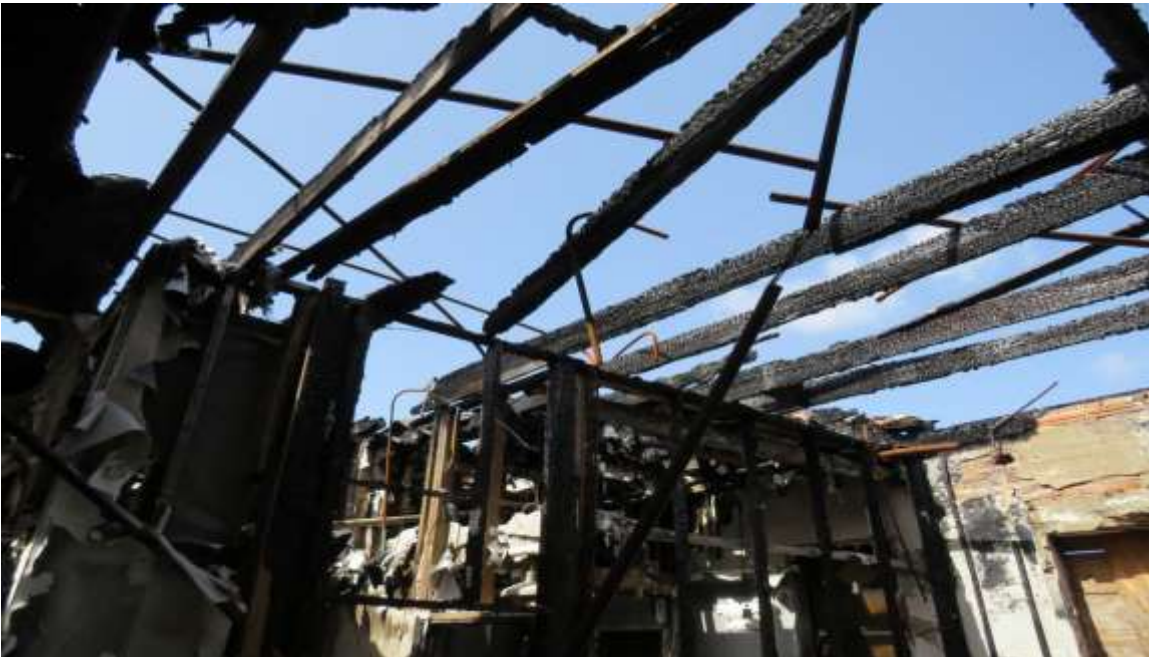
Photograph 10

The roof above the south section of the building had mostly collapsed with only severely charred portions of some rafters remaining (**Photograph 10**). The interior wood framed walls were severely charred, and there was a significant amount of debris on the floor in the south section of the building (**Photograph 11**).

The roof above the south section of the building had mostly collapsed with only severely charred portions of some rafters remaining.

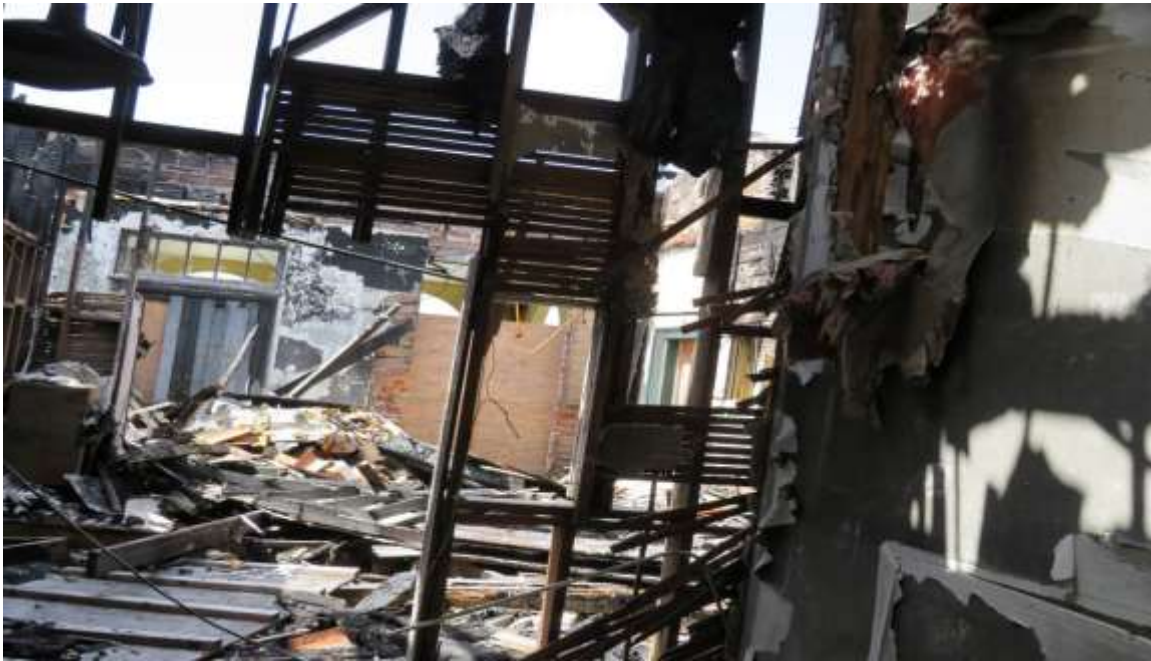
Photograph 11

The interior wood framed walls were severely charred and there was a significant amount of debris on the floor in the south section of the building.
