City of Delray Beach Intracoastal Waterway Water Level & Infrastructure Vulnerability Study

Submitted to:
City of Delray Beach

Submitted by:
Aptim Environmental & Infrastructure, Inc.

Project No. 631233074
October 2018

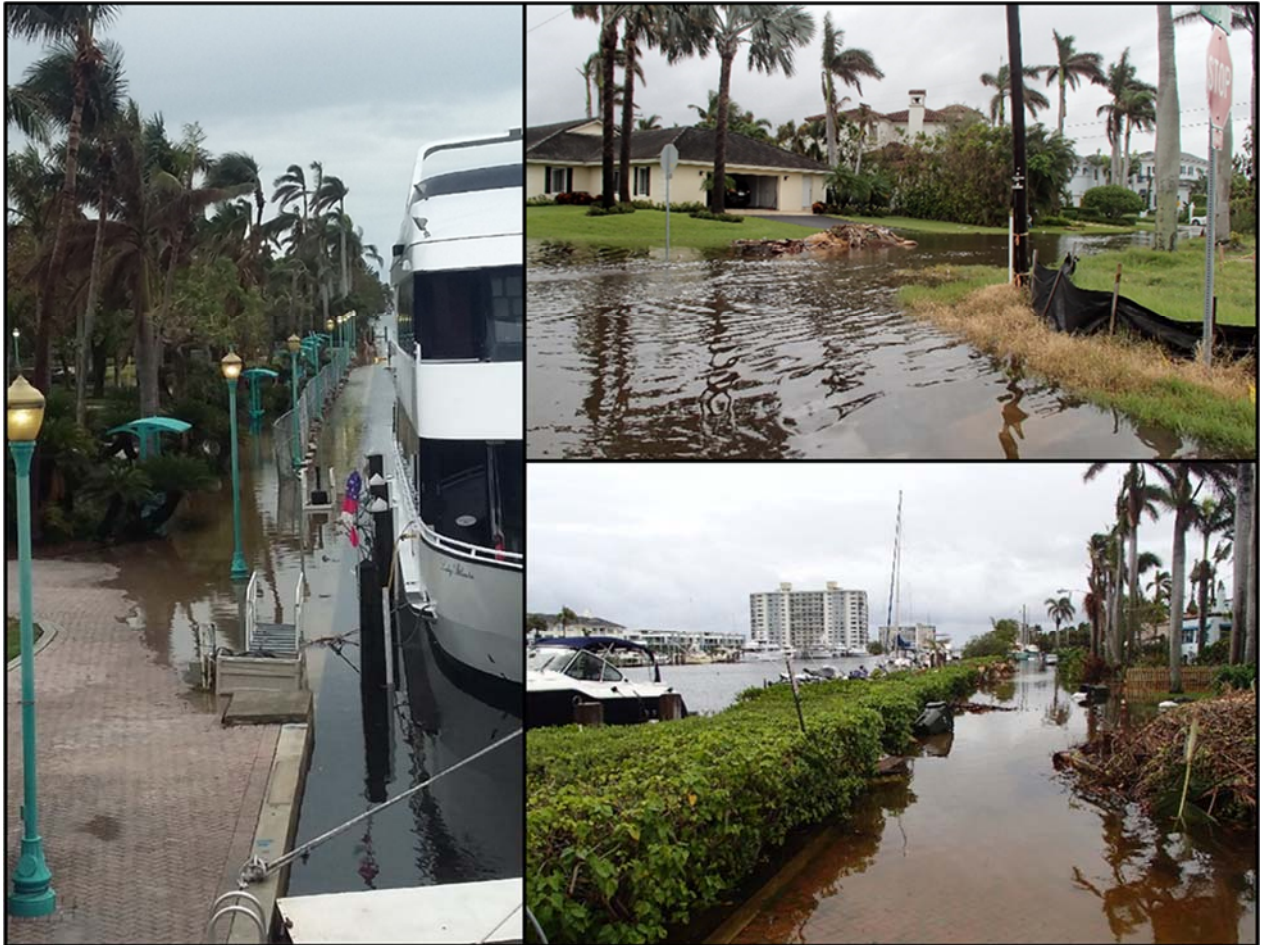
Figure 1. Flooding within the City of Delray Beach (October 5, 2017).

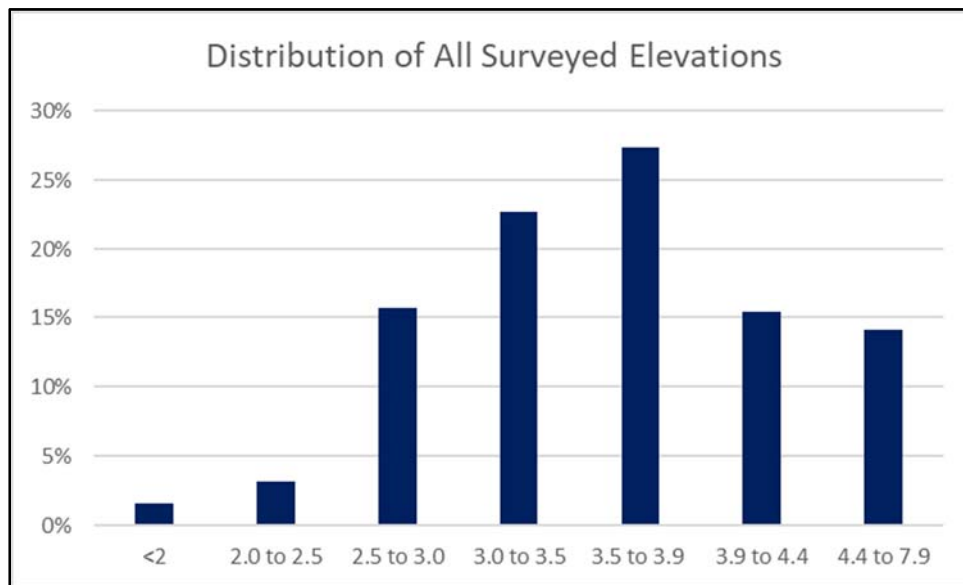
To assess the vulnerability of seawall overtopping in the City, the frequency of seawall elevations was determined using 0.5 foot elevation brackets (Figure 16). In order to relate the seawall elevations to the recommended 30-year planning elevations, a separate bracket for 3.9 to 4.4 feet was included and then all elevations above the upper range of 4.4 feet were grouped together. Figure 16 presents a summary of the elevations and distribution of points within the various elevation brackets measured throughout the study area. Considering the 30-year planning elevation range of 3.9 to 4.4 ft. NAVD, approximately 85% of waterfront parcels are vulnerable because they are at or below elevation 4.4 ft. and require seawall raisings to prevent flooding.

Figure 16. Seawall Elevation Summary
(Frequency of occurrence % vs. elevation (ft. NAVD)).

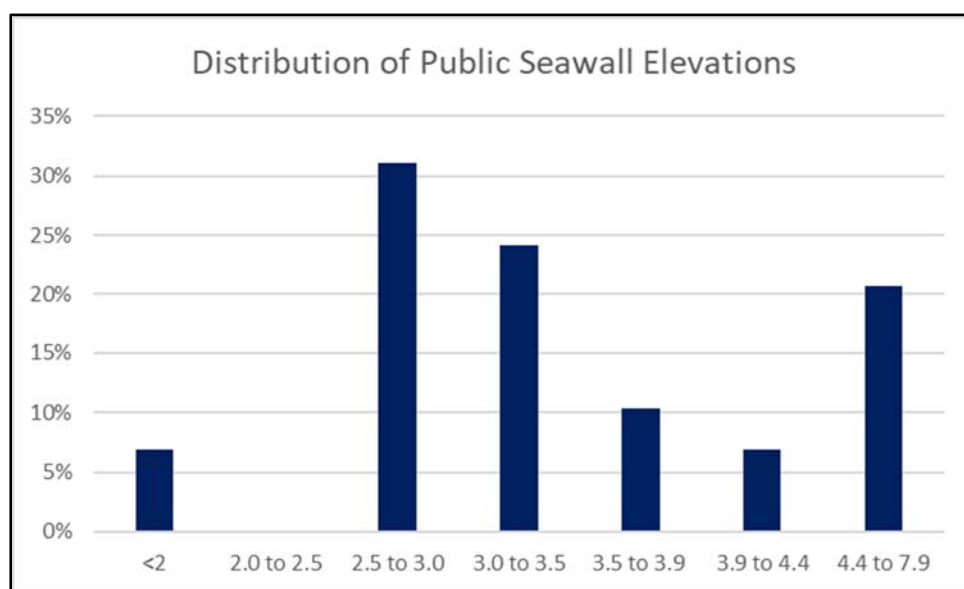
Figure 17 displays the distribution of elevations for the 29 public sites inspected during this study and presented in Appendix C. Of the publically owned sites, 22 seawalls and one (1) revetment are below elevation 4.4 feet and identified as vulnerable.

**Figure 17. Elevation Summary of Public Seawalls
(Frequency of occurrence % vs. elevation (ft. NAVD)).**

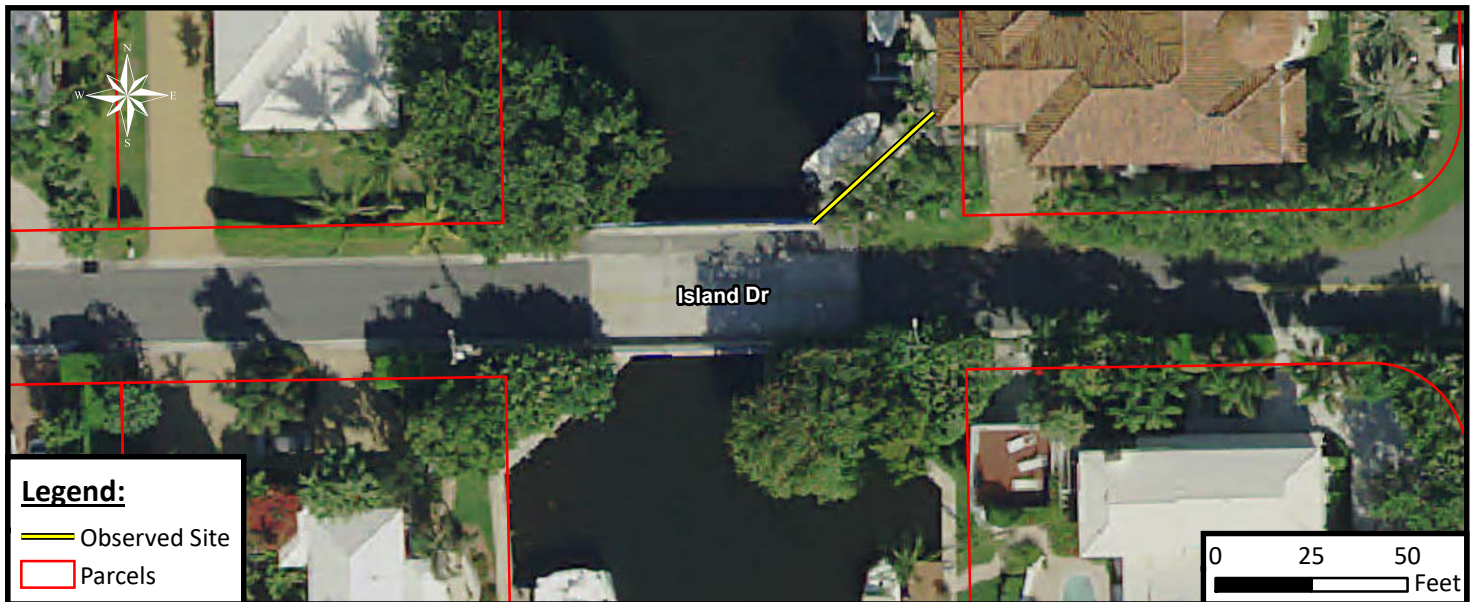
City Owned Seawall: Island Drive Bridge Abutment NE

25	P	Island Drive Bridge Abutment NE	Satisfactory	3.56	CE	Raise cap
26	W	Basin Drive	Fair to poor	5.13,3.78	CE	Raise cap on low portion
27	V	Thomas Street	Satisfactory to Fair	5.3	CE	Raise cap on lower gravity wall portion
28	DD	808 Seasage Drive ^A	Fair to poor	3.9	LK	Seawall panel was minimally repaired. Monitor for soil leakage.
29	N	SFWMD R/W Revetment structure at S40	Satisfactory	NA	NA	No action
30	K	Tropic Boulevard North side	Satisfactory	6.13	NA	No action
31	L	Tropic Boulevard South side	Satisfactory	6.5	NA	No action
32	I	Mangrove Park Ramp - North and West	Satisfactory	4.58	NA	No action
33	J	Mangrove Park Ramp - South and East	Satisfactory	4.65	NA	No action

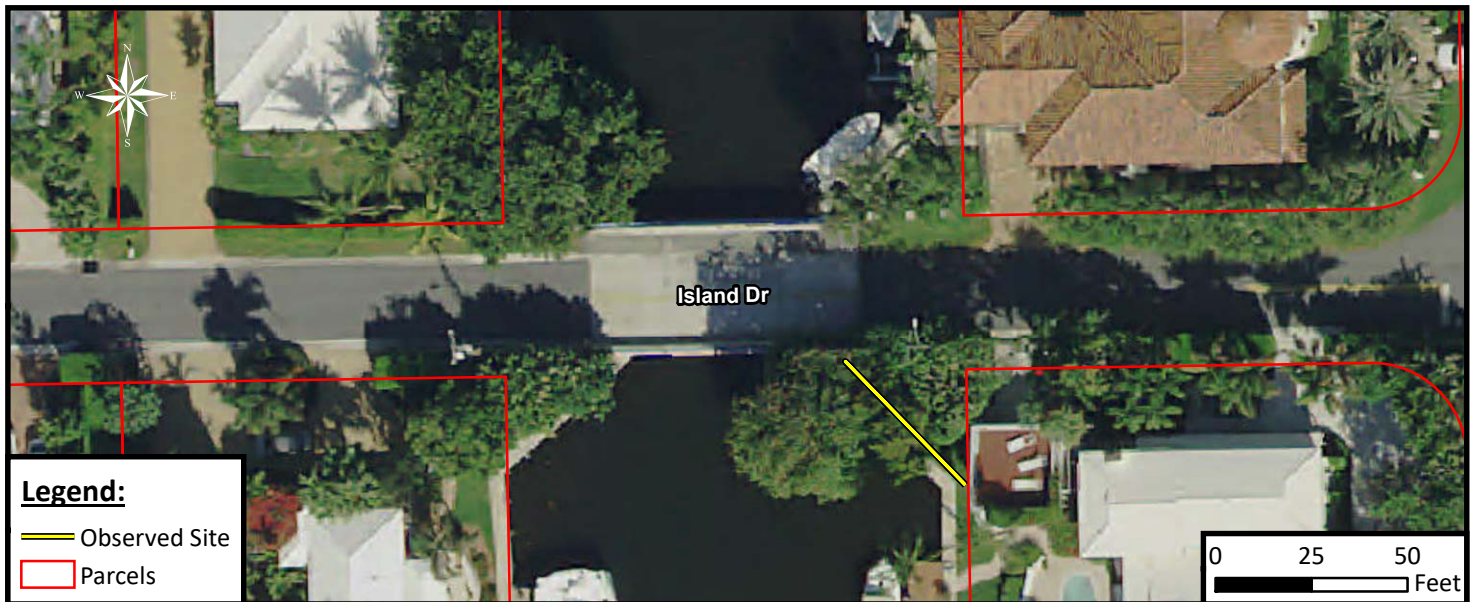
City Owned Seawall: Island Drive Bridge Abutment SE

Ranking Number	ID Letter	Site name (street name or other landmark)	Condition Assessment	Cap Elevation (Ft, NAVD)	Ranking Criteria	Recommendation
1	Q	Island Drive Bridge Abutment SE	Poor-Serious	4.26	SF	Replace seawall
2	D	NE 1 st Court	Fair	2.77	LK	Repair leak in seawall
3	W	Basin Drive	Fair to poor	5.13 & 3.78	LK	Repair the City reported leaks in wall
4	Z	Bucida Road	Fair to poor	3.18	LK	Repair the City reported leaks in wall. Replace seawall if appropriate.
5	A	NE 5 th Street	Fair to poor	3.43	LK	Raise cap. Repair the City reported leaks. Replace seawall if appropriate.
6	S	Beach Drive	Poor to Fair	2.79	SD	Replace seawall
7	O	Island Drive Bridge Abutment NW	Fair	3.87	SD	Remove upland trees and replace cap
8	Y	Casuarina Rd	Satisfactory	5.06	SD	Repair crack in cap
9	AA	Atlantic Dunes Park NW Lot between White Drive and Rhodes Villa Ave	Satisfactory	1.65	CE	Raise cap Address stormwater plan for parking lot Coordinate with County

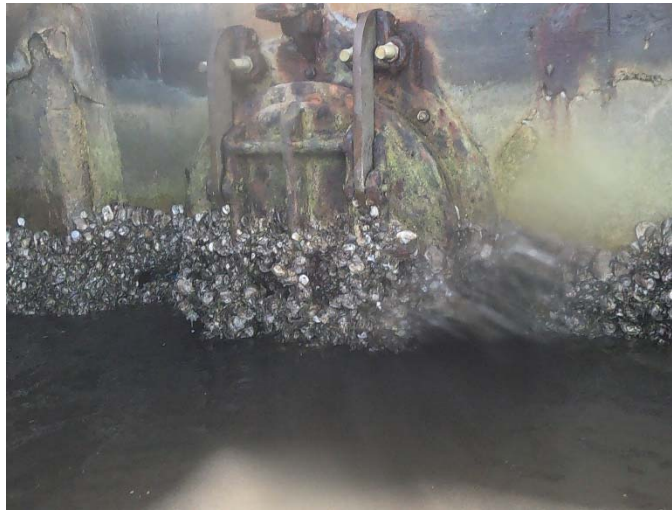
be performed at Basin Drive to determine the source of water leakage that is causing the pump to run.

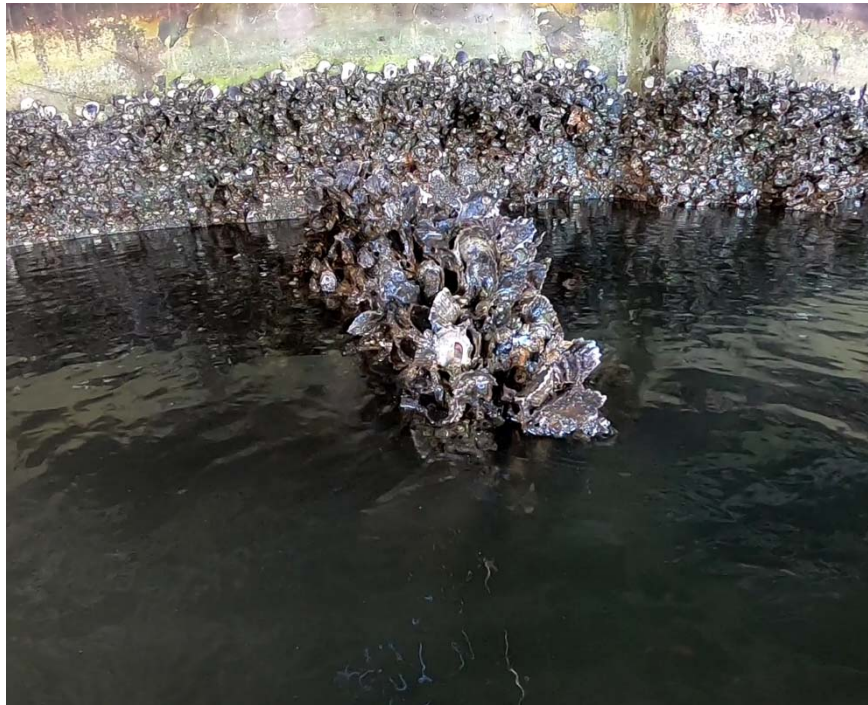
Spanish Circle N.
Oysters are in the bottom of the duckbill preventing closure.

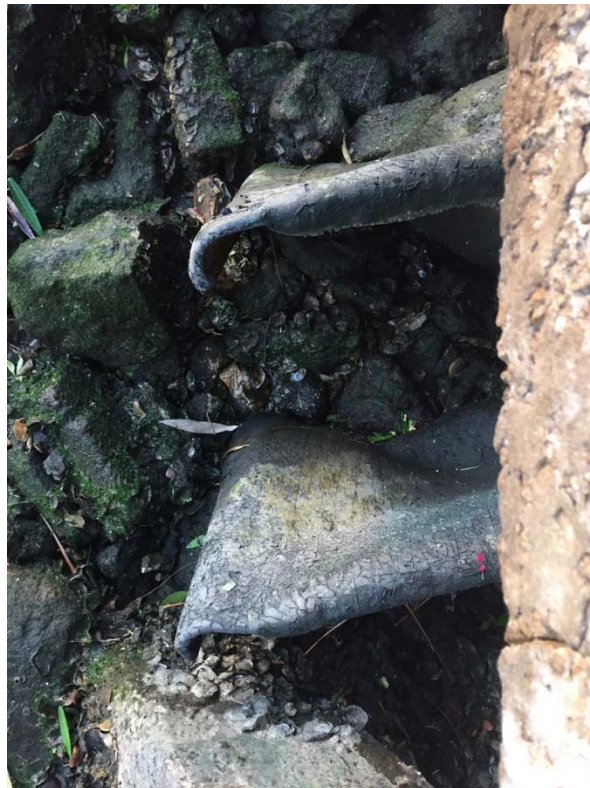
Beach Drive S 1 & Beach Drive S 2.
Seals but duckbill rests in sediment.
