## JUSTIFICATION' STATEMENT AS TO WHY WE NEED TO RECONSTRUCT THE EXISTING ROOF

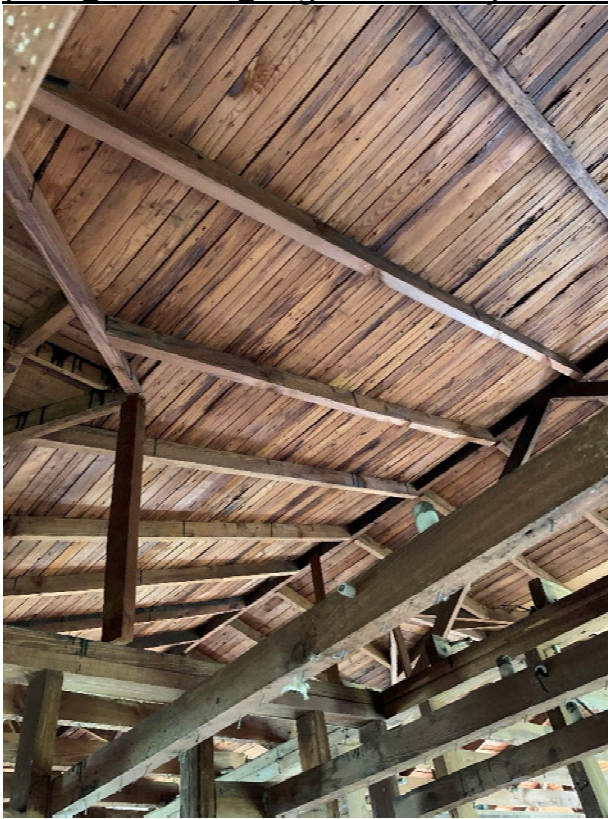
- I. The Main Roof Structure's 'Ridge Beam' and secondary roof members framed off-of this "Ridge Beam" are all 2 x 4 members and spanning far beyond the structural capacity for these sized members.

**(Pic-1 Main Roof Ridge/Secondary Member – note vertical support for West Gable)**

*This has caused the entire Main Roof to bow or sag*

*More so none of the secondary members are properly nailed/secured to the ridge beam and or to the top plate of the walls they rest upon.*

It is clear that these main roof structure members have to be replaced with new appropriately sized members and being that the (3) aforementioned, secondary roof structures are framed off-of/tied into this main roof structure, would then require the secondary roof structures' members to be replaced as well and not only for this reason but also for specific conditions related to each of the (3) secondary roof structures as follows:

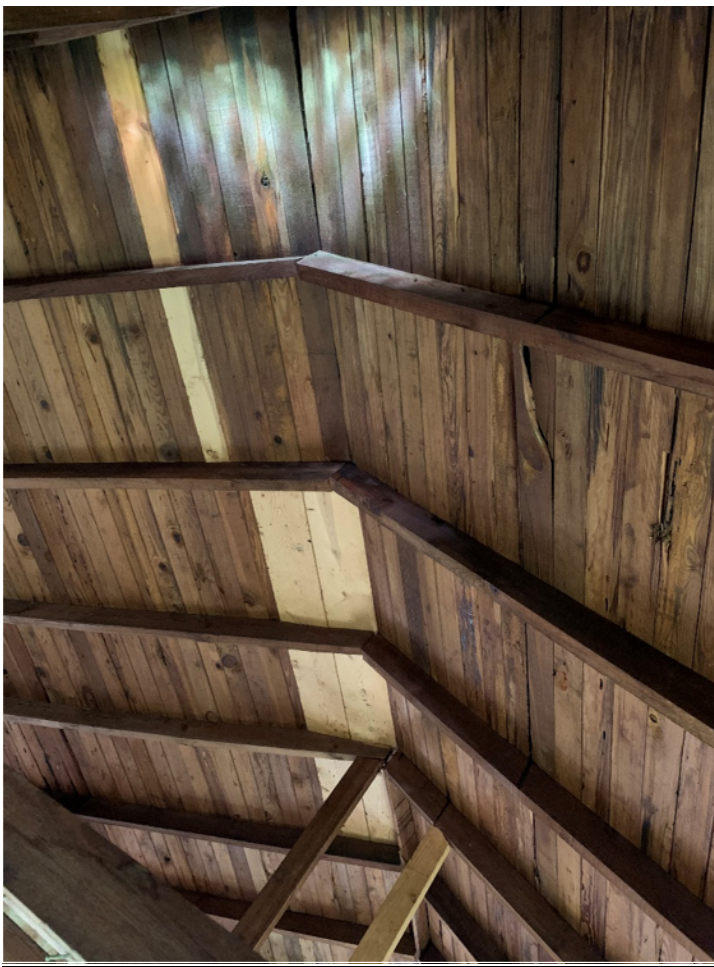
- II. The smaller west facing gabled, secondary roof structure (over the original porch) is missing a ridge beam altogether

**(Pic-2 West Porch No Ridge )**

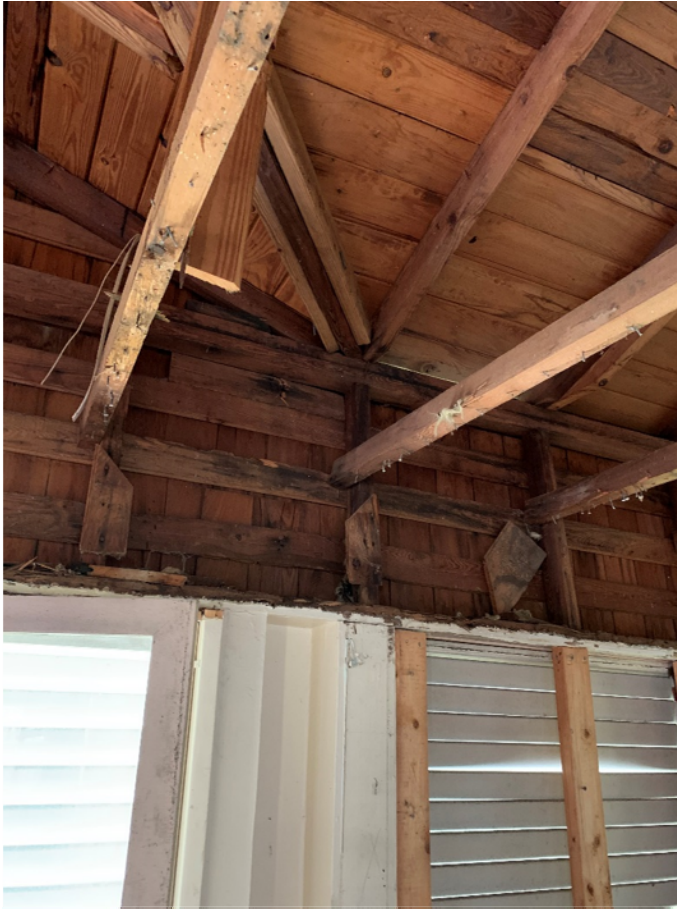
*More so at the junction where this roof (SE corner) and the main roof structure (SW corner) meet along the exterior wall has no vertical continuity for the forces of these roofs to come down to the foundation and has caused the exterior wall along the south to literally bow out and is also literally tearing apart the roof and wall*

(Pic 3 – Junction Main Roof/West Gable  
at Exterior wall – note vertical support)

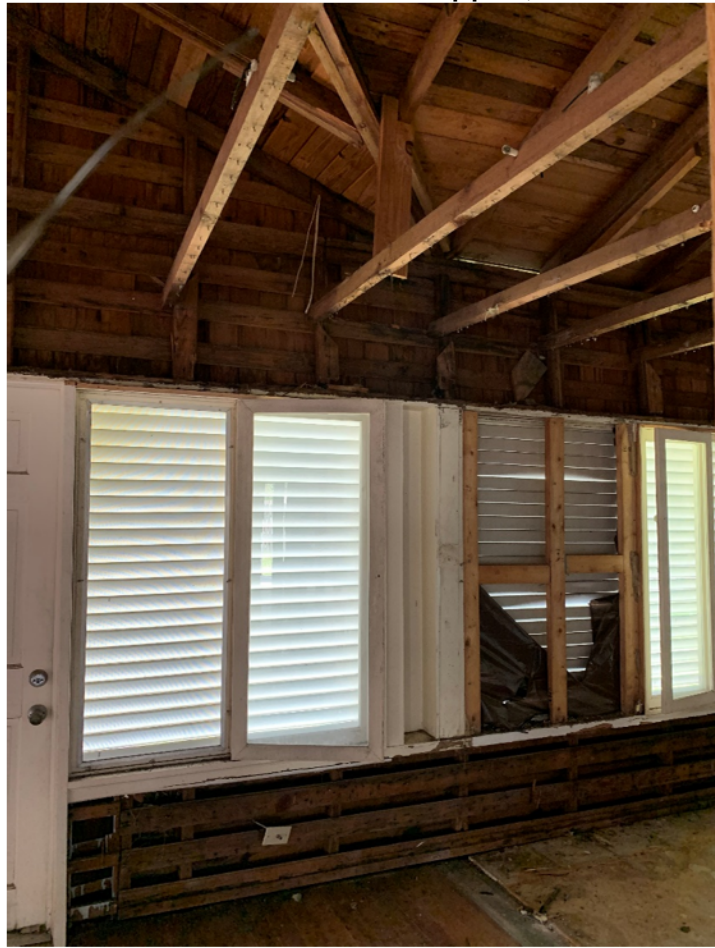
(Pic 4 – Junction Main Roof/West Gable  
at Exterior wall – note vertical support)

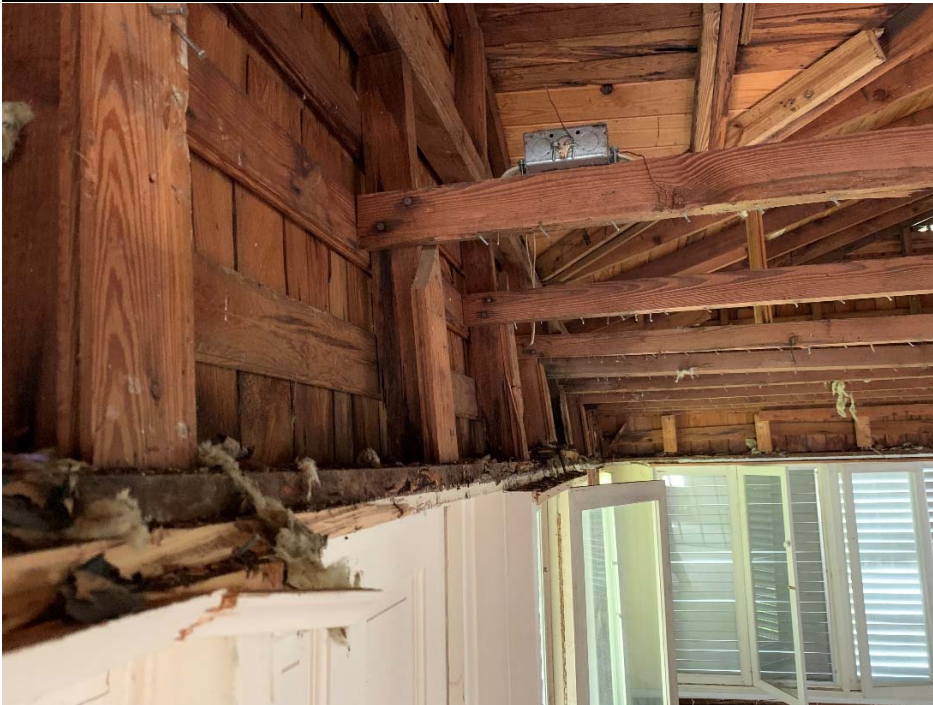
(Pic 5 – South Wall Pushed Out)

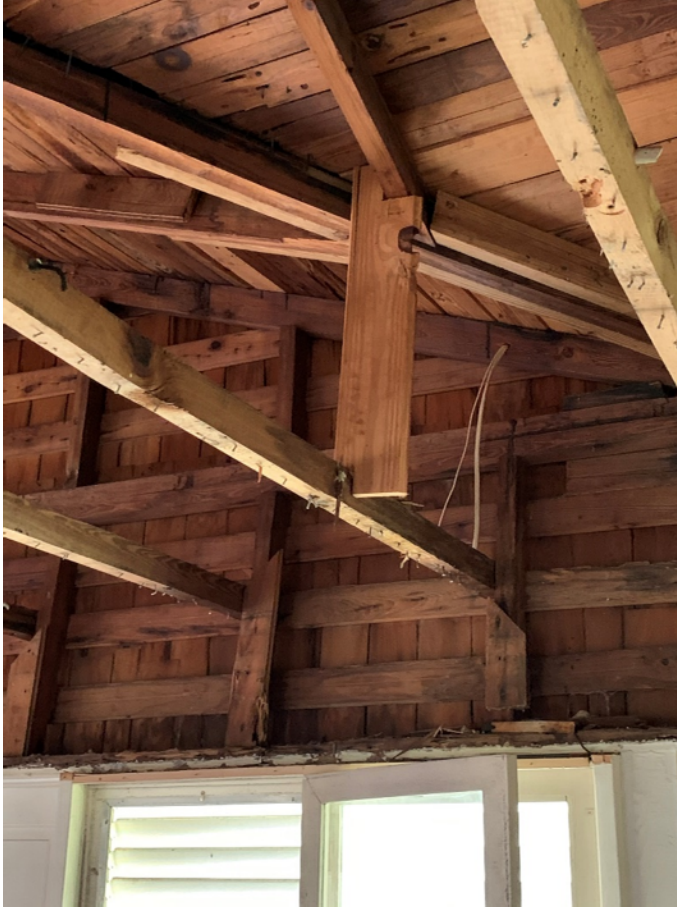
(Pic 6 – Junction Main/Porch Roof – method of vertical support implemented in order to attempt to support the roof deflection caused by poor design)

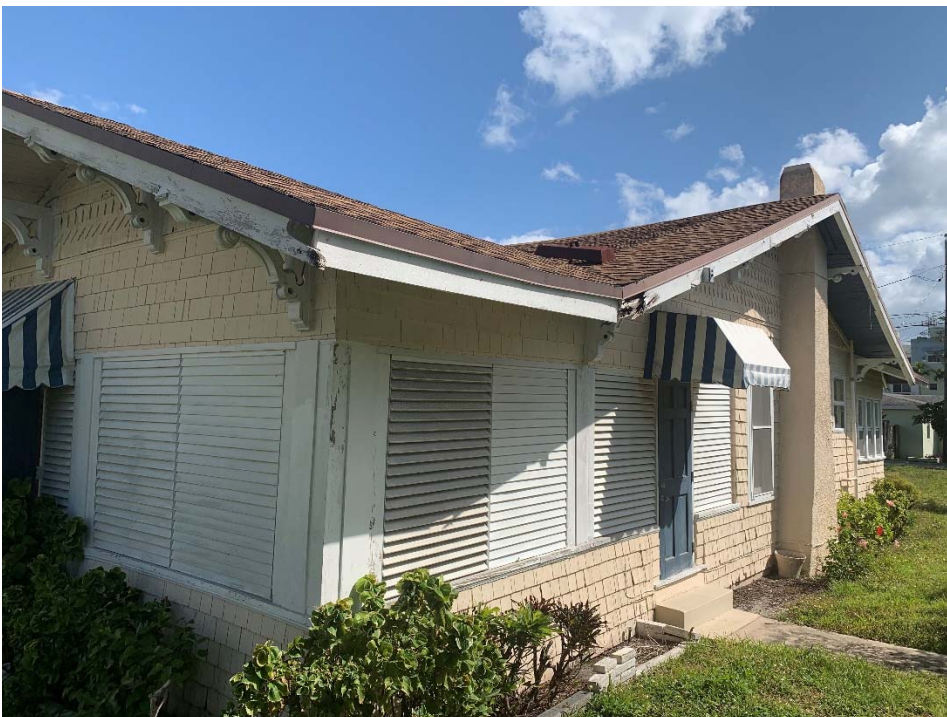
(Pic 7 – Junction Main/Porch Roof – Exterior Fascia)

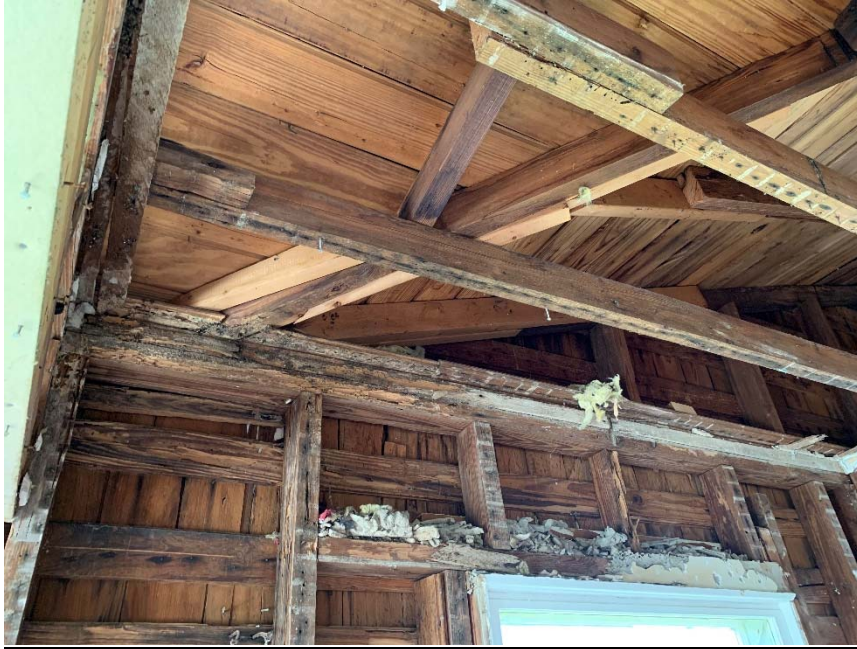
- III. East Facing Hipped Roof is also compromised due to the same factors affecting the main roof in that the roof members are undersized, not properly secured to each other or to the top of wall they rest upon and lack of vertical continuity.

In addition some of the existing members of this Hipped roof has rotted out and showing evidence of previous termite damage

**(Pic 8 East Hipped Roof- Junction at Main Roof along exterior wall)**

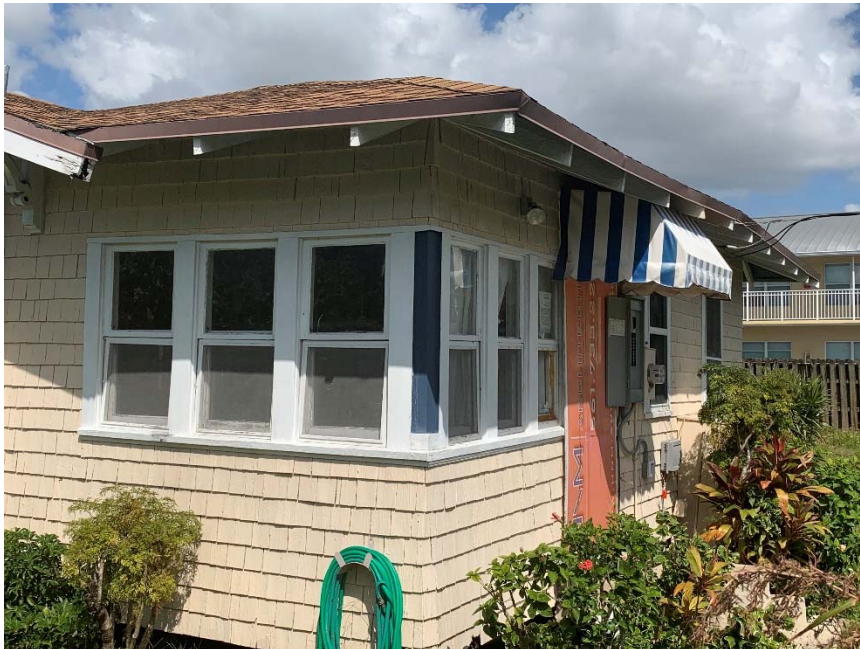
**(Pic 9 East Hipped Roof – junction at Main Roof – Fascia damaged/misaligned w/Hipped Roof)**

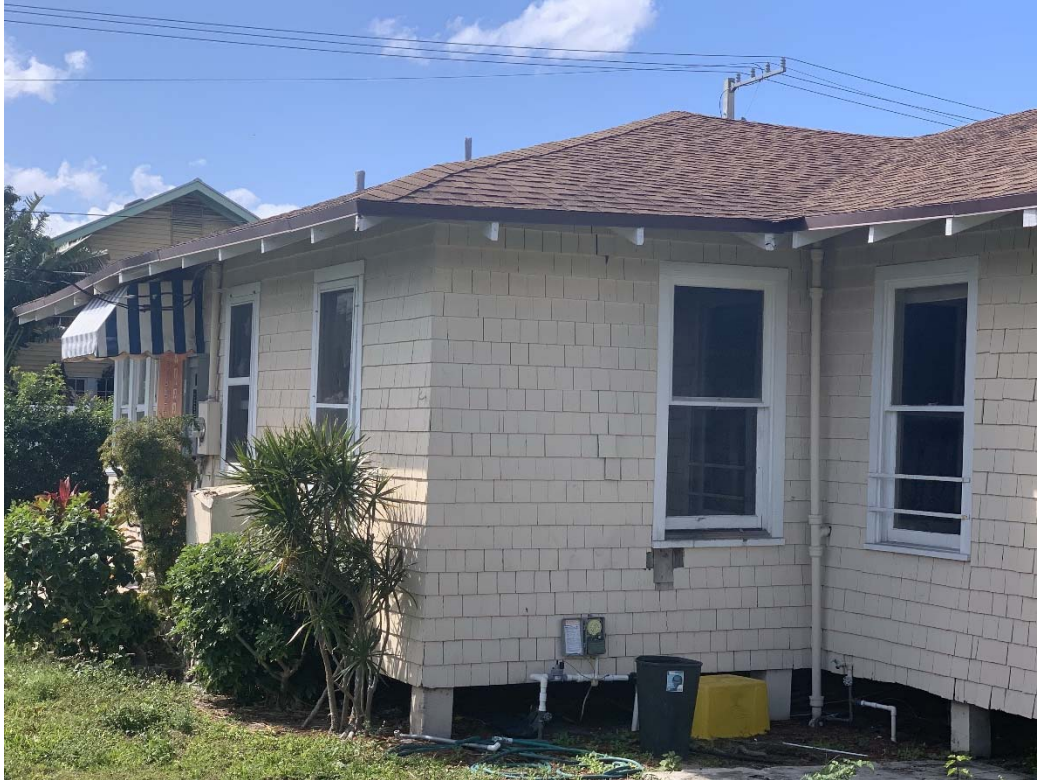
This has caused the roof to sag and has caused this roof and the main roof structure to tear apart from each other.

**(Pic 10 East Hipped Roof Exterior SE corner and NE corner Deflection)**

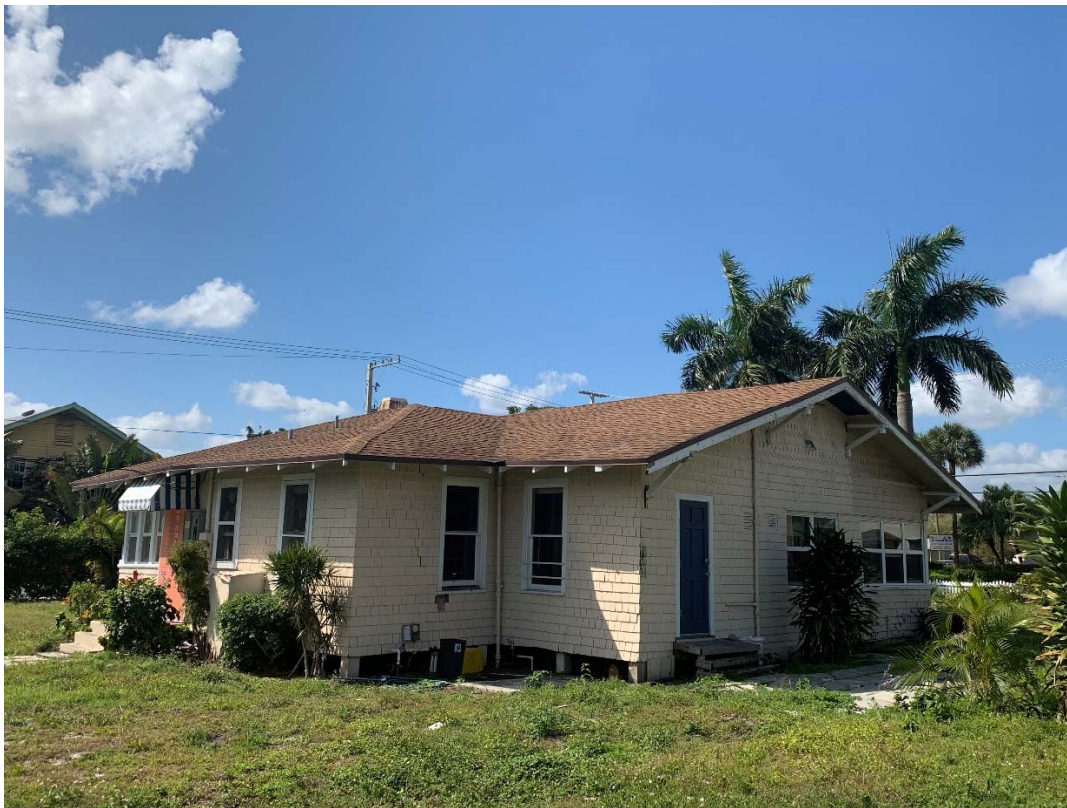
**(Pic 11 East Hipped Roof Deflection)**

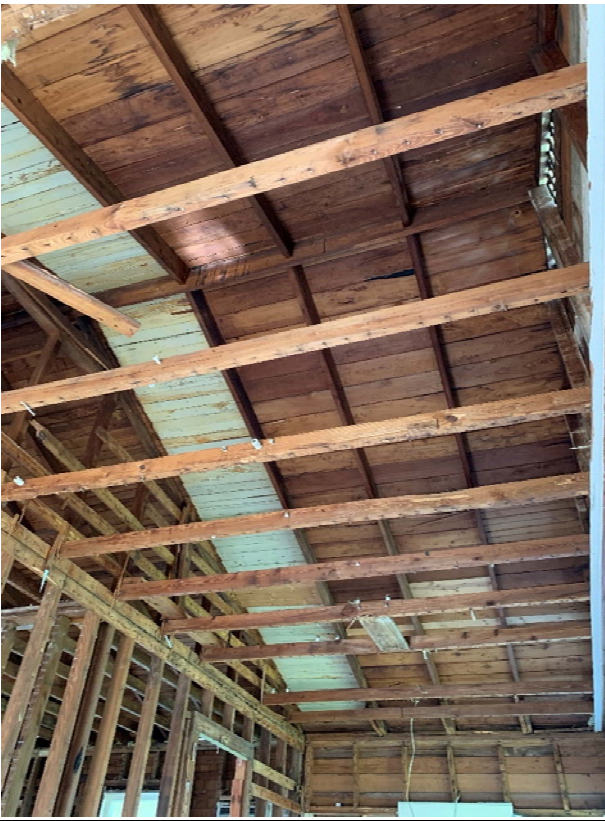
This roof structure is even more compromised than the Main Roof Structure, being that the Ridge Beam for this portion of the roof is comprised of a  $\frac{3}{4}$ " thick tongue and groove board, serving as the 'spine' for the secondary roof members framed off of this 'ridge beam' and to worsen the issue this ridge beam is improperly secured at both ends

**Pic 12 North Gable Addition – Ridge Beam**

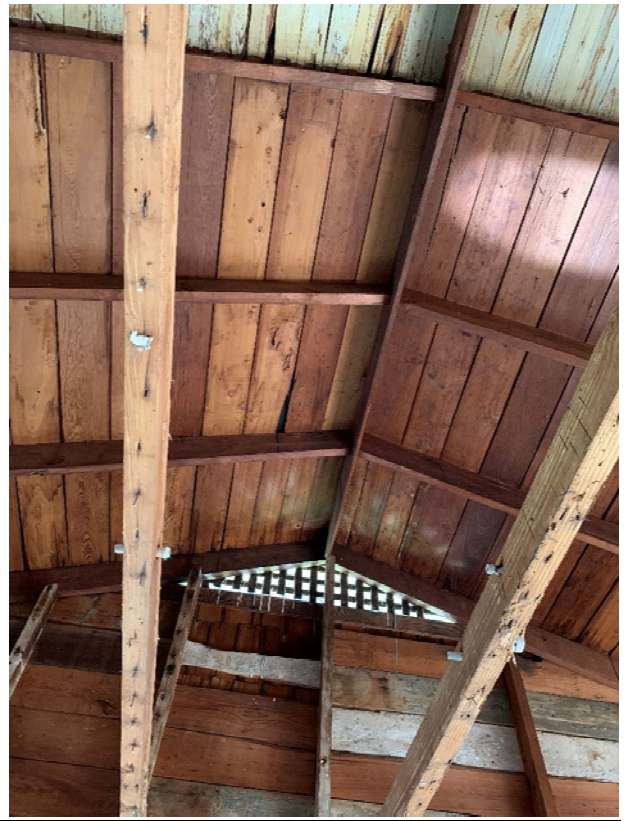
**Pic 13 – North Gable – Ridge@ Ext. Wall**

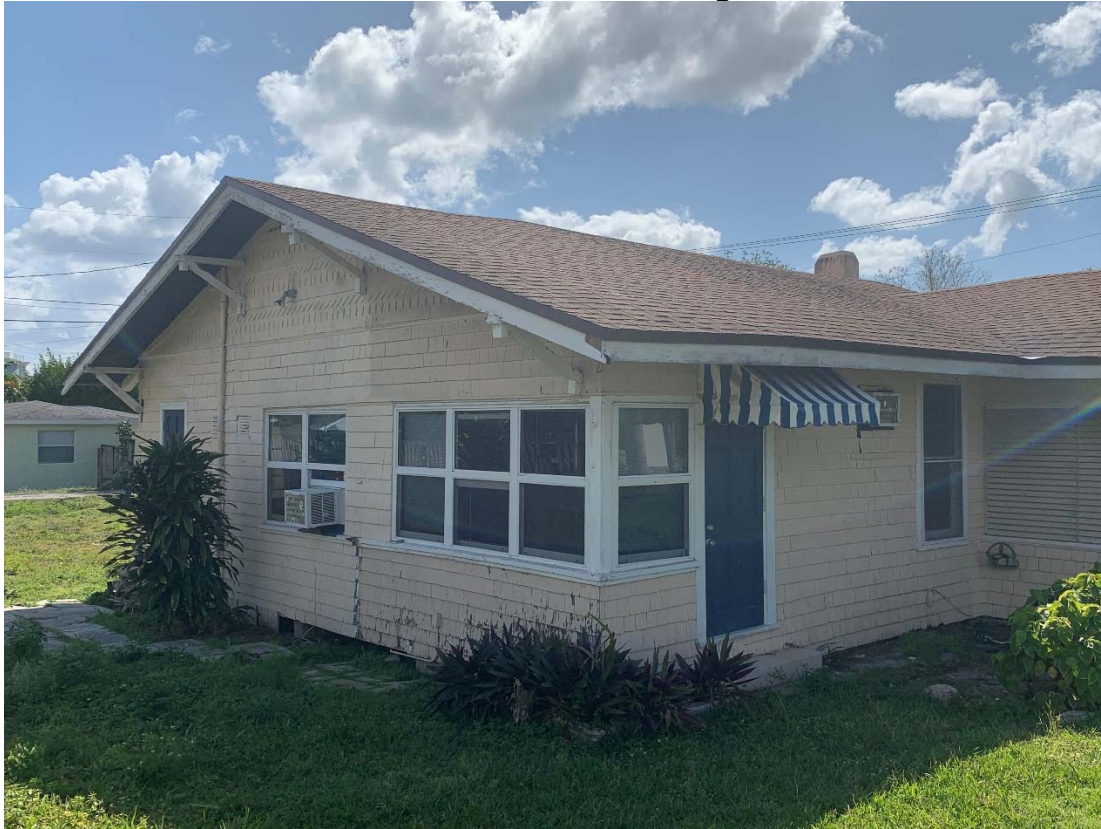
Due to these conditions this entire portion of the Roof (North Gable Addition) has deflected and as evidenced in the following pics is literally dropping down and off of the main roof structure.

Pic 14 – North Gable Exterior Deflection – note deflection at Junction of Original North End Gable and Addition as well as deflection along the fascia

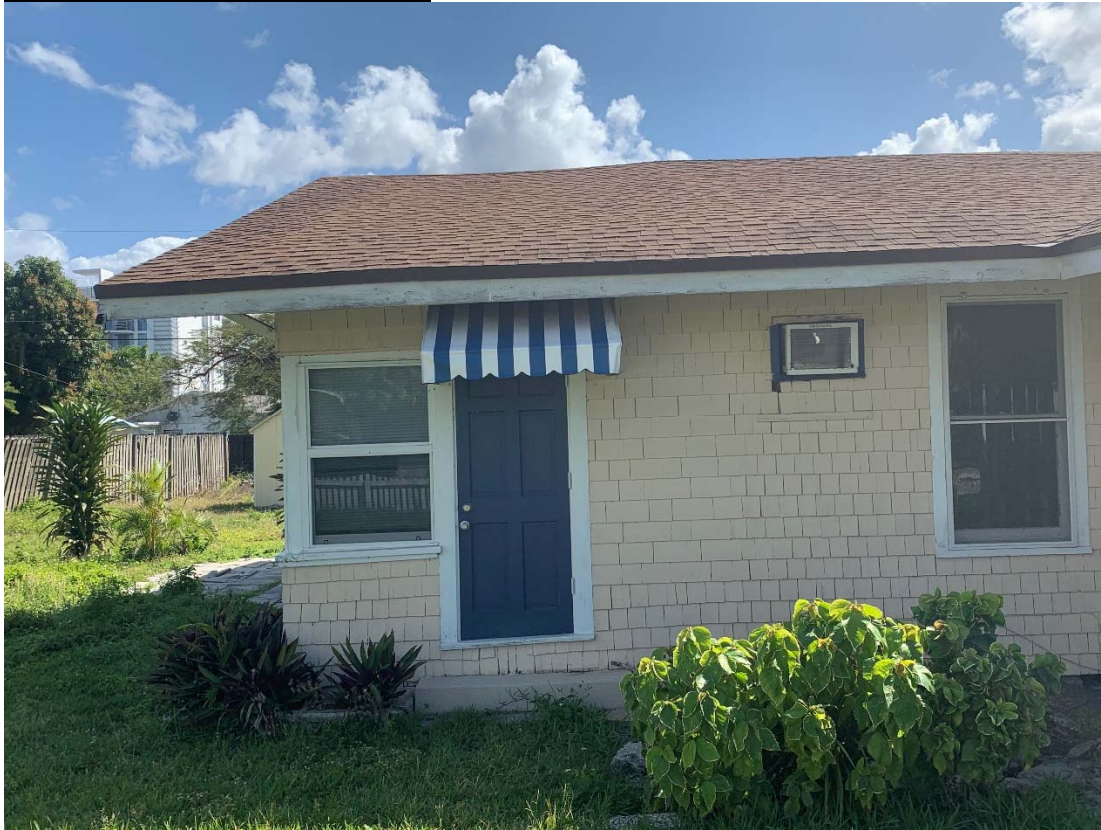
Pic 15 – North Gable Exterior Deflection – note deflection right at Junction of Original North End Gable and Addition

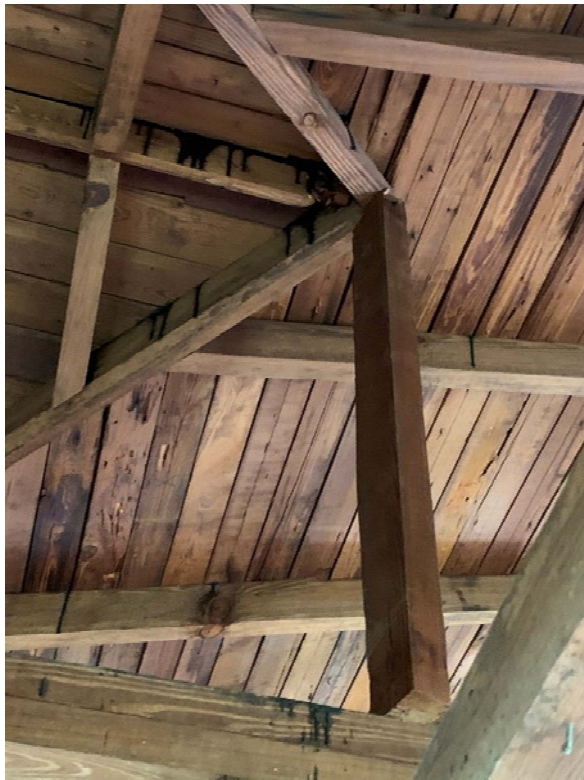
**Pic 16 – Unsecured Vertical Support at Junction of two Roofs**

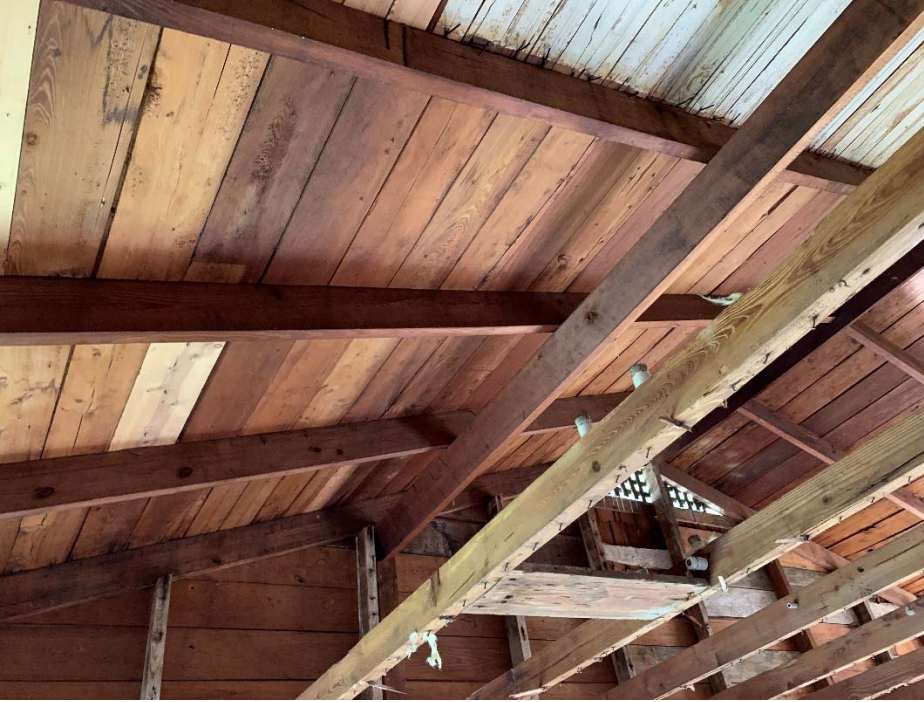
Pic 17 – Horizontal support unsecured to North Gabled Wall

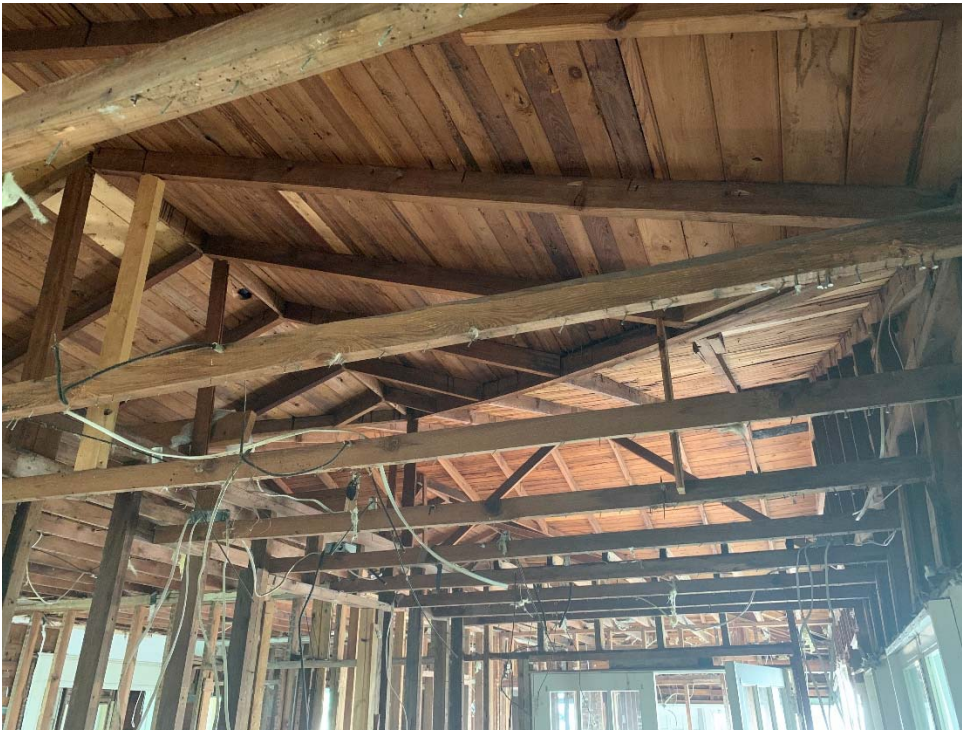
Pic 18– Randomly Placed Vertical Supports

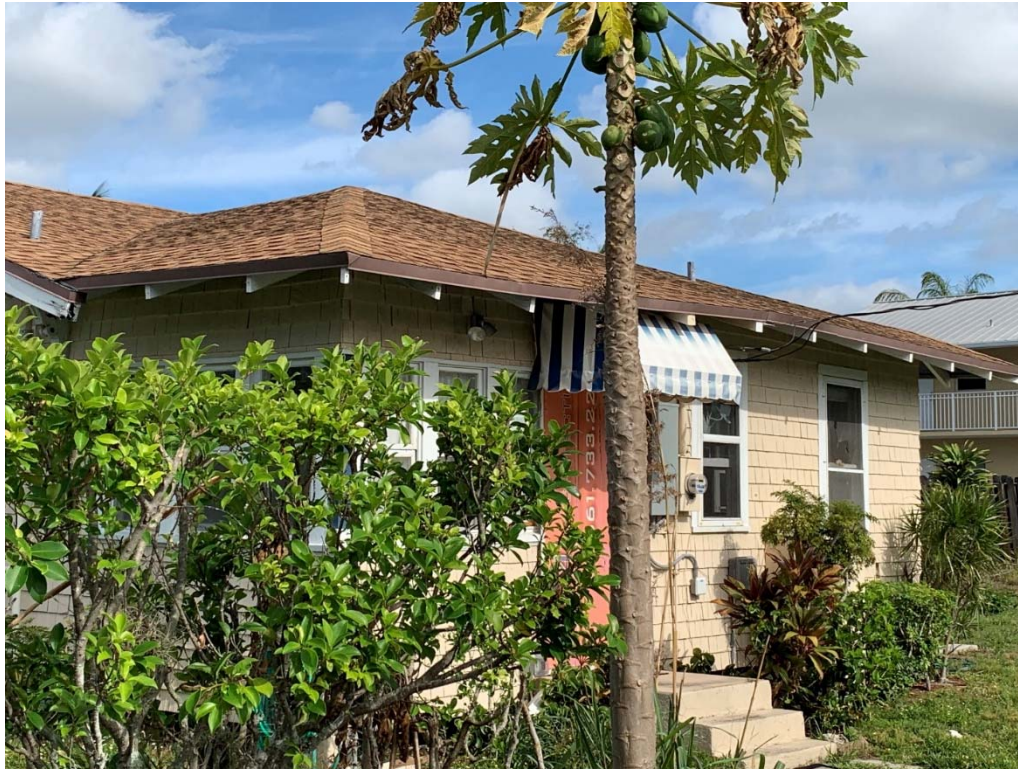
(SE Corner pic)

All of these existing factors have caused severe damage which has caused the roof to deflect in several locations.

In order to save this structure, assure it longevity and in order to make it an occupiable/safe structure for occupants, the entire roof must be reconstructed.
