February 12, 2020

RE: Structural Evaluation of Proposed new H&M Architectural Office
143 S. Swinton Ave., Delray Beach, FL

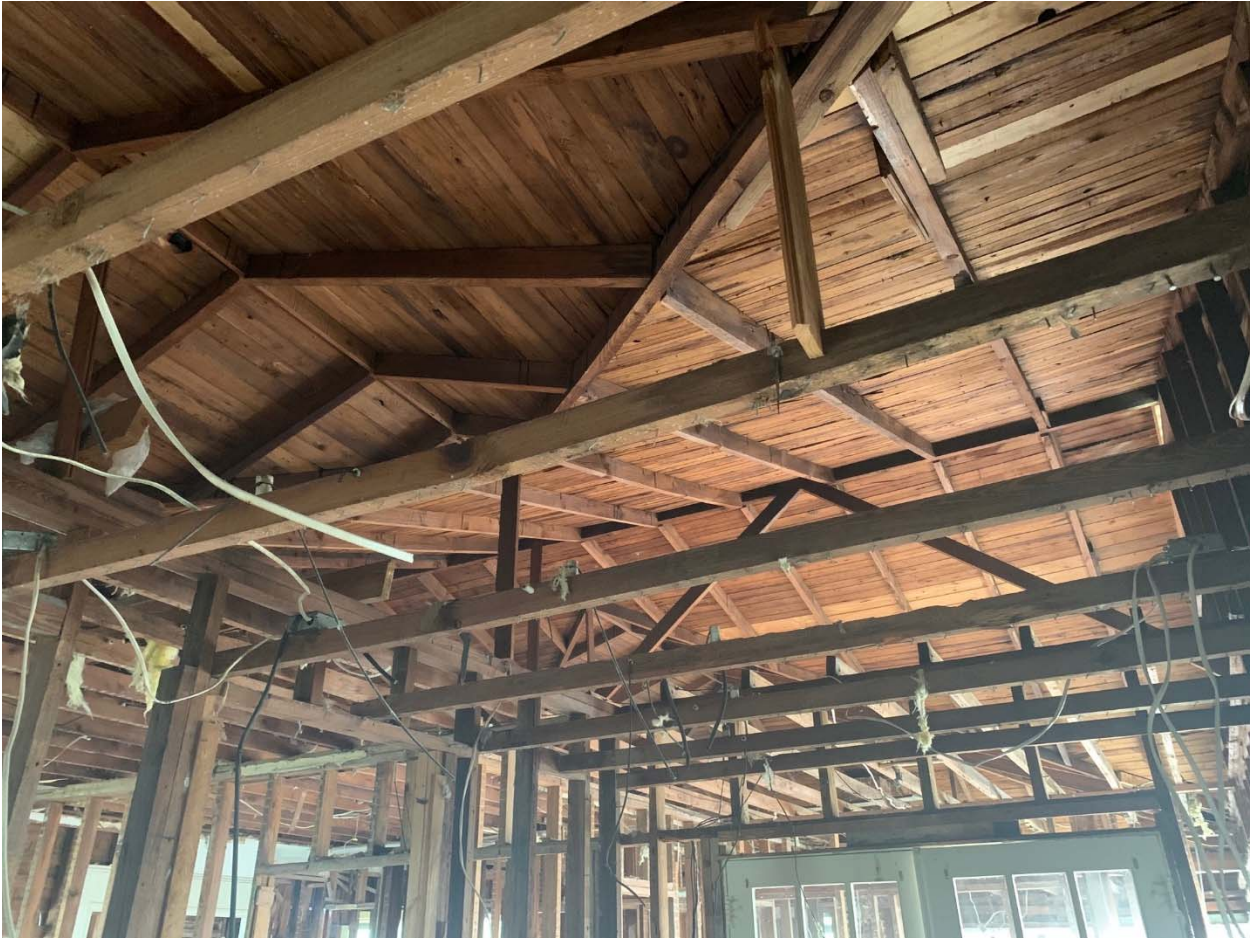
Hand framed roof framing without hurricane clips.

Significant decay observed at sill

Inadequate roof joist supports

Cripple wall framing above header without vertical continuity creates hinge condition

Lack of hurricane clips on wall studs

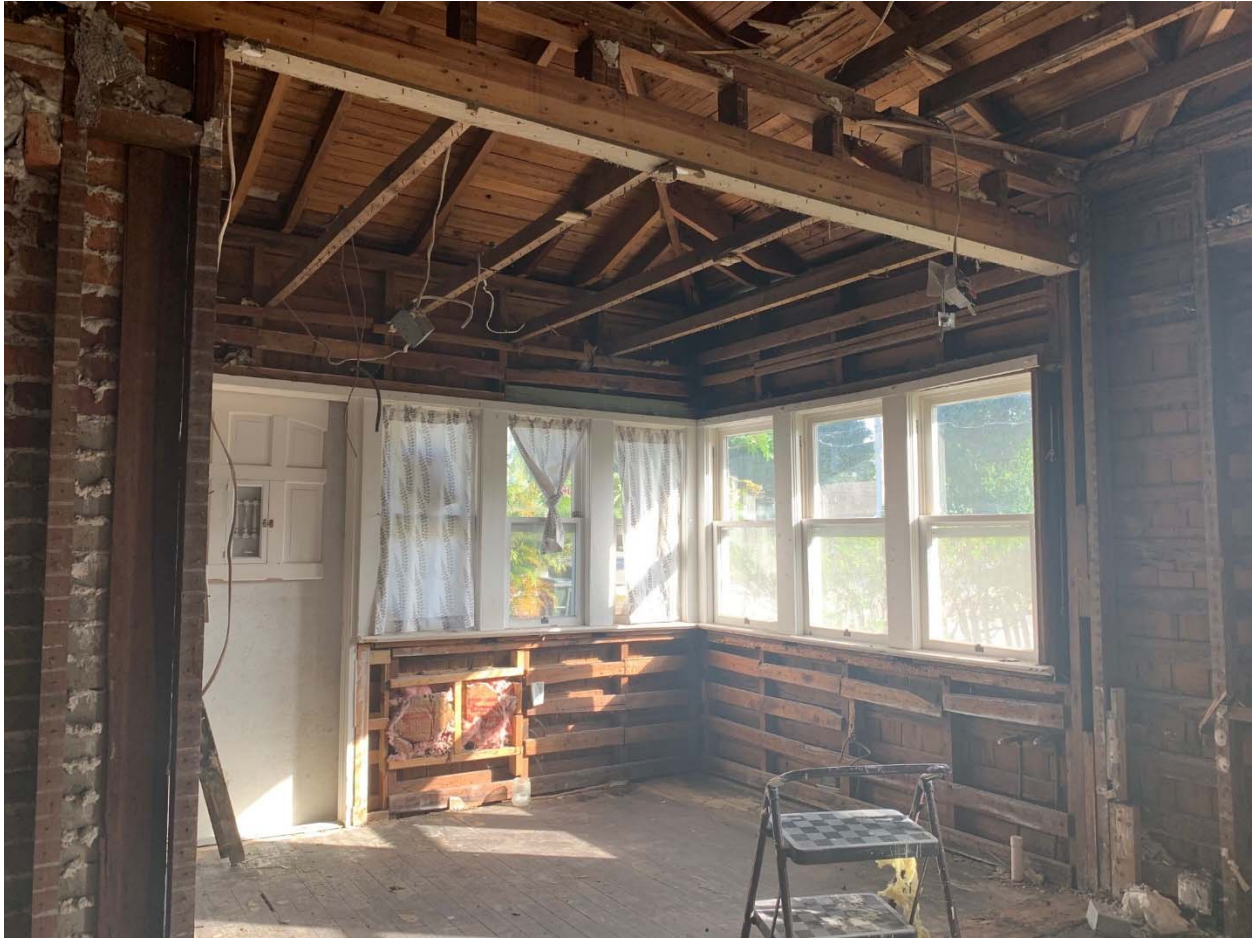
Hand framed roof framing without hurricane clips.

Significant decay observed at sill

Inadequate continuous jamb reinforcement

Cripple wall framing above header without vertical continuity creates hinge condition

Lack of hurricane clips on wall studs

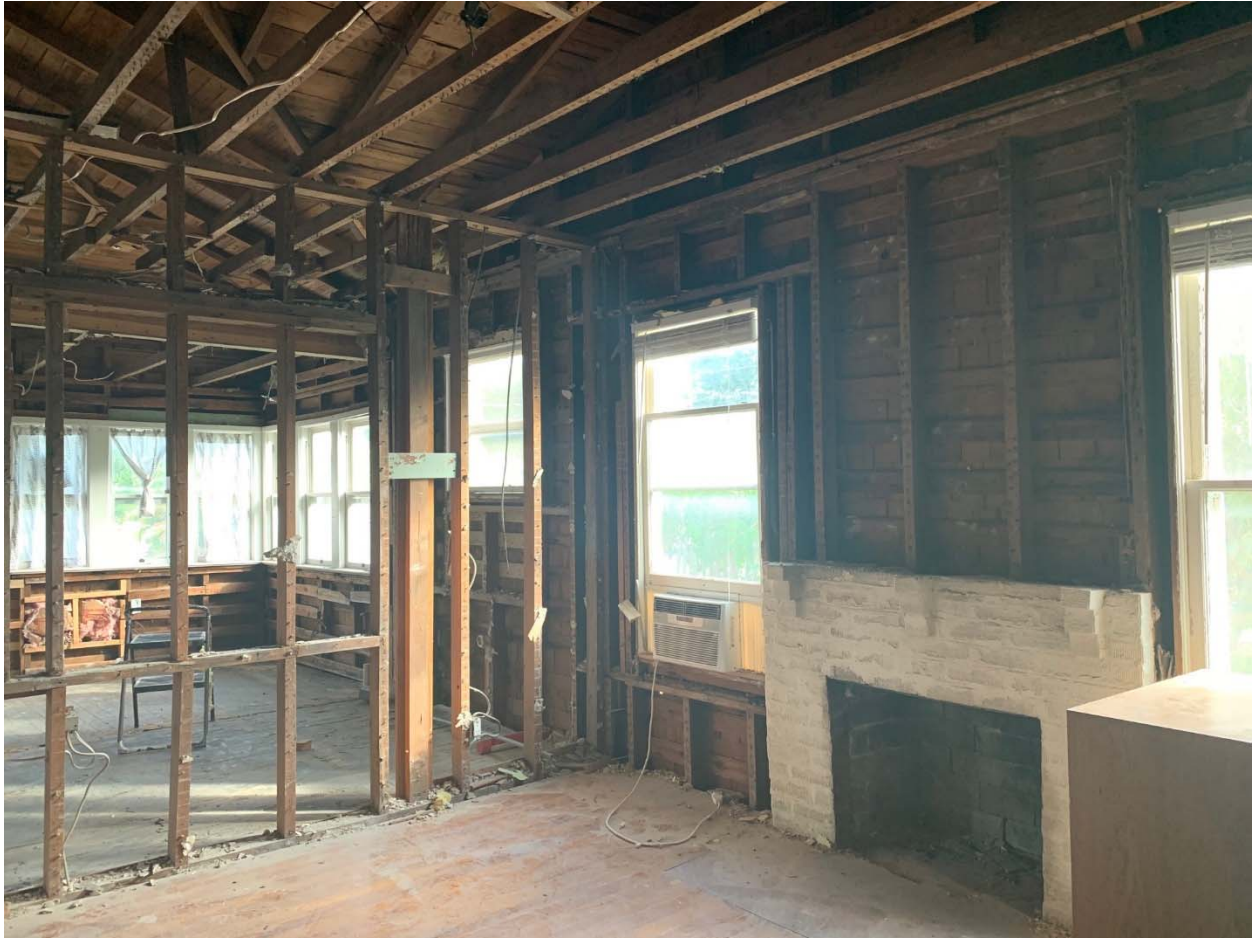
Hand framed roof framing without hurricane clips.

Significant decay observed at sill

Inadequate continuous jamb reinforcement

Lack of gable end wall bracing

Lack of hurricane clips on wall studs
