February 18, 2019

Re: Shade Tree Health Evaluation and Report for 1009 and 1023 Casuarina Road, Delray Beach, Florida

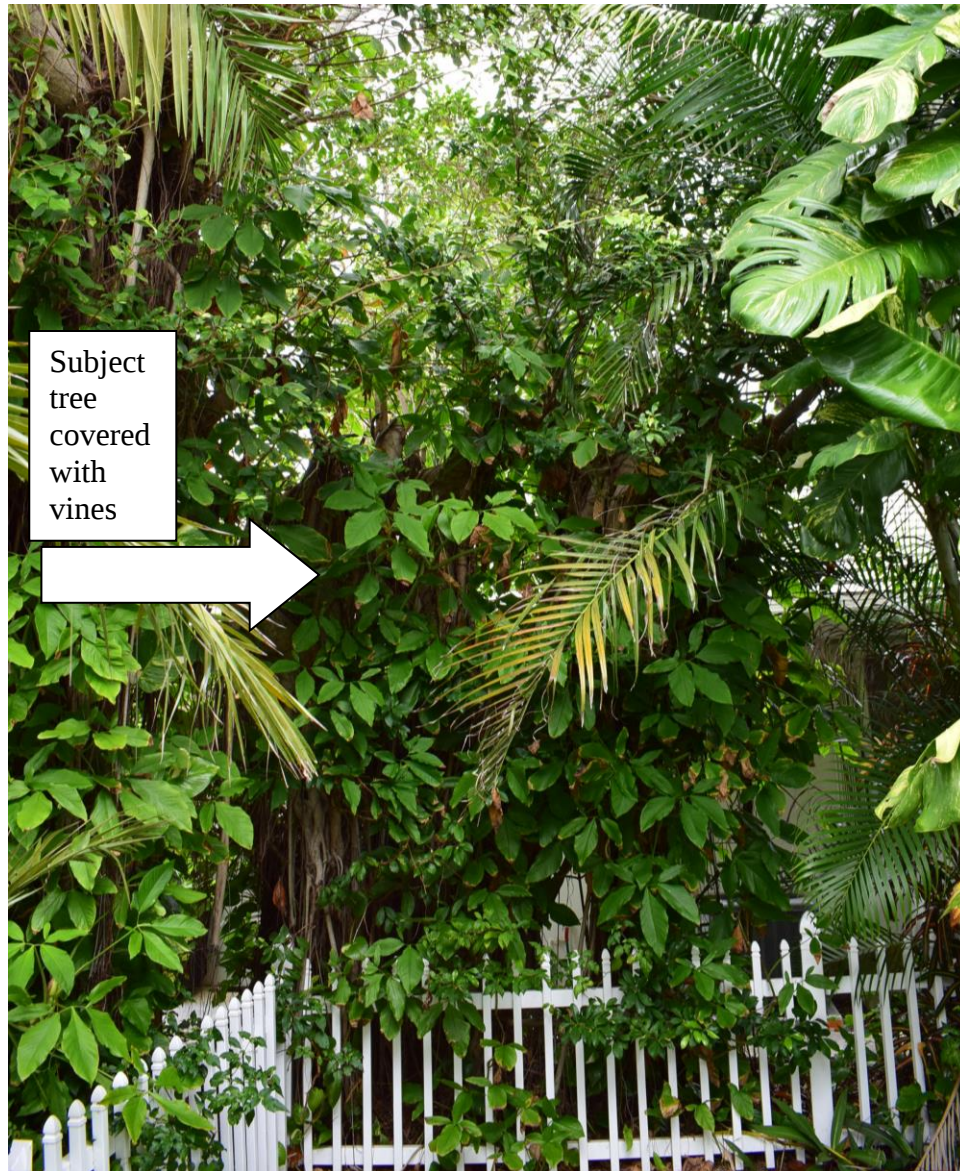
**Tree Three**

**Tree Three:** Weeping fig, *Ficus microcarpa*, approximately 10 feet tall, six feet wide. The trees trunk diameter was 50 inches. The tree has very poor health and structure since it has been hatracked (headed) with very few leaves remain. The tree is a stump covered with vines and located immediately beneath the overhead powerlines. The trees health condition is very poor with a 15% health condition percentage.

**View looking north**

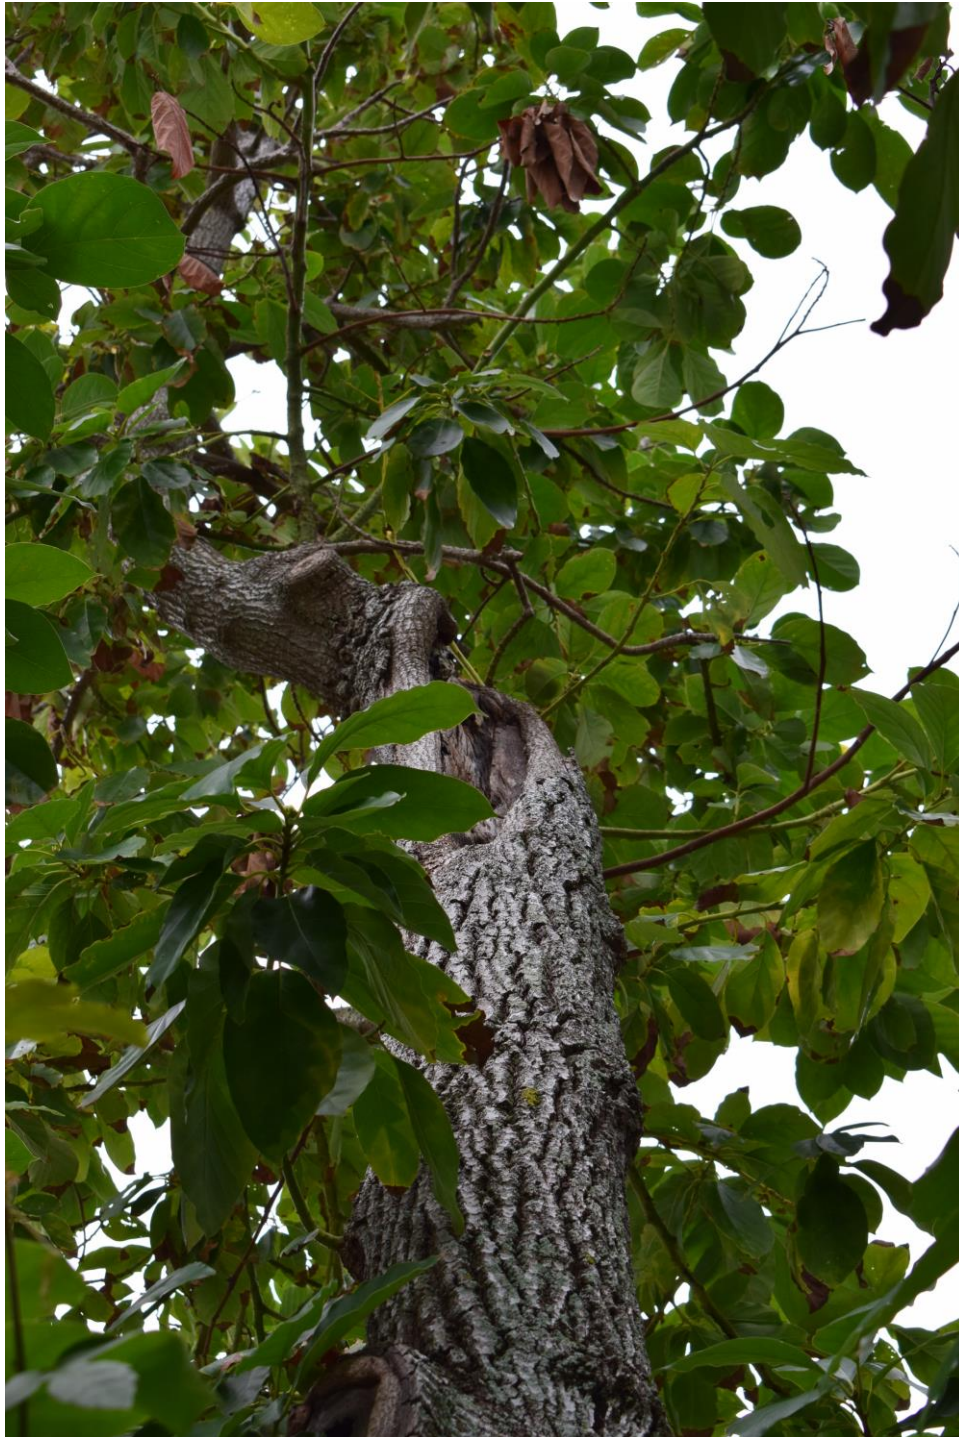
**Tree Nine:** *Persea americana*, Avocado approximately 30 feet tall, 15 feet wide, the tree was measured at breast height (dbh), 54 inches above ground level and was 13 inches in diameter. The tree has significant storm damage resulting in trunk wounds with cavities. The tree is in poor condition with a 30% health condition.

**Large wound with cavity where top was broken out of Avocado**

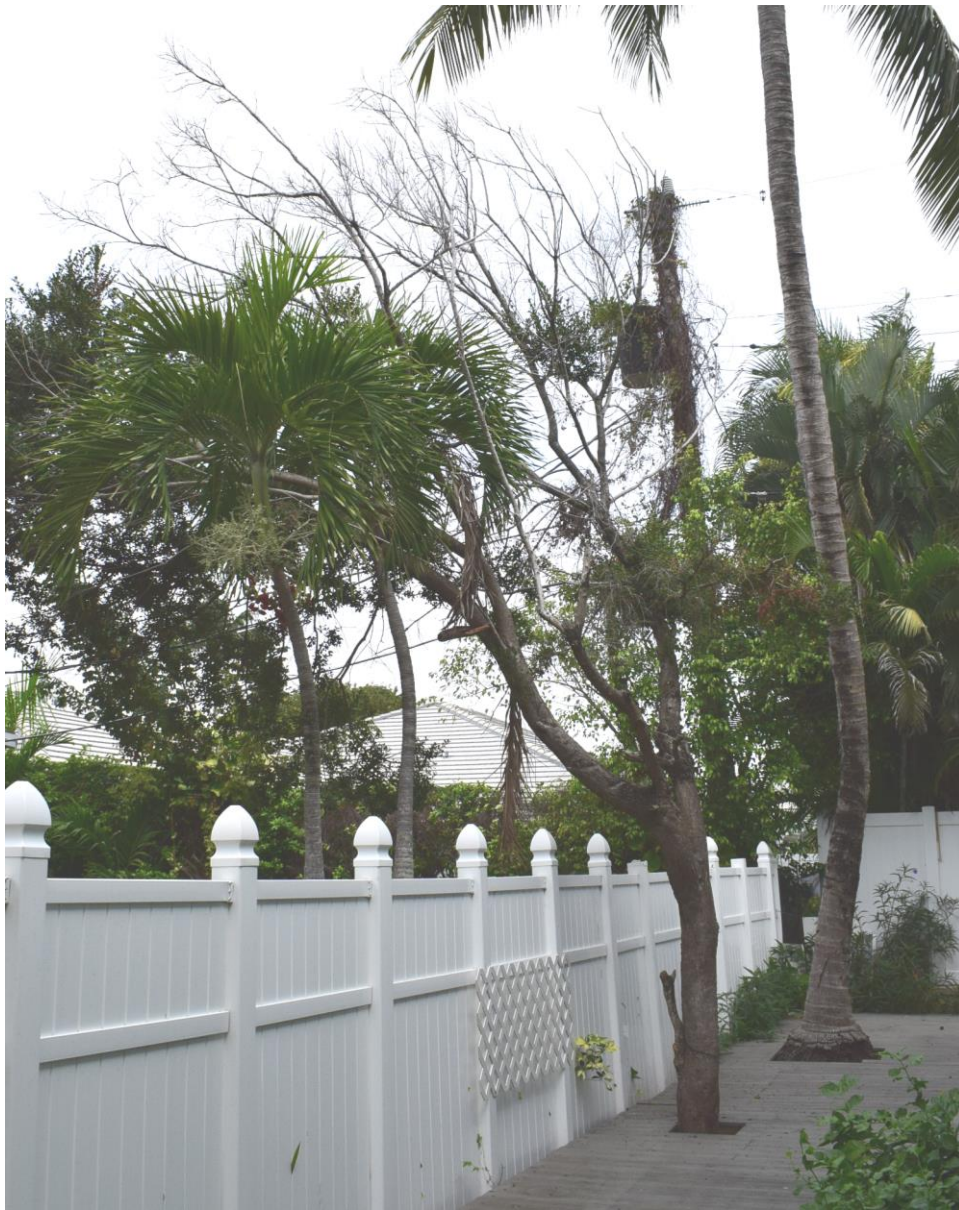
**Tree 13**

**Tree 13:** *Eugenia spp*, Stoppers 15 feet tall with a canopy of 15 feet the trunk of the tree was measured at dbh and was eight inches in diameter. The tree is declining with extensive dieback of twigs the eastern half of the tree is dead. The tree is in very poor health condition with a 15% health rating.

**View looking north at Eugenia spp extensive decline with dead limbs throughout canopy**
