Arboriculture Tree Report

Delray Ridge, Delray Beach, Fl. added trees

Date: July 7, 2021

Prepared by: John Sutton
International Society of Arboriculture Certified Arborist

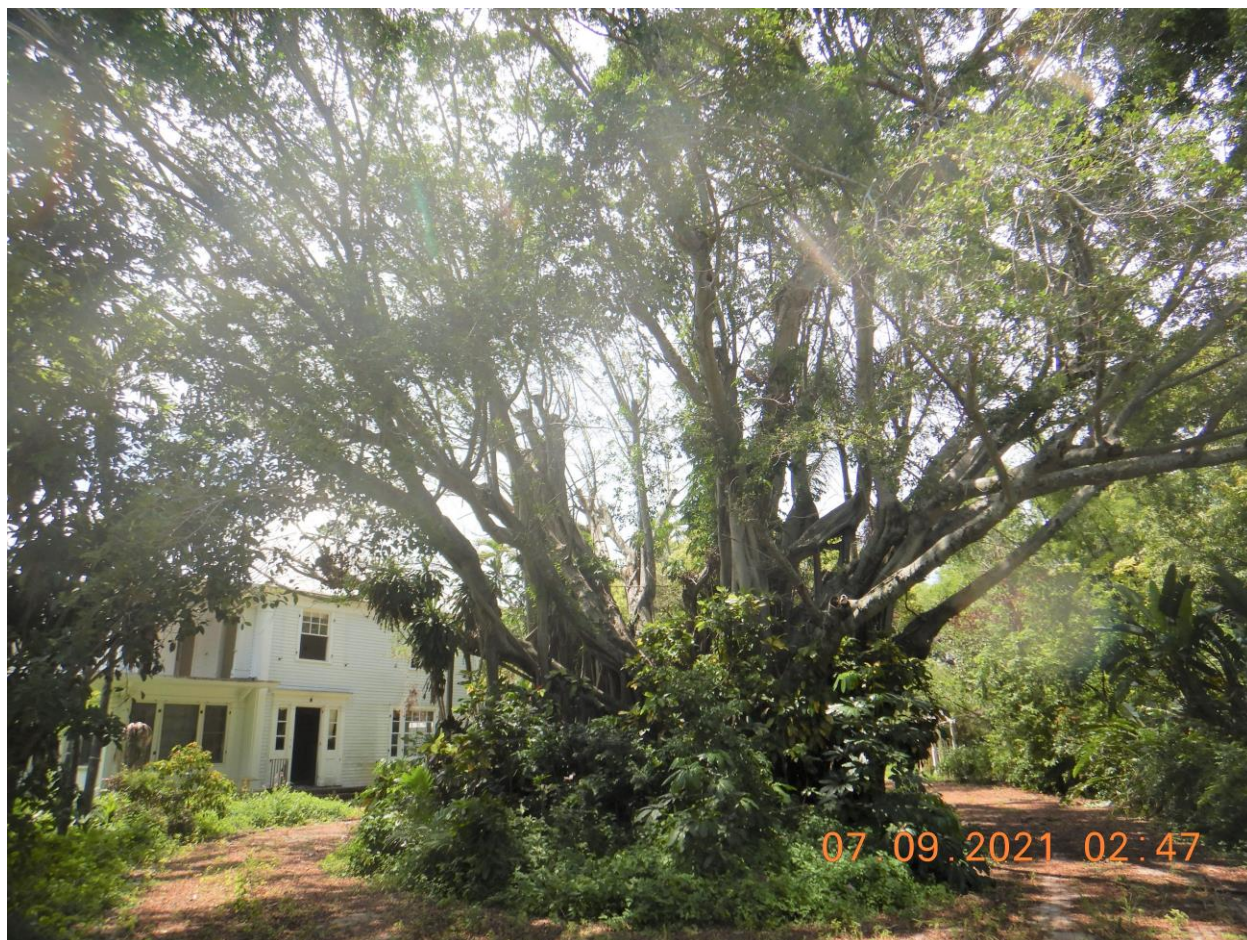
#122

Tree #	Common name	Scientific name	DBH	Condition	Gen. Notes
122	Ficus nitida	<i>Ficus microcarpa</i>	100+	30%	Cat 1, FLEPPC 2019 Invasive Plant List, dying
123	Same ficus as 122	<i>Ficus microcarpa</i>			Cat 1, FLEPPC 2019 Invasive Plant List
124	Same ficus as 122	<i>Ficus microcarpa</i>			Cat 1, FLEPPC 2019 Invasive Plant List
125	Same ficus as 122	<i>Ficus microcarpa</i>			Cat 1, FLEPPC 2019 Invasive Plant List
126	Same ficus as 122	<i>Ficus microcarpa</i>			Cat 1, FLEPPC 2019 Invasive Plant List
127	Same ficus as 122	<i>Ficus microcarpa</i>			Cat 1, FLEPPC 2019 Invasive Plant List
128	Same ficus as 122	<i>Ficus microcarpa</i>			Cat 1, FLEPPC 2019 Invasive Plant List
129	Same ficus as 122	<i>Ficus microcarpa</i>			Cat 1, FLEPPC 2019 Invasive Plant List
130	Same ficus as 122	<i>Ficus microcarpa</i>			Cat 1, FLEPPC 2019 Invasive Plant List
131	Same ficus as 122	<i>Ficus microcarpa</i>			Cat 1, FLEPPC 2019 Invasive Plant List
