| 7/2/2021 | | 1625 S. Ocean Blvd. Delray Beach, FL | | | | | | | | | |

1625 OCEAN  
1625 S. OCEAN BLVD. DELRAY BEACH, FLORIDA  
TREE DISPOSITION

TD-1  
PERMIT

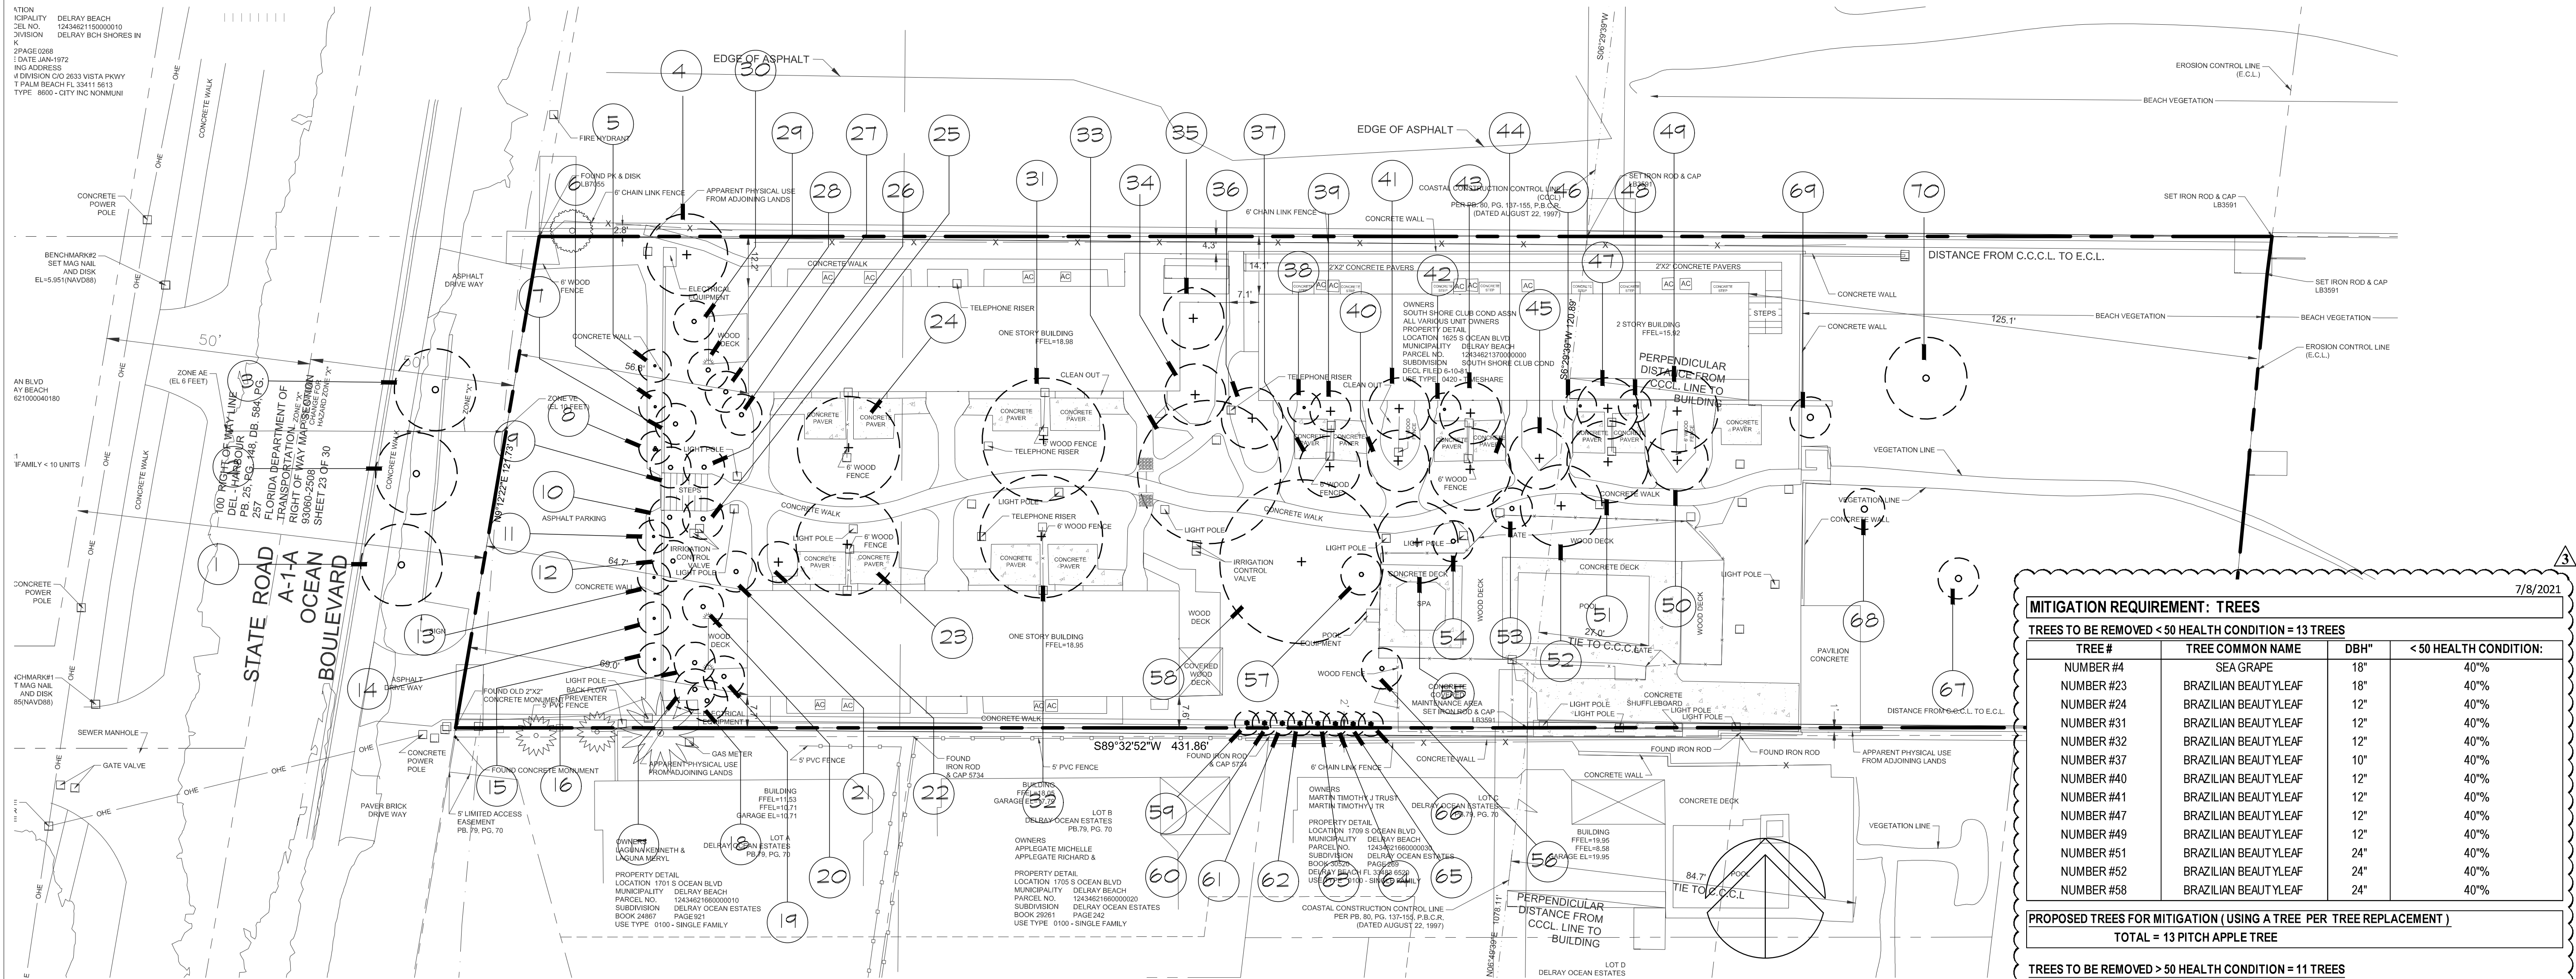
| 7/2/2021 | | 1625 S. Ocean Blvd. Delray Beach, FL | | | | | | | | | |
|---|---|---|---|---|---|---|---|---|---|--|--|
| 1 | Coconut Palm | <i>Cocos nucifera</i> | 20' gw | NA | | Good | 85% | K deficient | REMOVE | | |
| 4 | Sea Grape | <i>Coccoloba uvifera</i> | 15' | 20' | 26" | Poor | 40% | Codom @ 8" | REMOVE | | |
| 5 | Christmas Palm | <i>Adonidia merillii</i> | 8' | NA | | Fair | 75% | low trunk wounding | REMOVE | | |
| 8 | Christmas Palm | <i>Adonidia merillii</i> | 8' | NA | | Fair | 70% | Triple | REMOVE | | |
| 23 | Brazilian Beautyleaf | <i>Calophyllum brasiliense</i> | 20' | 25' | 24" | Poor | 40% | co-dom; cavities | REMOVE | | |
| 24 | Brazilian Beautyleaf | <i>Calophyllum brasiliense</i> | 15' | 25' | 32" | Poor | 40% | co-dom; cavities | REMOVE | | |

| Tree # | Common Name | Scientific Name | Height | Spread | DBH | Health Condition | Health Rating % | Comments | Disposition |
|---|---|---|---|---|---|---|---|---|---|
| 36 | Brazilian Beautyleaf | <i>Calophyllum brasiliense</i> | 15' | 15' | 12" | Poor | 50% | Leaning | REMOVE |
| 52 | Brazilian Beautyleaf | <i>Calophyllum brasiliense</i> | 15' | 20' | 36" | Poor | 40% | Multi-trunk; trunk crack | REMOVE |

| MITIGATION REQUIREMENT: TREES | | | | 7/8/2021 |
|---|---|---|---|---|
| TREES TO BE REMOVED < 50 HEALTH CONDITION = 13 TREES | | | | |

| PROPOSED TREES FOR MITIGATION (USING A TREE PER TREE REPLACEMENT) | | | |
| TOTAL = 13 PITCH APPLE TREE | | | |

| PROPOSED TREES FOR MITIGATION ( USING INCH FOR INCH REPLACEMENT ): | |
| <u>CALIPER OF TREE TO BE REPLACED USING A PAYMENT IN-LIEU</u> | |
| TOTAL = 70" CALIPER ( SEE CODE SEC. 4.6.19 ) \$ 63,300.00 | |
