*Marion*  
*131 NW First Avenue*  
*Delray Beach, Florida 33444*

Physical appearance prior to improvements

**DESCRIPTION OF PHYSICAL APPEARANCE PRIOR TO IMPROVEMENTS**

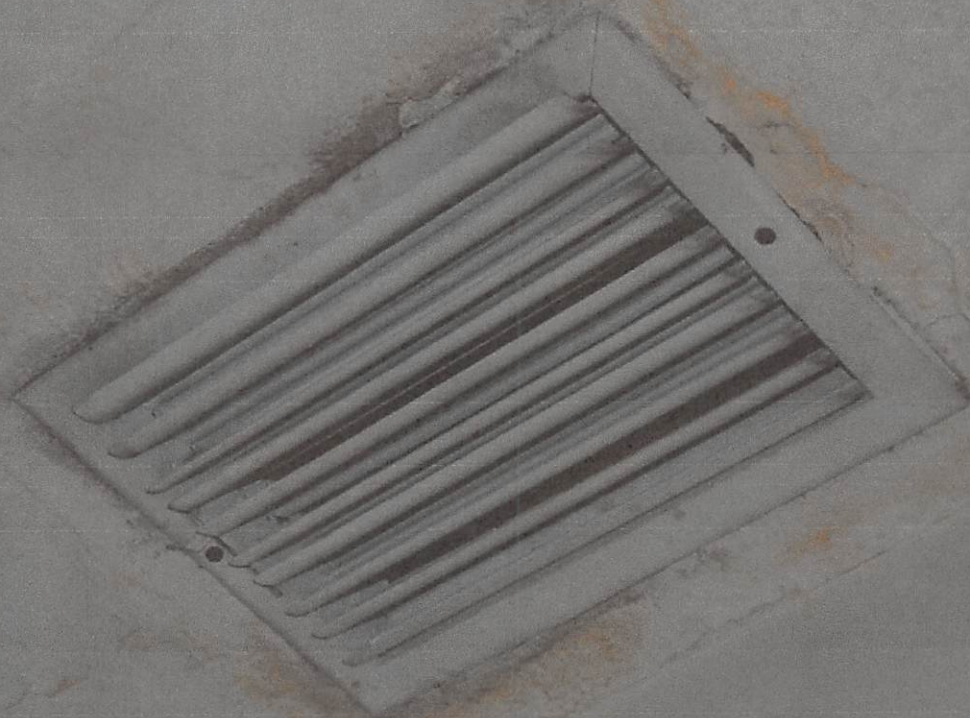
Inside of house air vent/ceiling needing repair from water leak. Facing North. May 26, 2020. 131 NW First Avenue, Delray Beach, Florida 33444. Joseph Marion Photo #21.

The rehabilitation which maintained 131's historical features was necessary for the survival of the building. Interior and exterior walls were rotted, as was the roof and ceiling. Windows were leaking and electrical and plumbing required total replacement.

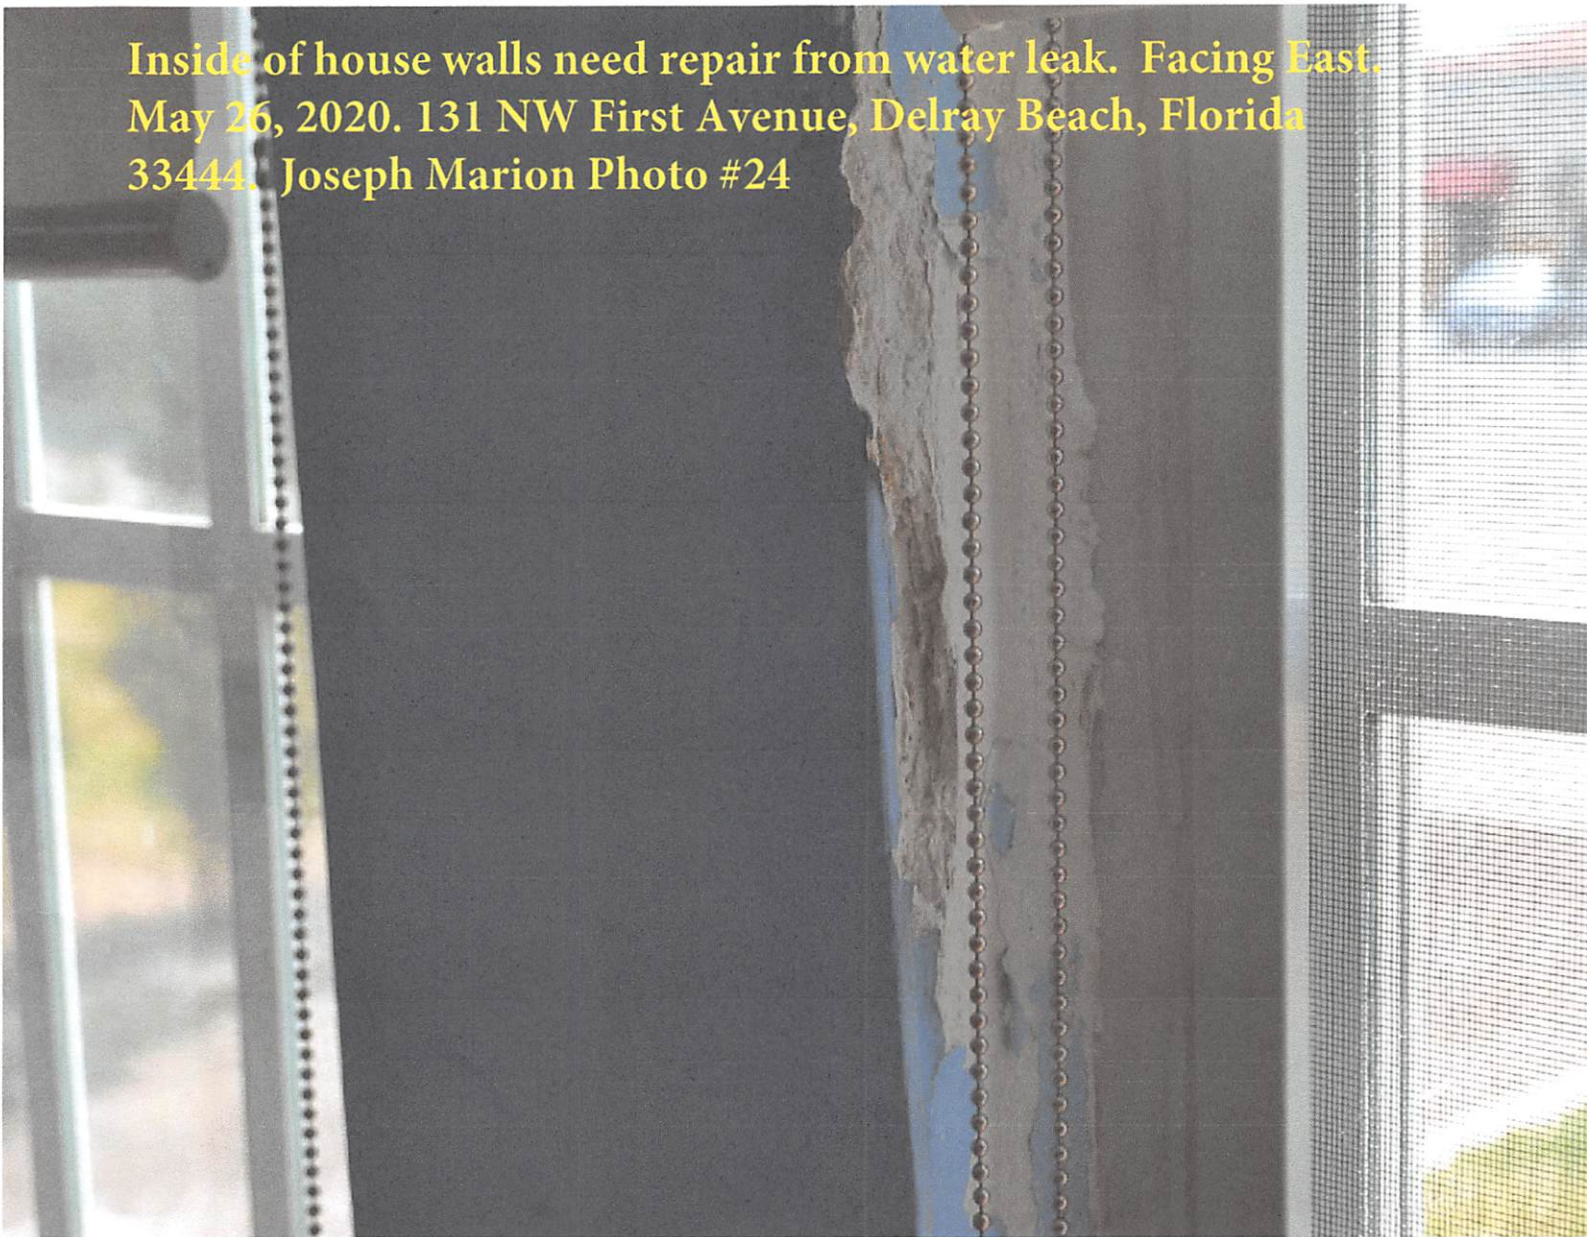
Inside of house walls need repair from water leak. Facing East.  
May 26, 2020. 131 NW First Avenue, Delray Beach, Florida  
33444. Joseph Marion Photo #24

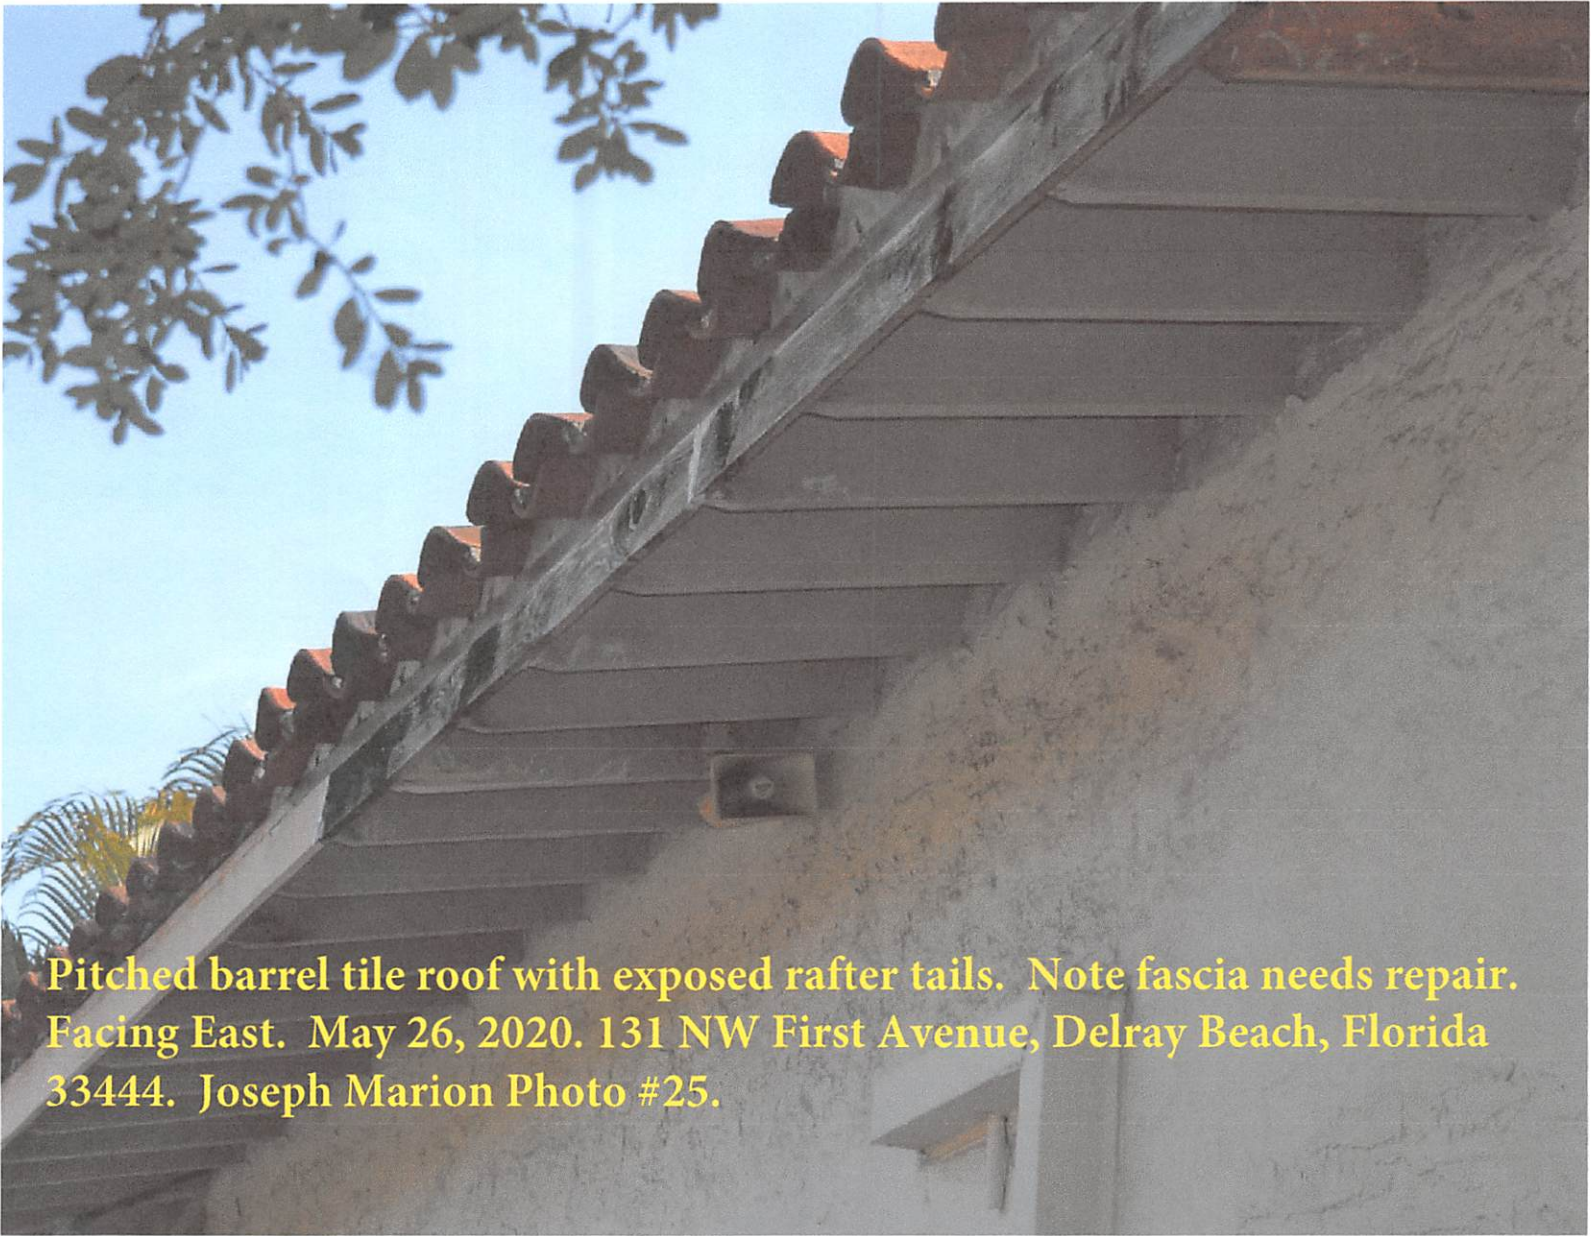
**Pitched barrel tile roof with exposed rafter tails. Note fascia needs repair. Facing East. May 26, 2020. 131 NW First Avenue, Delray Beach, Florida 33444. Joseph Marion Photo #25.**

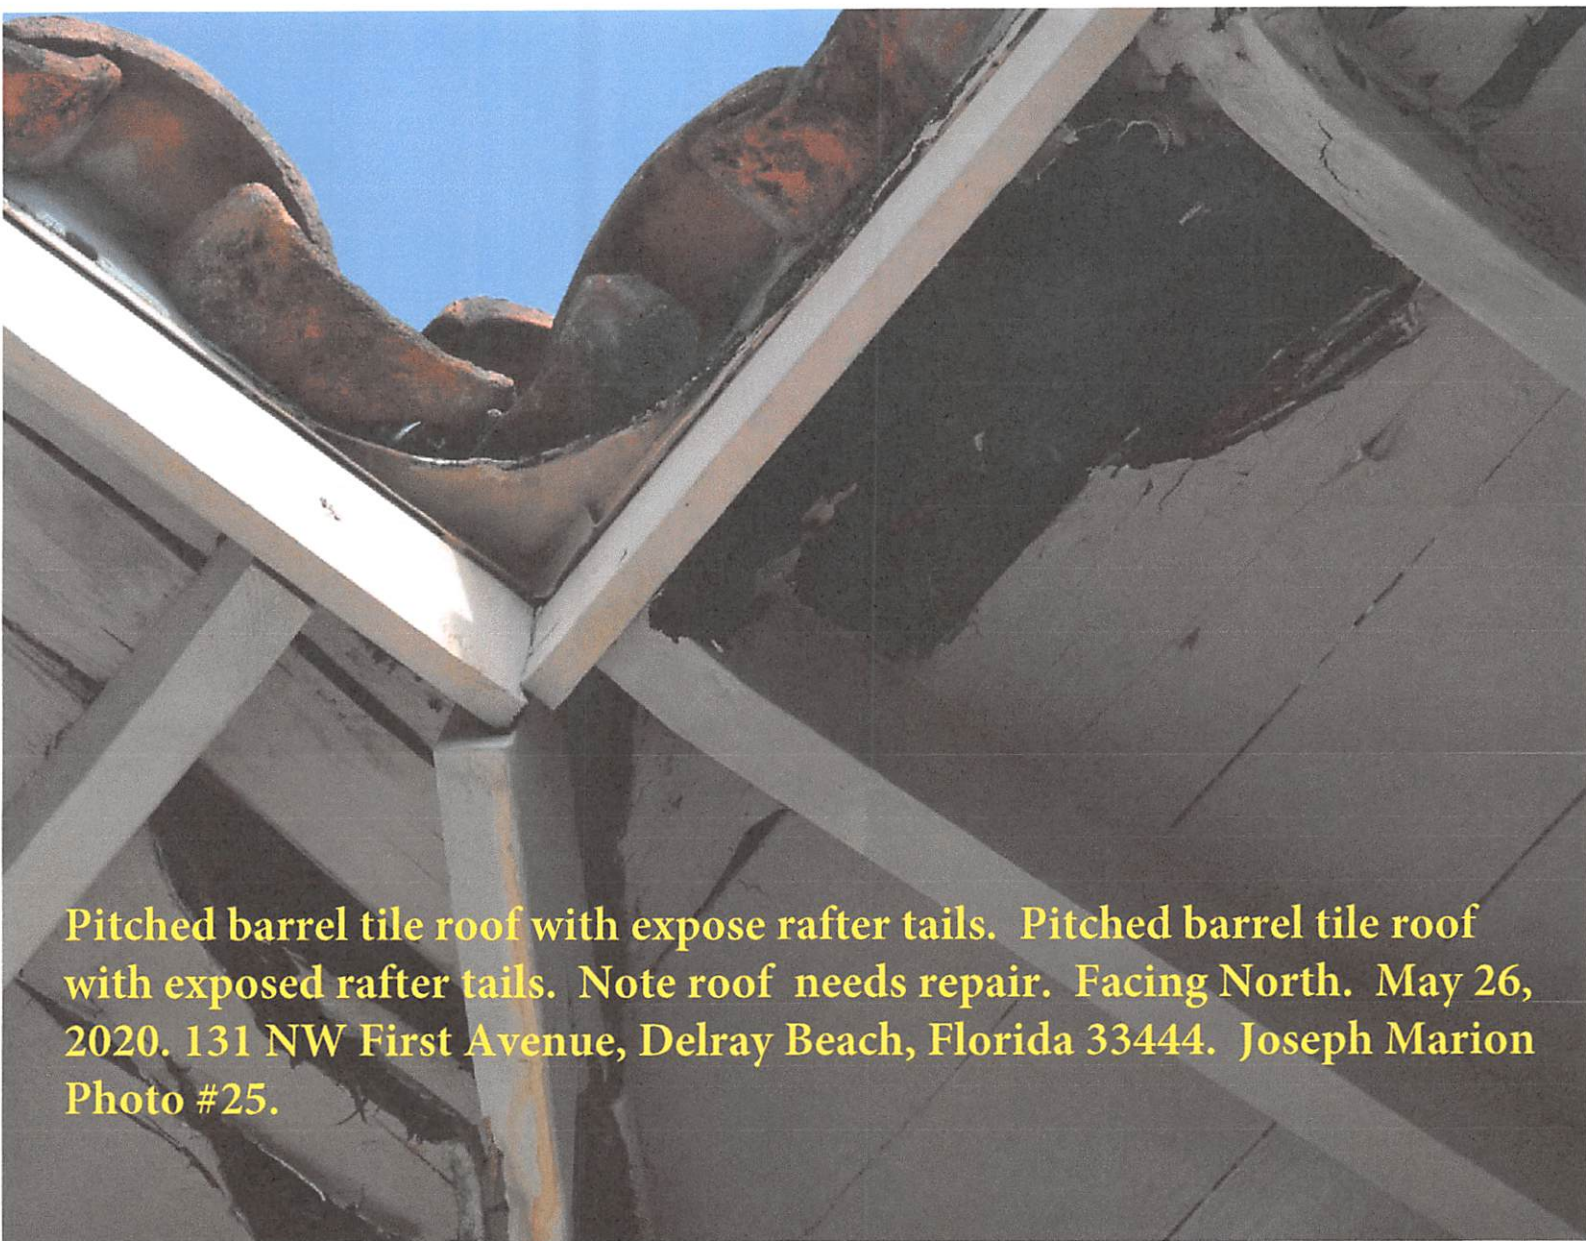
Pitched barrel tile roof with expose rafter tails. Pitched barrel tile roof with exposed rafter tails. Note roof needs repair. Facing North. May 26, 2020. 131 NW First Avenue, Delray Beach, Florida 33444. Joseph Marion Photo #25.

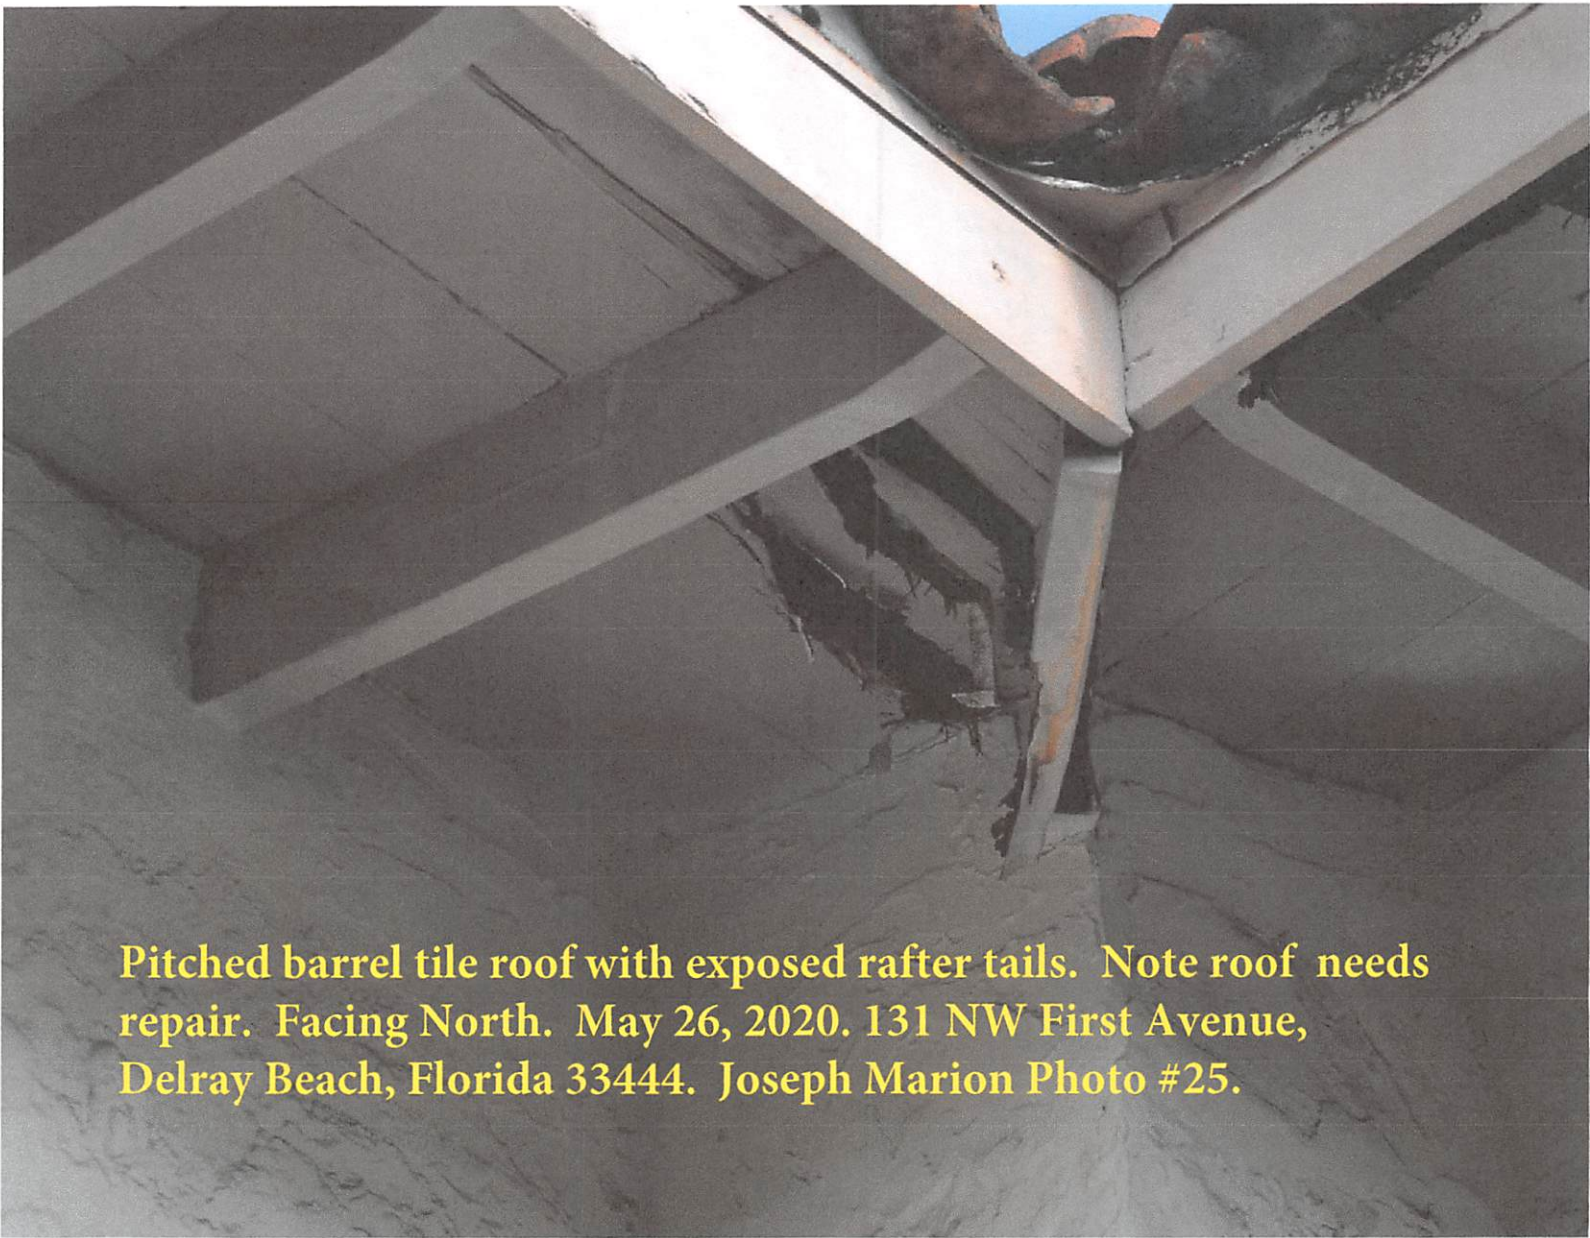
**Pitched barrel tile roof with exposed rafter tails. Note roof needs repair. Facing North. May 26, 2020. 131 NW First Avenue, Delray Beach, Florida 33444. Joseph Marion Photo #25.**

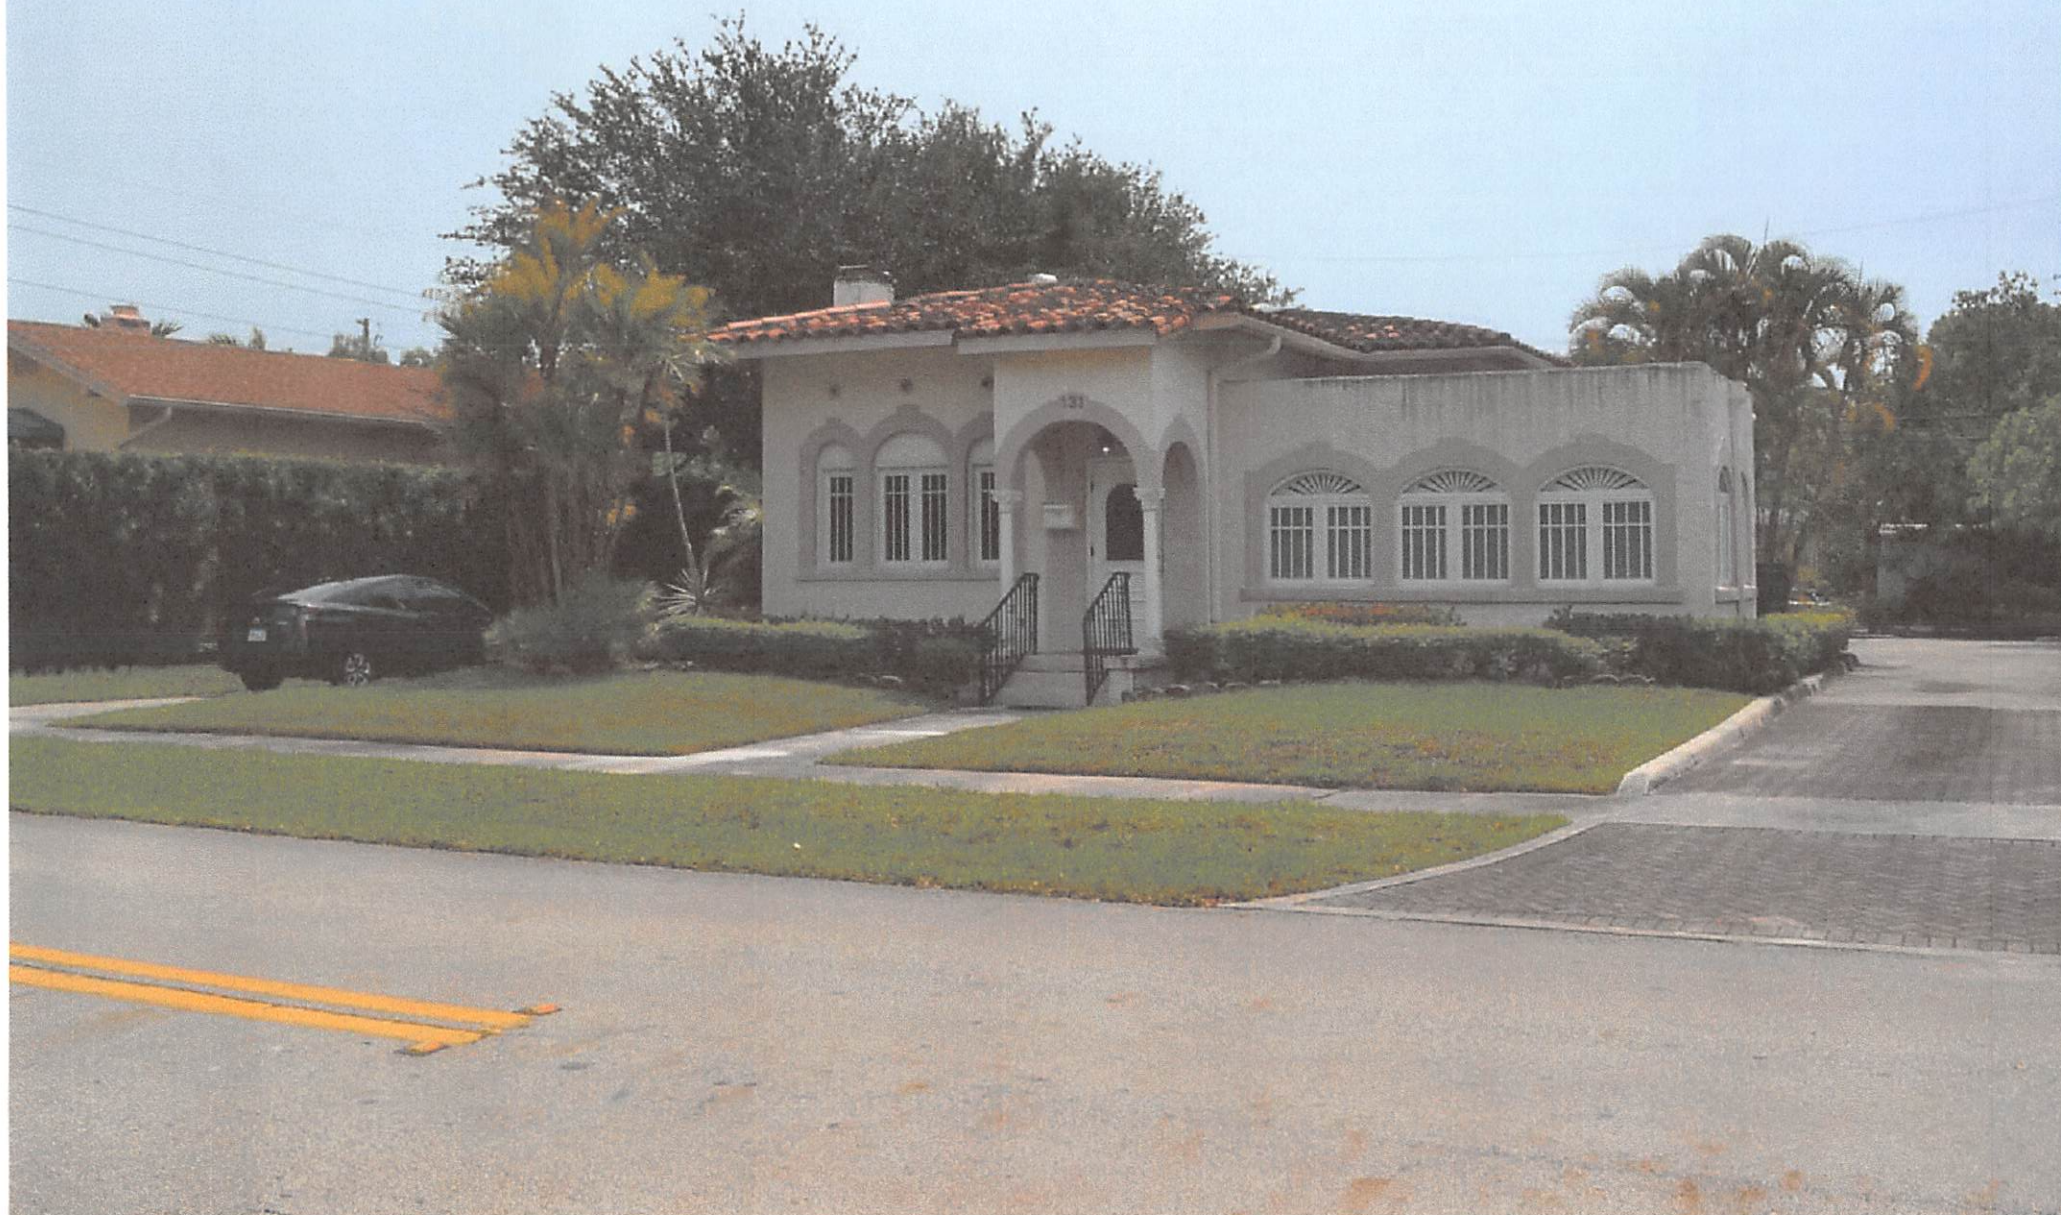
Front of Building picture taken facing East-before

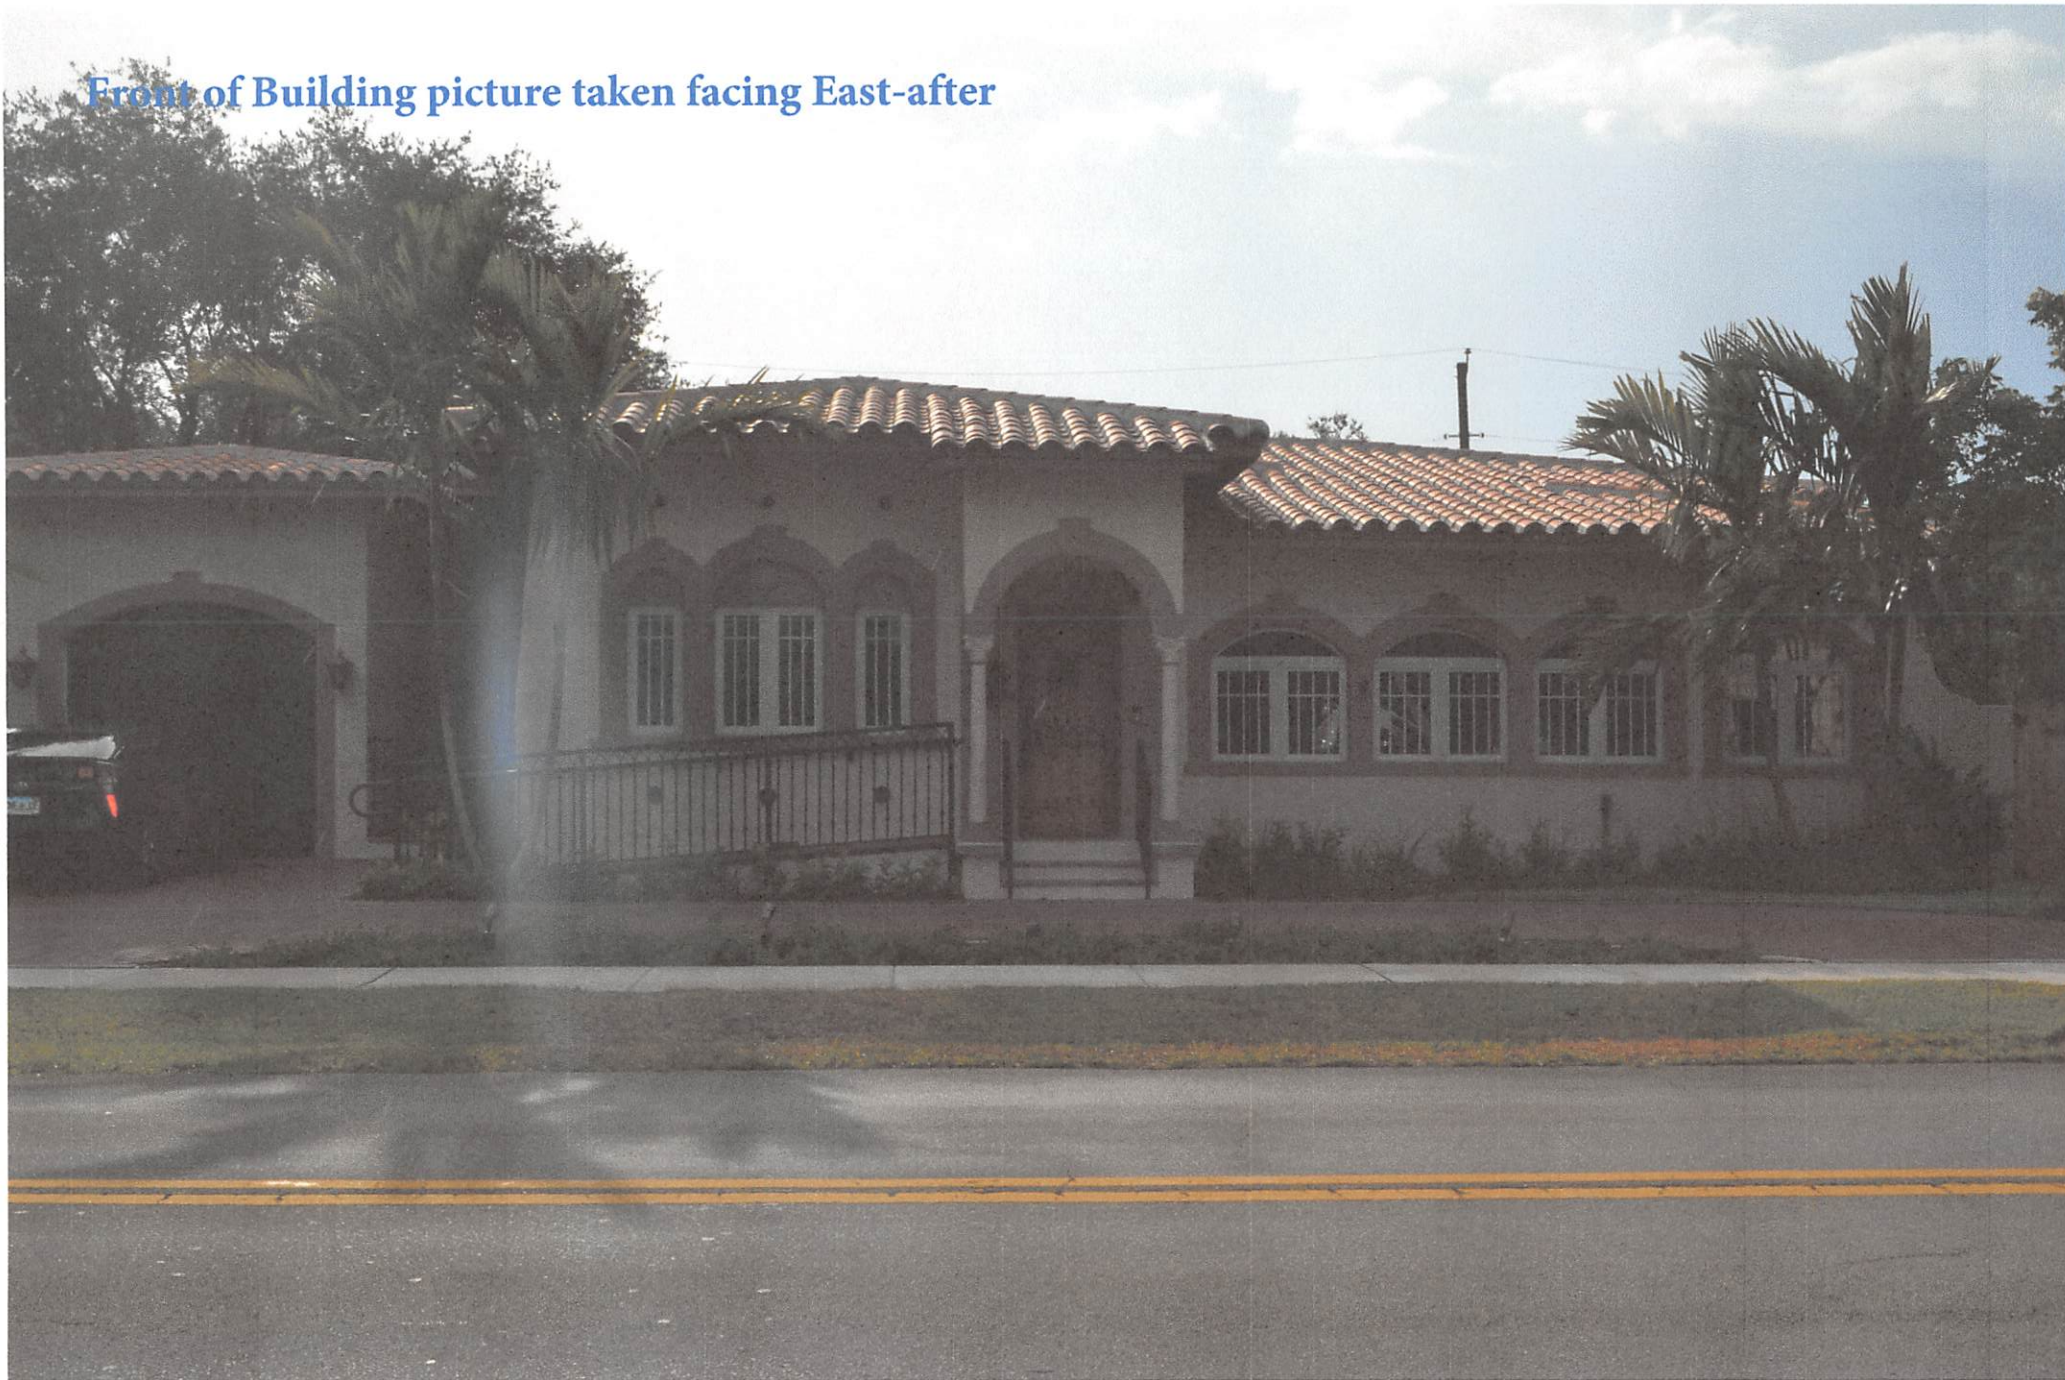
Front of Building picture taken facing East-after

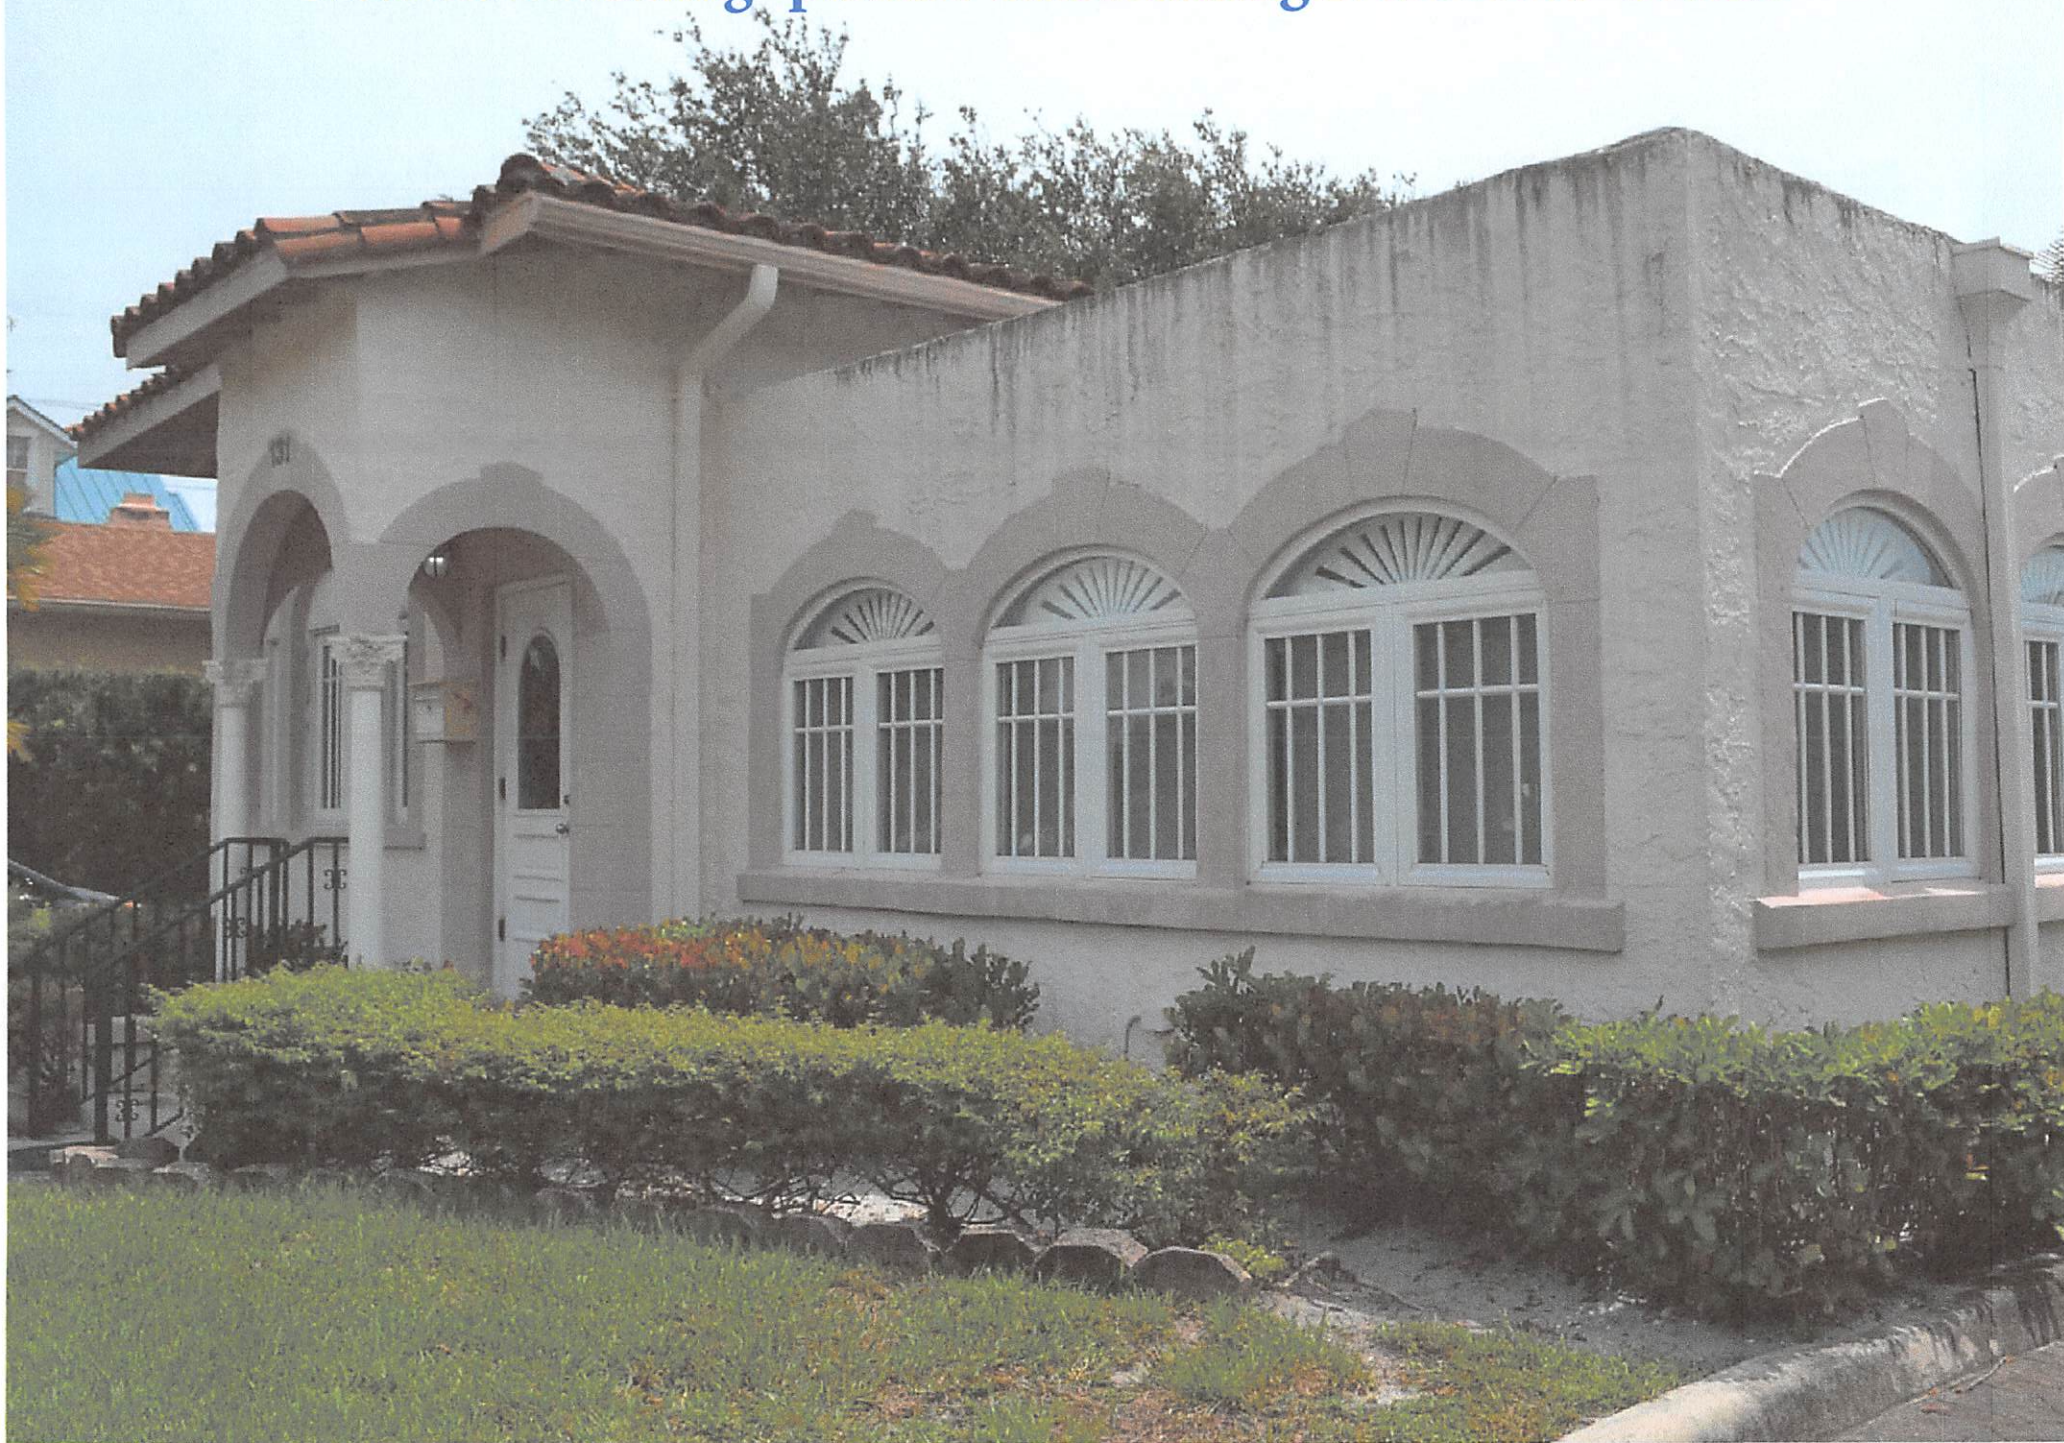
**Front of Building- picture taken facing Northeast- before**

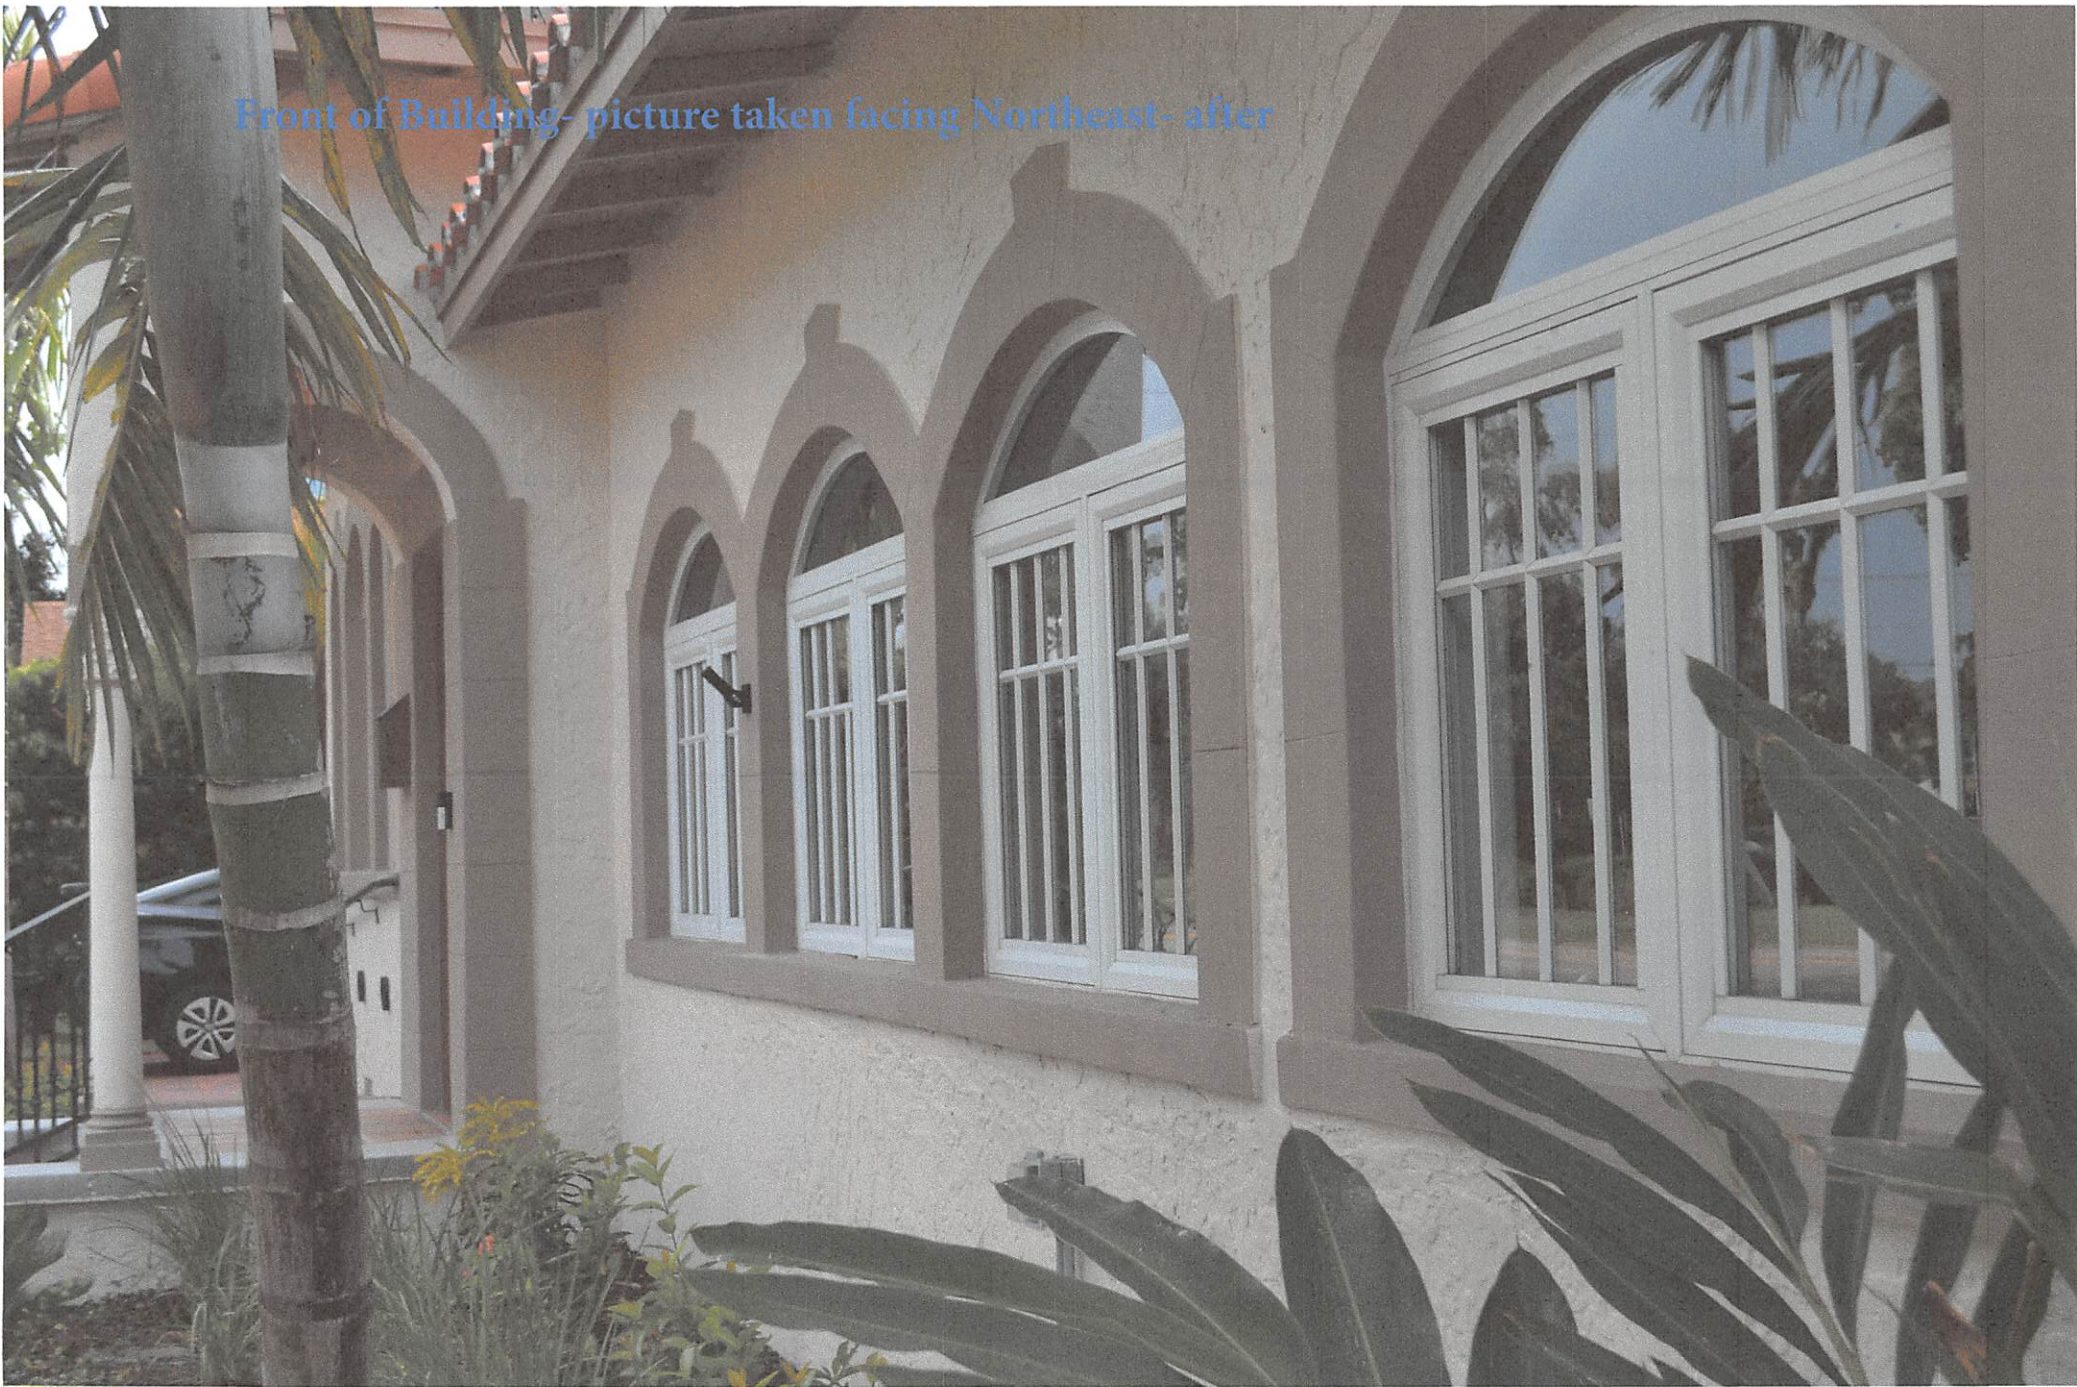
Front of Building- picture taken facing Northeast- after
