*Marion*  
*131 NW First Avenue*  
*Delray Beach, Florida 33444*

Physical appearance prior to improvements

**DESCRIPTION OF PHYSICAL APPEARANCE PRIOR TO IMPROVEMENTS**

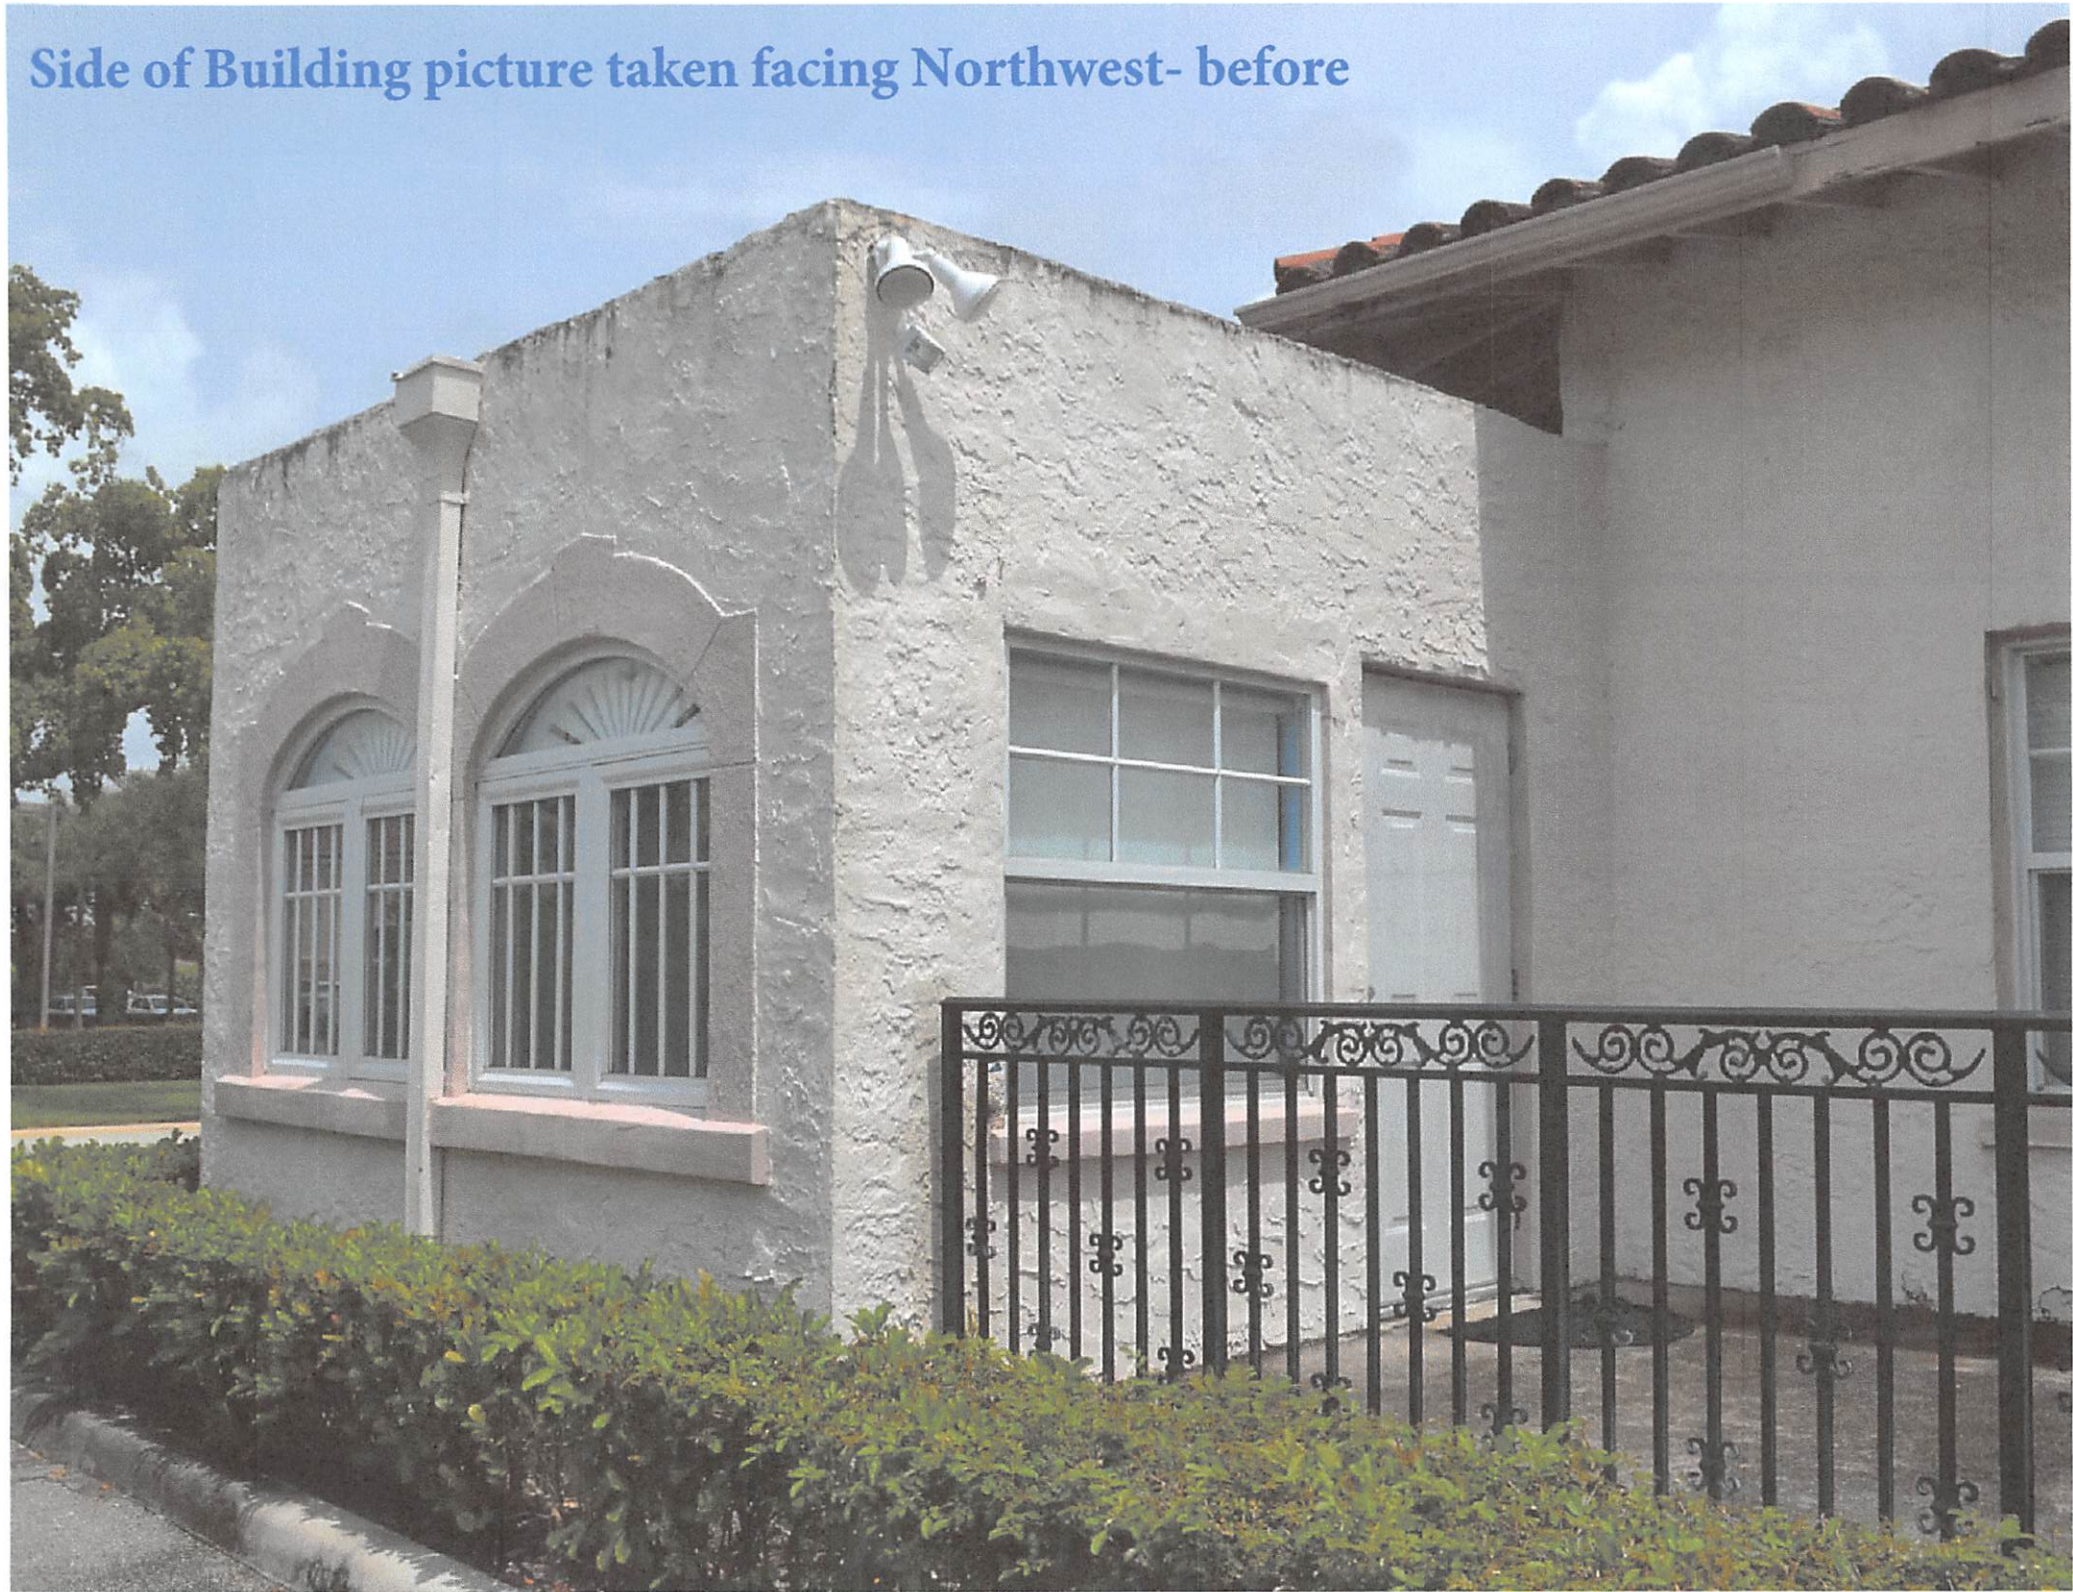
Side of Building picture taken facing Northwest- before

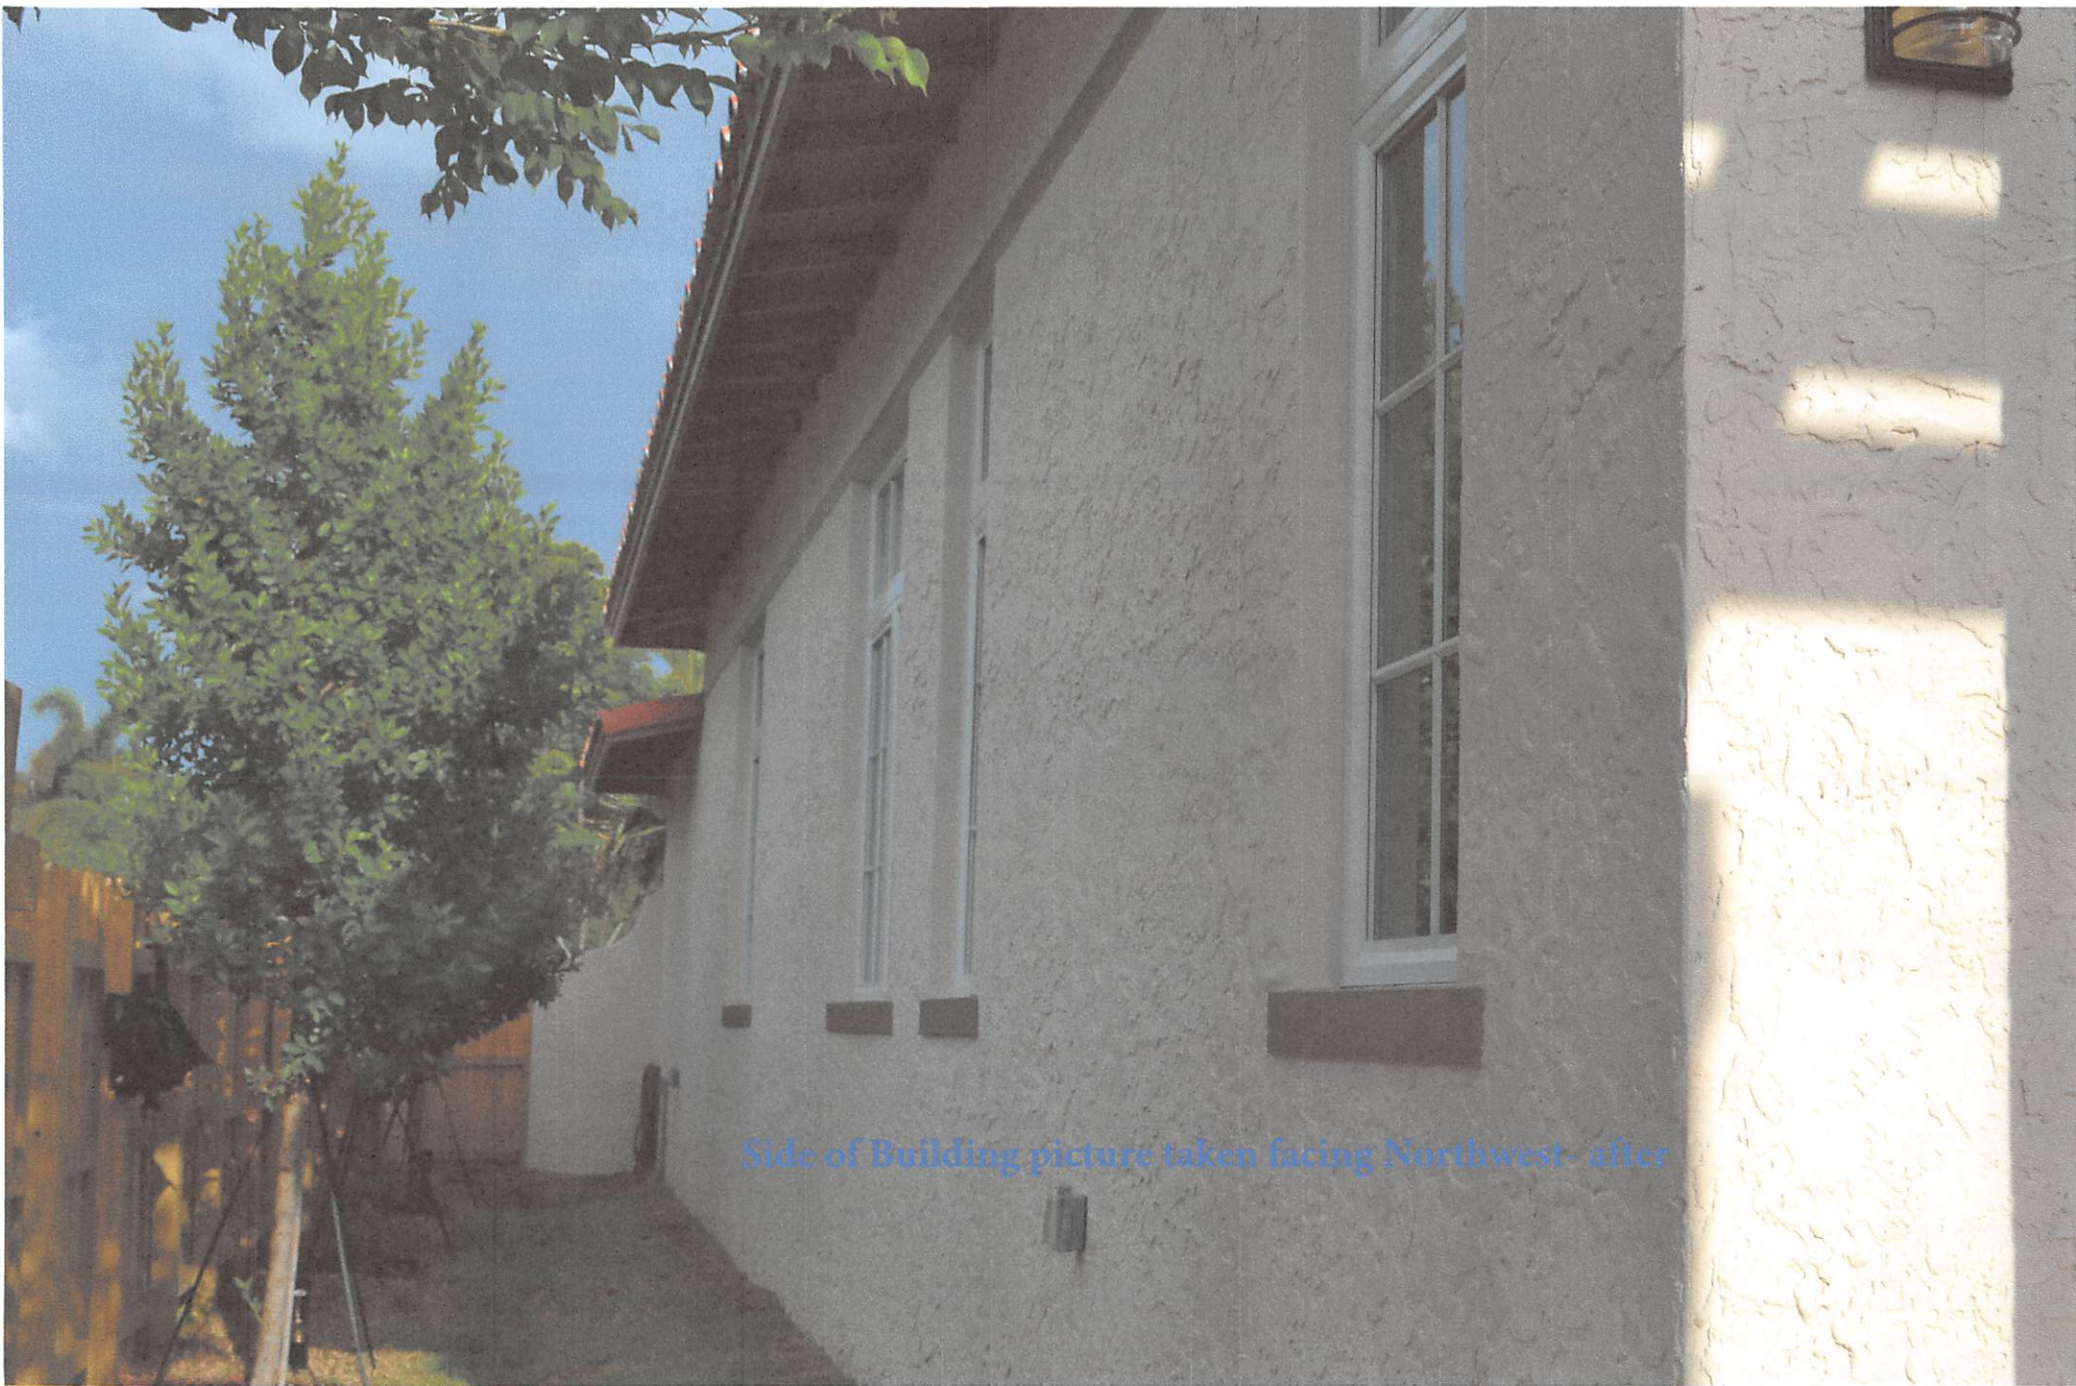
Side of Building picture taken facing Northwest- after

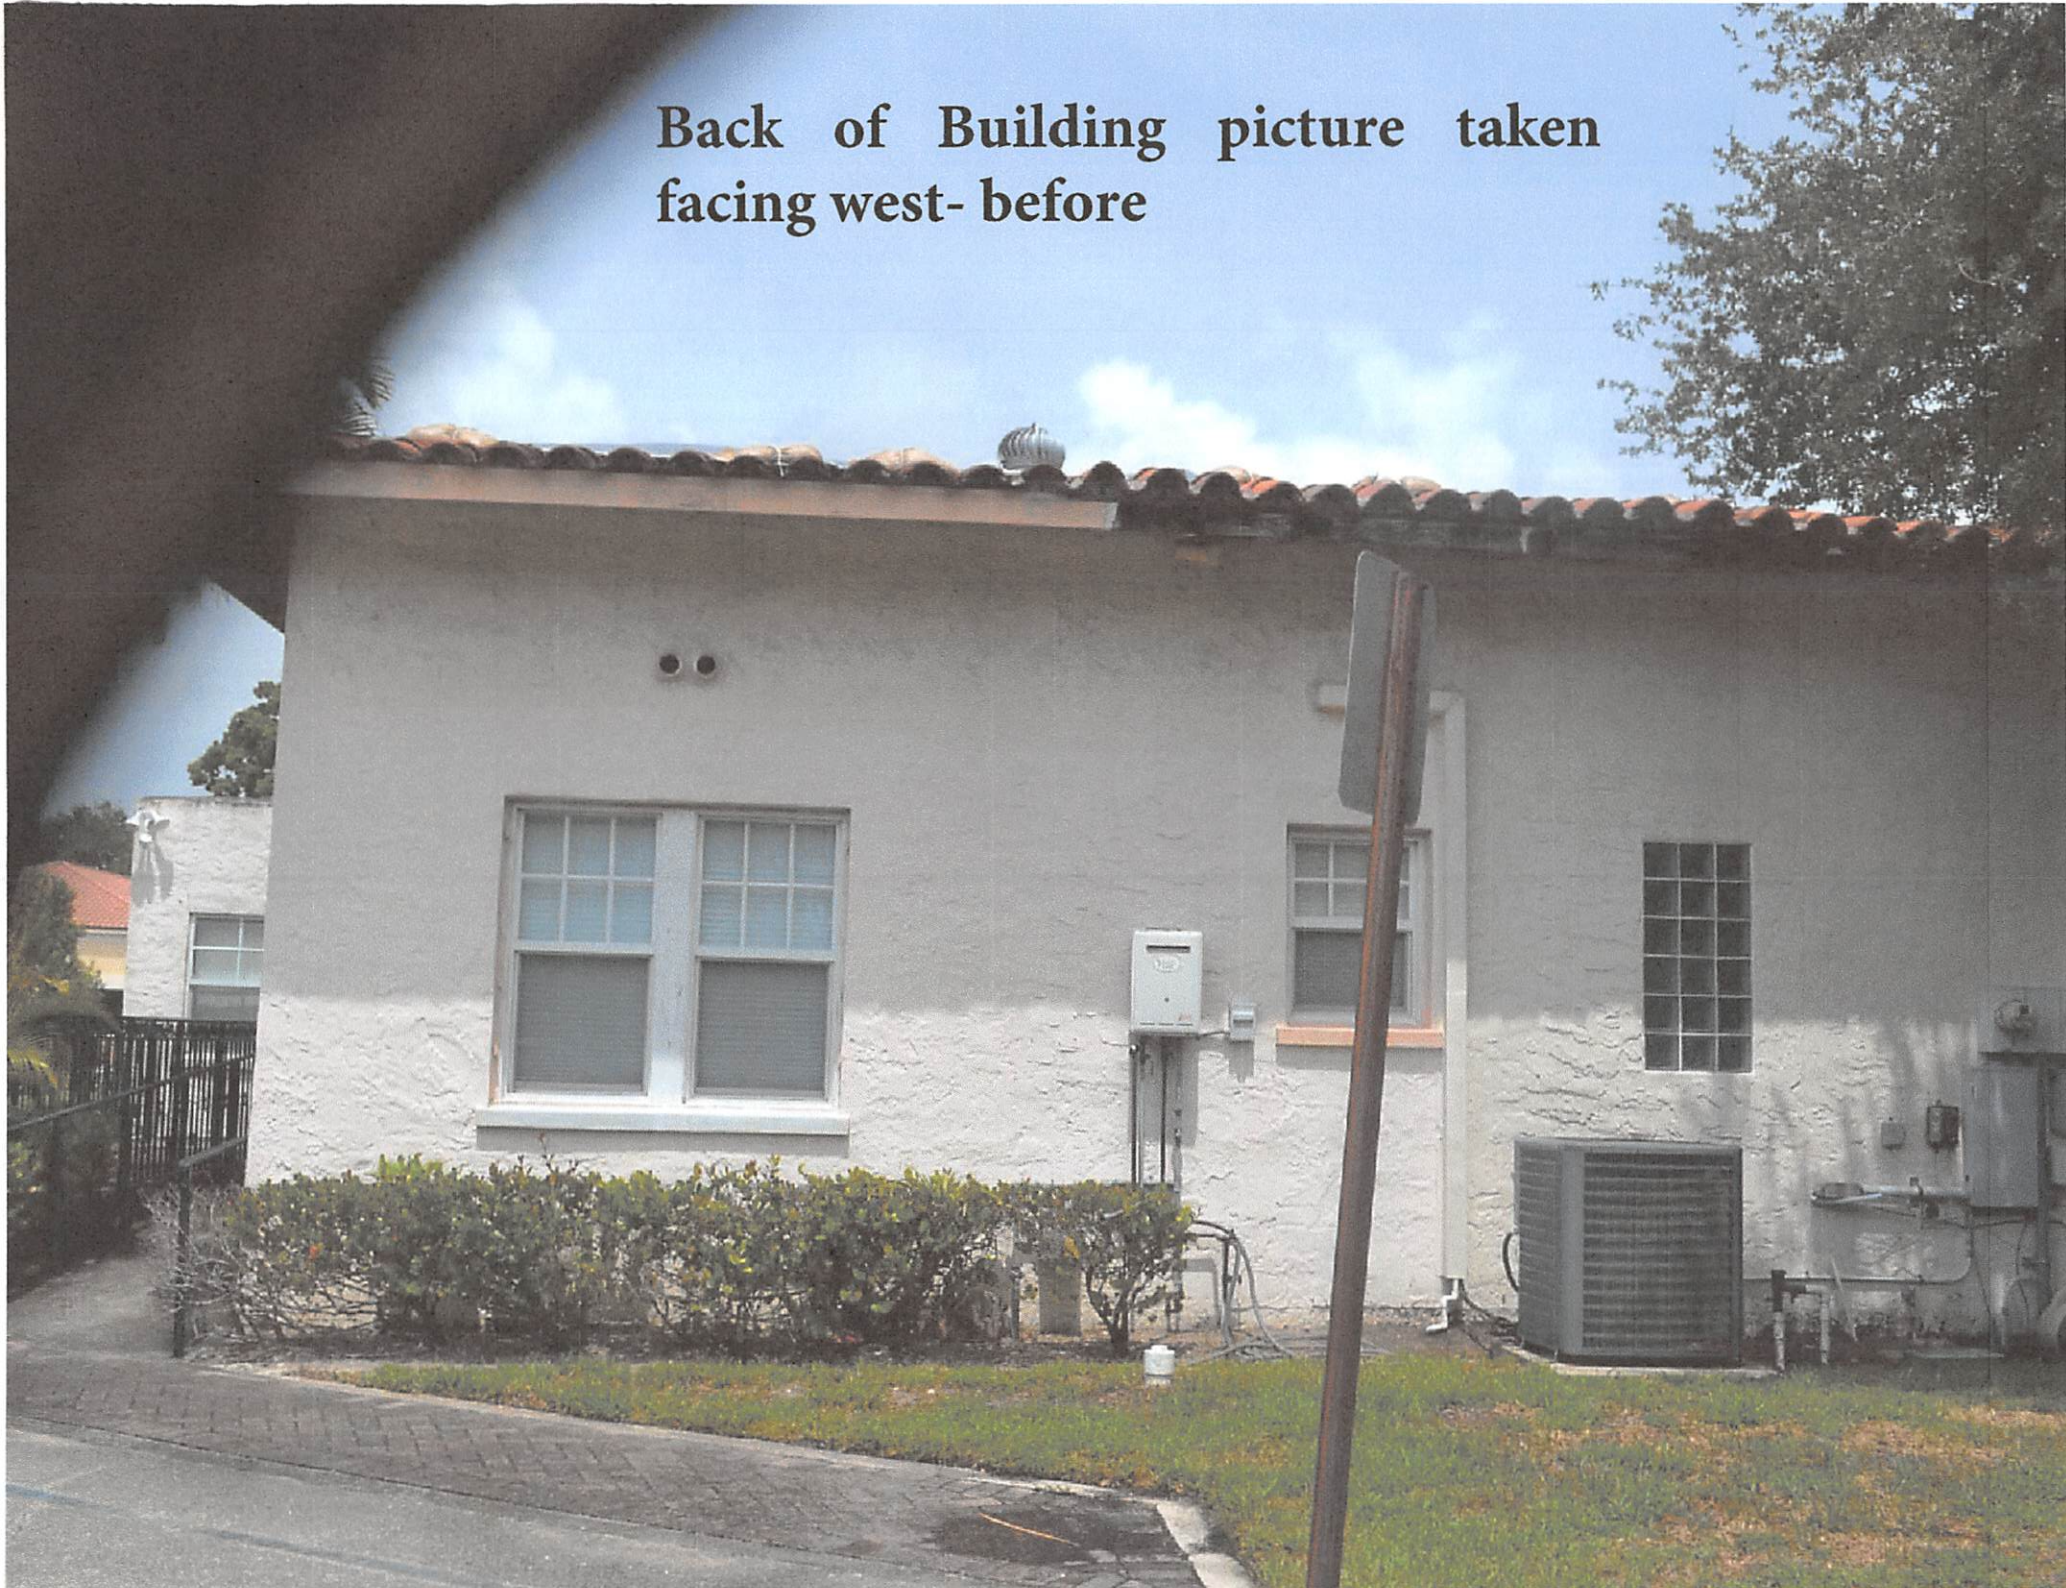
Back of Building picture taken  
facing west- before

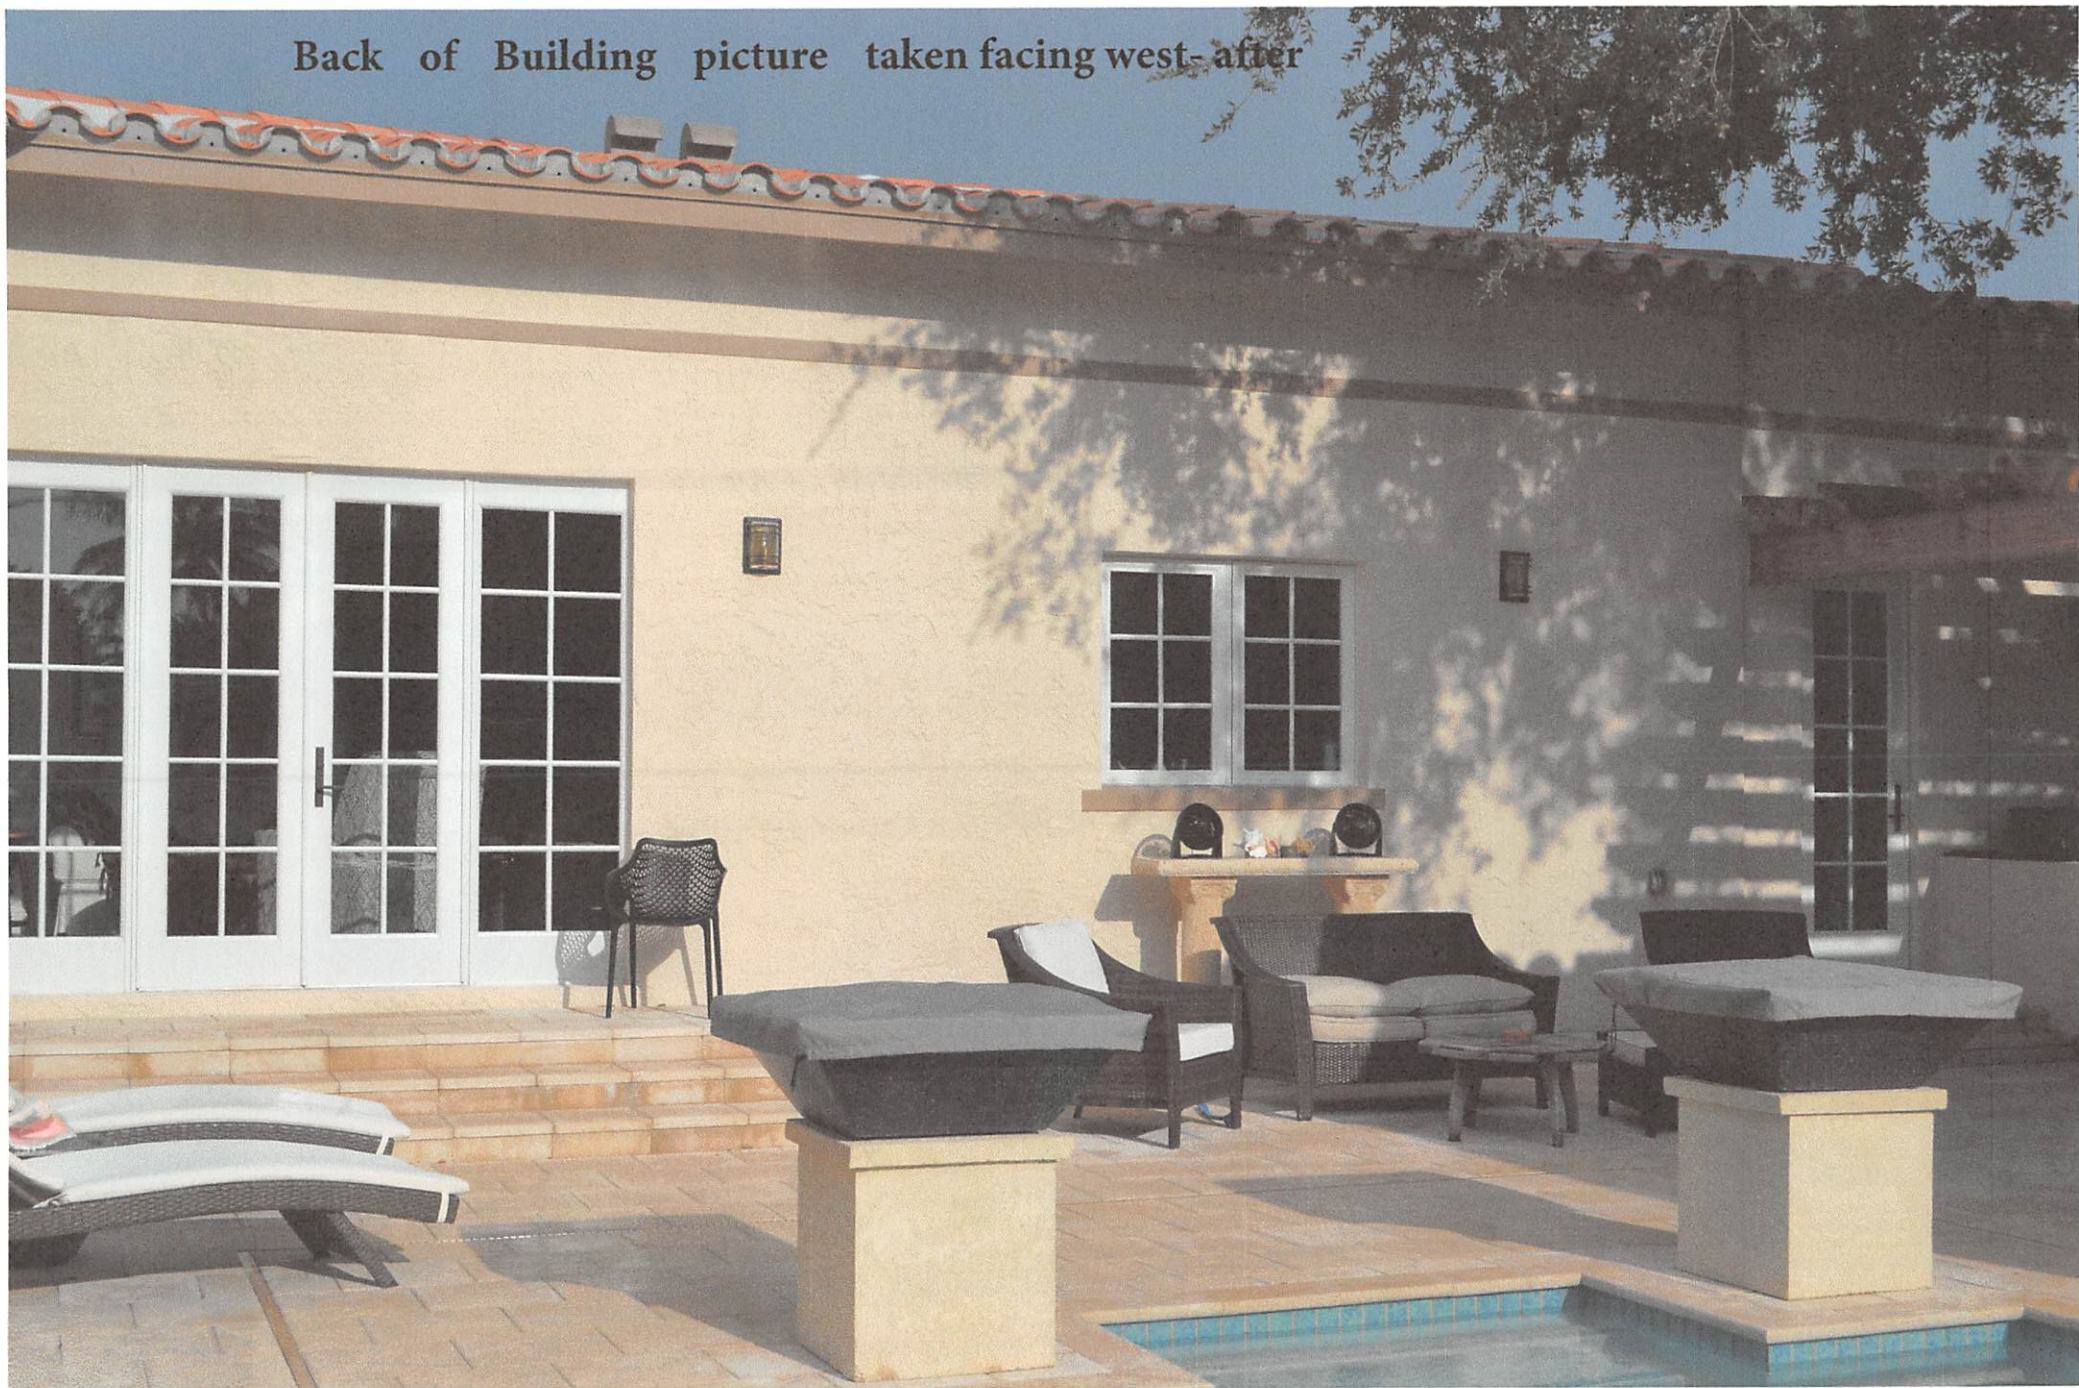
Back of Building picture taken facing west- after

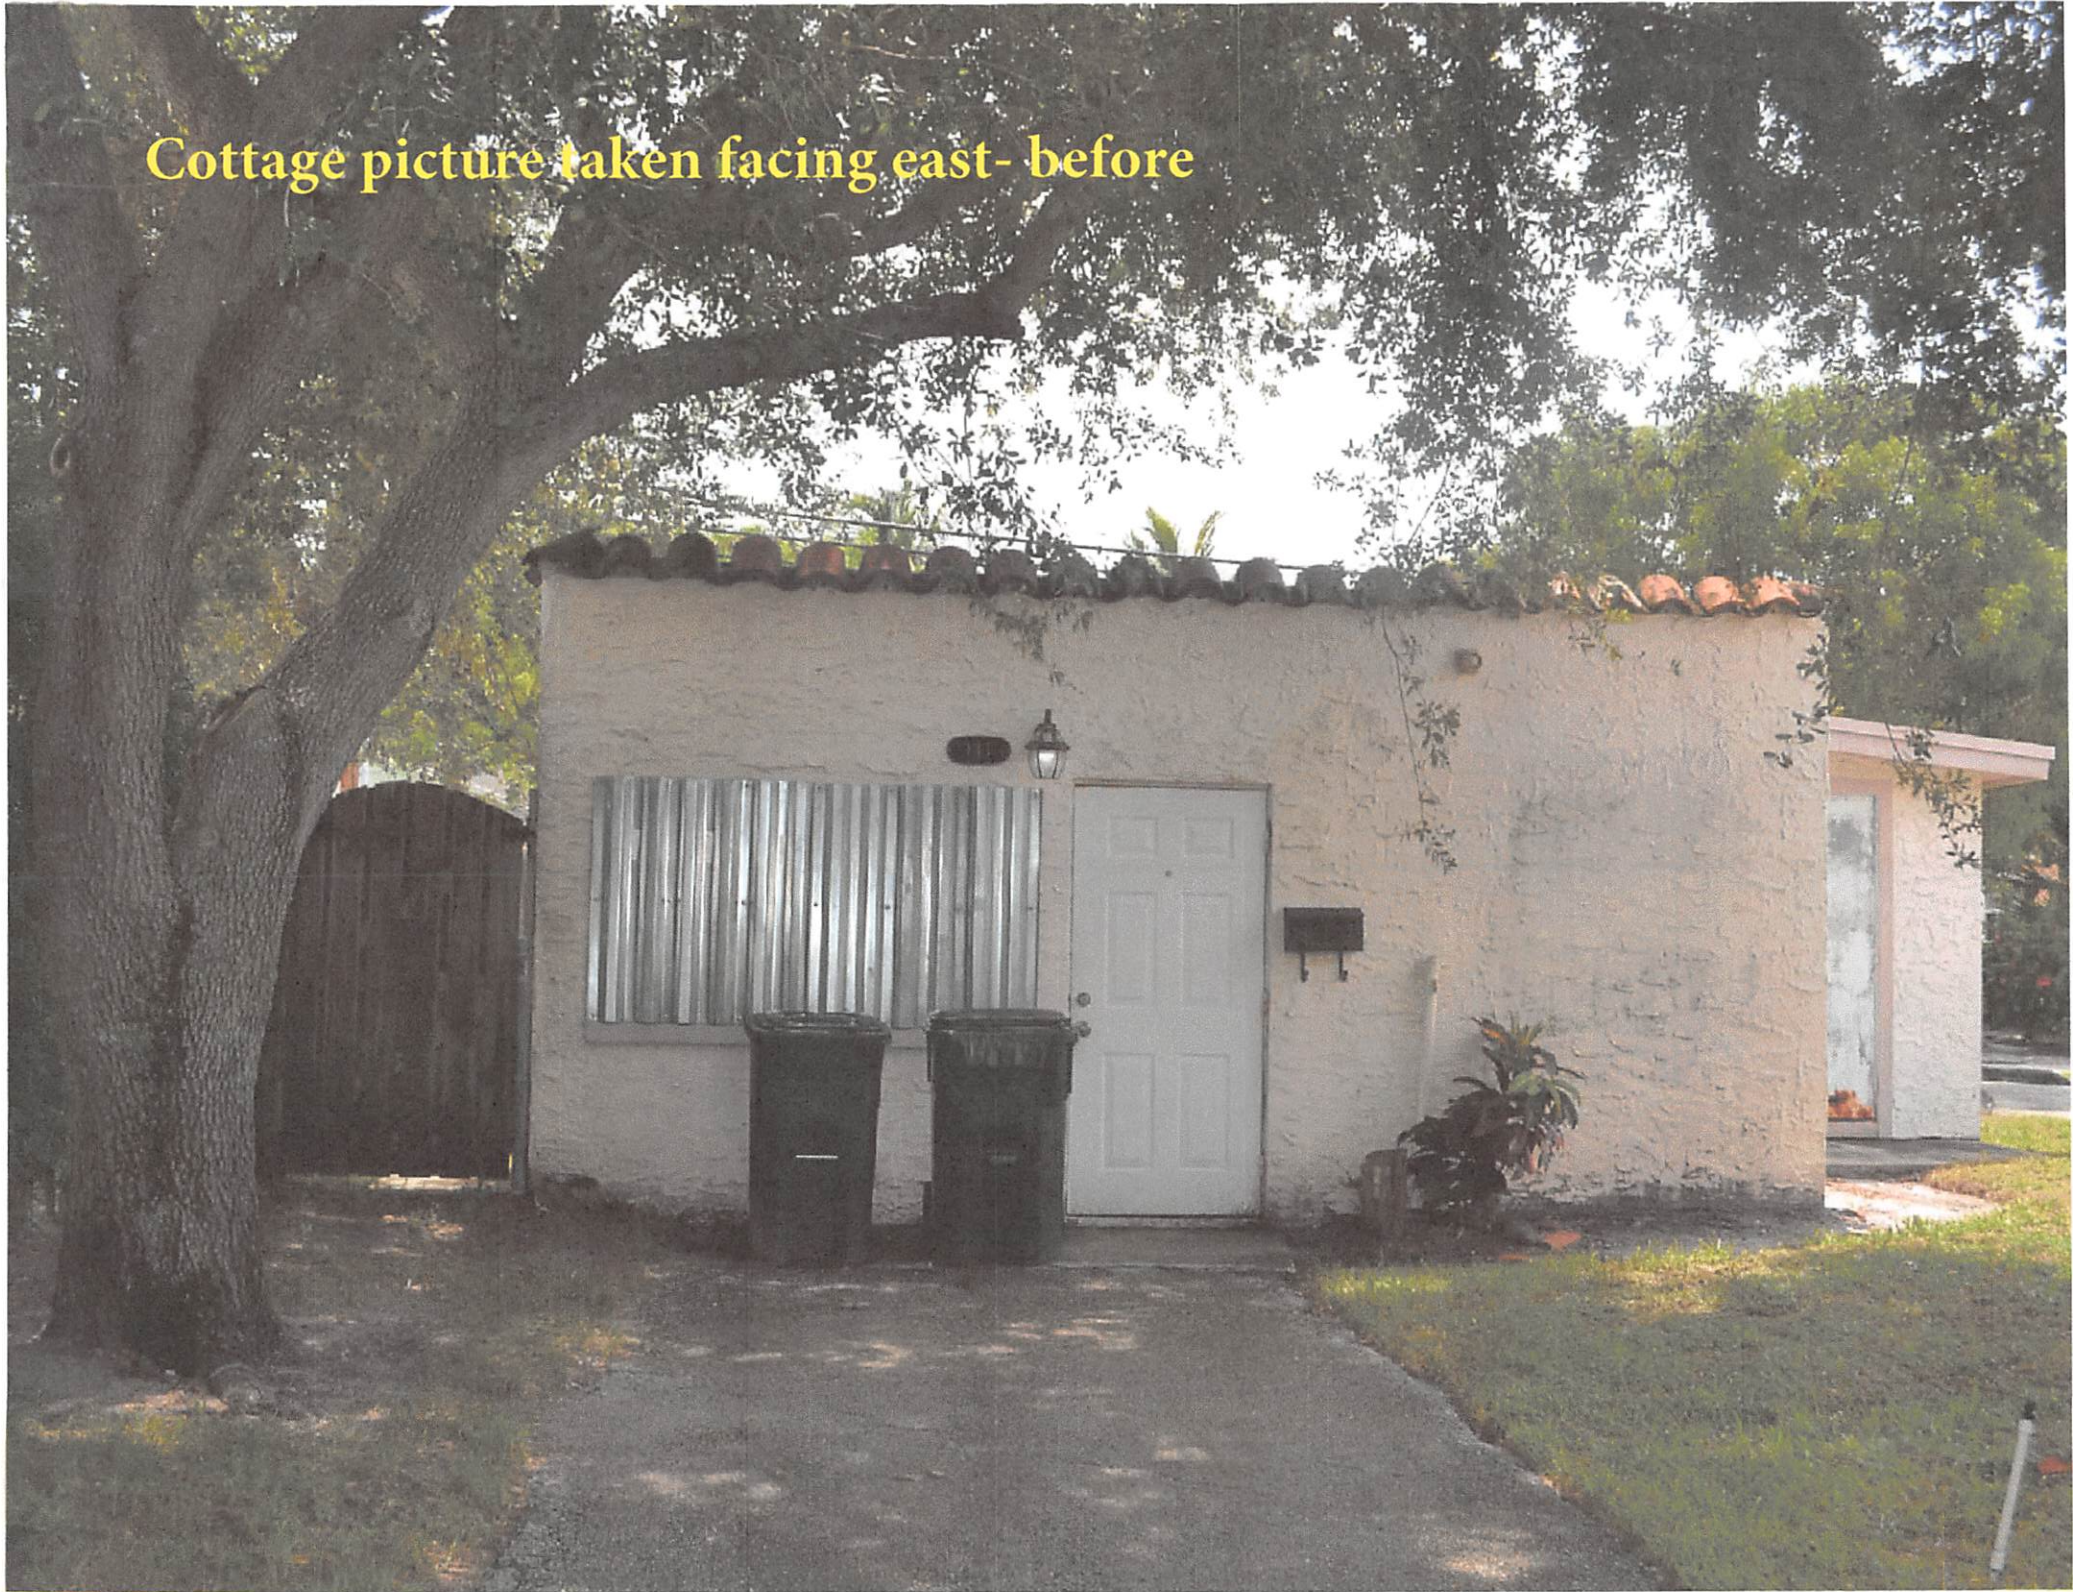
Cottage picture taken facing east- before

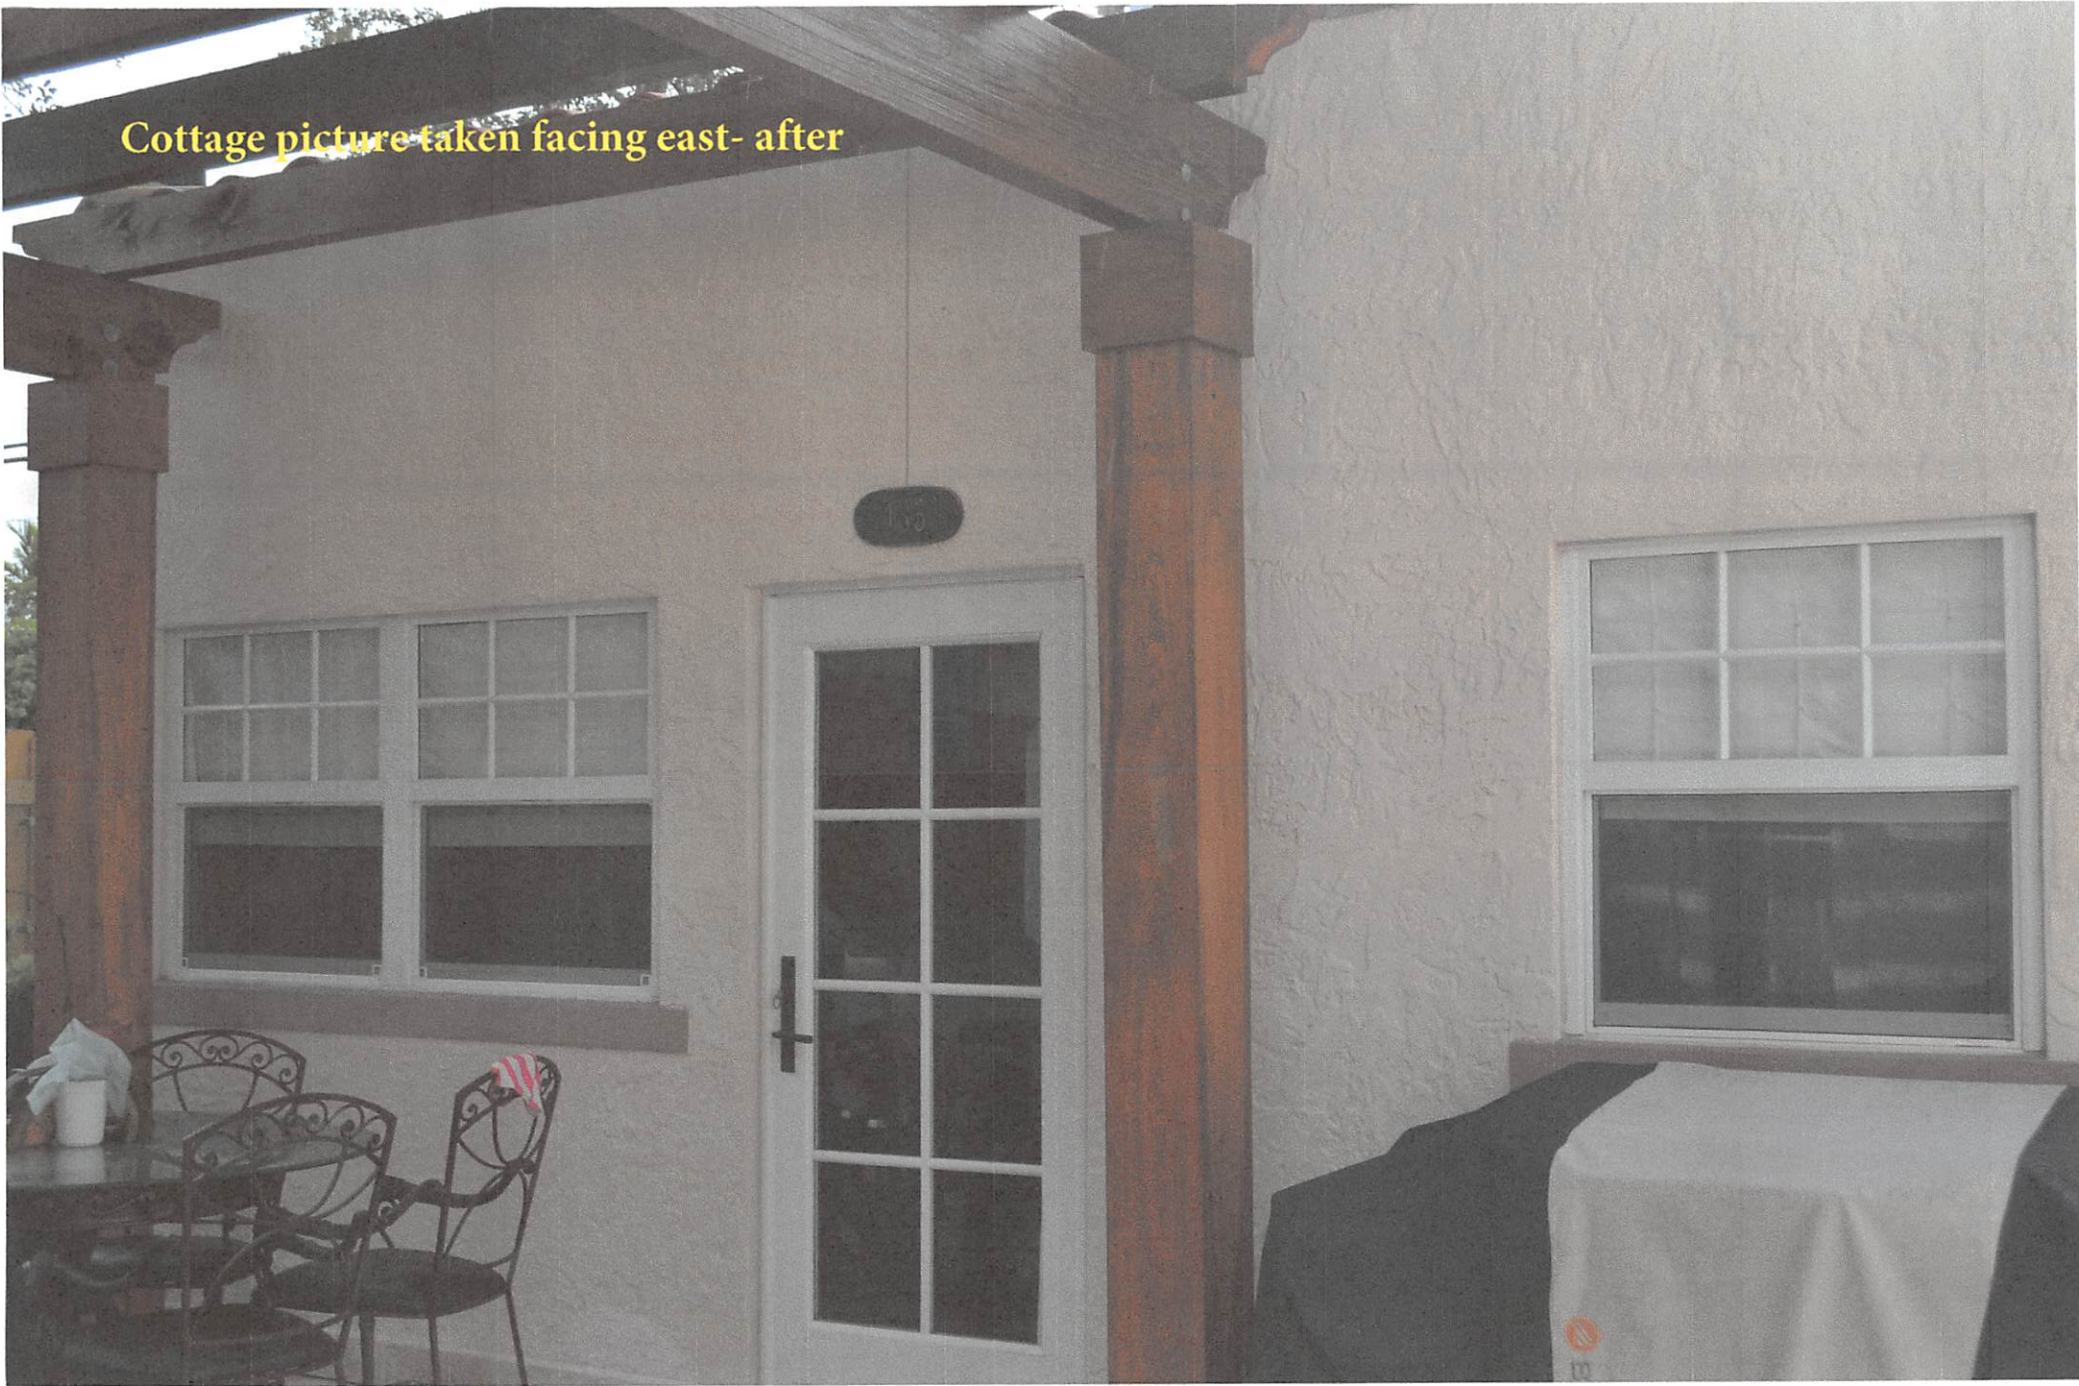
Cottage picture taken facing east- after

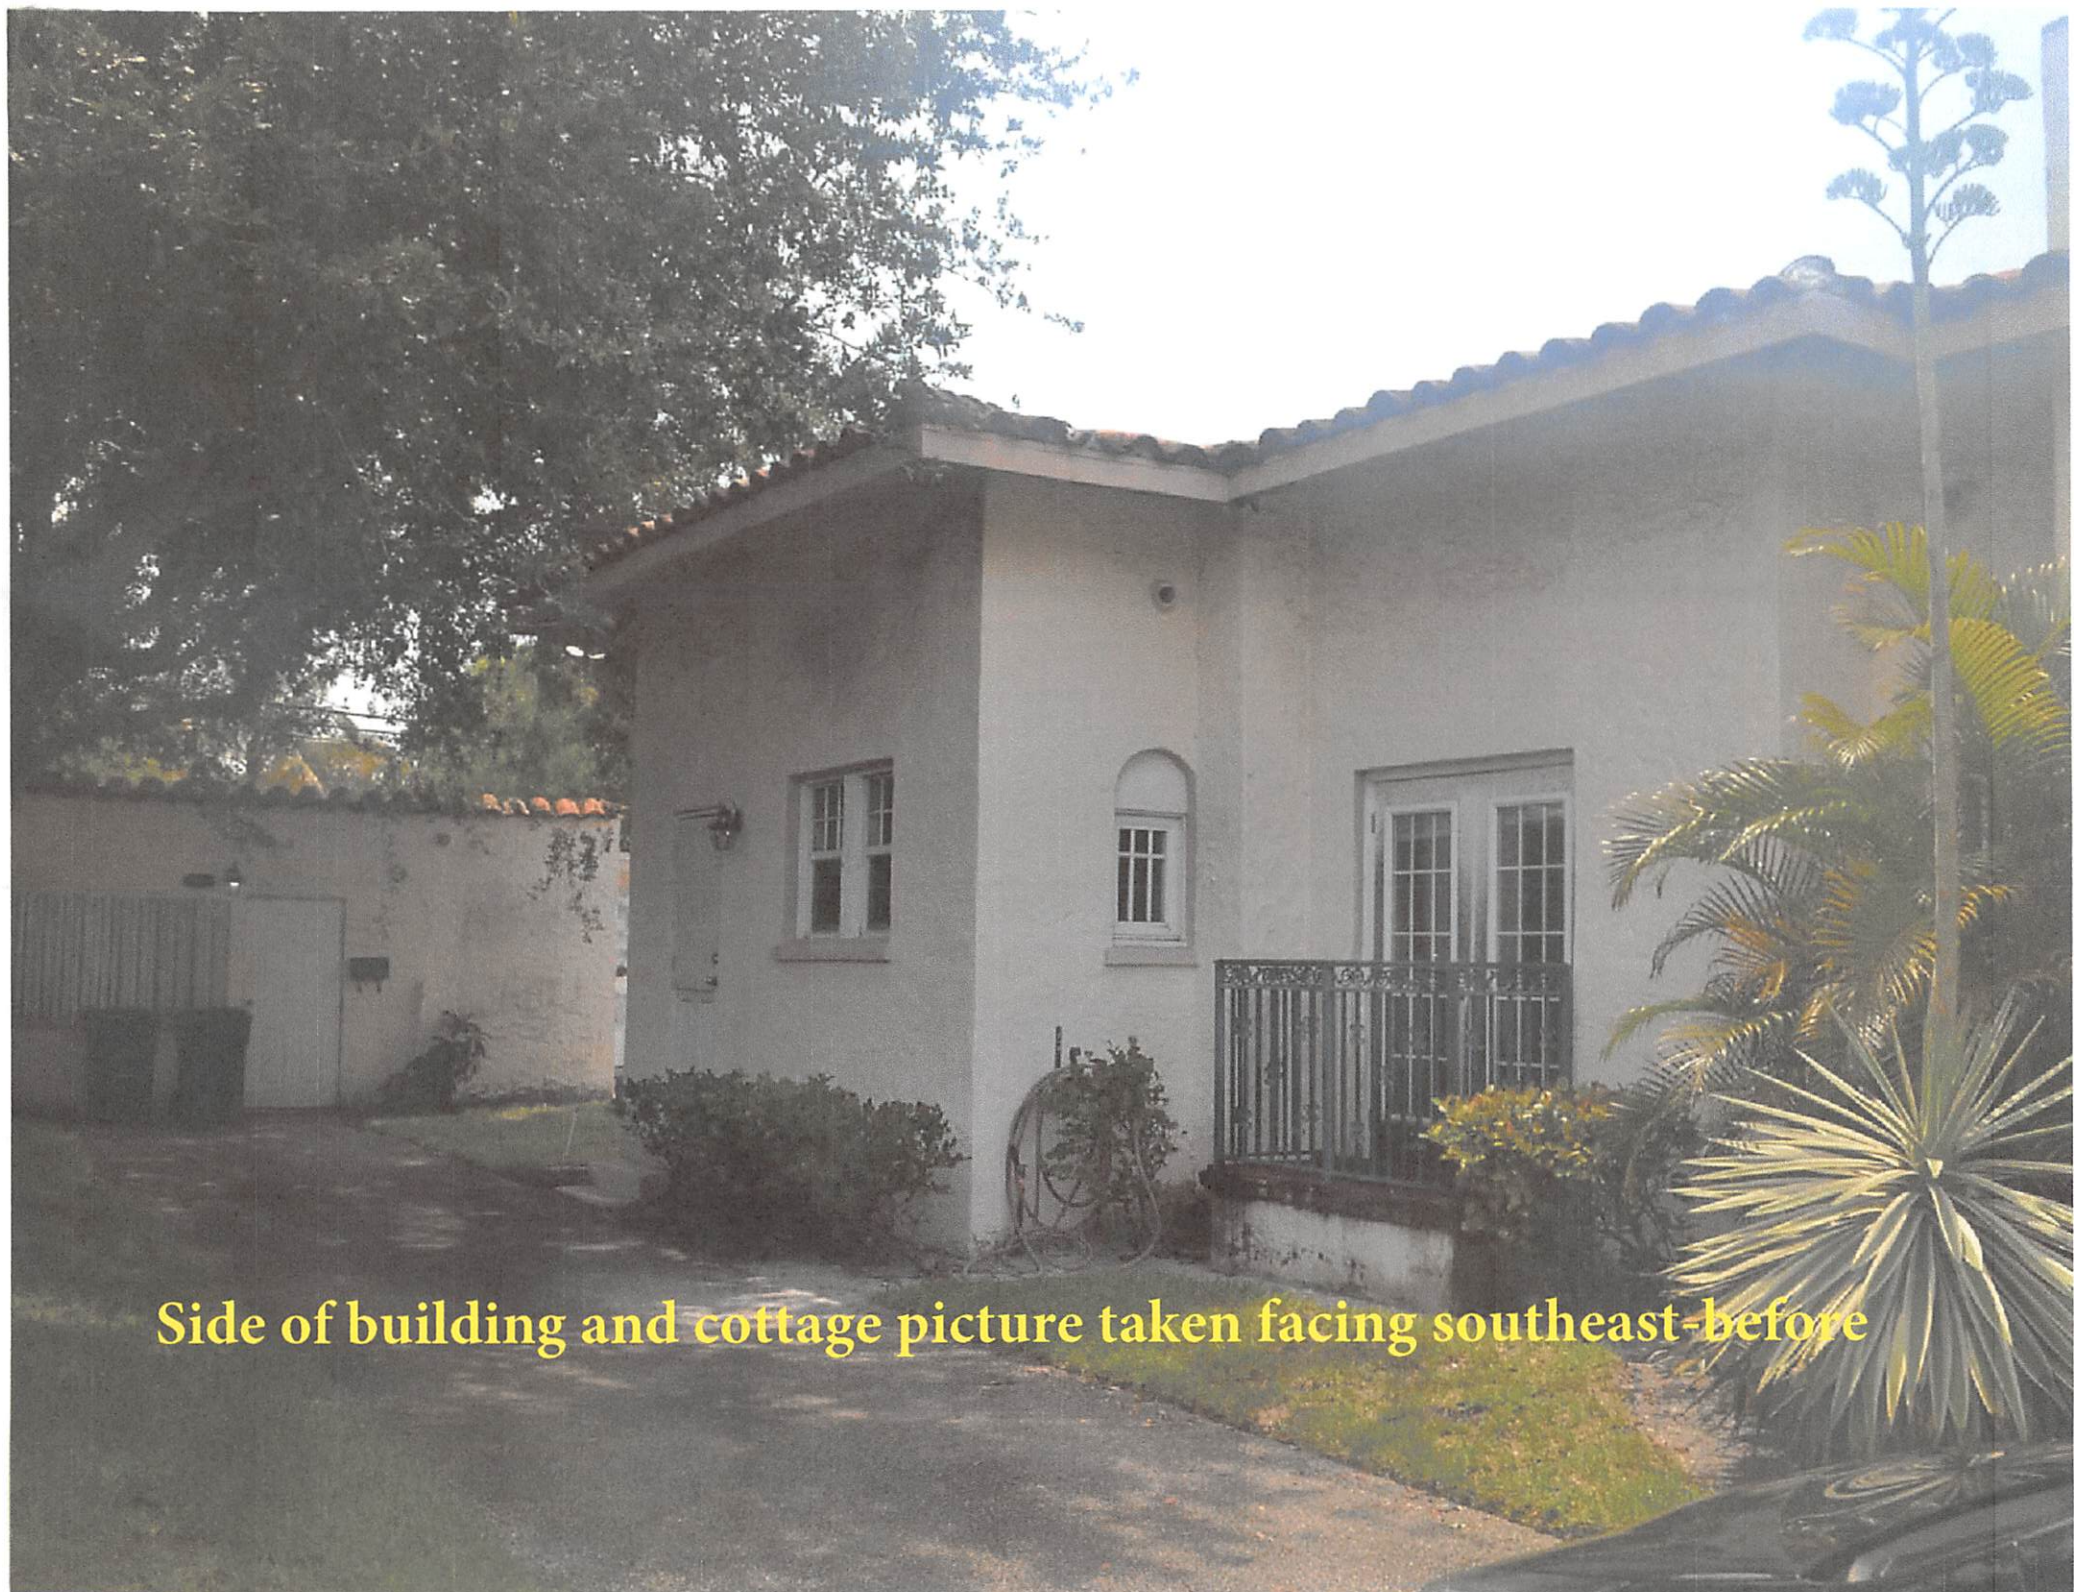
**Side of building and cottage picture taken facing southeast-before**
