*Marion*  
*131 NW First Avenue*  
*Delray Beach, Florida 33444*

Physical appearance prior to improvements

**DESCRIPTION OF PHYSICAL APPEARANCE PRIOR TO IMPROVEMENTS**

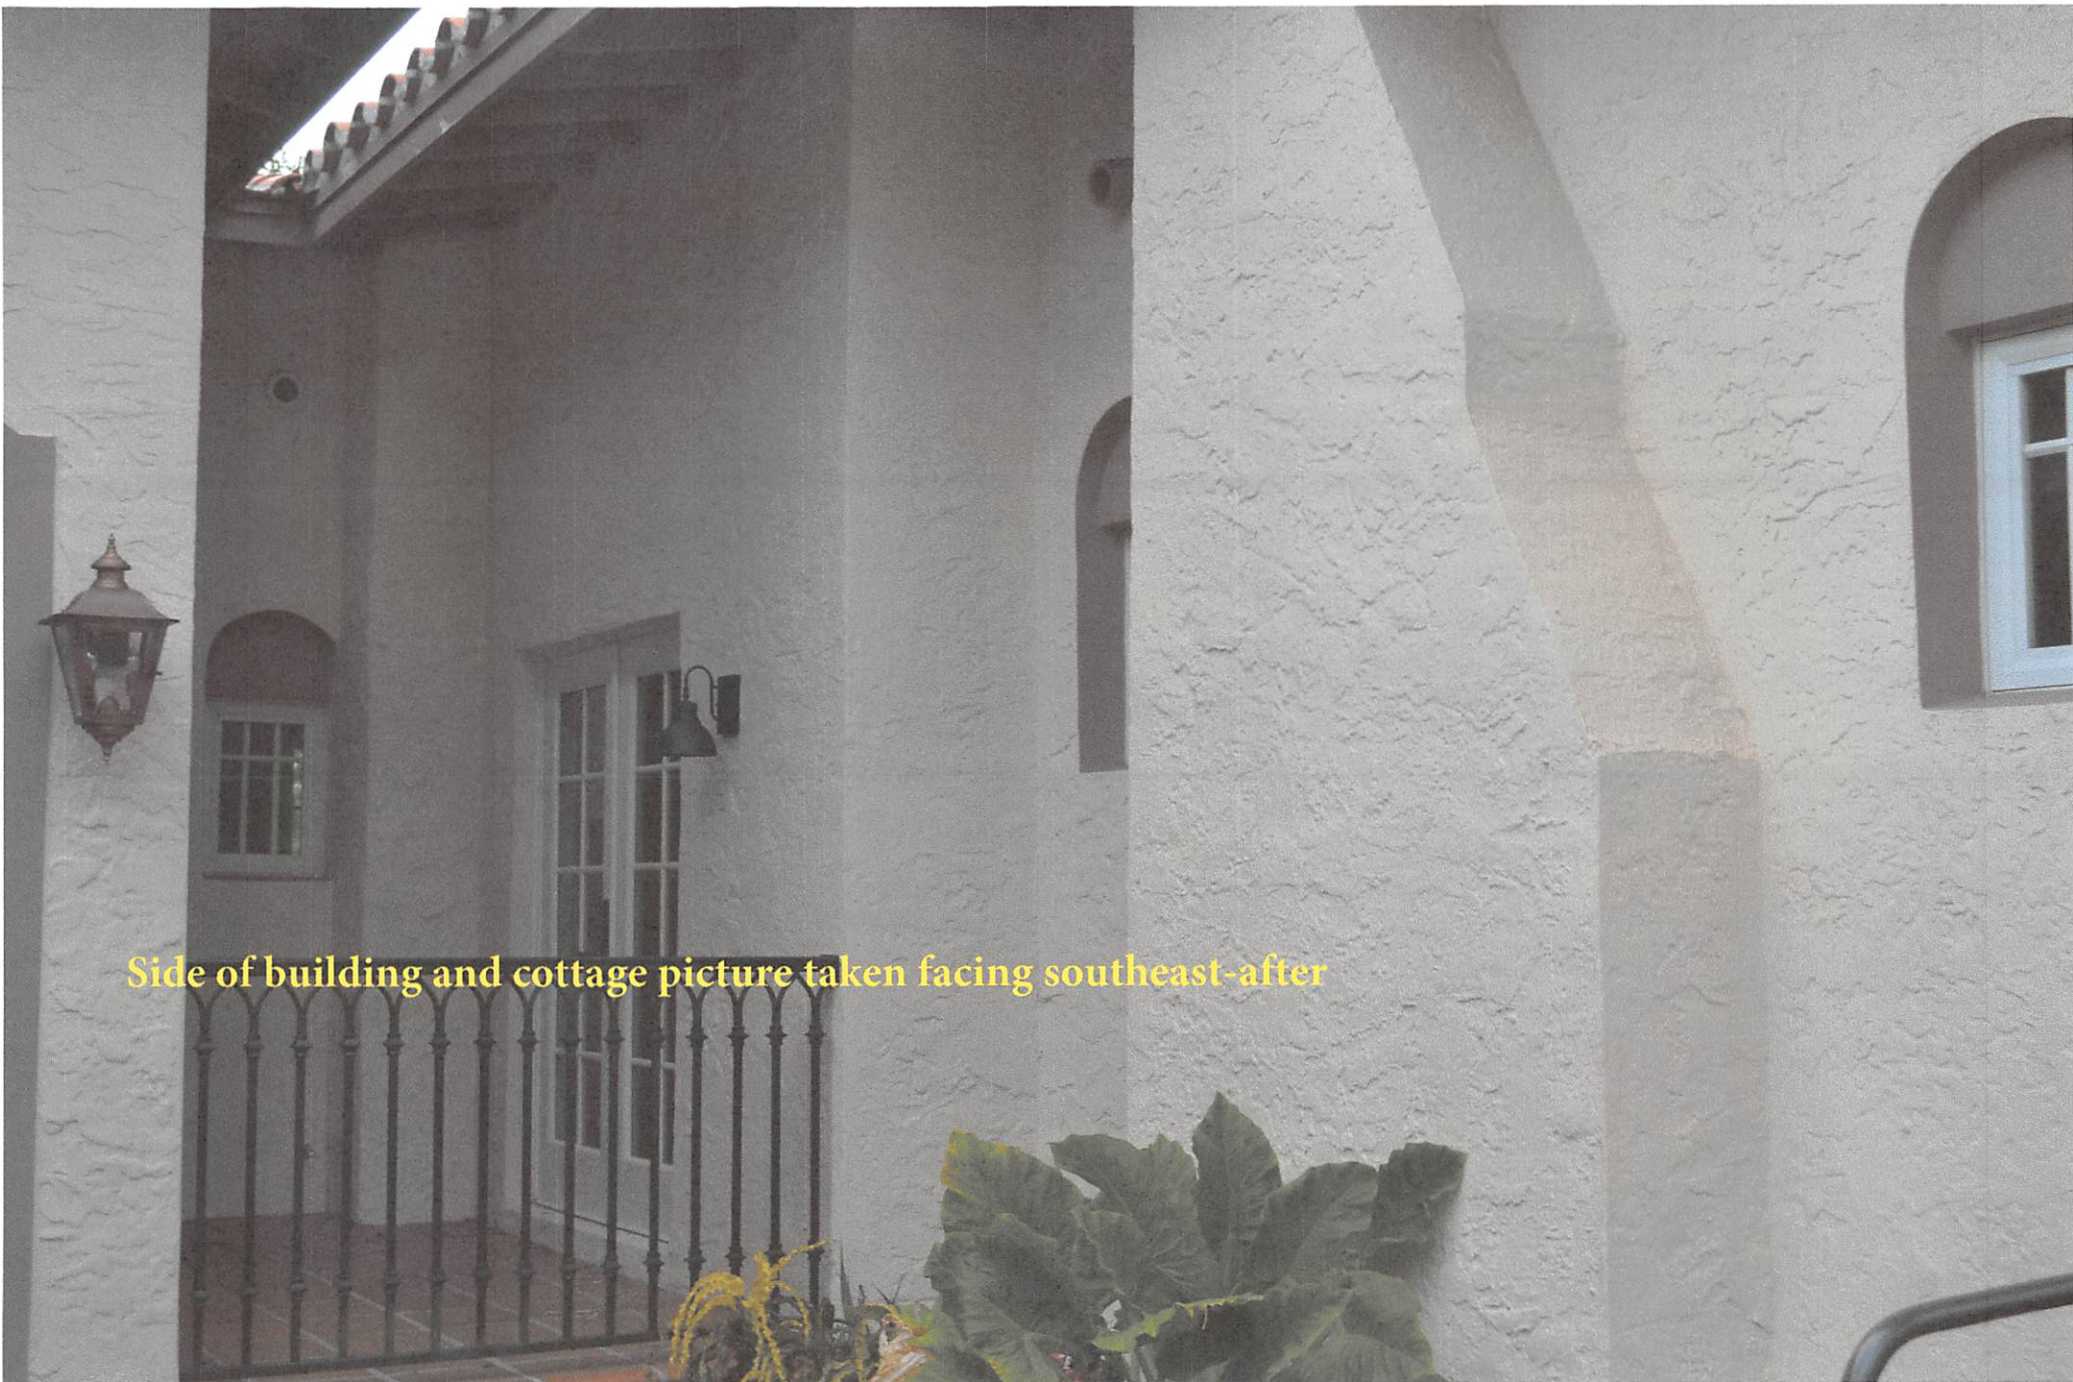
Side of building and cottage picture taken facing southeast-after
