BOARD ACTION REPORT – APPEALABLE ITEM

Project Name: 145 NE 6th Avenue (2018-089)

Request: Certificate of Appropriateness

Approved the Certificate of Appropriateness (2018-089) request associated with the demolition and reconstruction of the existing contributing garage.

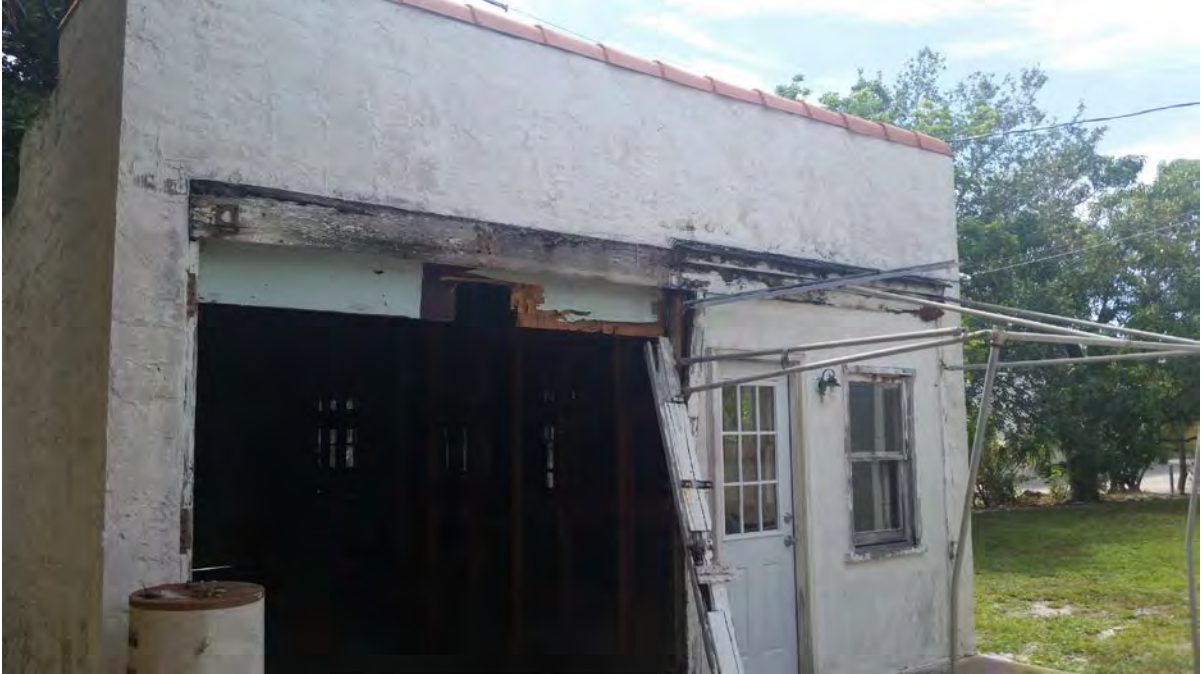
Exhibit 1. General view of Exterior of the Building through garage

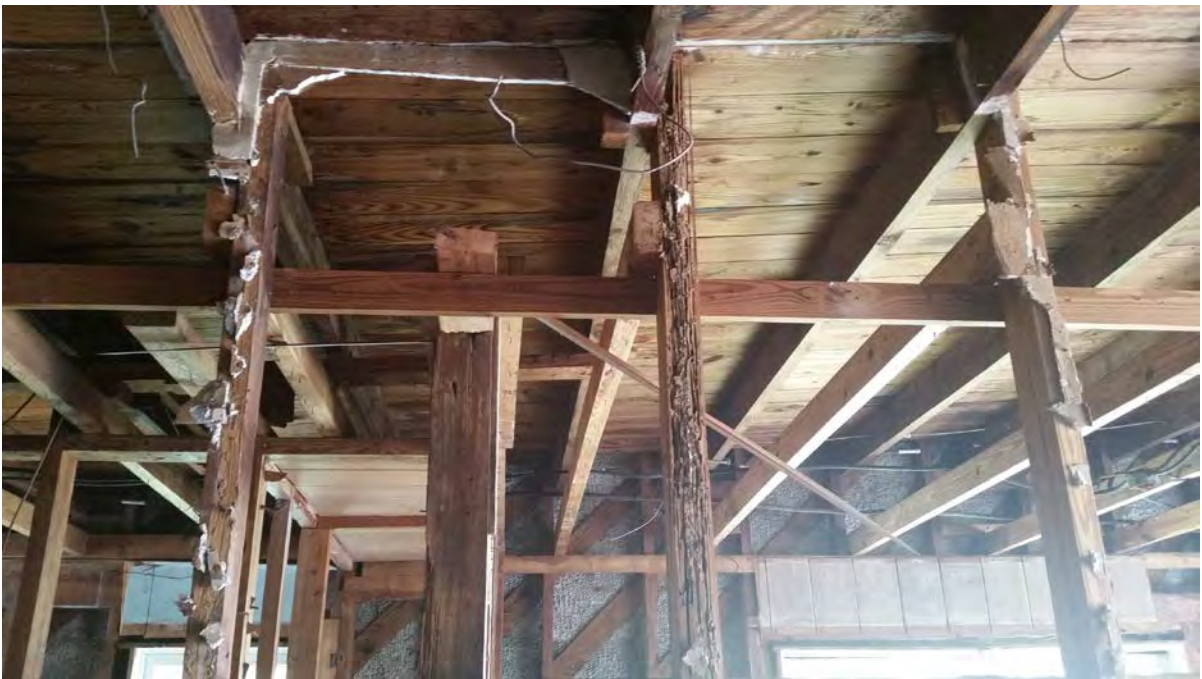
Exhibit 2. Typical Rotted Wood Wall Studs

The accessory garage has sustained a large amount of deterioration throughout the entire structure that has continued into further decline over the years. The attached documentation describes the condition of the structure as beyond repair. The proposed reconstruction of the one-story garage is not anticipated to harm the historic integrity of the site as it will consist of the same Mediterranean Revival architectural style, materials such as barrel tile roof, stucco façade, as well the same design features as the original. The reconstruction of the garage can help to revitalize the site and bring it out of its current deteriorated state. The reconstructed one-story garage can be considered compatible with the two-story main structure on the property.

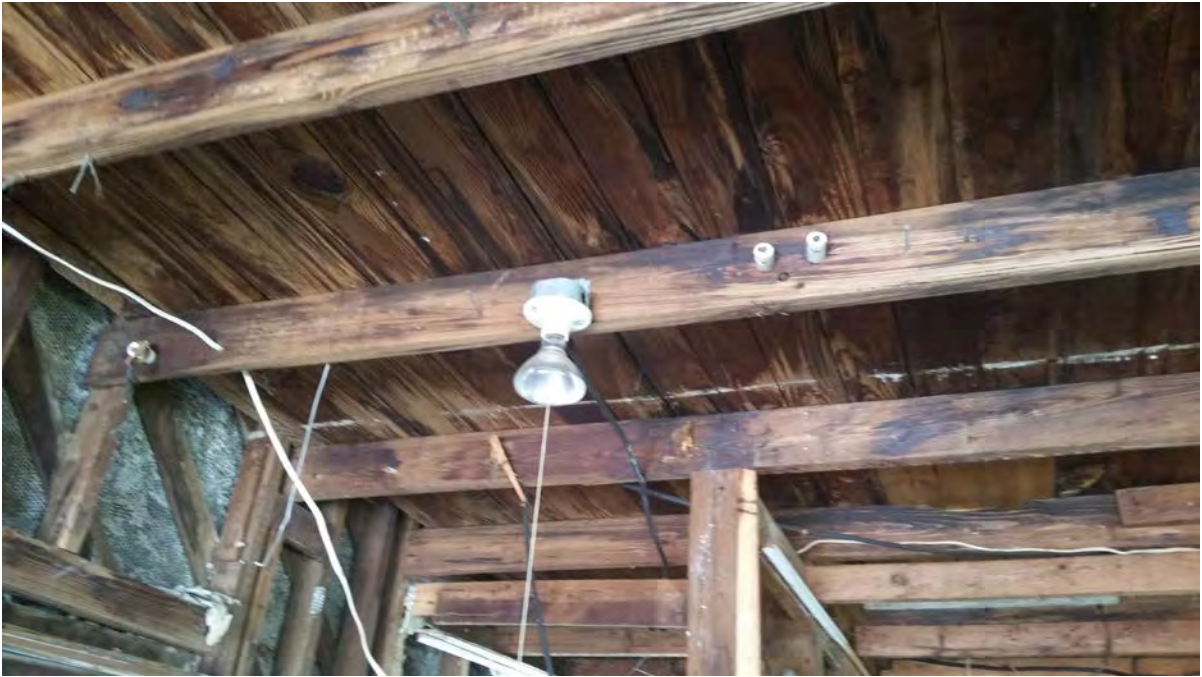
Exhibit 3. Water damaged roof joist, decking and ledger board

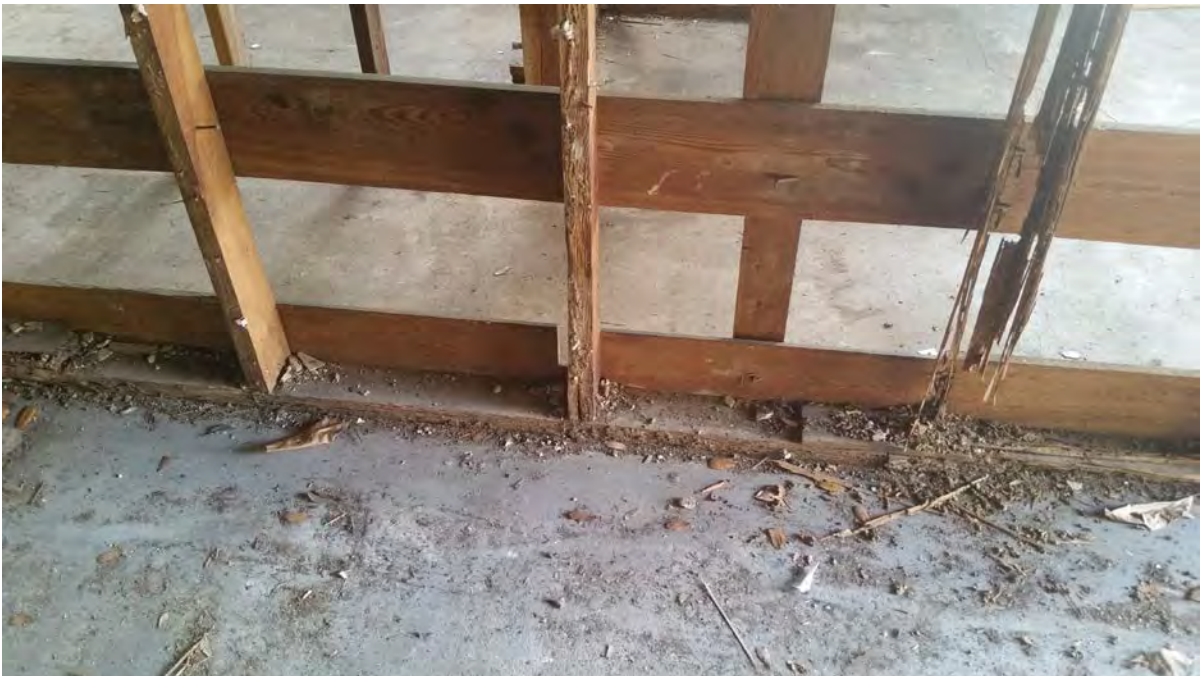
Exhibit 4. Typical missing/eroded wood wall studs

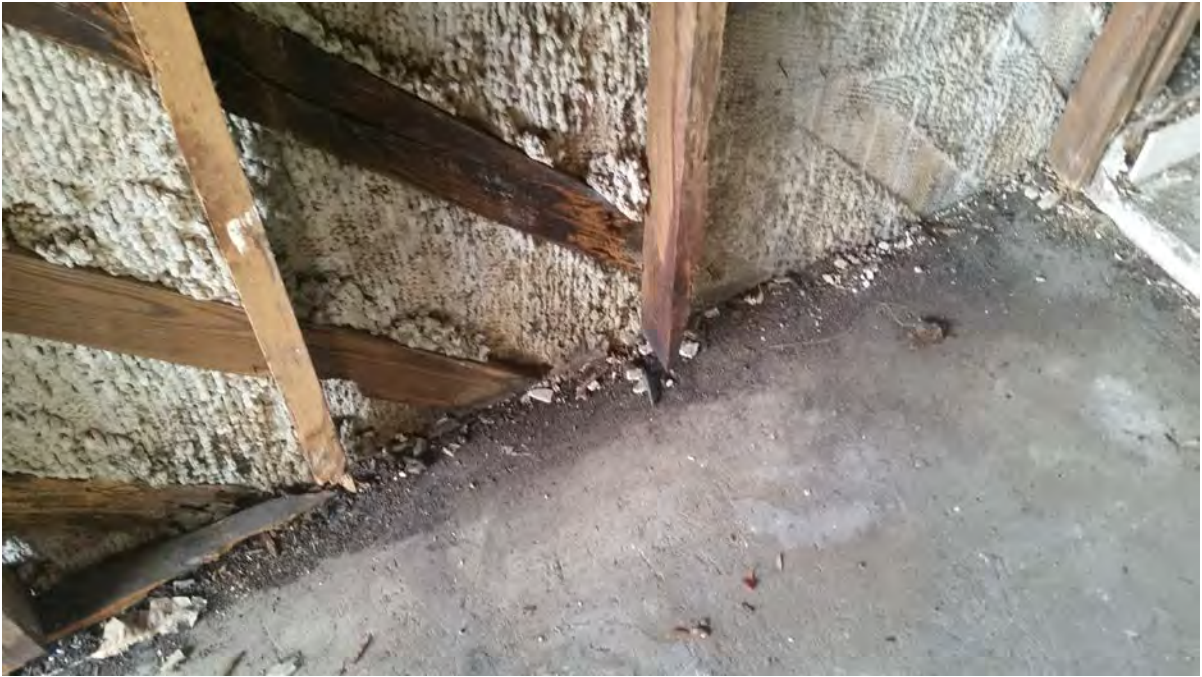
Exhibit 5. Typical Missing/eroded base plate of exterior wood frame walls

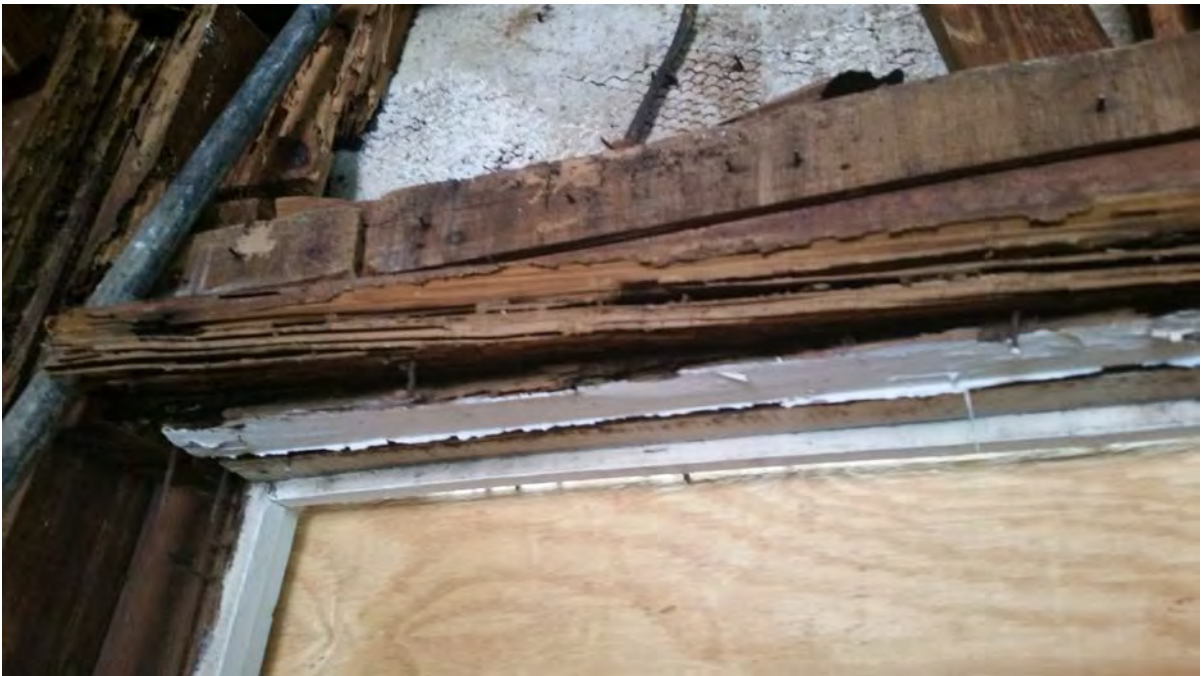
Exhibit 6. Typical rooted wood header/jamb at exterior openings

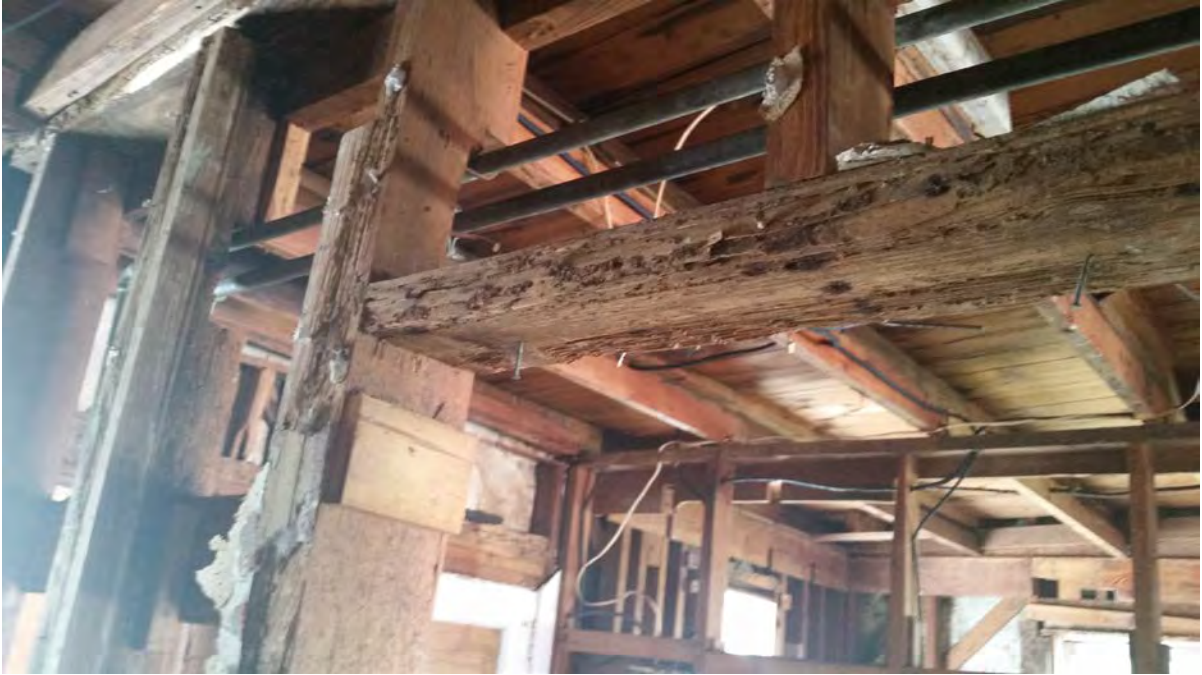
Exhibit 7. Typical rotted wood header at interior load bearing walls

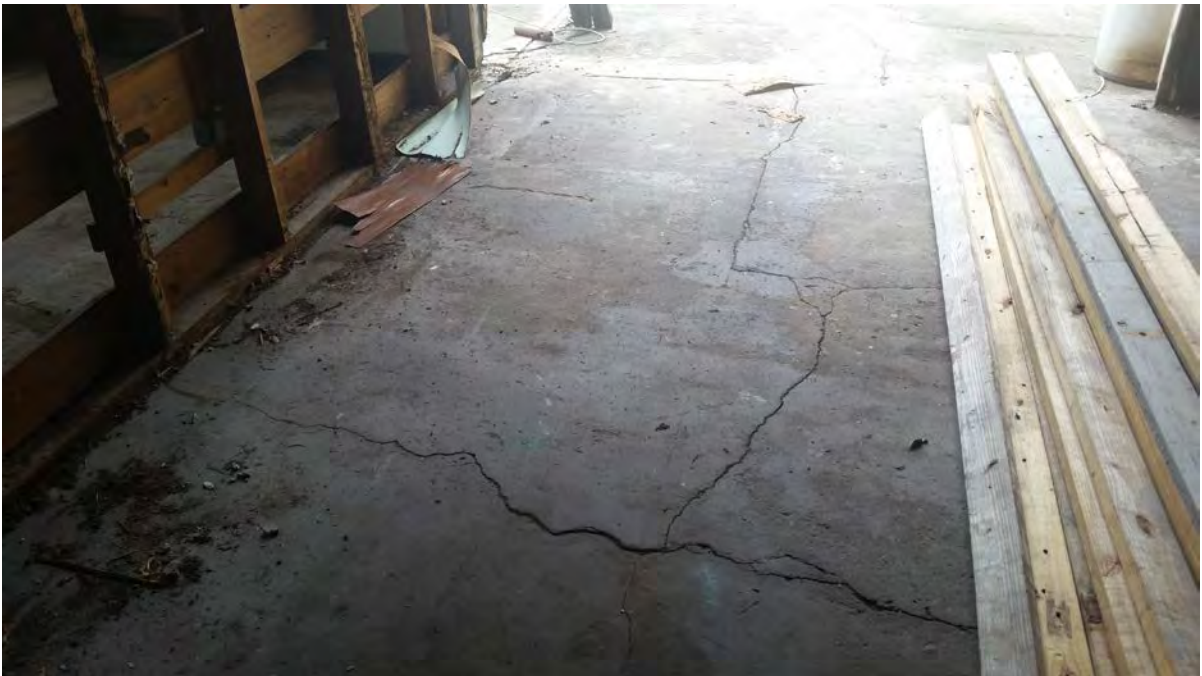
Exhibit 8. Typical Continuous Concrete slab cracks

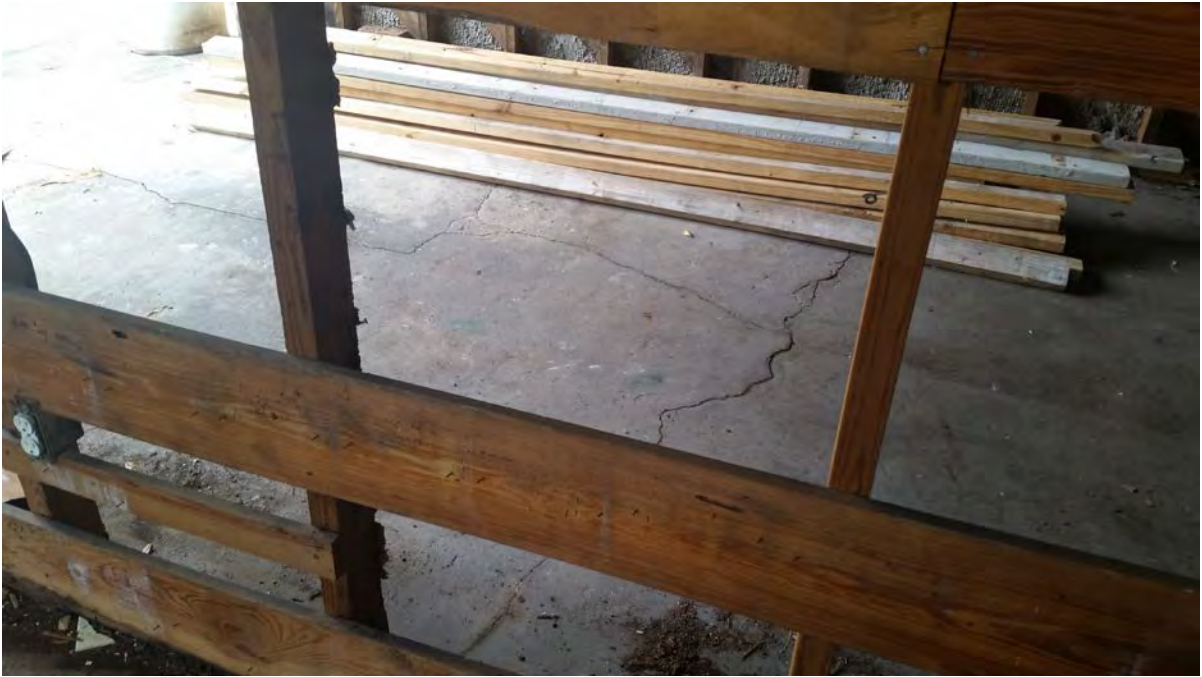
Exhibit 9. Typical Continuous Concrete slab cracks at garage area

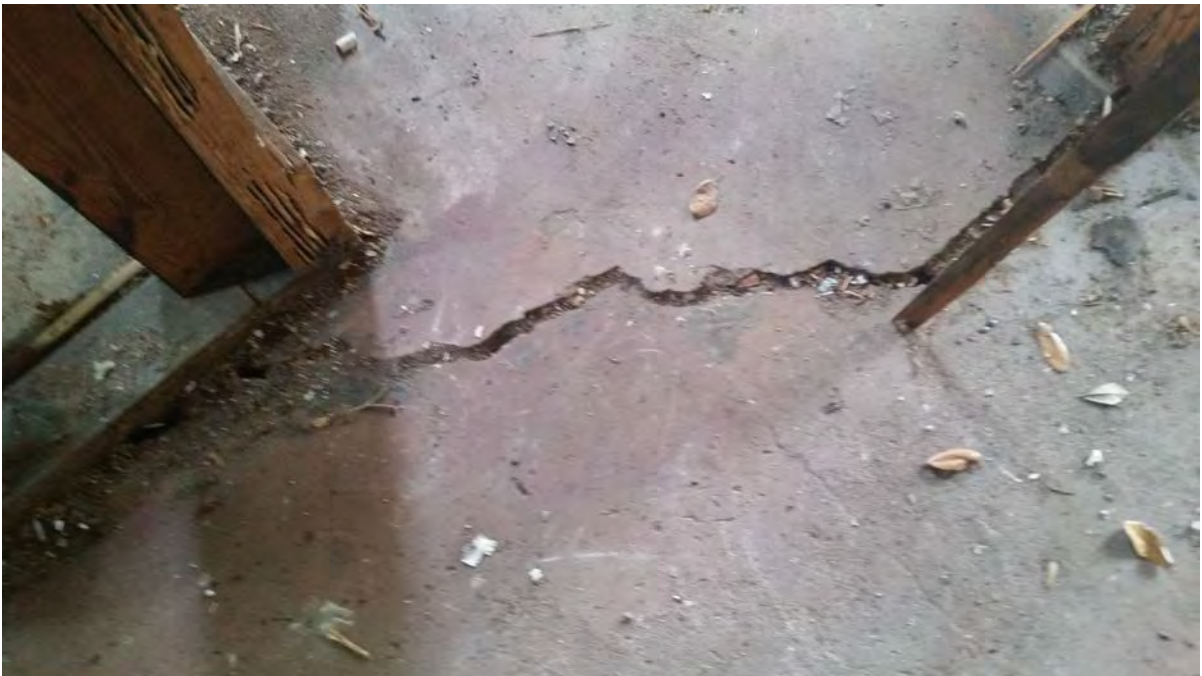
Exhibit 10. Typical Continuous Concrete slab cracks

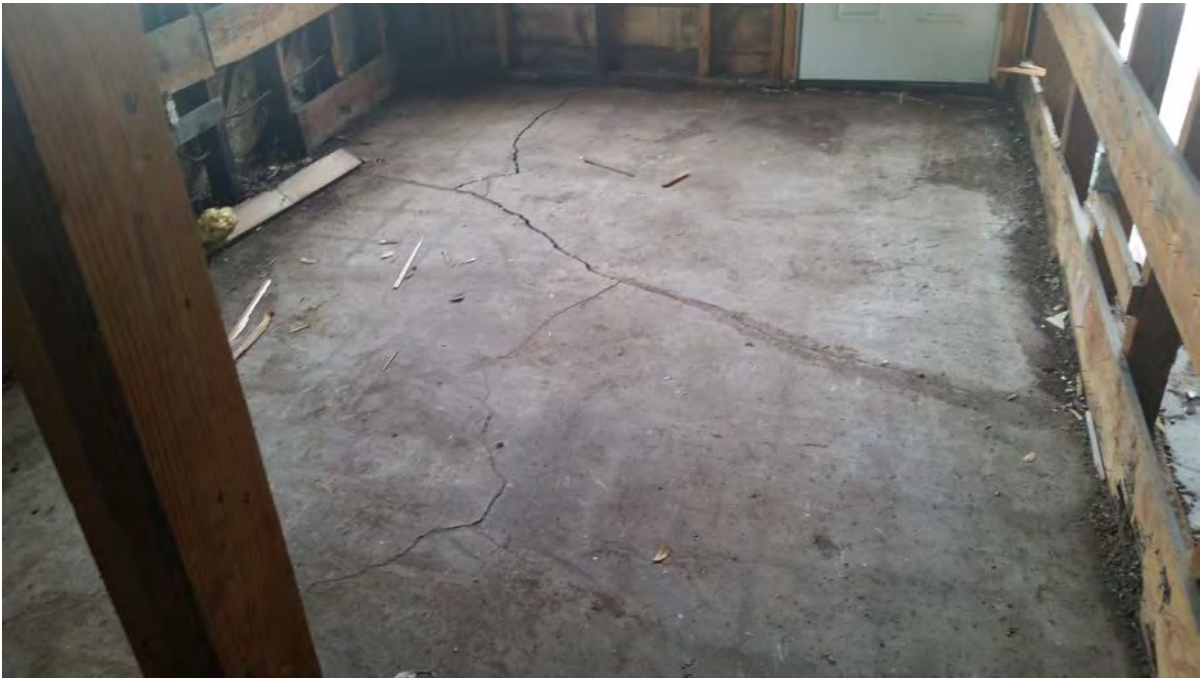
Exhibit 11. Typical Continuous Concrete slab cracks at room

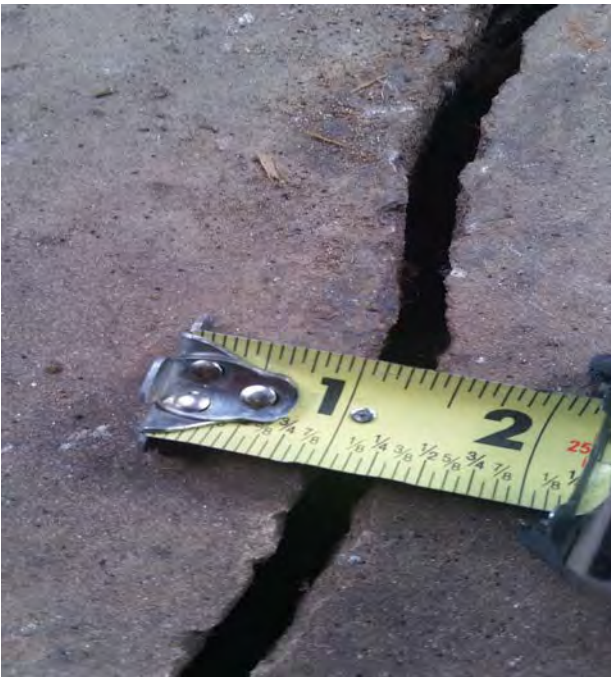
Exhibit 12. Typical Crack separation
