## HISTORIC PRESERVATION BOARD STAFF REPORT

### 110 Marine Way

Meeting	File No.	Application Type
October 6, 2021	2021-239	Certificate of Appropriateness

The item before the Board is in consideration of a Certificate of Appropriateness (2021-239) request associated with the alteration of the historic fountain situated at the center of the property located at **110 Marine Way, Marina Historic District**.

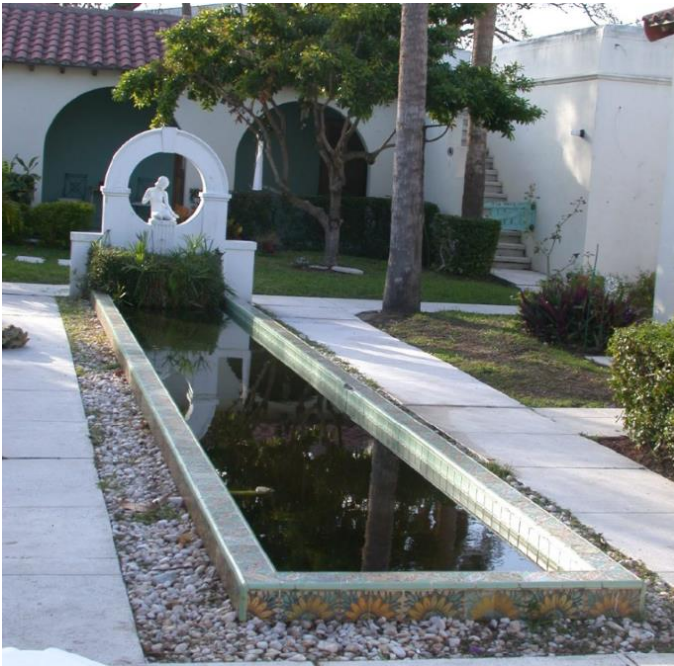
*Image of the fountain with the original tiles.*

Standards 2, 3, 5, 6, and 9 are applicable. The COA request is for an after-the-fact alteration of the existing historic fountain as a result of the decision on the code enforcement violation by the Special Magistrate. The historic fountain contained original 1930's Addison Mizner style tilework, which have been removed and replaced with solid color orange and blue tiles. The tilework is important to the character of the historic property given it is/was original to the site and is utilized throughout the property. For example, the 1930's Addison Mizner style decorative tiles exist surrounding openings on each of the five structures. Below depict images of the fountain in its original state, after the original tiles had been removed, and existing with the new tiles.

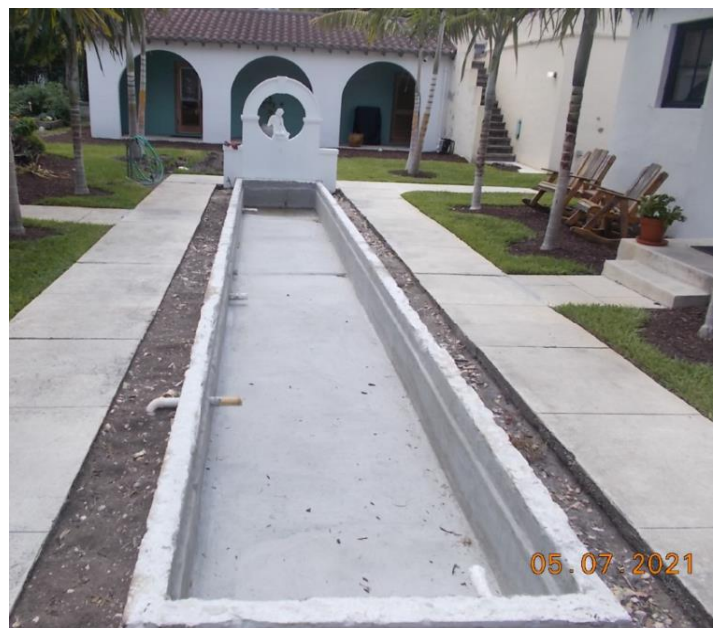
*Image of the fountain after the original tiles were removed.*

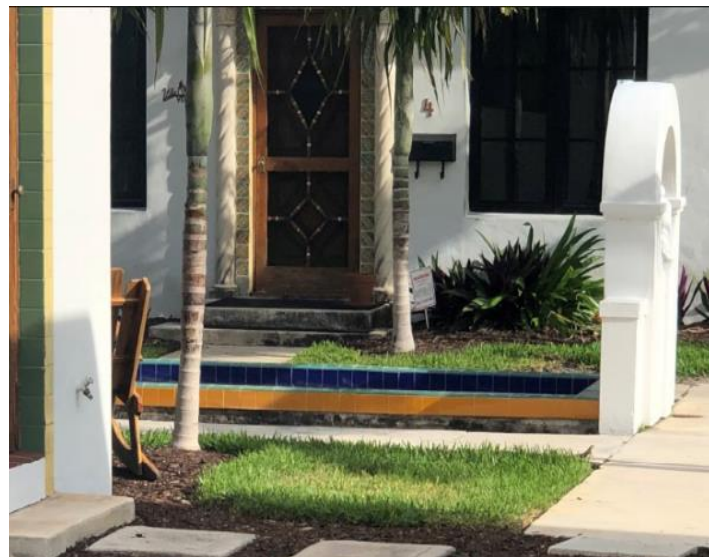
*Image of the fountain after the new tiles were applied.*

There is concern regarding the proposal's ability to meet the required Secretary of the Interior's Standards. First, **the historic character of a property shall be retained and preserved and removal of historic materials or alteration of features and spaces that characterize a property shall be avoided (Standard 2).** The requested alteration removed the original historic tilework that help to characterize the property and replaces the tile with modern style solid color orange and blue tiles.

**Each property shall be recognized as a physical record of its time, place, and use. Changes that create a false sense of historical development, such as adding conjectural features or architectural elements from other buildings, shall not be undertaken (Standard 3).** The requested alteration creates a false sense of historic development as the original historic tiles were removed and replaced with new solid color tiles rather than preserved. The tiles were **distinctive** and were an **example of the craftsmanship that characterized this historic property (Standard 5).**

**Deteriorated historic features shall be repaired rather than replaced. Where the severity of deterioration requires replacement of a distinctive feature, the new feature shall match the old in design, color, texture, and other visual qualities and, where possible, materials. Replacement of missing features shall be substantiated by documentary, physical, or pictorial evidence (Standard 6).** The existing fountain is considered a contributing accessory structure to the historic site as it was designed and constructed at the same time (1937) as the residential structures on the property. The alteration of the fountain represents an **exterior alteration of historic materials** (original tilework) **that were characteristic to the property (Standard 9).**
