JANUARY 16, 2026

CREST THEATRE
CONCEPT DESIGN AND ASSESSMENT

DRAFT

PREPARED BY:
MILLS + SCHNOERING ARCHITECTS,LLC

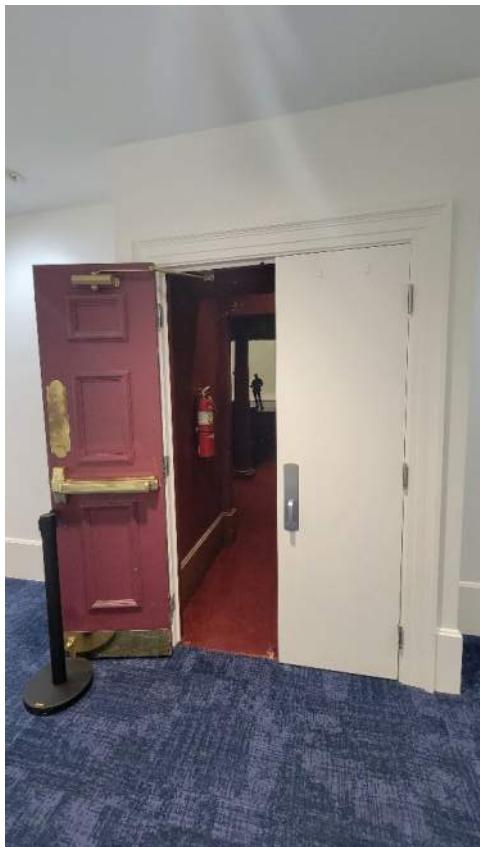
Figure 7. Entrance doors to Auditorium are not accessible.

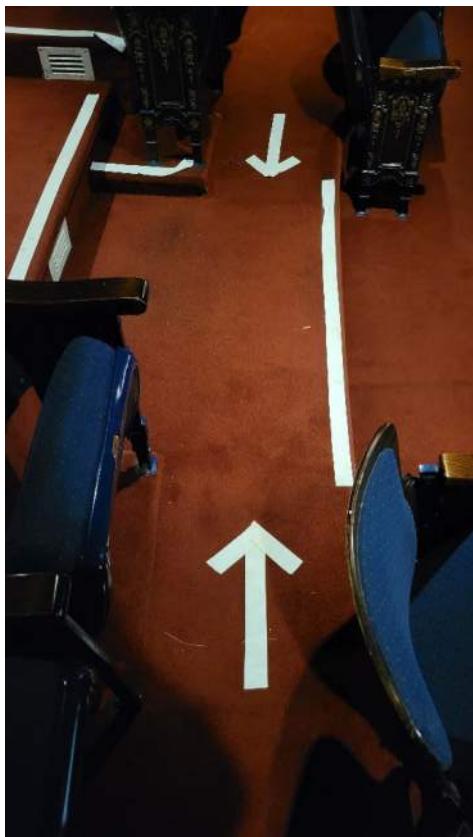
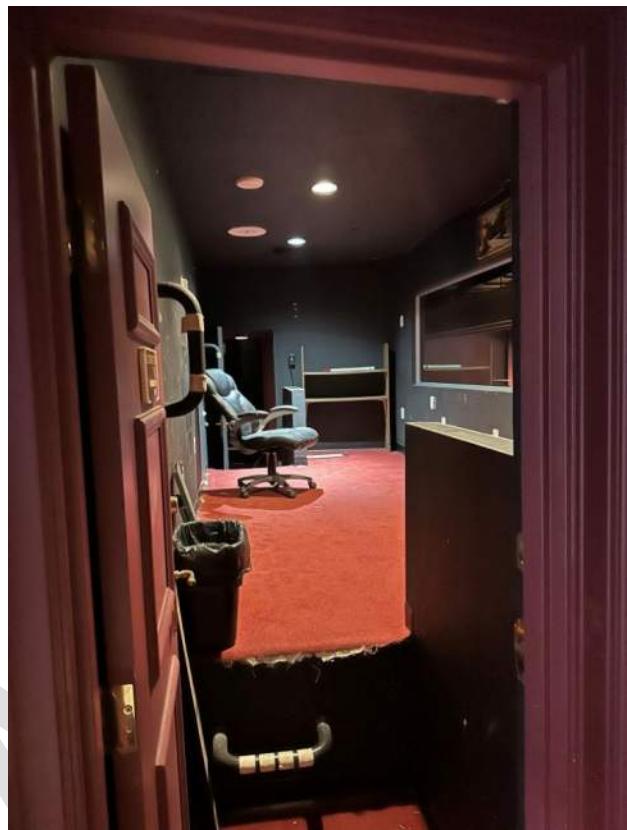
Figure 11. Tape markings on carpeting at left. View into central followspot room showing difficult access with floor level change.

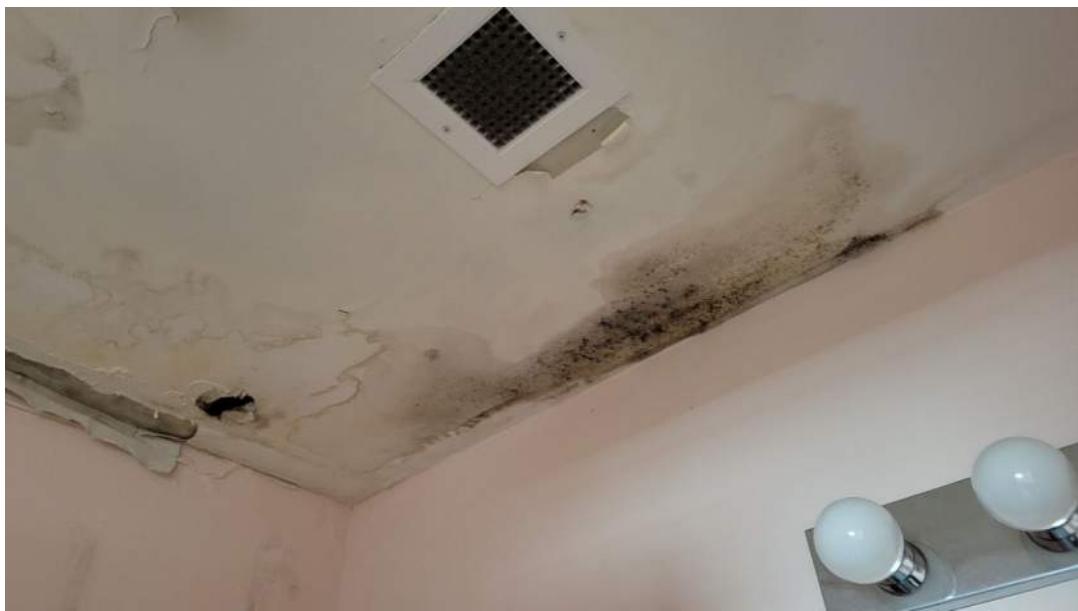
Condition: Fair condition; Ceiling tiles are stained. Wallboard ceilings in toilet rooms show mold growth.

Figure 26. View of moldy shower ceiling in second floor toilet room.

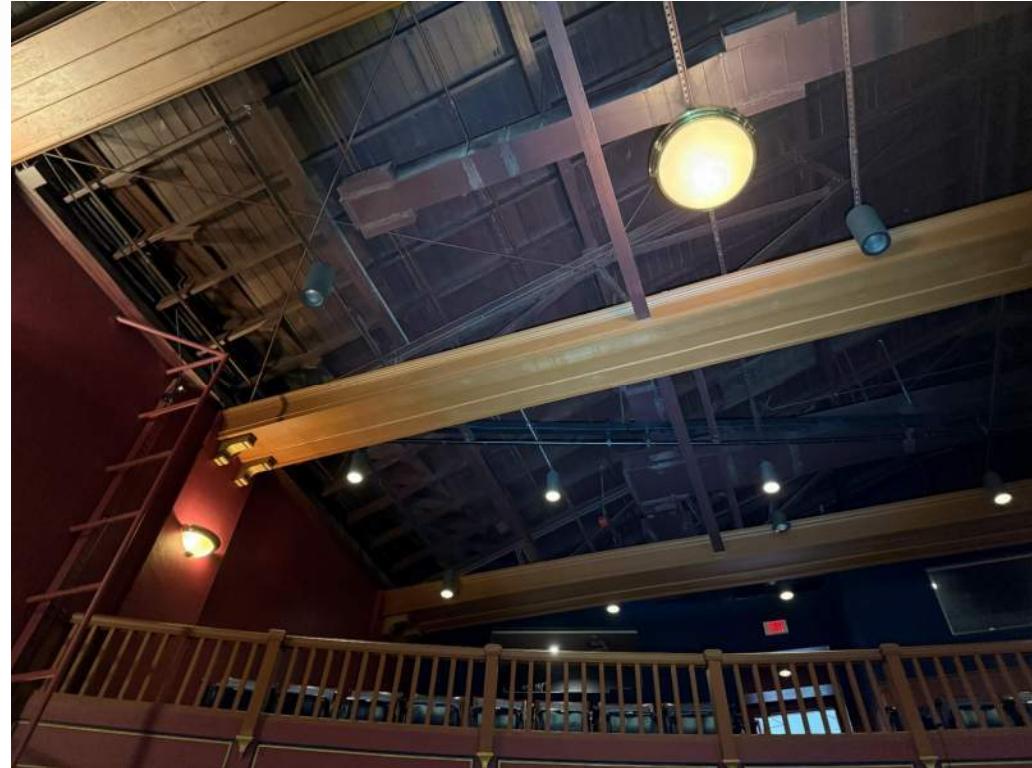
Photograph 1 - Steel Trusses in Auditorium

Per the 1992 Structural Drawings, it appears that the entire stage and backstage were new construction. The extent of the new structure began just west of the new stage, with the boundary of existing to new located in the auditorium. Per Drawing S-1, the existing footings of the auditorium were cut just west of the stage, and the new footings begin to the east of this line, framing the new stage and backstage. This is also supported in Drawing S-3, where the first existing steel truss to the west of the stage is to remain, and all new roof framing is specified for the stage and backstage. See Photograph 1 of the steel trusses in the auditorium.

All of the structural framing observed during the survey is in EXCELLENT condition, with no visual signs of deflection, distress or deterioration. In addition, every dimension and size that was measured by AES (omitting the catwalk at Stage Left) matched what was specified in the 1992 Structural Drawings.

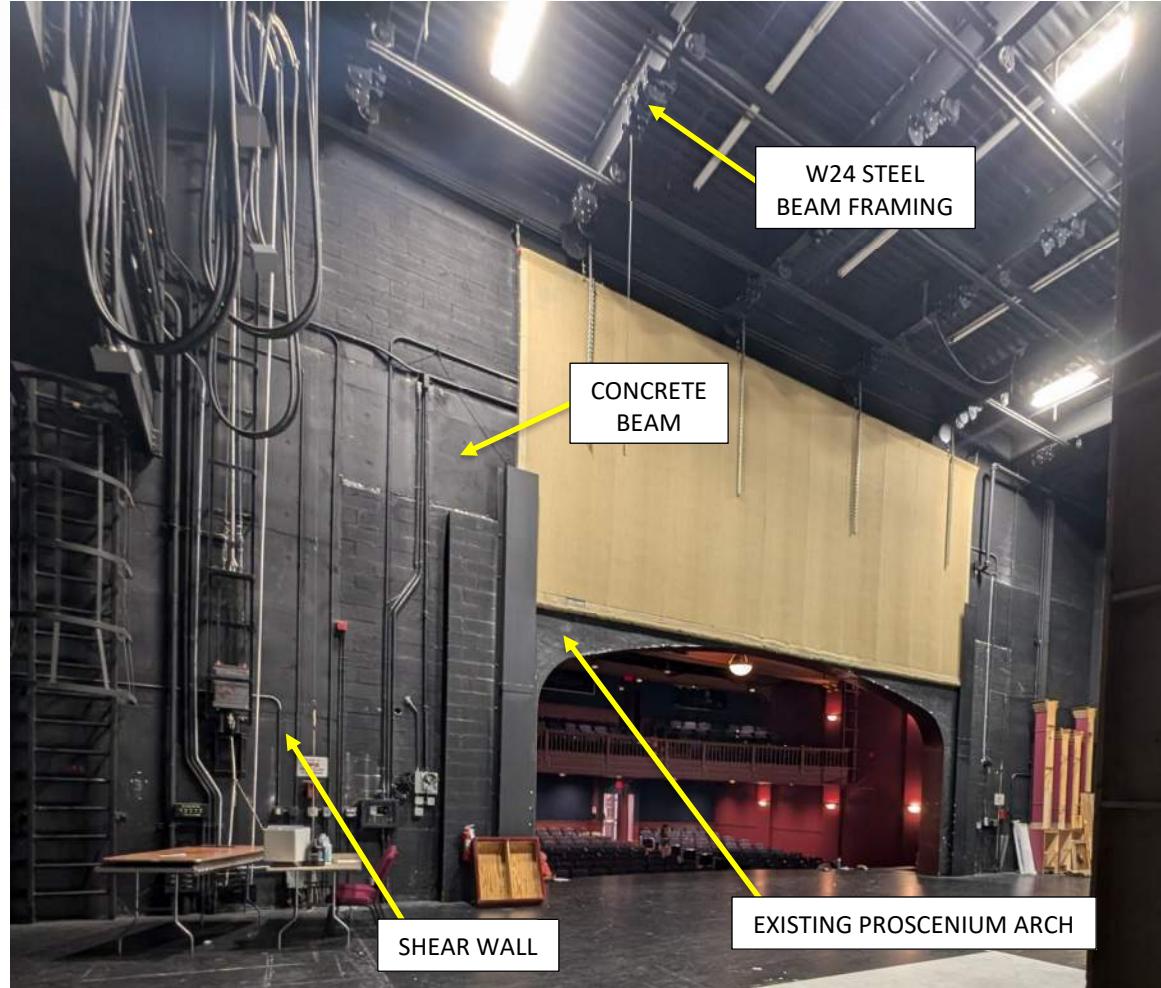
Photograph 2 - Proscenium

The only portion of the existing stage that was specified to remain in the new stage space is the historic proscenium arch. As shown in Detail 1/S-1, the existing proscenium arch and supporting concrete columns were to remain, with new concrete masonry unit (CMU) shear walls built on either side of it. A new concrete beam spanned to the CMU shear walls cast above the proscenium arch, to support the CMU wall above and roof framing. CMU infill and stud infill are specified between the shear walls and proscenium concrete columns. See Photograph 2.

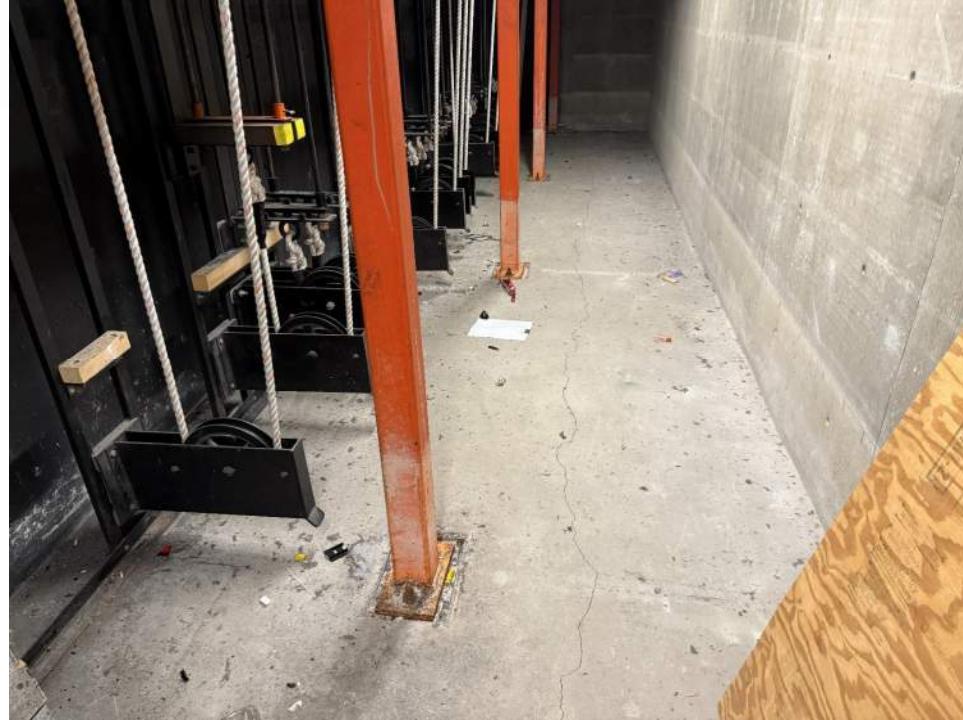
Photograph 3 - Arbor Well

The footings are all shallow continuous concrete footings. The stage is 4-inch-thick concrete slab on grade, depressed 2-7/8" in the center stage portion to allow for the stage floor. On the south end of the stage, there is an arbor well that is 7'-5" deep and 7'-1" wide. The walls of the arbor well are reinforced concrete. Steel tubes support the stage floor at the center of the arbor well. See Photograph 3.

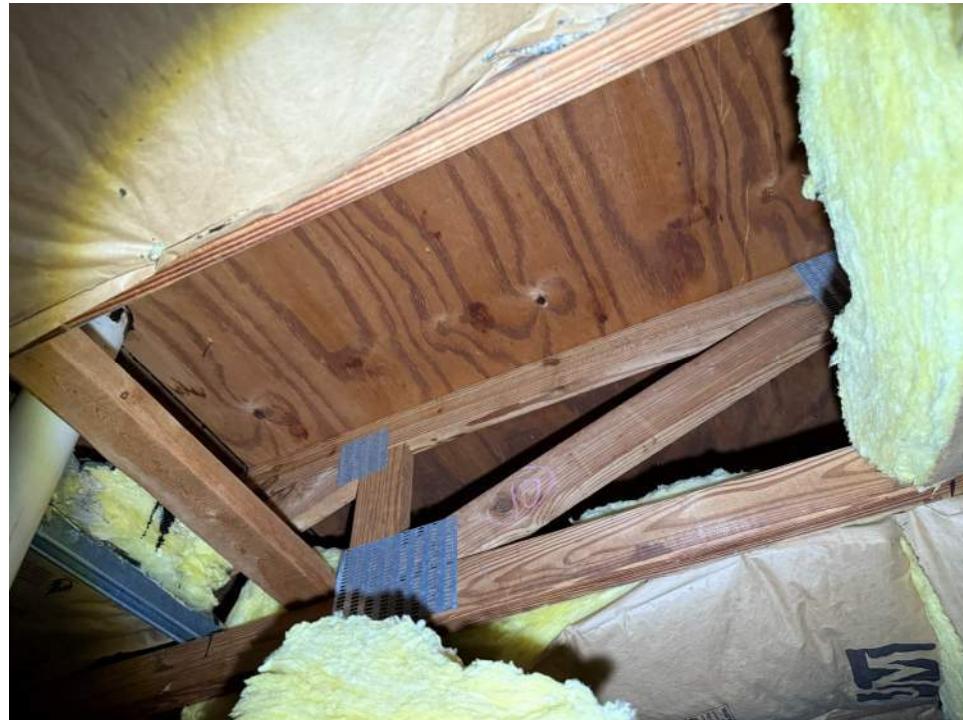
Photograph 4 - Roof Framing in Backstage

The roof framing above the stage consists of W24x55 steel beams spanning E-W, with a 3-inch metal roof deck. W6x9 brace beams are provided at various intervals along the length of the W24 beams. The beams supporting the roof and catwalk are W24x103. In the backstage, the roof framing is 18" deep wood trusses at 24" o.c. See Photograph 4.

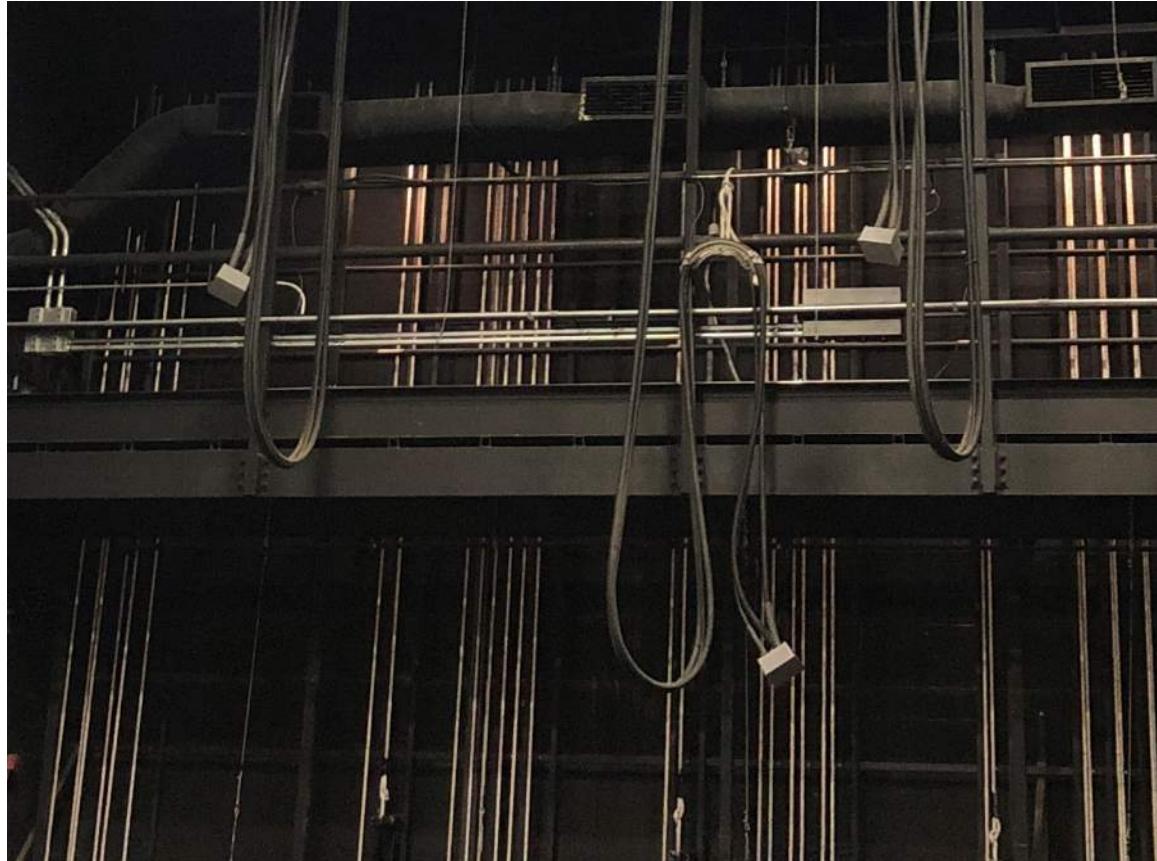
Photograph 5 - Catwalk Framing at Stage Left

Per the 1992 Structural Drawings, Detail 4/S-2, the specified structure for the catwalk at Stage Left was C4x5.4 channels spanning to the main MC12x10.6 channel beams. Tube steel (T.S. 3x3x1/4) hangers were specified to support the MC channel beams. However, during the site visit, it was observed that the catwalk was not built as specified on the construction documents. Instead of the C4x5.4 channels that are specified in Detail 4/S-2, tube steel was provided. These tube sections were not measured on site, but may be as small as T.S. 2x2x3/16 based on visual estimation. See Photograph 5.

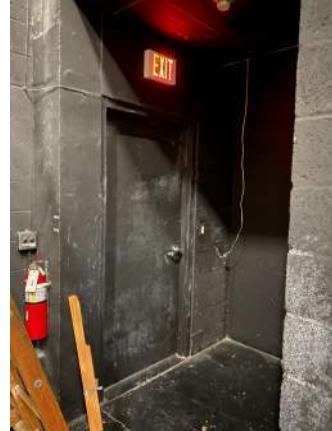
4. **Stair "0" Exterior Door USR:** Door opens directly to condensing unit for stage. Noise audible on stage through stairwell. Doors do not have perimeter sound gasketing.

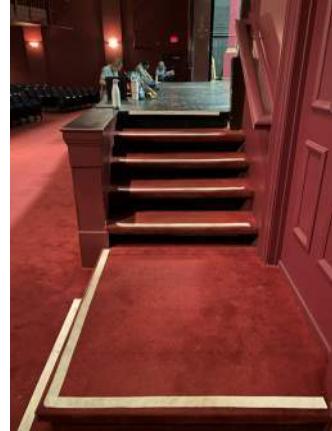
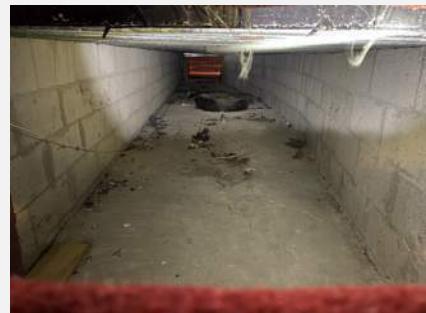
return air for the audience chamber is brought through the risers in the stage stairs to a plenum below the stage apron. Duct in floor of the plenum brings air back to the remote air handling unit. Noise levels are slightly elevated and audible close to the stairs (noise levels in theater measured at NC-35 max). Reduction of noise levels can be addressed relatively easily if desired. Attention to open area for air flow is important if stage stairs are reworked.

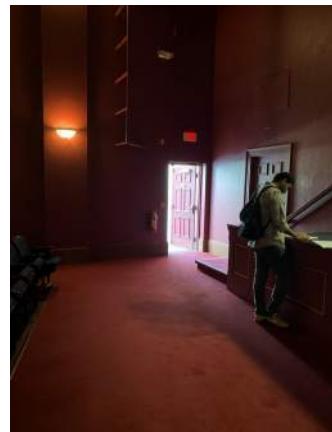
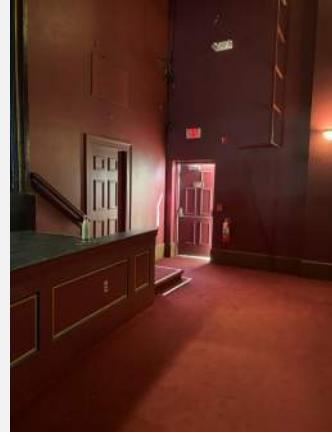
**10. House Right/House Left Doors to Exterior:**

both doors are located at the front (stage) end of the room, and open close to or on to outdoor areas where condensing units are currently located. Doors are not equipped with perimeter sound gasketing and noise is audible in the house with doors closed.

**11. House Left outdoor condensing area:**

Condensers located adjacent to house left theater door. These serve other areas of the building and are currently protected by open fencing – this does not prevent noise transmission into the theater through the door.

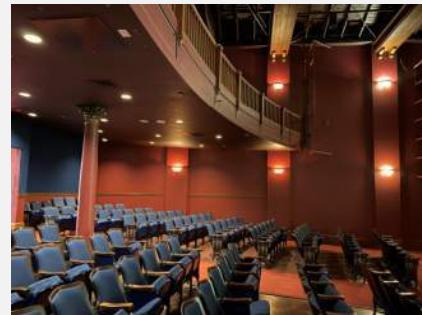
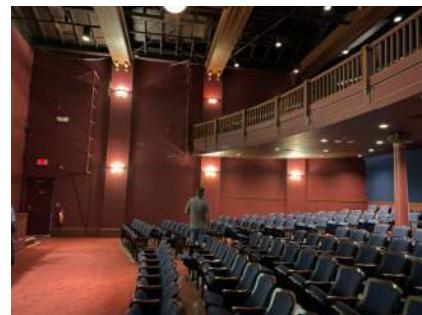
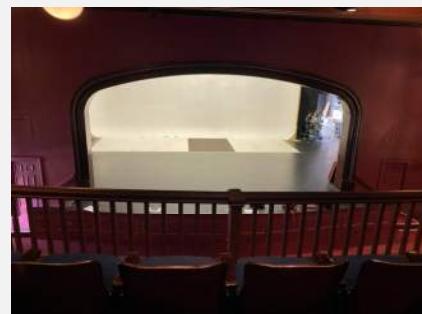
**13. Theater Interior:** Theater walls appear to be gypsum board with no insulation in cavity (hollow when thumped) and most likely furred out from CMU or concrete structural substrate. Flooring is painted/stained concrete under seating areas with carpeting in main circulation aisles, front and rear. 1" thick acoustic panels are installed on upper half of rear walls on both main and balcony levels and are in good condition. The room feel is intimate and sounds

appropriately controlled with the current finishes with no excessive reverberation other than that emanating from the empty stagehouse. It should be noted that some seating areas in the balcony do have compromised sightlines to all parts of the stage, even with open balcony rail.

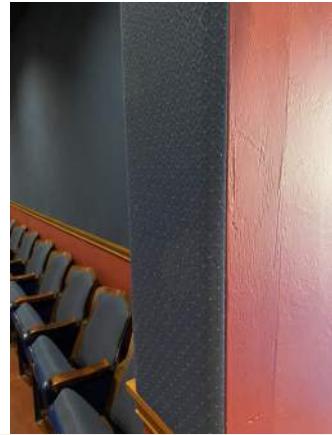
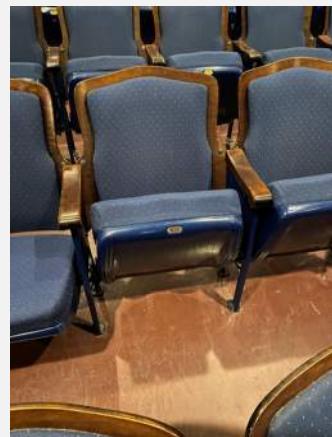
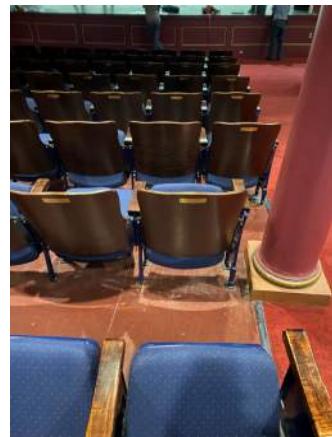
14. Audience Seating: Audience chairs appear worn, but in workable condition. Seats have hard (metal) seat pans and wood backs which are desirable for room acoustic and audience participation aspects. These elements should be retained in any modification, refurbishment or replacement. Wood seat pans should be considered.

1. Replace finishes: carpet, paint, counters
2. Seating: Replace seating with refurbished end standards. Considerations include:
 - a. Improve layout to correct for line of sight between heads
