Arboriculture Tree Report

Delray Ridge, Delray Beach, Fl. added trees

Date: July 7, 2021

Prepared by: John Sutton
International Society of Arboriculture Certified Arborist

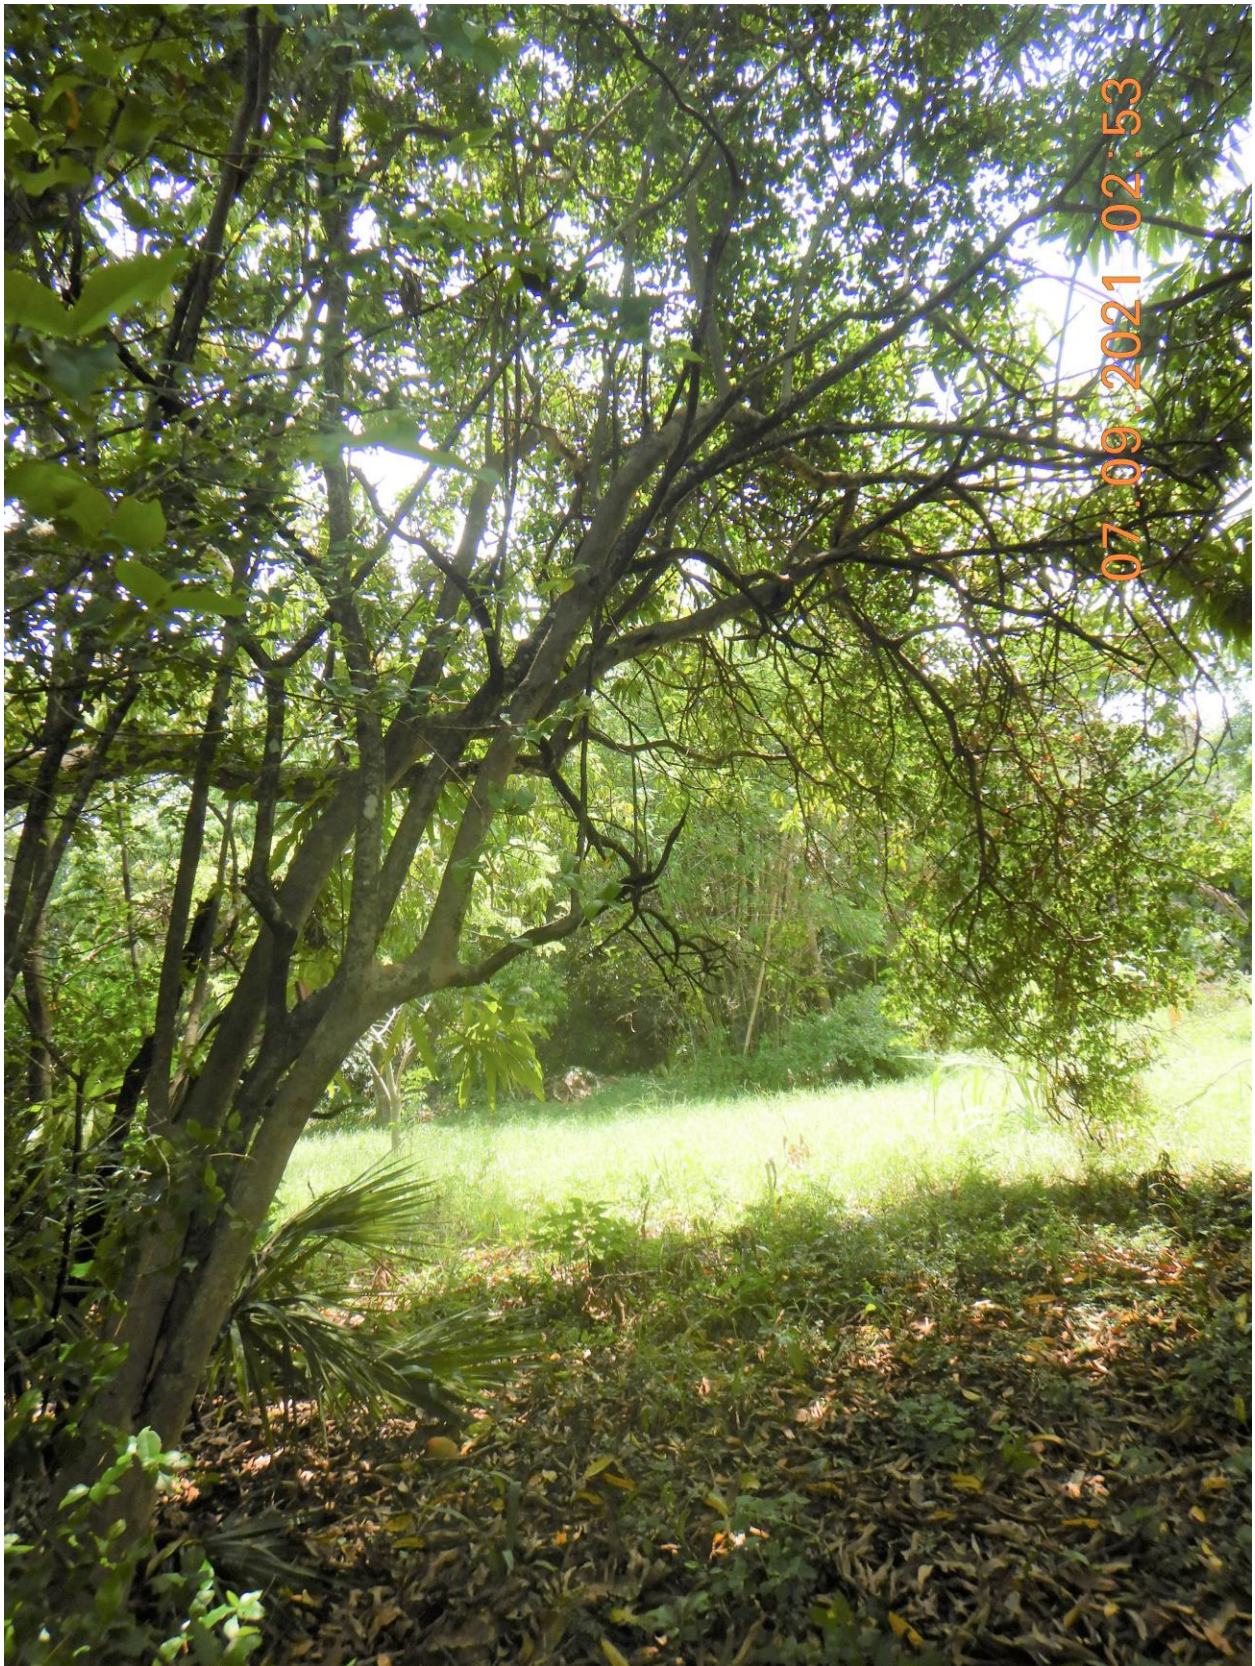
Tree #	Common name
80	Cherry

Tree #	Common name	Scientific name	DBH	Condition	Gen. Notes
80	Cherry	<i>Cherry spp</i>	6.5	10%	Sub canopy
122	Ficus nitida	<i>Ficus microcarpa</i>	100+	30%	Cat 1, FLEPPC 2019 Invasive Plant List, dying
123	Same ficus as 122	<i>Ficus microcarpa</i>			Cat 1, FLEPPC 2019 Invasive Plant List
124	Same ficus as 122	<i>Ficus microcarpa</i>			Cat 1, FLEPPC 2019 Invasive Plant List
125	Same ficus as 122	<i>Ficus microcarpa</i>			Cat 1, FLEPPC 2019 Invasive Plant List
126	Same ficus as 122	<i>Ficus microcarpa</i>			Cat 1, FLEPPC 2019 Invasive Plant List
127	Same ficus as 122	<i>Ficus microcarpa</i>			Cat 1, FLEPPC 2019 Invasive Plant List
128	Same ficus as 122	<i>Ficus microcarpa</i>			Cat 1, FLEPPC 2019 Invasive Plant List
129	Same ficus as 122	<i>Ficus microcarpa</i>			Cat 1, FLEPPC 2019 Invasive Plant List
130	Same ficus as 122	<i>Ficus microcarpa</i>			Cat 1, FLEPPC 2019 Invasive Plant List
131	Same ficus as 122	<i>Ficus microcarpa</i>			Cat 1, FLEPPC 2019 Invasive Plant List

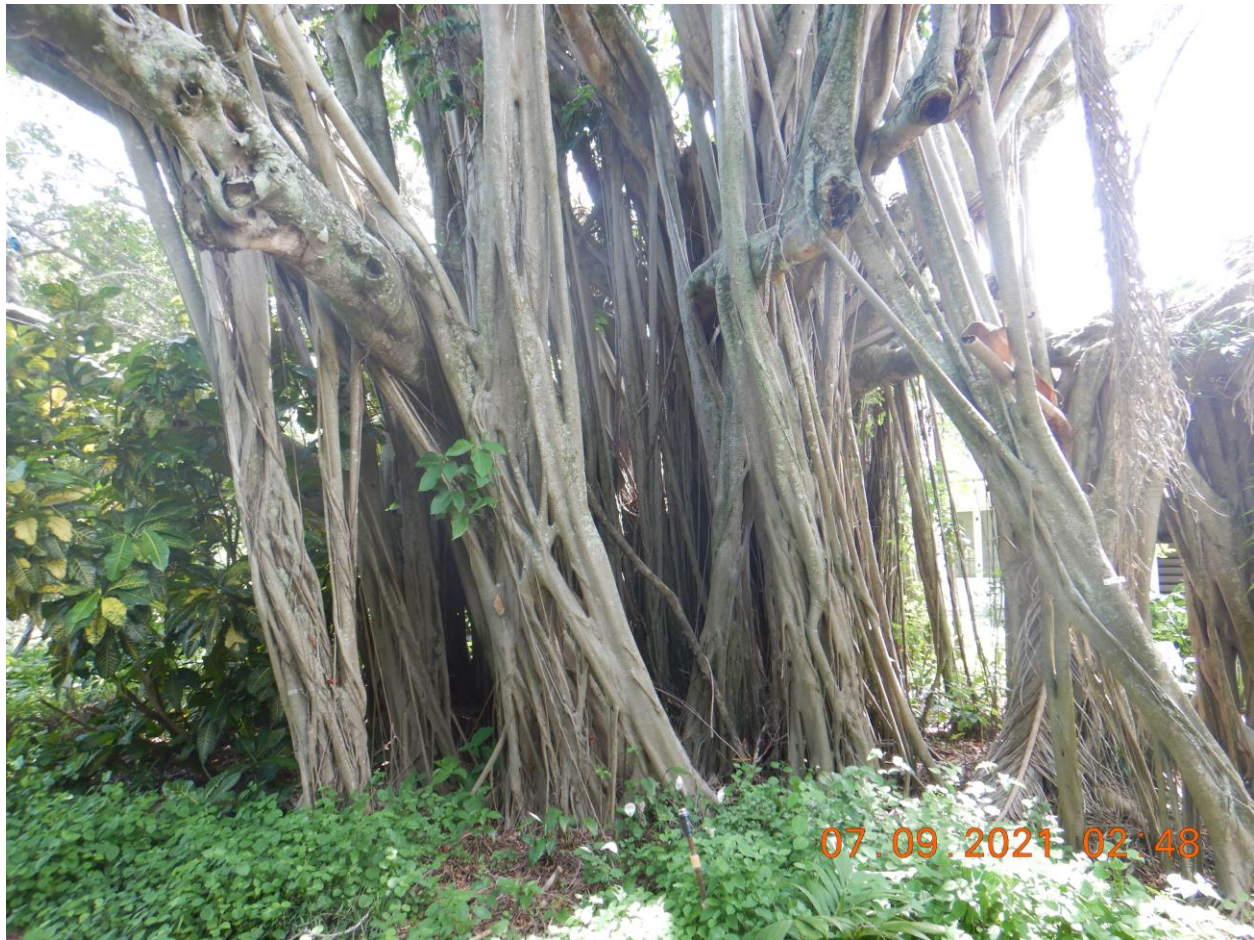
#122

Tree #	Common name	Scientific name	DBH	Condition	Gen. Notes
122	Ficus nitida	<i>Ficus microcarpa</i>	100+	30%	Cat 1, FLEPPC 2019 Invasive Plant List, dying
123	Same ficus as 122	<i>Ficus microcarpa</i>			Cat 1, FLEPPC 2019 Invasive Plant List
124	Same ficus as 122	<i>Ficus microcarpa</i>			Cat 1, FLEPPC 2019 Invasive Plant List
125	Same ficus as 122	<i>Ficus microcarpa</i>			Cat 1, FLEPPC 2019 Invasive Plant List
126	Same ficus as 122	<i>Ficus microcarpa</i>			Cat 1, FLEPPC 2019 Invasive Plant List
127	Same ficus as 122	<i>Ficus microcarpa</i>			Cat 1, FLEPPC 2019 Invasive Plant List
128	Same ficus as 122	<i>Ficus microcarpa</i>			Cat 1, FLEPPC 2019 Invasive Plant List
129	Same ficus as 122	<i>Ficus microcarpa</i>			Cat 1, FLEPPC 2019 Invasive Plant List
130	Same ficus as 122	<i>Ficus microcarpa</i>			Cat 1, FLEPPC 2019 Invasive Plant List
131	Same ficus as 122	<i>Ficus microcarpa</i>			Cat 1, FLEPPC 2019 Invasive Plant List
