Delray Beach Golf Clubhouse, Delray Beach, FL Emergency Operation Center Feasibility Report

Jeffrey Bergmann, P.E.
FL PE No. 50159
Wantman Group, Inc.
Cert. No. 6091-LB No. 7055
561-839-1721
Job # 41011004.22
May, 2017

Introduction

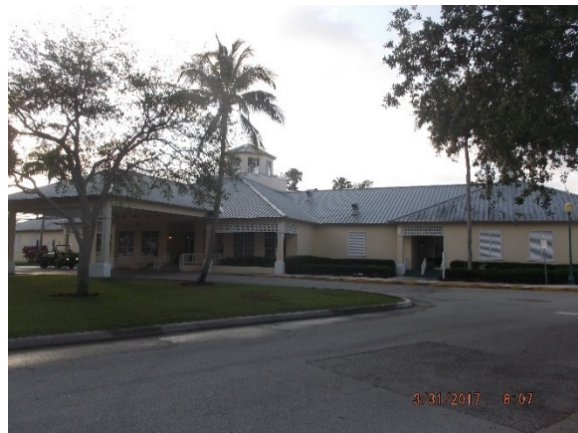
NW Elevation of Clubhouse

The field assessment reviewed the general protection of the doors and windows of the structure. The windows were found to be protected by roll-down shutters or have window glazing systems indicating a Metro-Dade County Approval 91-0905.5 (expired June 1995). Because of the age of the window systems, it would be prudent to consider these windows non-impact resistant.

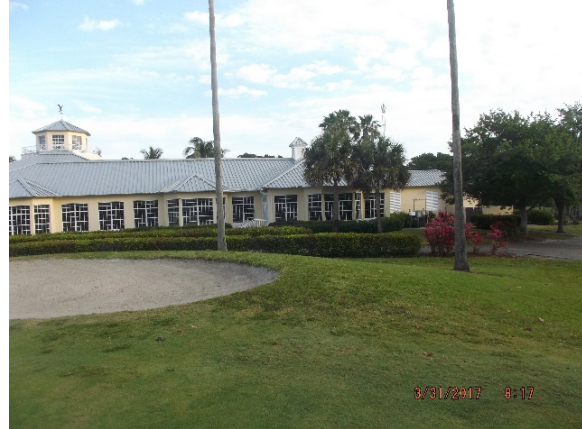
SE Elevation of Clubhouse

No structural plans for the octagonal cupola could be obtained. Based on visual inspection the structure appears to be constructed of timber framing. The cupola is open to below with windows on each side. Due to its height and configuration, the cupola is at risk of being damaged during a hurricane event. Damage to either the cupola's roof or walls will jeopardize the structure's resistance to hurricane force winds. Without having the ability to verify the anchorage and construction of the cupola before the building is used as an EOC this structure should be removed to enhance the roof's integrity. The proceeding evaluation of the building will be completed assuming the removal of the cupola.
