City of Delray Beach Intracoastal Waterway Water Level & Infrastructure Vulnerability Study

Submitted to:
City of Delray Beach

Submitted by:
Aptim Environmental & Infrastructure, Inc.

Project No. 631233074
October 2018

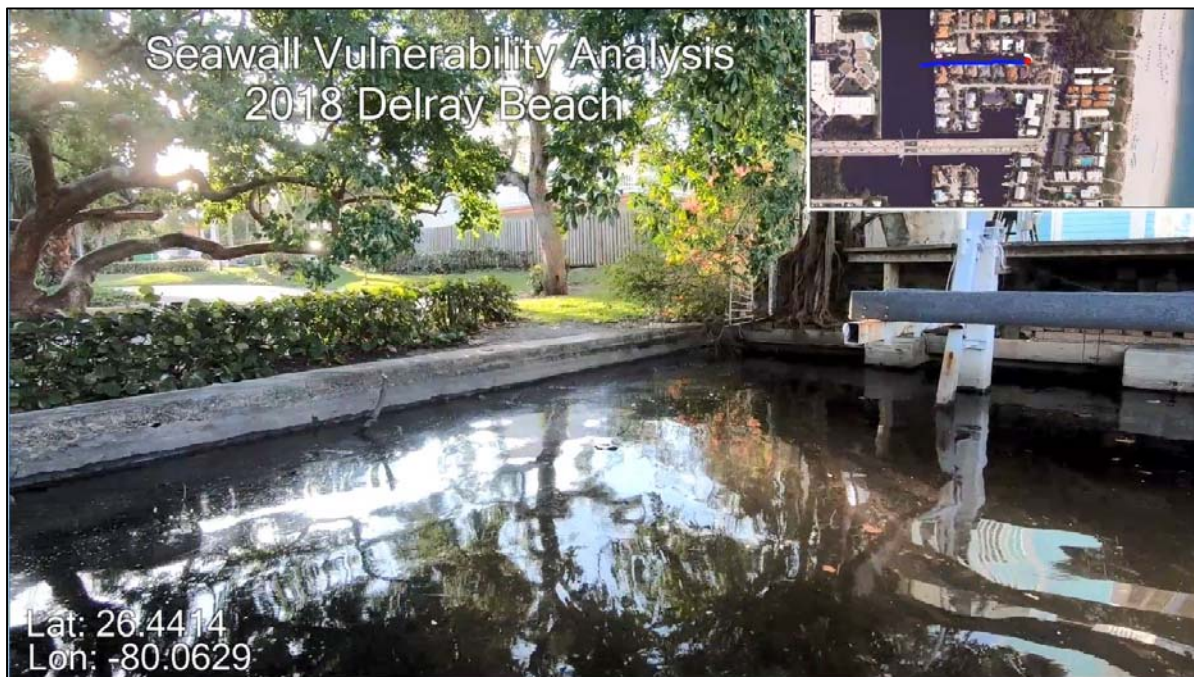
Figure 13. Screenshot from GPS-Coordinated Video West of Atlantic Dunes Park.

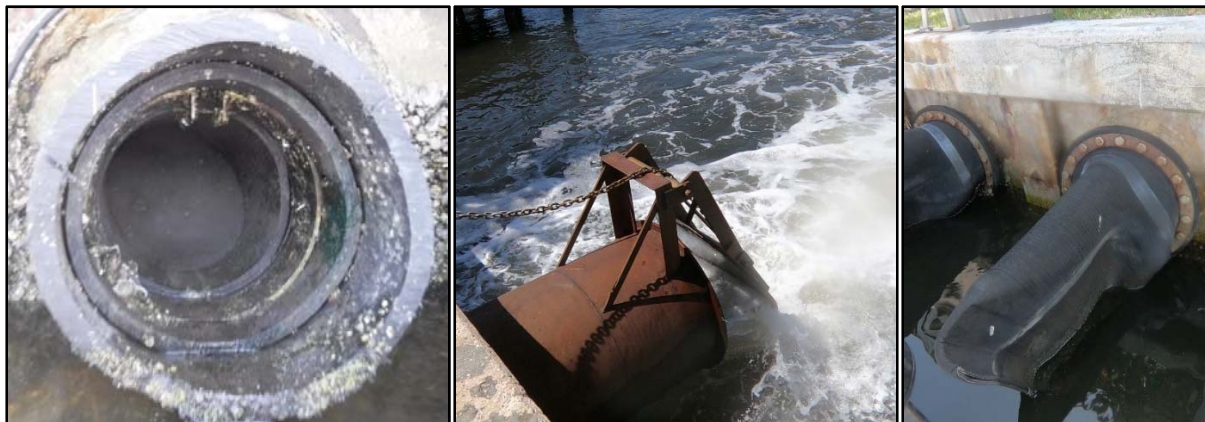
Currently, there are three types of backflow prevention devices installed throughout the study area including: flap gates, duckbills (both straight and recurved) and inline check valves (Figure 15). In support of this study, APTIM inventoried 27 backflow prevention devices. Results of these investigations are presented within Appendices F and G, provided in the geodatabase digital deliverable and discussed further in the analysis section of this report. The City has previously identified select outfalls for future installation of inline check valves, these locations are indicated within Appendix F by a [PI] label for proposed inline check valve.

Figure 15. Examples of Functioning Backflow Prevention Devices Currently Installed (left: inline valve, center: flap gate, right: recurved duckbill valve).

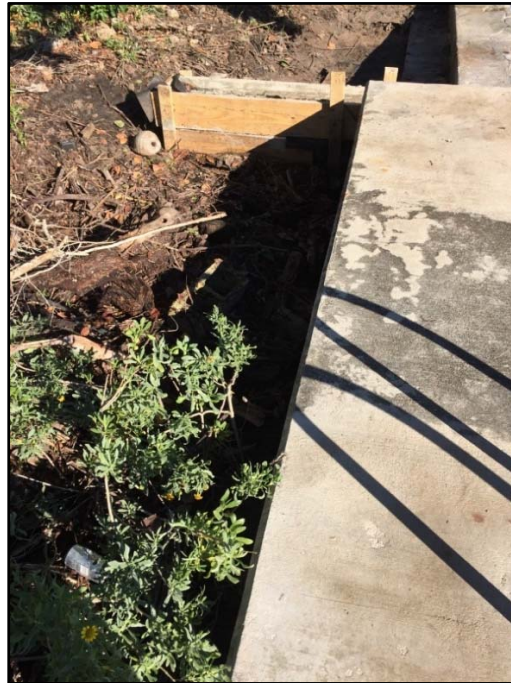
Figure 18. View of the North End of the Seawall Cap at NE 1st Court.

Based on the findings of this study, while the City can improve publically owned seawalls against future high tides, this effort may not prevent future flooding without private owner improvements. For example, consider the seawall at NE 1st Court (Figure 18), where the existing elevation is 2.77 feet NAVD. The City can raise the seawall to the adopted future elevation, but flooding will not be prevented until the adjoining seawall (upper right corner) is also raised.

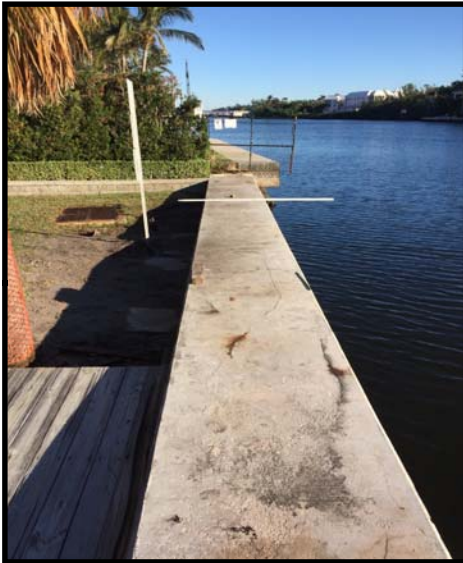
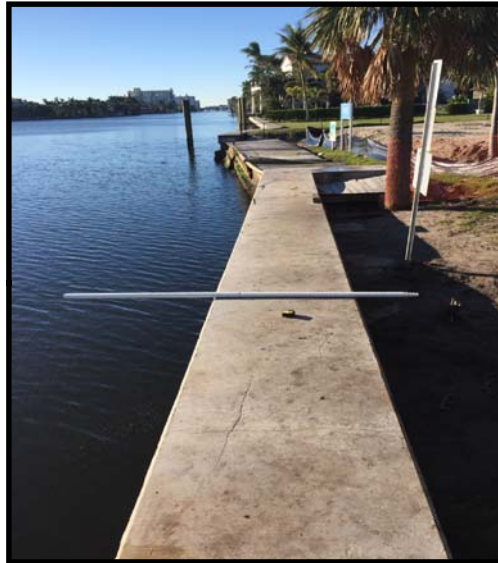
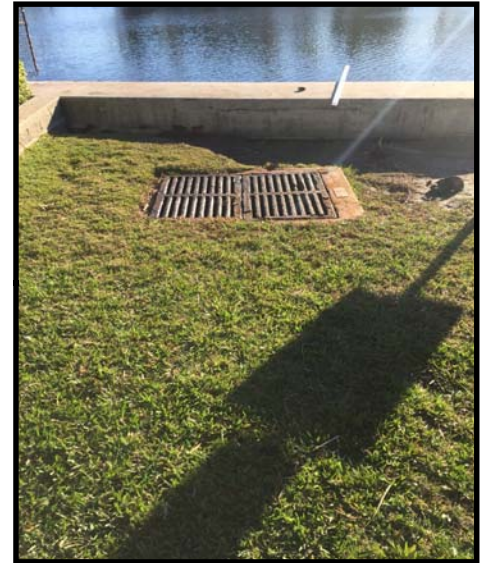
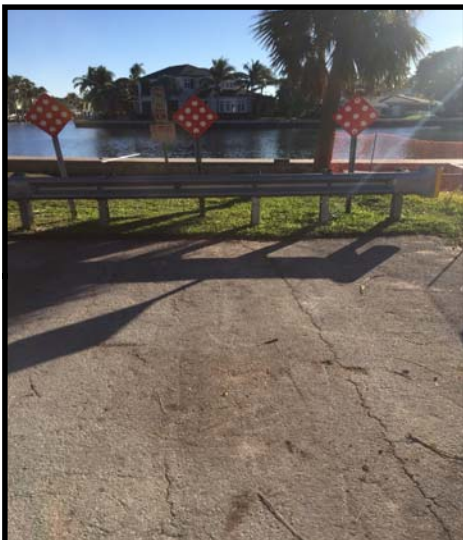
City Owned Seawall: NE 5th Street

Structure Type: Bulkhead Structure Material: Concrete General Condition: Poor Anchored: Yes Anchor Type: Batter Pile Toe Wall: No Dock Frontage: No Toe Scour Stones: No	Continuous: Yes Fence Railing: No Vegetation: Yes Vegetation Location: Back Property Length along Waterway: 48.6' Source: Plat Water Depth: 5' Cap Height Relative Above MHW: 48" Joints: No	Cap Elevation: 3.4' NAVD Cap Width: 42" Cap Height: 18" Utilities: No Stormwater: Yes Outfall: Yes Outfall Pipe Diameter: 48" Outfall Material: Steel
---	---	--

There are longitudinal cracks on the back of the cap. There are two transverse cracks in the top of the cap. The wood deck landward of cap is in poor condition. There is a longitudinal crack in the cap front along most of the cap. There is a crack in the southeast corner of the cap. City reported the wall leaks.

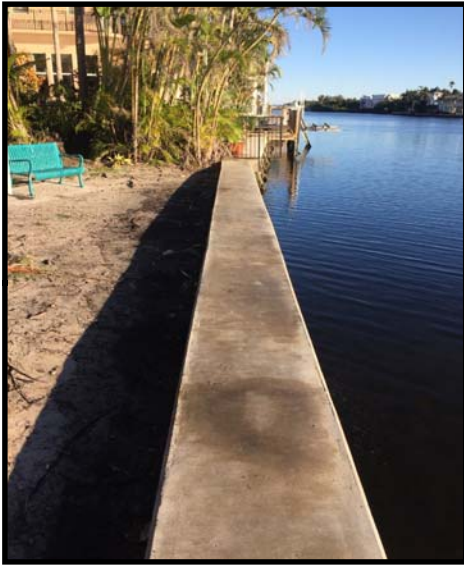
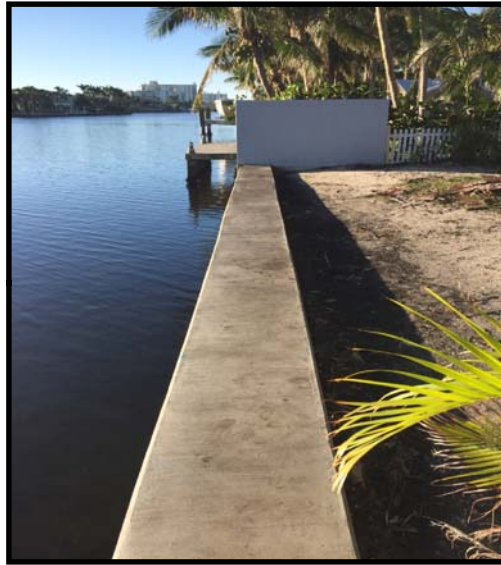
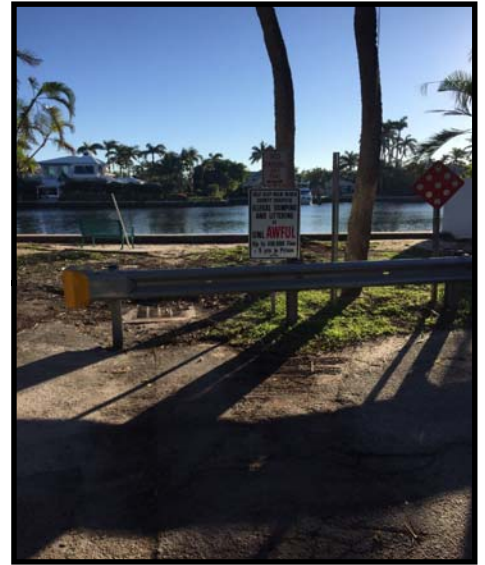
City Owned Seawall: NE 4th Street

**General Condition:
Satisfactory**

The construction appears to be a recent cap over an old seawall cap.

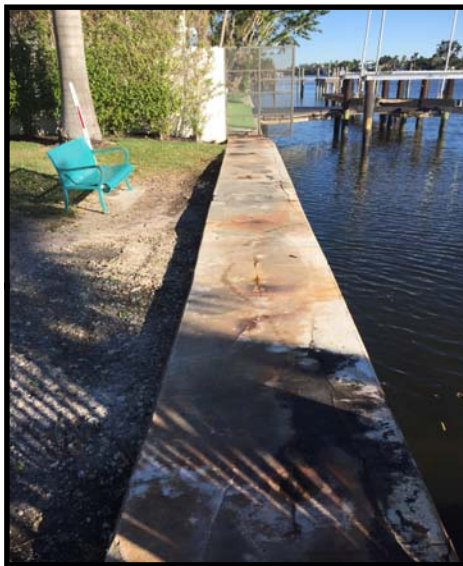
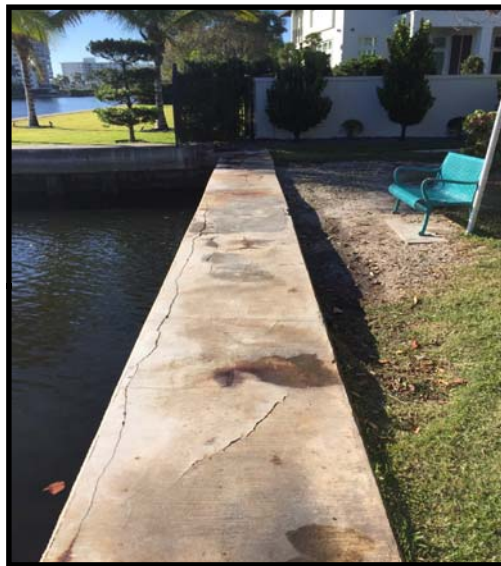
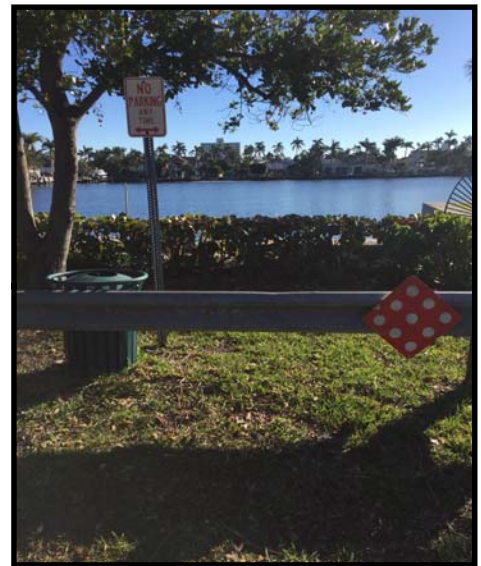
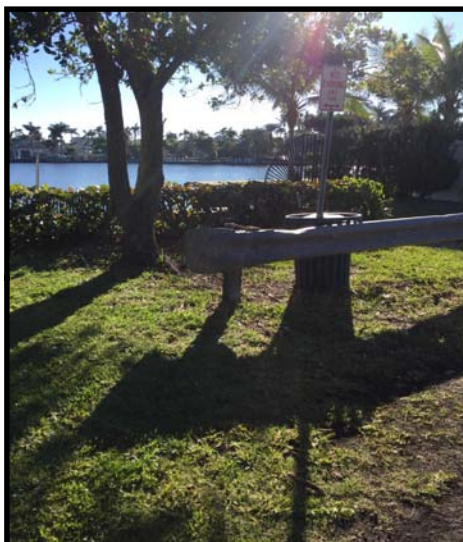
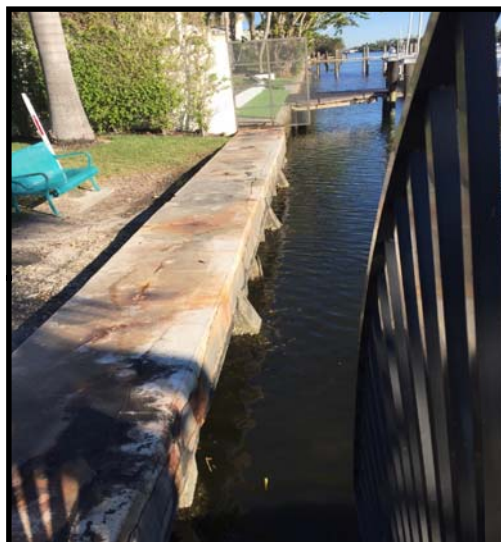
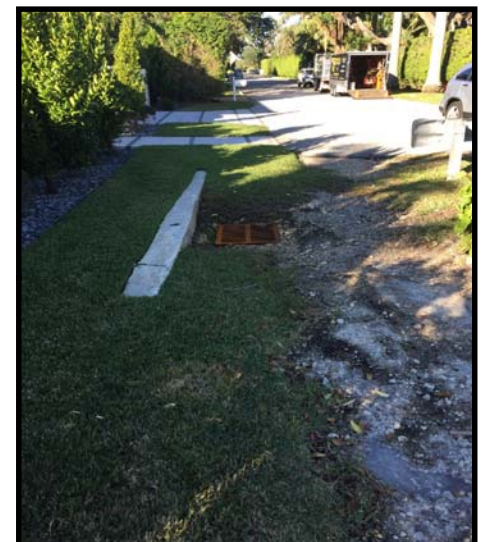
City Owned Seawall: NE 2nd Street

Structure Type: Bulkhead Structure Material: Concrete General Condition: Fair Anchored: Yes Anchor Type: Batter Pile Toe Wall: No Dock Frontage: No Toe Scour Stones: No	Continuous: Yes Fence Railing: No Vegetation: No Vegetation Location: Back Property Length along Waterway: 40' Source: Field Measure Water Depth: 3' Cap Height Relative Above MHW: 36" Joints: No	Cap Elevation: 2.8' NAVD Cap Width: 42" Cap Height: 18" Utilities: No Stormwater: Yes Outfall: Yes Outfall Pipe Diameter: 36" Outfall Material: Concrete
---	---	---

There are two outfalls: one 36 inch diameter and one 48 inch diameter. Both neighbors' property boundaries are not apparent. North neighbor appears to be managing grass at north end of street end. A resident reports flooding at 2nd, 4th, and 5th street ends. Bad flooding occurs at 5th. The cap has rust stains throughout. There are longitudinal cracks on the top and the front of the cap.

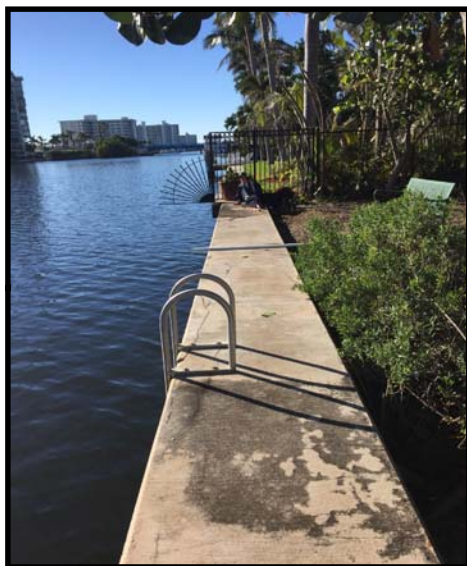
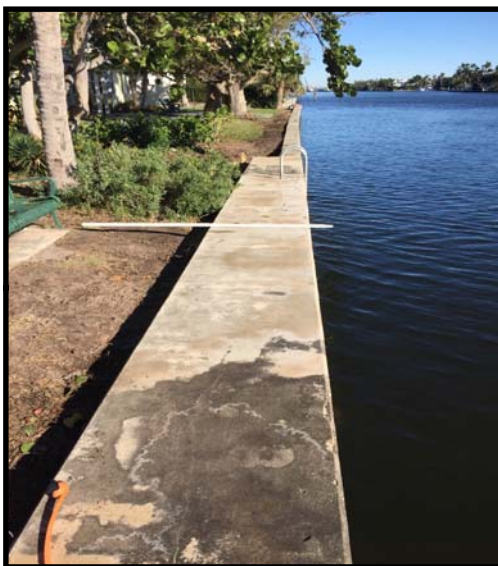
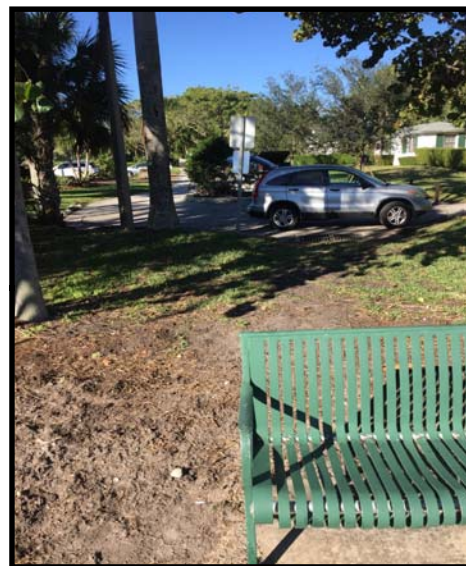
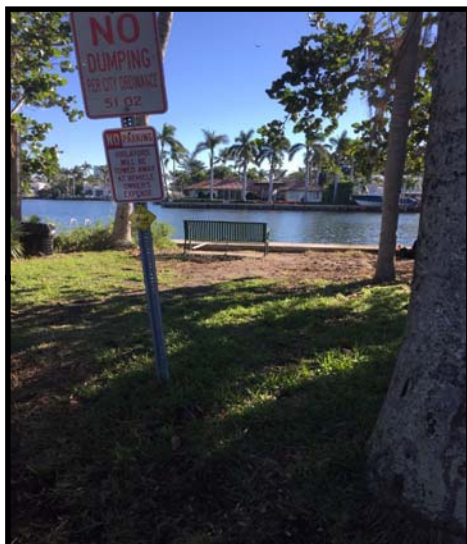
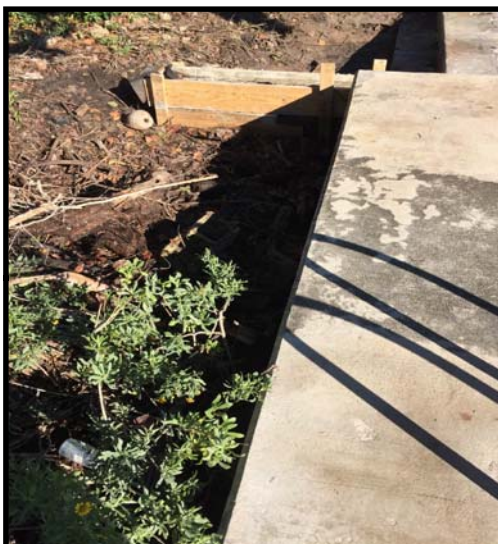
City Owned Seawall: NE 1st Court

Structure Type: Bulkhead Structure Material: Concrete General Condition: Fair Anchored: Yes Anchor Type: Batter Pile Toe Wall: No Dock Frontage: No Toe Scour Stones: No	Continuous: Yes Fence Railing: No Vegetation: Yes Vegetation Location: Back Property Length along Waterway: 44.2' Source: Plat Water Depth: 4' Cap Height Relative Above MHW: 32" Joints: No	Cap Elevation: 2.8' NAVD Cap Width: 42" Cap Height: 24" Utilities: No Stormwater: Yes Outfall: Yes Outfall Pipe Diameter: 12" Outfall Material: Concrete
---	---	---

The seawall leaks at north end. Ladder installed by private owner. Vegetation is one overhanging seagrape, two coconut palms, one seagrape tree, and weeds. There are longitudinal cracks in the front and the top of cap. Soil losses are apparent. North adjoiner is a concreted rubble seawall with a concrete cap. Base of seawall extends into the street right of way. Note: North adjoiner raised cap elevation slightly by April 2018.

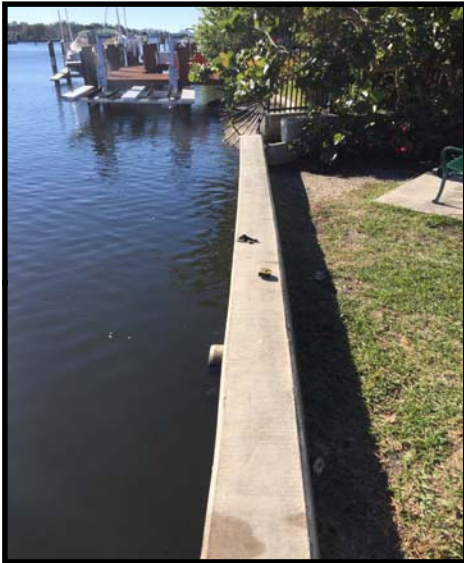
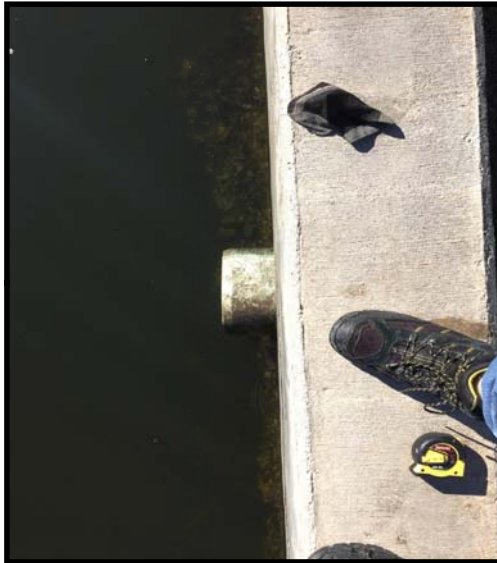
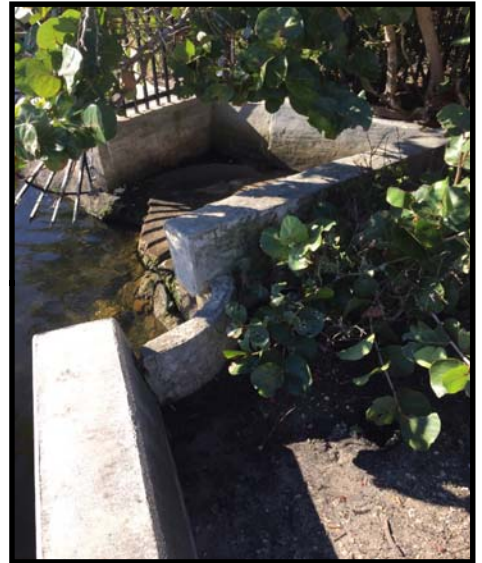
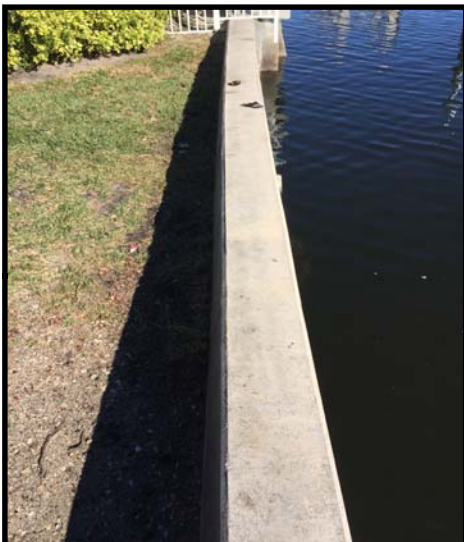
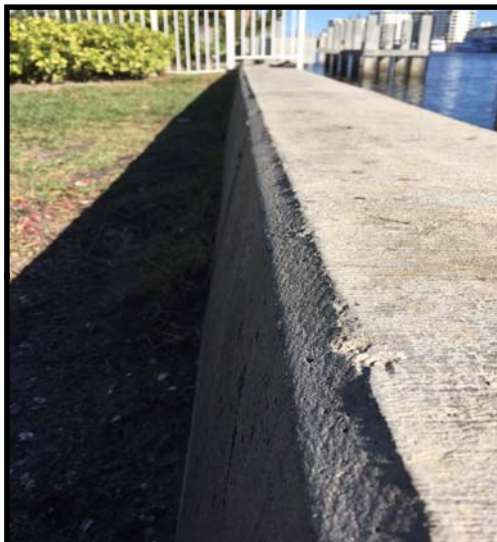
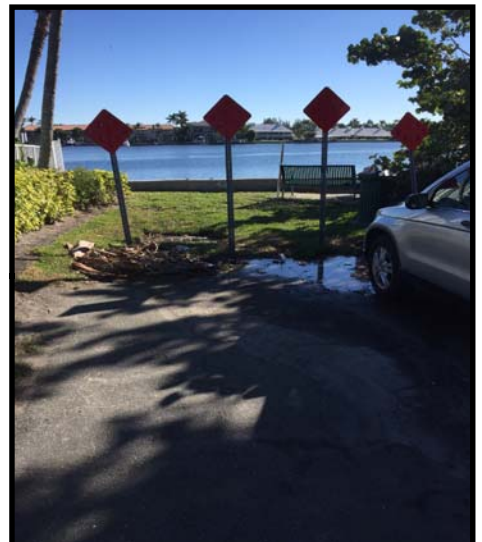
City Owned Seawall: SE 3rd Street

Structure Type: Bulkhead Structure Material: Concrete General Condition: Satisfactory Anchored: Unknown Anchor Type: N/A Toe Wall: No Dock Frontage: No Toe Scour Stones: No	Continuous: Yes Fence Railing: No Vegetation: No Vegetation Location: Back Property Length along Waterway: 36' Source: Plat Water Depth: 4' Cap Height Relative Above MHW: 48" Joints: Yes	Cap Elevation: 3.7' NAVD Cap Width: 13" Cap Height: 0" Utilities: No Stormwater: Yes Outfall: Yes Outfall Pipe Diameter: 12" Outfall Material: PVC
--	---	---

This is a poured wall. There is no cap. There is a horizontal crack in the front face of the concrete, but only in the north half. This is possibly a gravity wall. There are two outfall pipes. 12 inch PVC over a 60 inch concrete pipe which is slightly angled to the northeast. There is an old seawall at the south end. It is unclear where the property boundary is. The south seawall is lower. See photos.

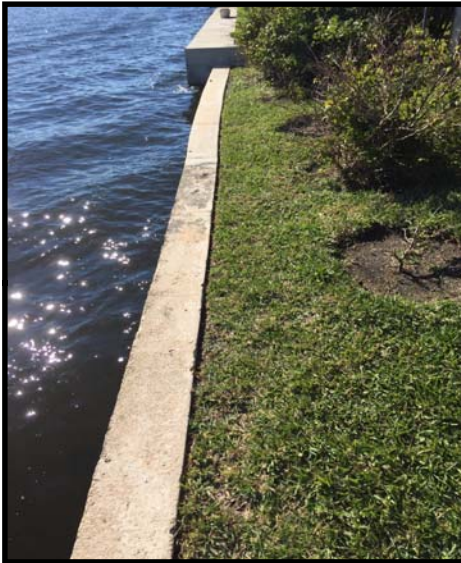
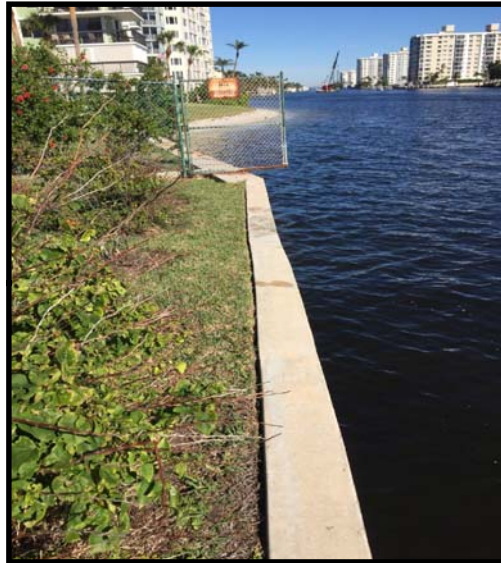
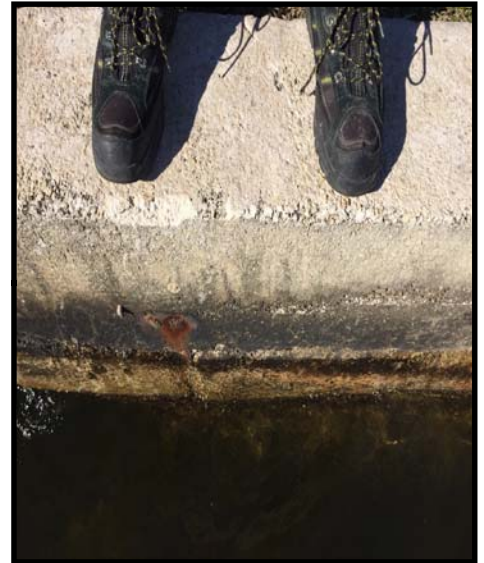
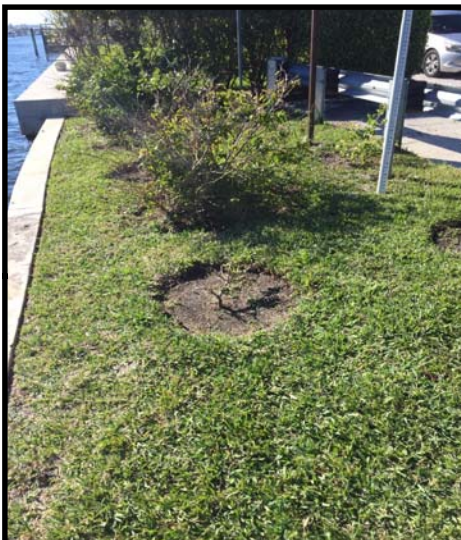
City Owned Seawall: SE 7th Street

Structure Type: Bulkhead Structure Material: Concrete General Condition: Satisfactory Anchored: Unknown Anchor Type: N/A Toe Wall: No Dock Frontage: No Toe Scour Stones: No	Continuous: Yes Fence Railing: No Vegetation: Yes Vegetation Location: Back Property Length along Waterway: 44' Source: Plat Water Depth: 4' Cap Height Relative Above MHW: 36" Joints: No	Cap Elevation: 2.9' NAVD Cap Width: 12" Cap Height: 0" Utilities: No Stormwater: Yes Outfall: Yes Outfall Pipe Diameter: 36" Outfall Material: Concrete
---	---	--

Vegetation is rose bushes. Wall is two types: poured concrete on north half and pile and panel on the south half. Outfall present. No inlet observed.

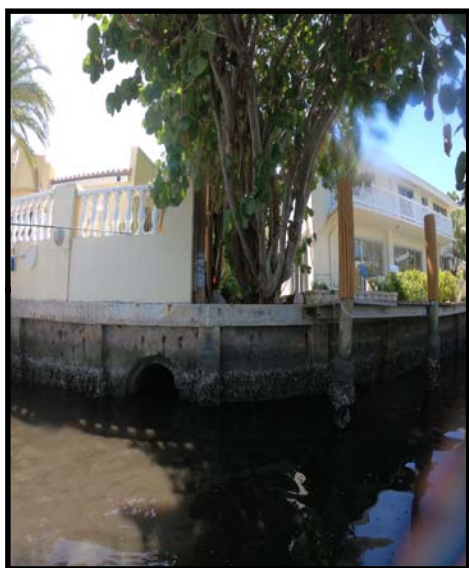
City Owned Seawall: SE 9th Court

Structure Type: Bulkhead Structure Material: Concrete General Condition: Fair Anchored: Unknown Anchor Type: N/A Toe Wall: No Dock Frontage: No Toe Scour Stones: No	Continuous: Yes Fence Railing: No Vegetation: Yes Vegetation Location: Back Property Length along Waterway: 16' Source: Other Water Depth: 4' Cap Height Relative Above MHW: 36" Joints: No	Cap Elevation: 3.3' NAVD Cap Width: 12" Cap Height: 12" Utilities: No Stormwater: Yes Outfall: Yes Outfall Pipe Diameter: 42" Outfall Material: Concrete
---	--	---

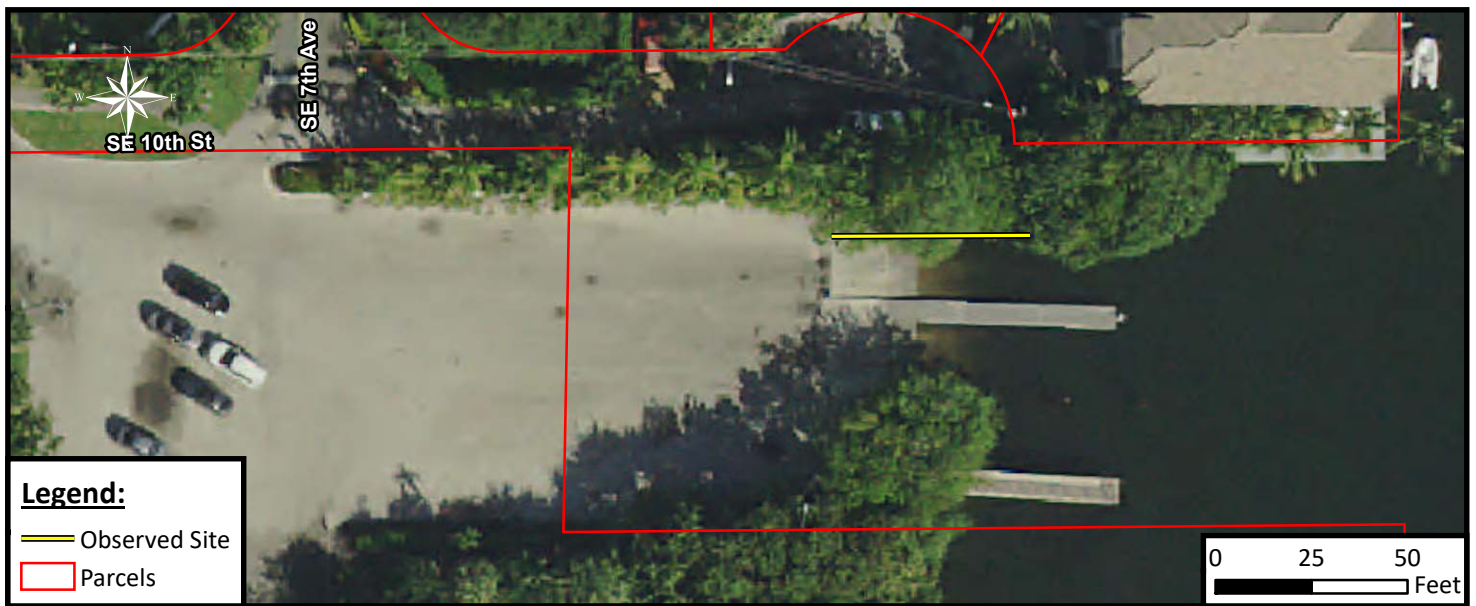
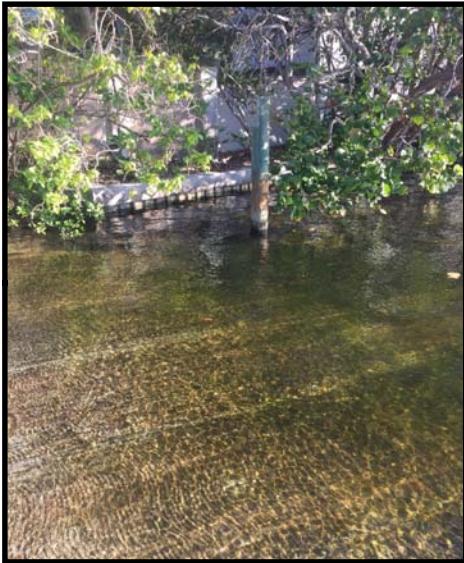
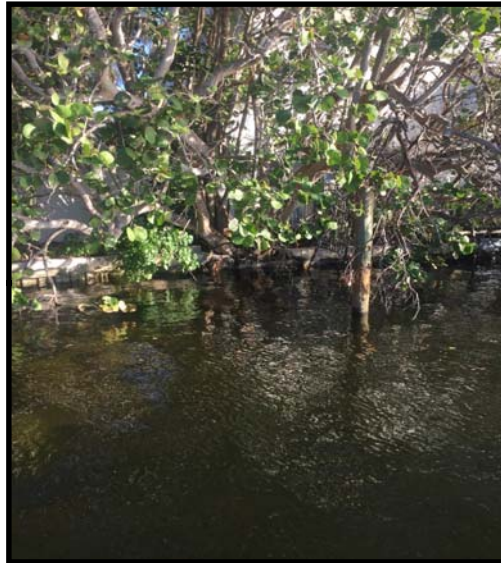
City Owned Seawall: SE 10th Street (Knowles Park)

Structure Type: Bulkhead
Structure Material: Other
General Condition:
Satisfactory
Anchored: Unknown
Anchor Type: N/A
Toe Wall: No
Dock Frontage: No
Toe Scour Stones: No

This is the side wall to the Knowles Park boat ramp aka 10th Street. Ownership is uncertain.

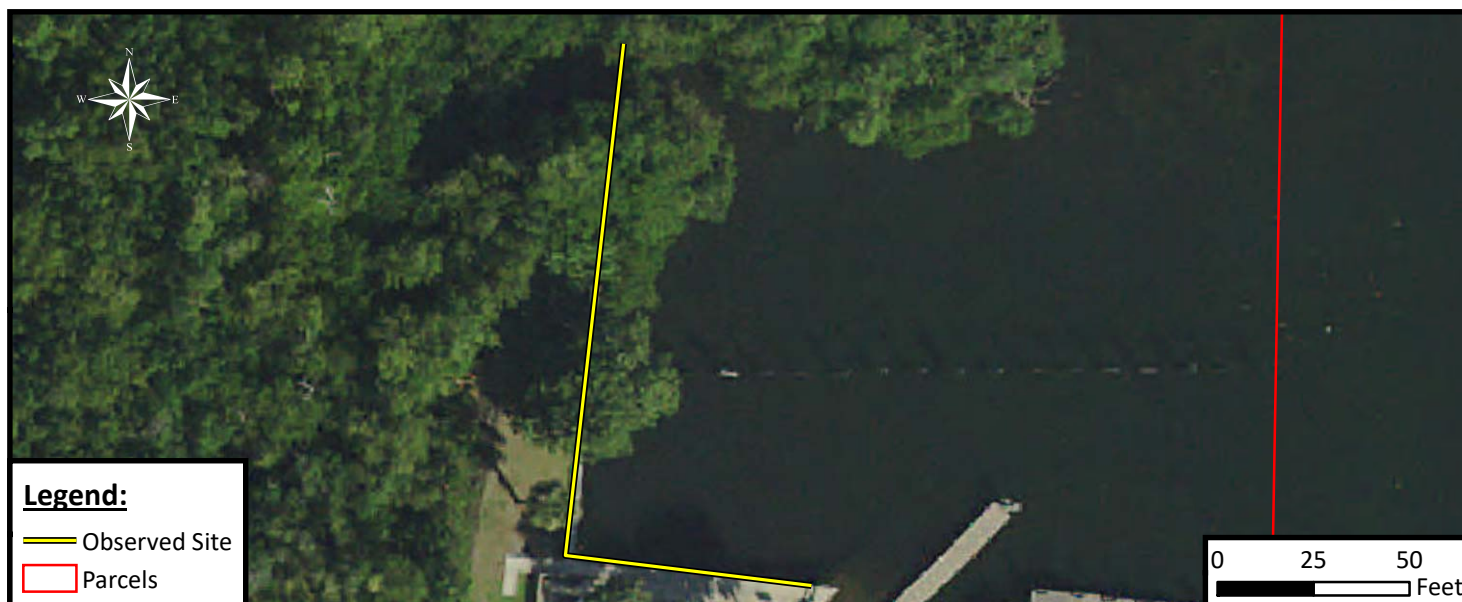
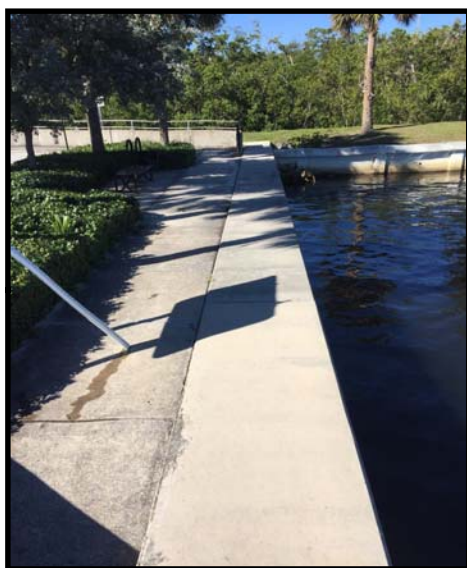
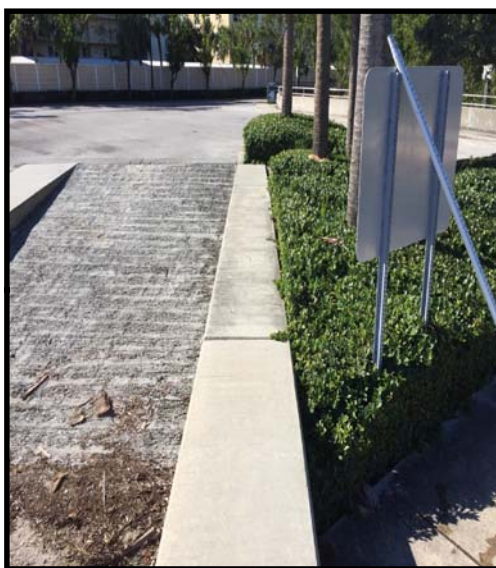
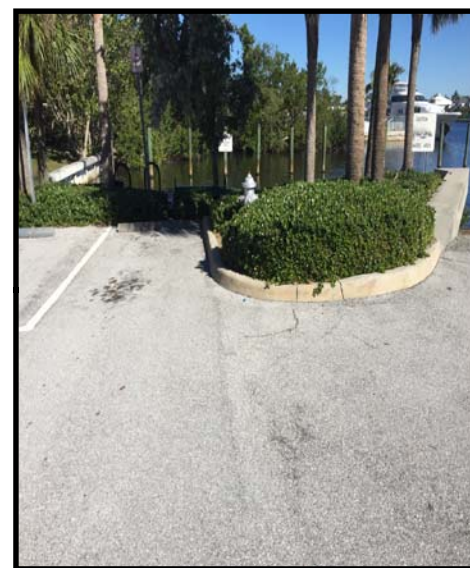
City Owned Seawall: Mangrove Park Ramp - North and West

Structure Type: Bulkhead Structure Material: Concrete General Condition: Satisfactory Anchored: Yes Anchor Type: Tie Back Toe Wall: No Dock Frontage: No Toe Scour Stones: Yes	Continuous: No Fence Railing: No Vegetation: Yes Vegetation Location: Back Property Length along Waterway: 180' Source: Other Water Depth: 5' Cap Height Relative Above MHW: 42" Joints: Yes	Cap Elevation: 4.6' NAVD Cap Width: 43" Cap Height: 32" Utilities: No Stormwater: No Outfall: No Outfall Pipe Diameter: 0" Outfall Material: N/A
--	---	---

North wall has two legs. North piece is old pile and panel with a 2 feet wide cap. Toe stones in corner. East wall is newer. It is a pile and panel seawall, with two batter piles at the east end. North end terminates in mangroves.

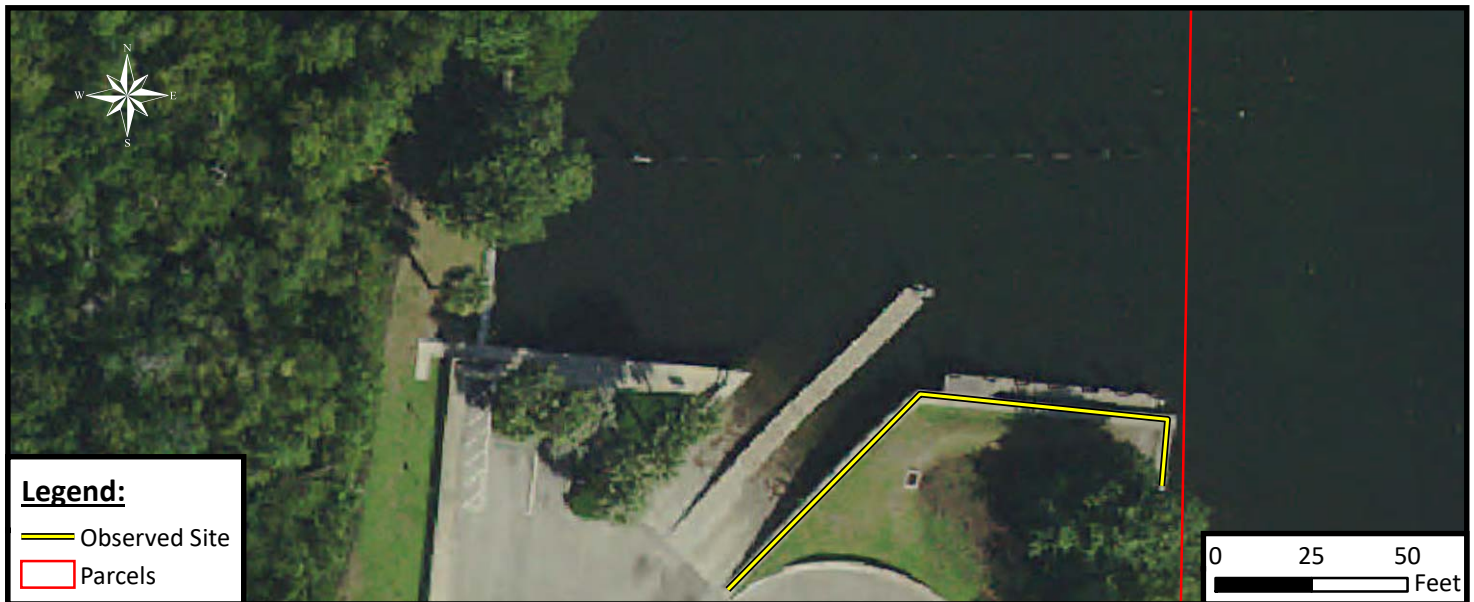
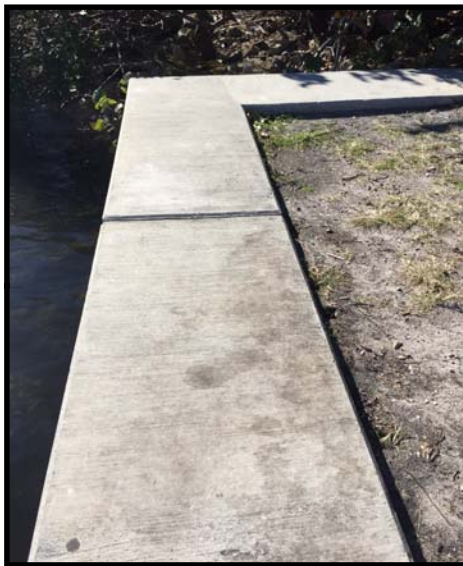
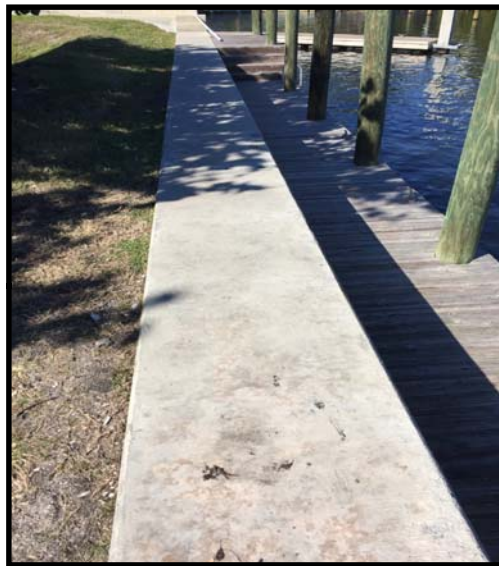
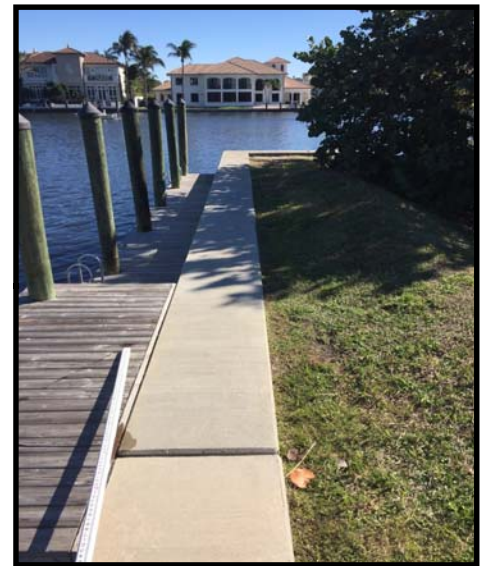
City Owned Seawall: Mangrove Park Ramp - South and East

Structure Type: Bulkhead Structure Material: Concrete General Condition: Satisfactory Anchored: Unknown Anchor Type: N/A Toe Wall: No Dock Frontage: Yes Toe Scour Stones: Yes	Continuous: No Fence Railing: No Vegetation: No Vegetation Location: Other Property Length along Waterway: 160' Source: Other Water Depth: 6' Cap Height Relative Above MHW: 42" Joints: Yes	Cap Elevation: 4.7' NAVD Cap Width: 36" Cap Height: 30" Utilities: No Stormwater: Yes Outfall: Yes Outfall Pipe Diameter: 12" Outfall Material: CMP
---	---	--

The wall is the south part of the ramp bulkhead. Terminates in mangroves. Outfall is from the overflow of a storm water basin. Dock is low relative to mean high water for boat access.

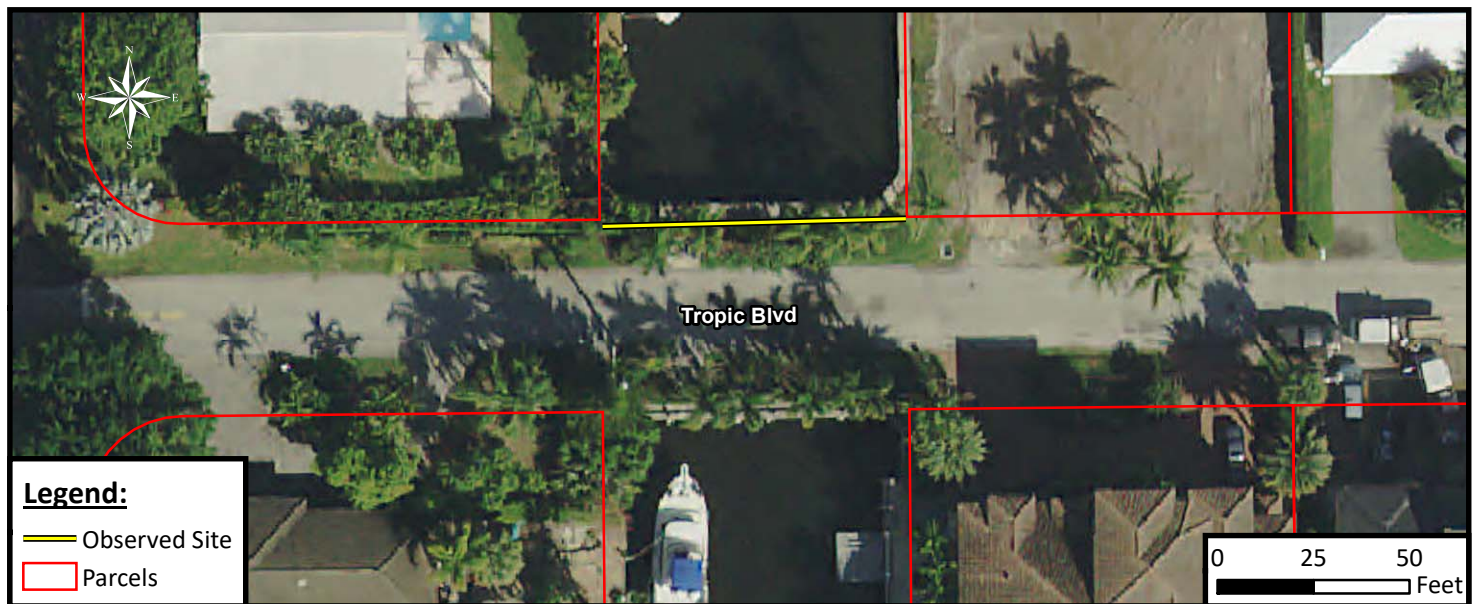
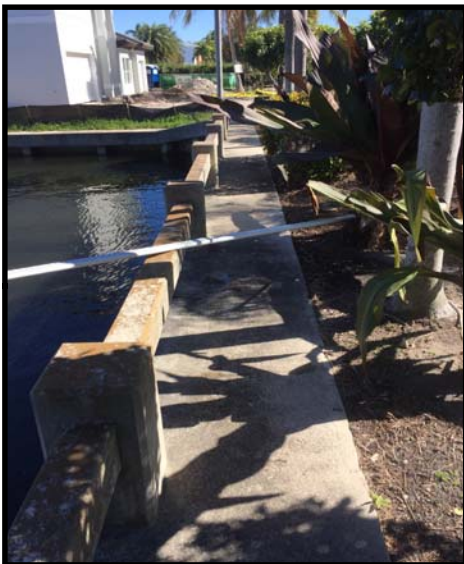
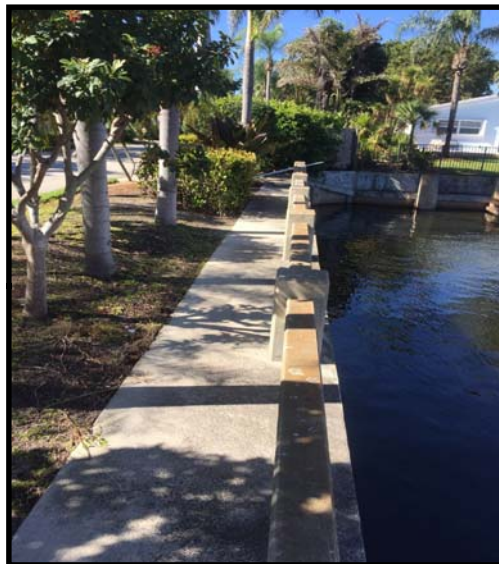
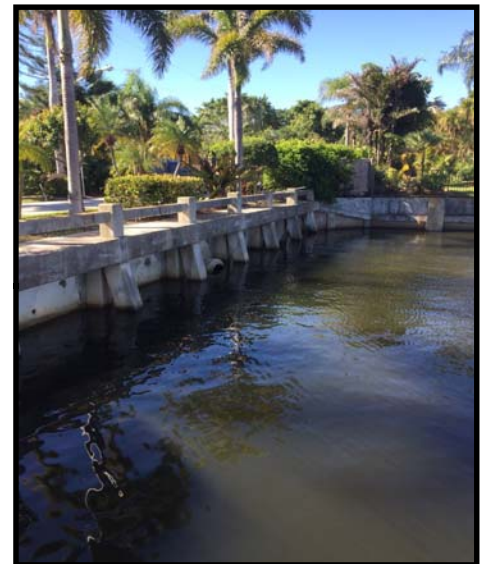
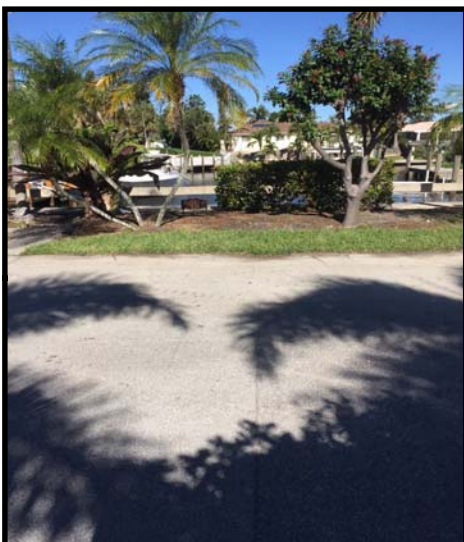
City Owned Seawall: Tropic Boulevard - North Side

Structure Type: Bulkhead Structure Material: Concrete General Condition: Satisfactory Anchored: Yes Anchor Type: Batter Pile Toe Wall: No Dock Frontage: No Toe Scour Stones: No	Continuous: Yes Fence Railing: Yes Vegetation: Yes Vegetation Location: Back Property Length along Waterway: 80' Source: Other Water Depth: 4.5' Cap Height Relative Above MHW: 60" Joints: No	Cap Elevation: 6.1' NAVD Cap Width: 45" Cap Height: 18" Utilities: No Stormwater: Yes Outfall: Yes Outfall Pipe Diameter: 24" Outfall Material: CMP
---	---	--

The outfall is adjacent to the inlet immediately landward of the cap. A concrete pipe is connected under the causeway.

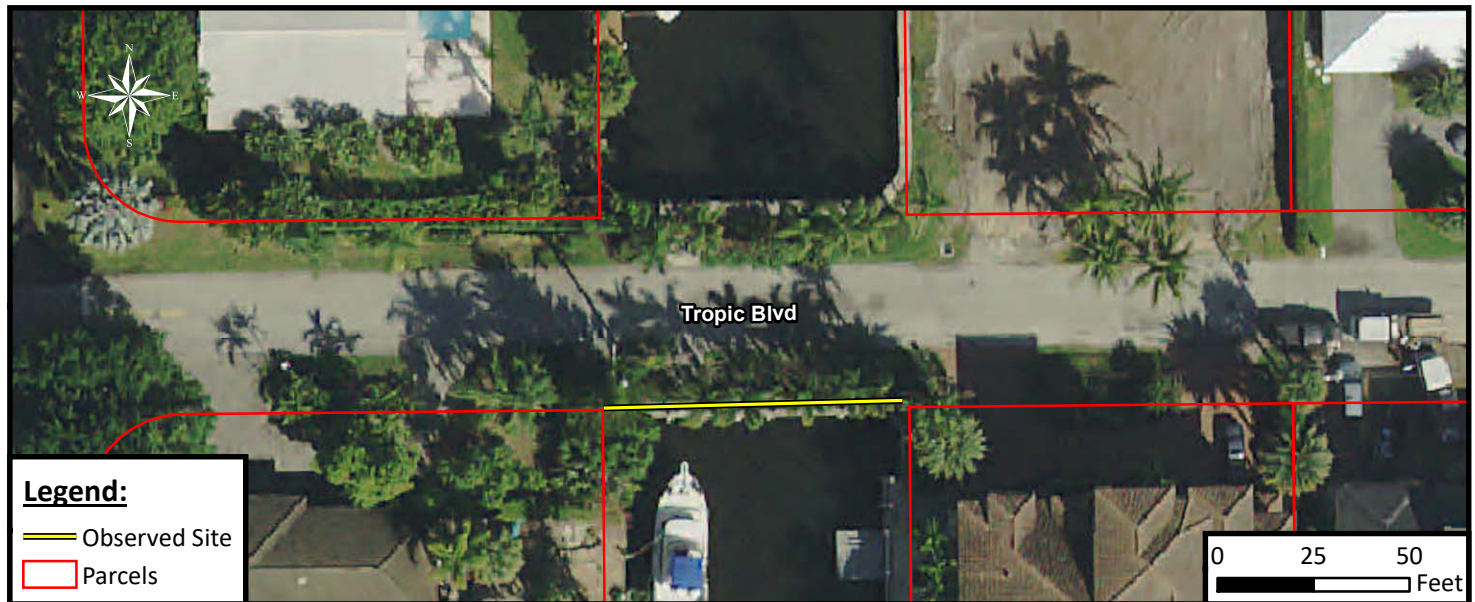
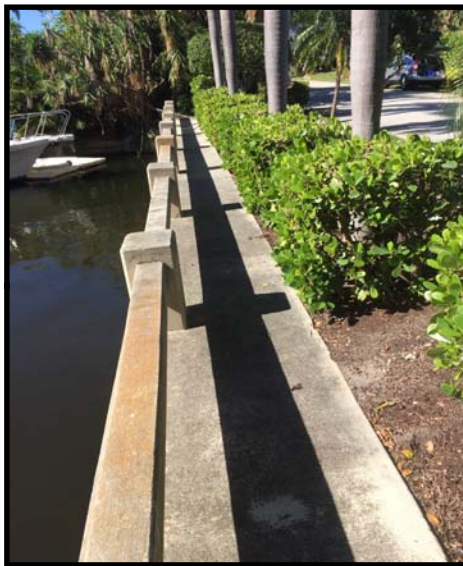
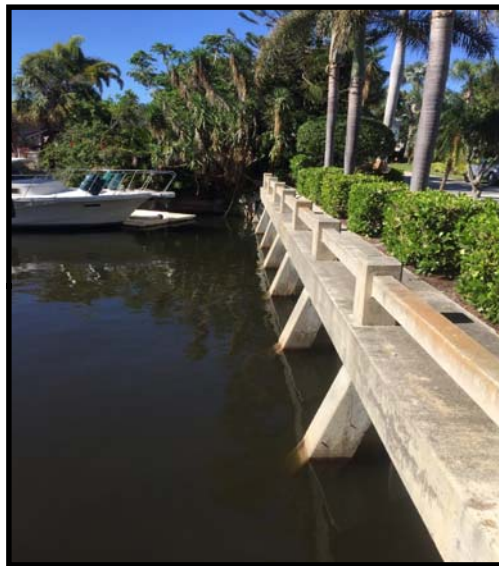
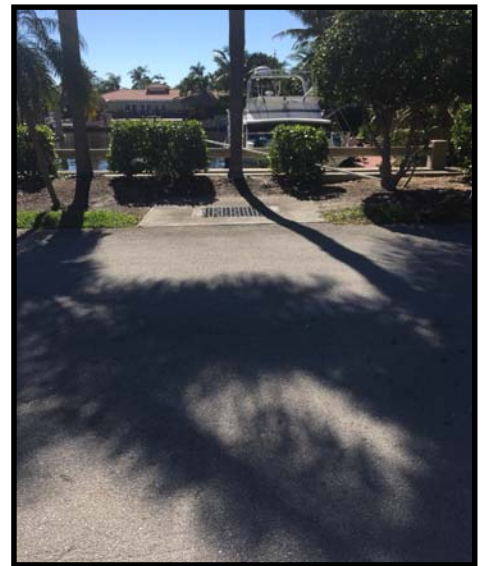
City Owned Seawall: Tropic Boulevard - South Side

Structure Type: Bulkhead Structure Material: Concrete General Condition: Satisfactory Anchored: Yes Anchor Type: Batter Pile Toe Wall: No Dock Frontage: No Toe Scour Stones: No	Continuous: Yes Fence Railing: Yes Vegetation: Yes Vegetation Location: Back Property Length along Waterway: 77' Source: Other Water Depth: 5' Cap Height Relative Above MHW: 60" Joints: No	Cap Elevation: 6.5' NAVD Cap Width: 45" Cap Height: 18" Utilities: No Stormwater: Yes Outfall: Yes Outfall Pipe Diameter: 24" Outfall Material: CMP
---	---	--

A concrete pipe is connected under the causeway. There is a landscaped upland.

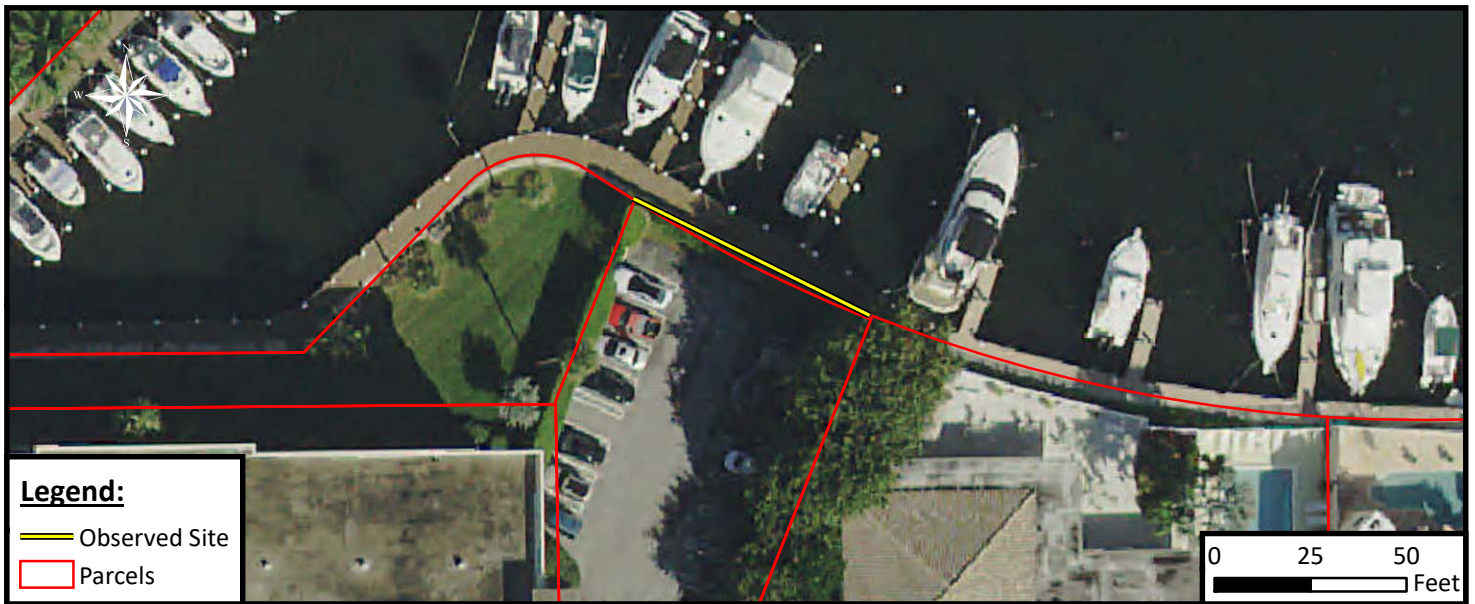
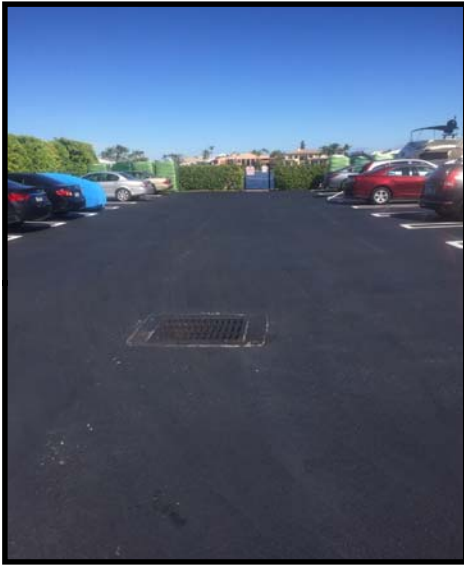
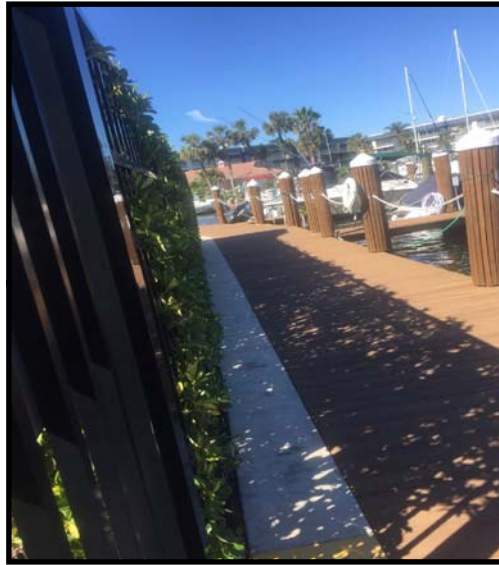
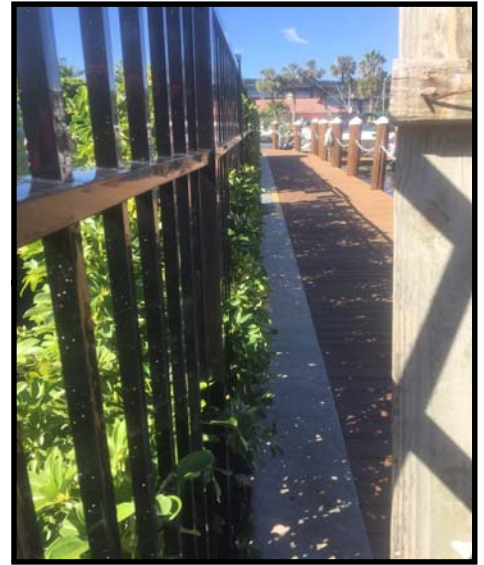
City Owned Seawall: Spanish Circle

Structure Type: Bulkhead Structure Material: Concrete General Condition: Satisfactory Anchored: Unknown Anchor Type: N/A Toe Wall: No Dock Frontage: Yes Toe Scour Stones: No	Continuous: Yes Fence Railing: Yes Vegetation: Yes Vegetation Location: Back Property Length along Waterway: 69' Source: Plat Water Depth: 3.5' Cap Height Relative Above MHW: 18" Joints: No	Cap Elevation: 2.9' NAVD Cap Width: 16" Cap Height: 10" Utilities: No Stormwater: Yes Outfall: Yes Outfall Pipe Diameter: 24" Outfall Material: Concrete
--	--	---

Limited access due to locked gate and overhanging dock. Outfall located during outfall survey.
