City of Delray Beach Intracoastal Waterway Water Level & Infrastructure Vulnerability Study

Submitted to:
City of Delray Beach

Submitted by:
Aptim Environmental & Infrastructure, Inc.

Project No. 631233074
October 2018

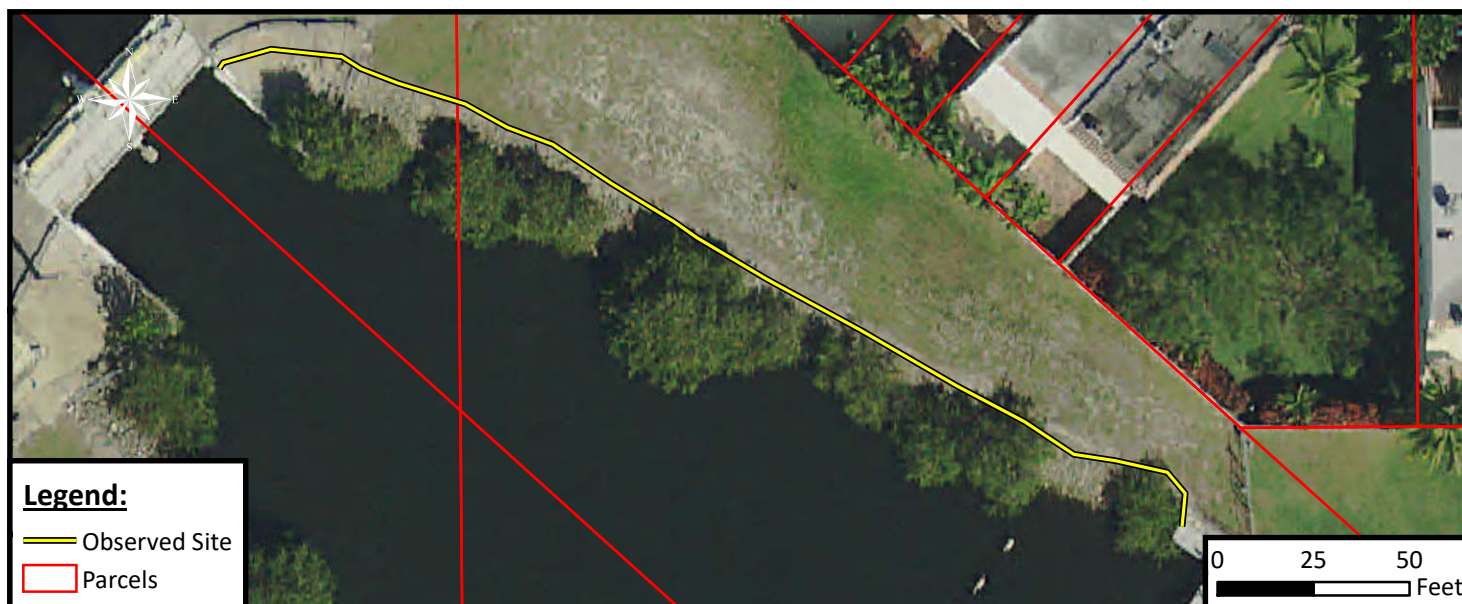
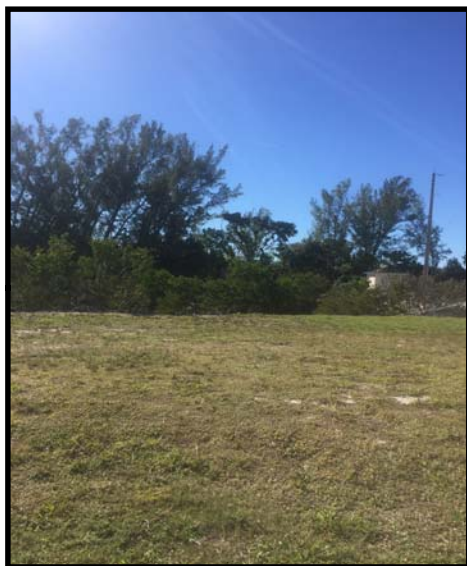
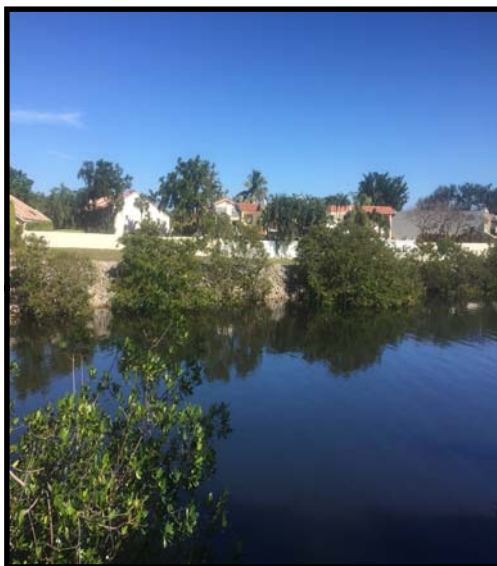
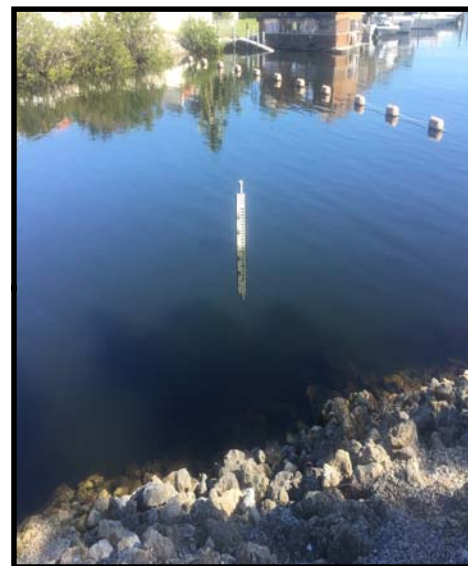
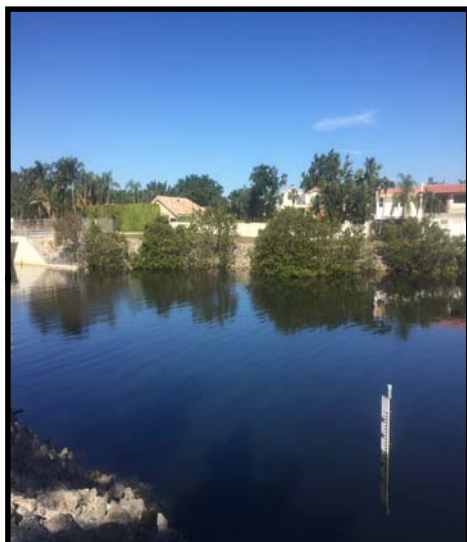
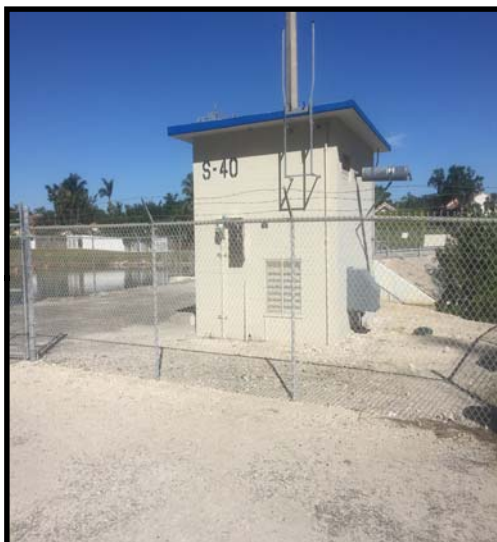
City Owned Seawall: SFWMD R/W Revetment at Structure S40

**Structure Type: Revetment****Structure Material: Rock****General Condition:
Fair****Anchored: N/A****Anchor Type: N/A****Toe Wall: No****Dock Frontage: No****Toe Scour Stones: No****Continuous: No****Fence Railing: No****Vegetation: Yes****Vegetation Location: Back****Property Length along****Waterway: 250'****Source: Other****Water Depth: N/A****Cap Height Relative
Above MHW: N/A****Joints: N/A****Cap Elevation: N/A****Cap Width: N/A****Cap Height: N/A****Utilities: No****Stormwater: Yes****Outfall: Yes****Outfall Pipe Diameter: 24"****Outfall Material: CMP****Field Notes:**

No access from north side. Visible from south bank. Pipe information from outfall inspection.

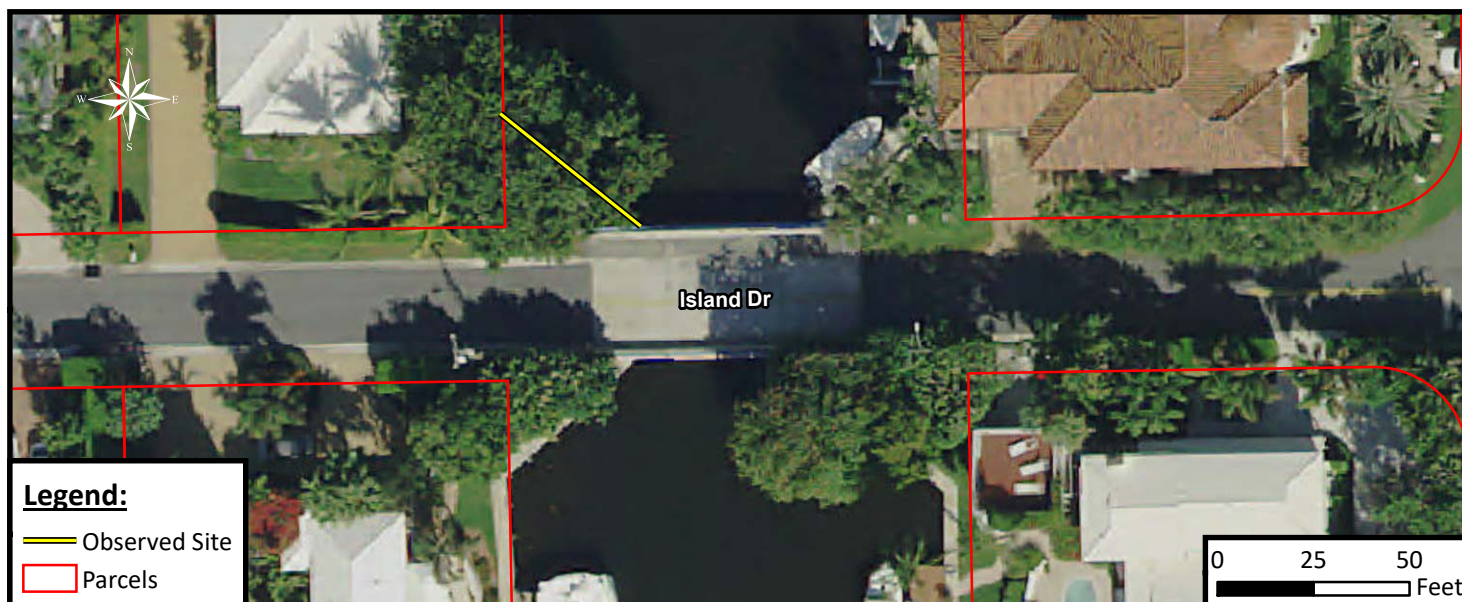
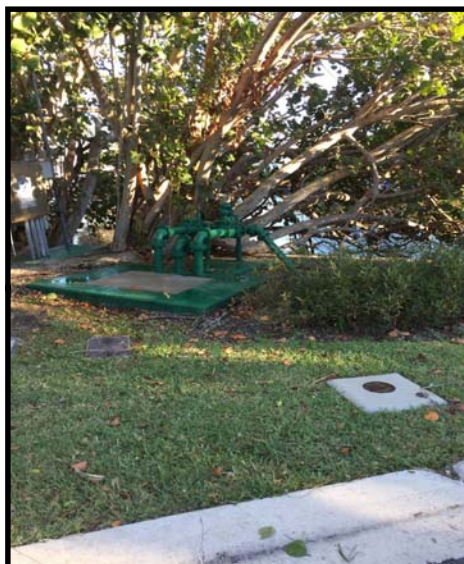
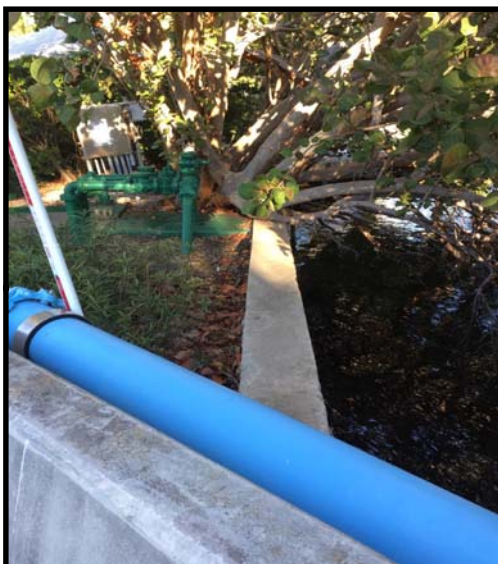
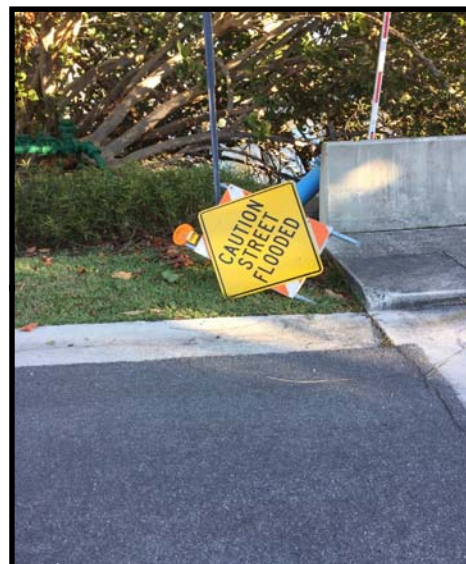
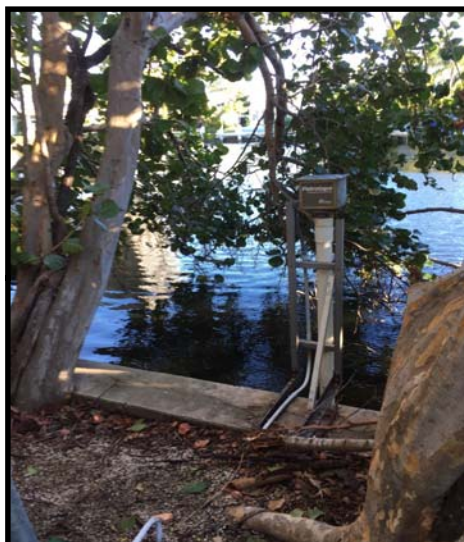
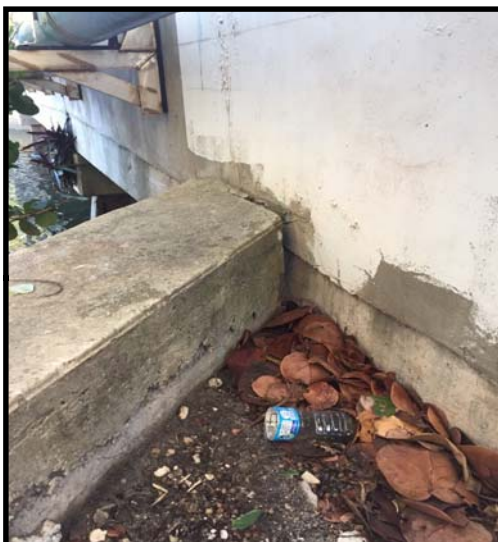
City Owned Seawall: Island Drive Bridge Abutment NW

Structure Type: Bulkhead Structure Material: Concrete General Condition: Fair Anchored: Unknown Anchor Type: N/A Toe Wall: Yes Dock Frontage: No Toe Scour Stones: No	Continuous: Yes Fence Railing: No Vegetation: Yes Vegetation Location: Over Property Length along Waterway: 45' Source: Other Water Depth: 3' Cap Height Relative Above MHW: 50" Joints: No	Cap Elevation: 3.9' NAVD Cap Width: 16" Cap Height: 11" Utilities: Yes Stormwater: Yes Outfall: Yes Outfall Pipe Diameter: 8" Outfall Material: Steel
--	--	--

There are three large sea grape trees overhanging the bulkhead. Cap has minor longitudinal cracks. There is a lift station landward of the bulkhead. There is a water level gage on site. The seawall cap joint is open at the bridge.

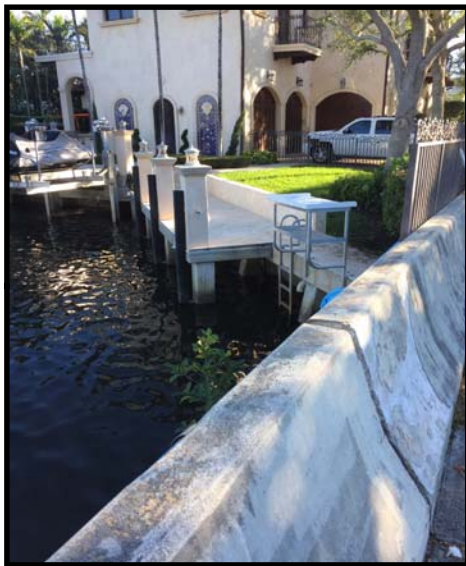
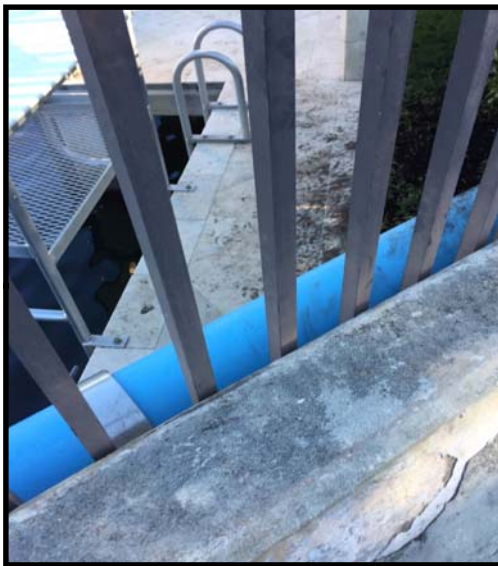
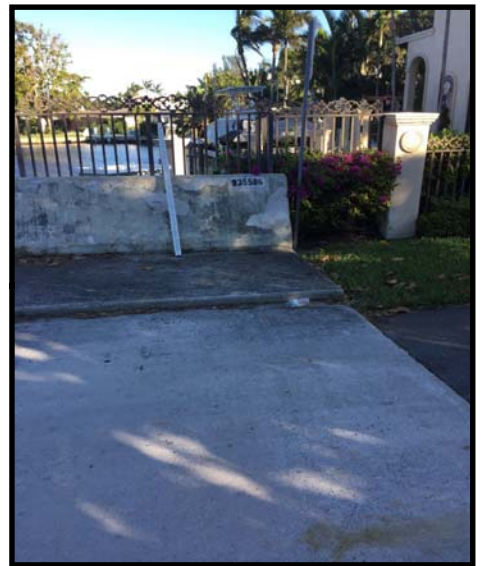
**City Owned Seawall:
Island Drive Bridge Abutment NE**

Structure Type: Bulkhead Structure Material: Concrete General Condition: Good Anchored: Yes Anchor Type: Batter Pile Toe Wall: Unknown Dock Frontage: Yes Toe Scour Stones: Unknown	Continuous: Yes Fence Railing: Yes Vegetation: No Vegetation Location: Back Property Length along Waterway: 34' Source: Other Water Depth: 4' Cap Height Relative Above MHW: 48" Joints: No	Cap Elevation: 3.6' NAVD Cap Width: 36" Cap Height: 15" Utilities: Yes Stormwater: No Outfall: No Outfall Pipe Diameter: 0" Outfall Material: N/A
---	--	--

The seawall is fenced off. There is no access. Some measurements estimated from adjacent bridge. Utilities cross the cap. The cap and the wall were repaired with the adjacent private property. The cap matches aesthetics of the adjoining property.

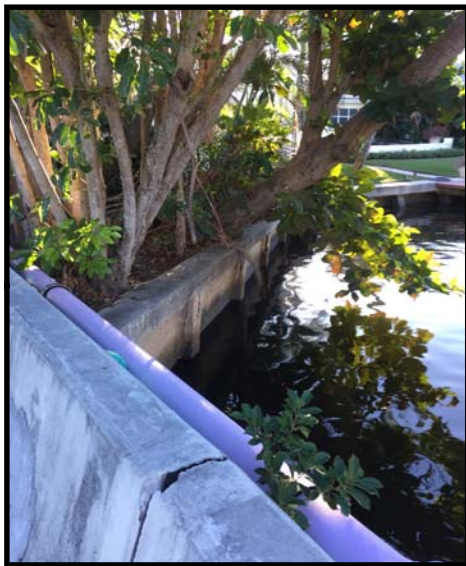
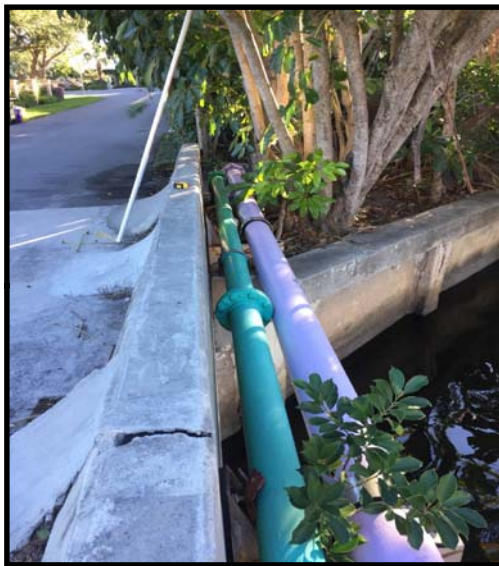
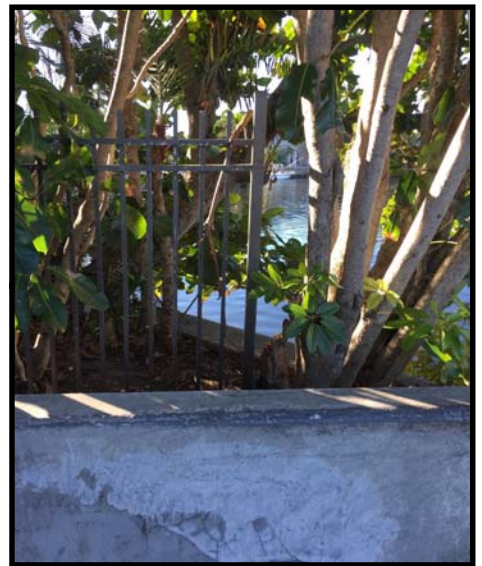
**City Owned Seawall:
Island Drive Bridge Abutment SE**

Structure Type: Bulkhead	Continuous: Yes	Cap Elevation: 4.3' NAVD
Structure Material: Concrete	Fence Railing: Yes	Cap Width: 10"
General Condition: Poor	Vegetation: Yes	Cap Height: 14"
Anchored: Unknown	Vegetation Location: Over	Utilities: Yes
Anchor Type: N/A	Property Length along	Stormwater: No
Toe Wall: Yes	Waterway: 40'	Outfall: No
Dock Frontage: No	Source: Other	Outfall Pipe Diameter: 0"
Toe Scour Stones: No	Water Depth: 3'	Outfall Material: N/A
	Cap Height Relative	
	Above MHW: 60"	
	Joints: No

There is a large overhanging tree overturning the seawall. Original piles contain vertical cracks. Private fence prevents access to the seawall.

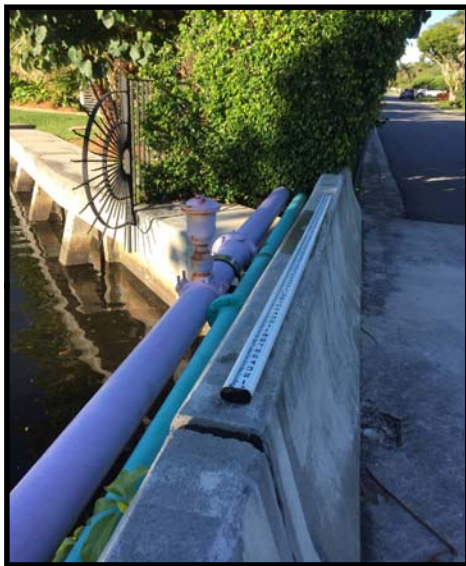
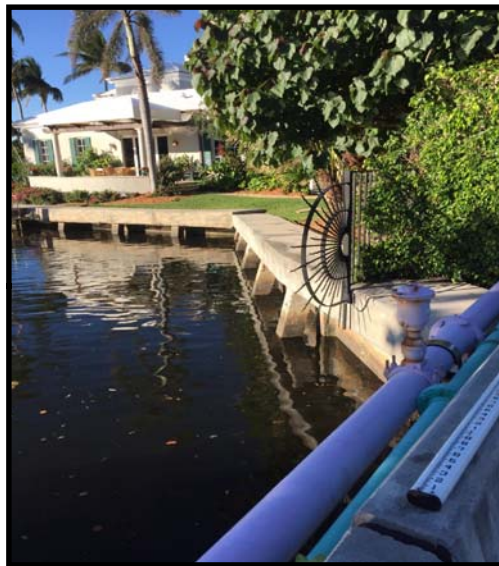
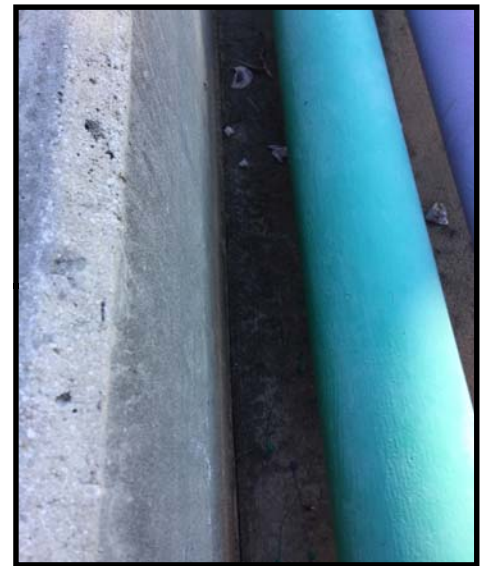
**City Owned Seawall:
Island Drive Bridge Abutment SW**

Structure Type: Bulkhead Structure Material: Concrete General Condition: Satisfactory Anchored: Yes Anchor Type: Batter Pile Toe Wall: No Dock Frontage: No Toe Scour Stones: No	Continuous: Yes Fence Railing: Yes Vegetation: Yes Vegetation Location: Back Property Length along Waterway: 49' Source: Other Water Depth: 3' Cap Height Relative Above MHW: 60" Joints: No	Cap Elevation: 3.4' NAVD Cap Width: 42" Cap Height: 19" Utilities: Yes Stormwater: No Outfall: No Outfall Pipe Diameter: 0" Outfall Material: N/A
---	---	--

A private fence prevents access to the seawall. The seawall includes a repaired cap and batter piles which are similar to the adjoining wall. Water utilities cross over the cap.

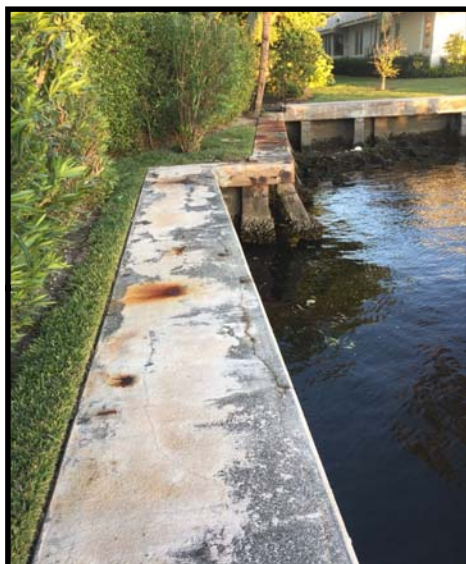
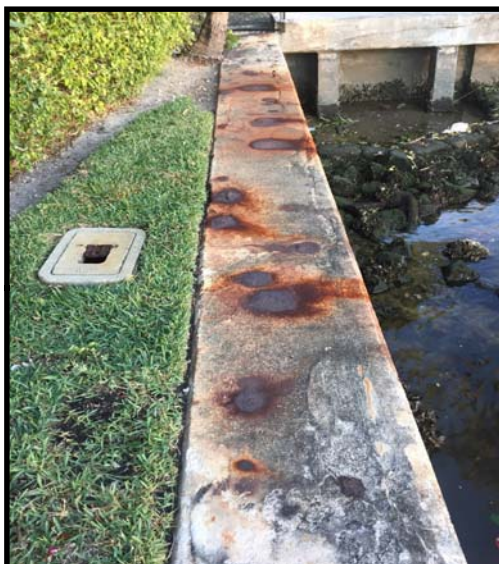
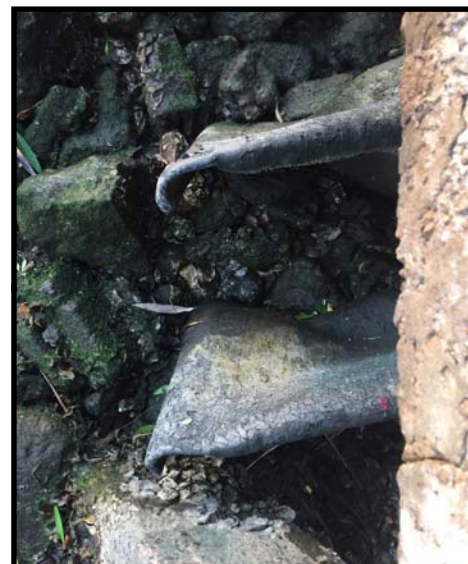
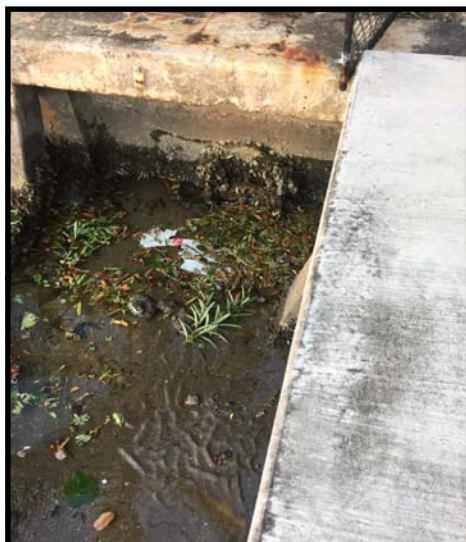
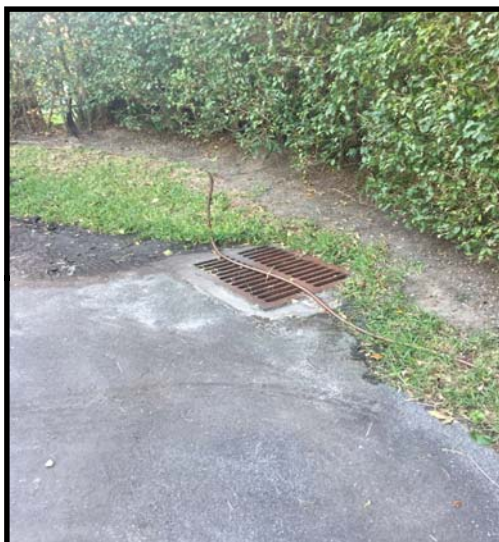
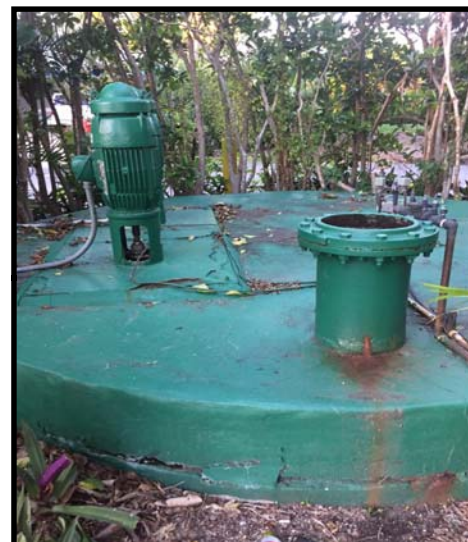
**City Owned Seawall:
Beach Drive**

Structure Type: Bulkhead Structure Material: Concrete General Condition: Poor Anchored: Yes Anchor Type: Batter Pile Toe Wall: No Dock Frontage: No Toe Scour Stones: Yes	Continuous: Yes Fence Railing: No Vegetation: Yes Vegetation Location: Back Property Length along Waterway: 155' Source: Other Water Depth: 3' Cap Height Relative Above MHW: 36" Joints: No	Cap Elevation: 2.8' NAVD Cap Width: 36" Cap Height: 15" Utilities: No Stormwater: Yes Outfall: Yes Outfall Pipe Diameter: 12" Outfall Material: Concrete
--	---	---

Wall zig zags. East end is in poor condition. West end is in fair condition condition. There are toe stones in east corner. There are two duckbill backflow valves at the wall. There is one flap gate in the mud. All outfalls are in the east end of the wall.

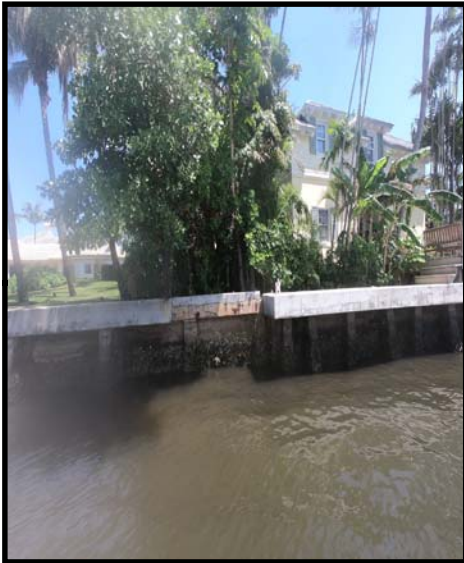
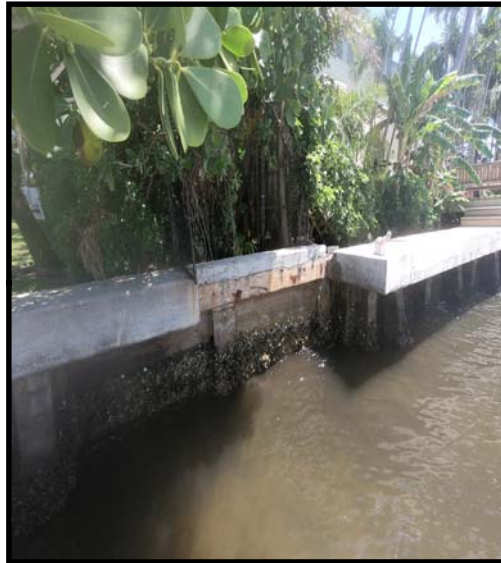
**City Owned Seawall:
Seaspray Avenue**

Structure Type: Bulkhead Structure Material: Concrete General Condition: Fair Anchored: Unknown Anchor Type: N/A Toe Wall: No Dock Frontage: No Toe Scour Stones: No	Continuous: Yes Fence Railing: Yes Vegetation: Yes Vegetation Location: Back Property Length along Waterway: 10' Source: Plat Water Depth: 3' Cap Height Relative Above MHW: 36" Joints: No	Cap Elevation: 3.4' NAVD Cap Width: 12" Cap Height: 18" Utilities: No Stormwater: Yes Outfall: Yes Outfall Pipe Diameter: 24" Outfall Material: Concrete
---	--	---

No access from road. Densely vegetated. Outfall was located during outfall observation.

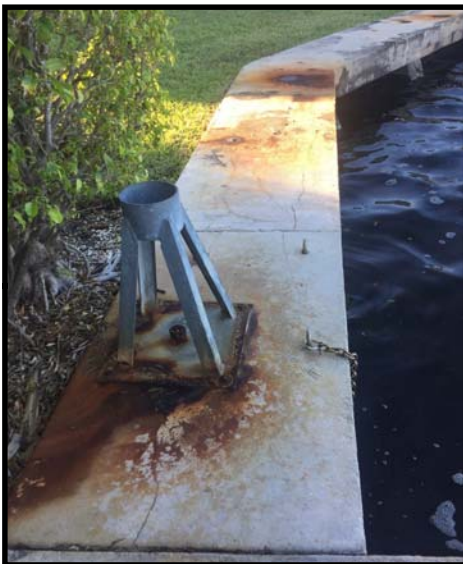
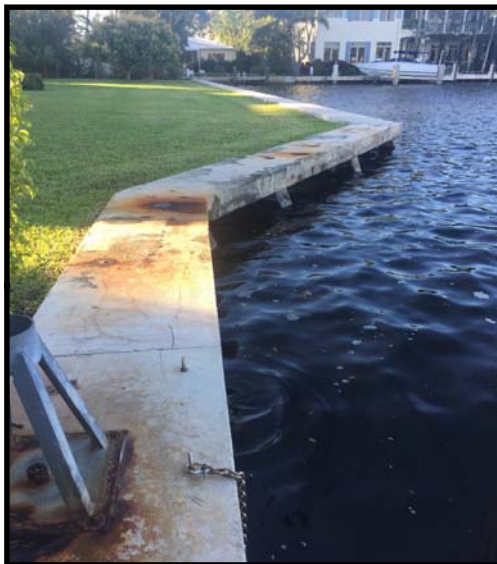
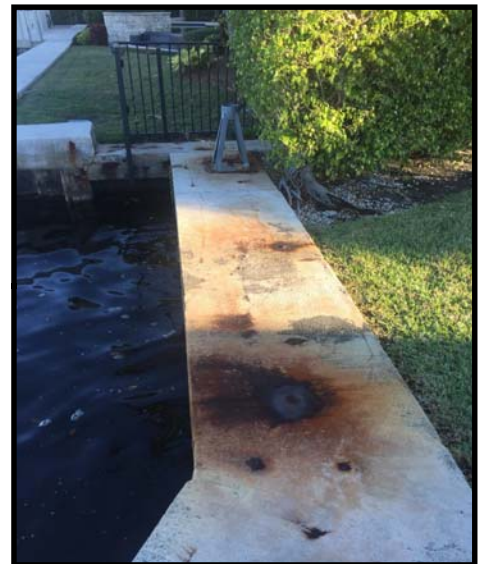
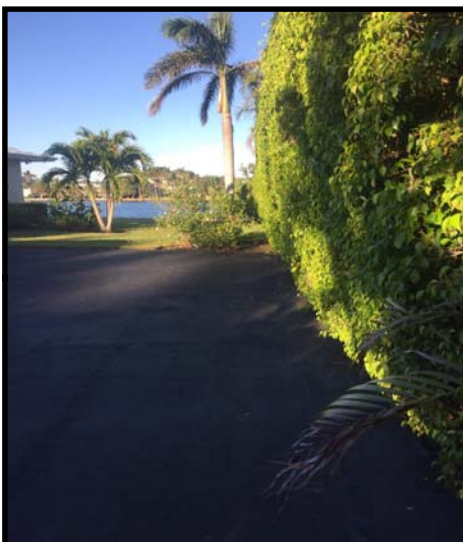
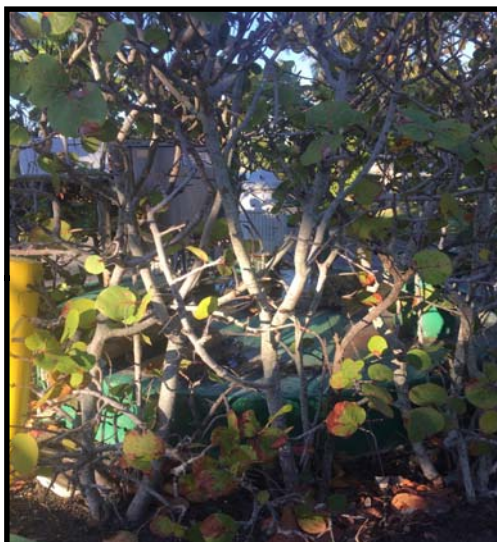
**City Owned Seawall:
Waterway Lane**

Structure Type: Bulkhead Structure Material: Concrete General Condition: Fair Anchored: Yes Anchor Type: Batter Pile Toe Wall: No Dock Frontage: No Toe Scour Stones: No	Continuous: Yes Fence Railing: No Vegetation: Yes Vegetation Location: Back Property Length along Waterway: 15' Source: Other Water Depth: 3' Cap Height Relative Above MHW: 24" Joints: Yes	Cap Elevation: 2.8' NAVD Cap Width: 36" Cap Height: 12" Utilities: No Stormwater: Yes Outfall: Yes Outfall Pipe Diameter: 12" Outfall Material: Concrete
---	---	---

There are two outfalls. One has a flapgate. One is open. The open one discharged via the pump while on site for one minute.

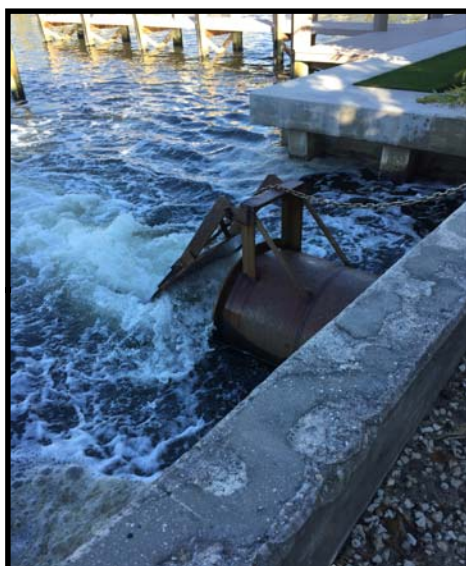
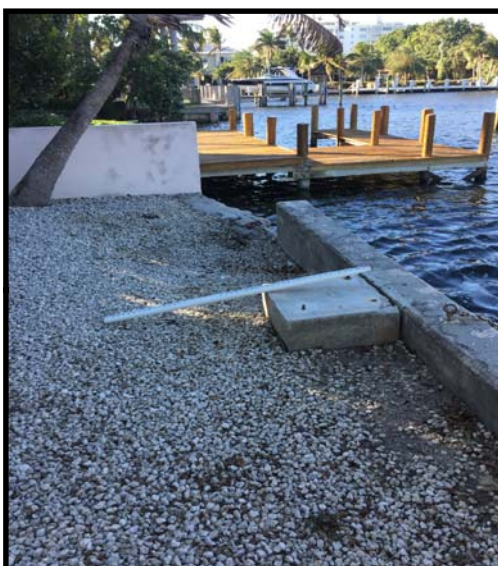
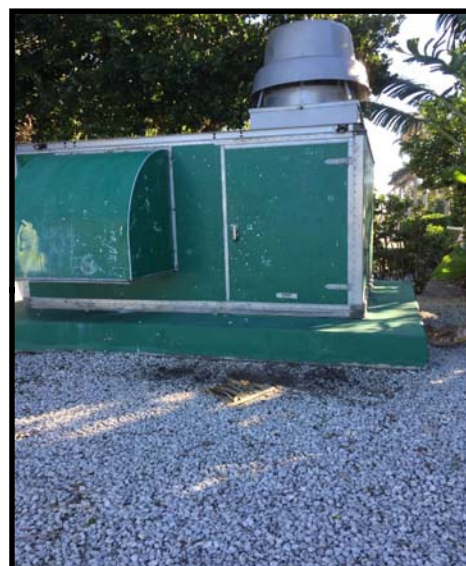
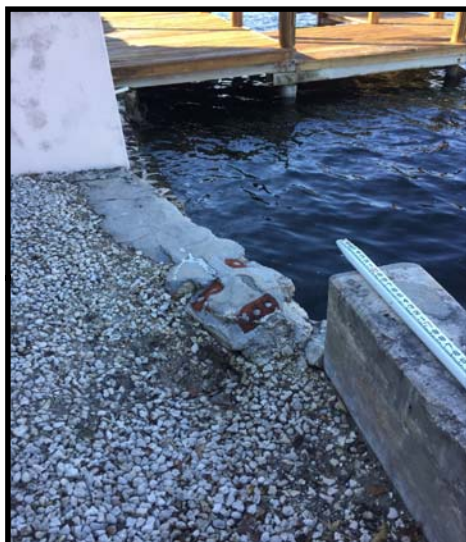
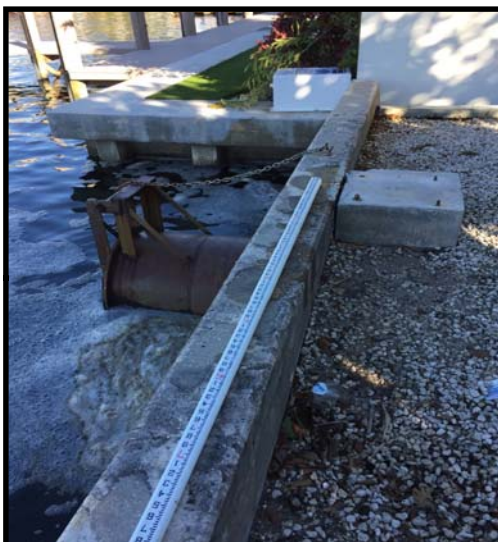
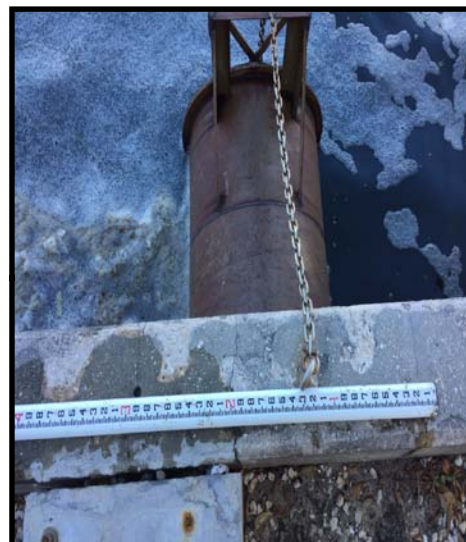
**City Owned Seawall:
Thomas Street**

Structure Type: Bulkhead Structure Material: Concrete General Condition: Satisfactory Anchored: Unknown Anchor Type: N/A Toe Wall: No Dock Frontage: No Toe Scour Stones: No	Continuous: Yes Fence Railing: No Vegetation: No Vegetation Location: N/A Property Length along Waterway: 25' Source: Other Water Depth: 5' Cap Height Relative Above MHW: 54" Joints: Yes	Cap Elevation: 5.3' NAVD Cap Width: 12" Cap Height: 0" Utilities: Yes Stormwater: Yes Outfall: Yes Outfall Pipe Diameter: 36" Outfall Material: Other
---	---	--

There is a storm water flap gate present. There was active discharge. South 7 feet of wall is concrete masonry gravity wall which is one foot lower in elevation. The flap appeared to close on pump shut down. There is no cap on the wall, just a poured concrete wall.

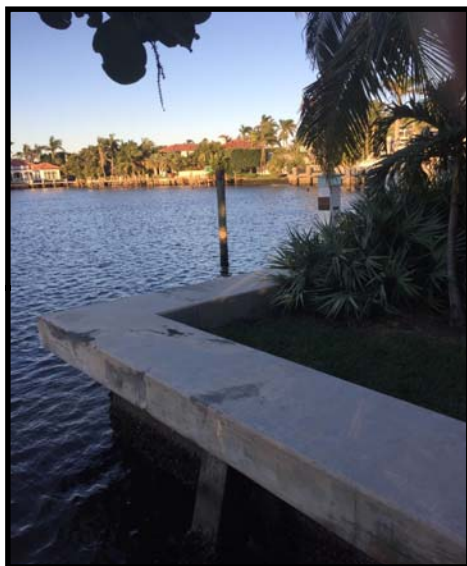
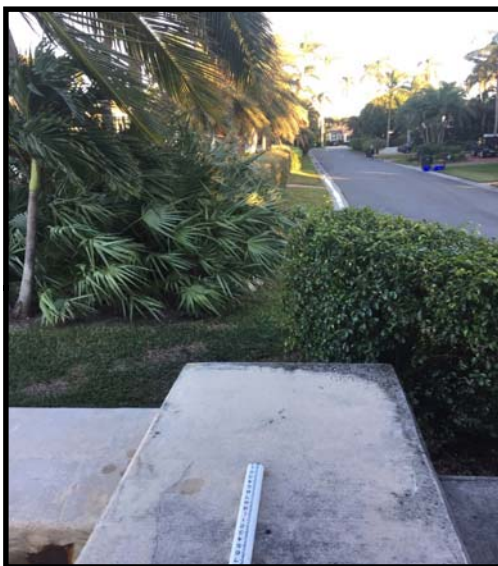
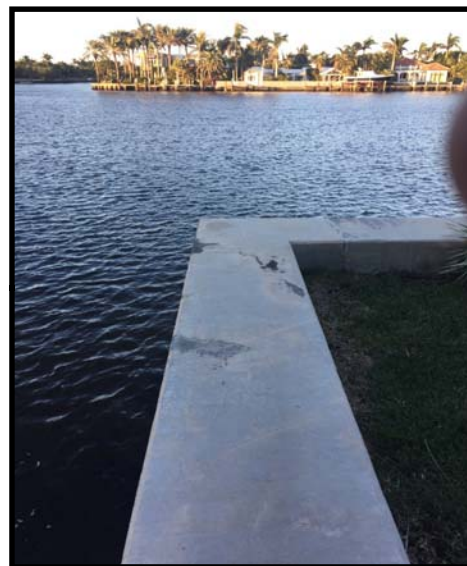
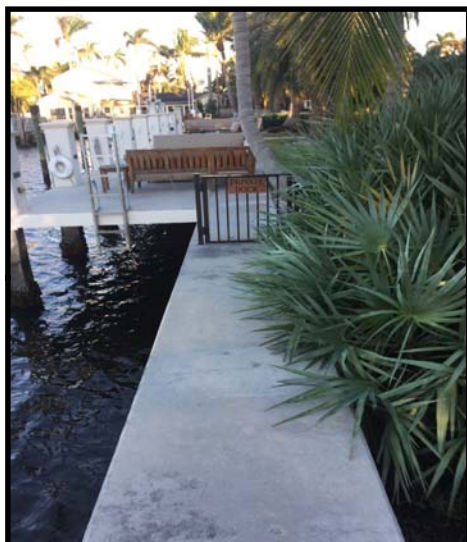
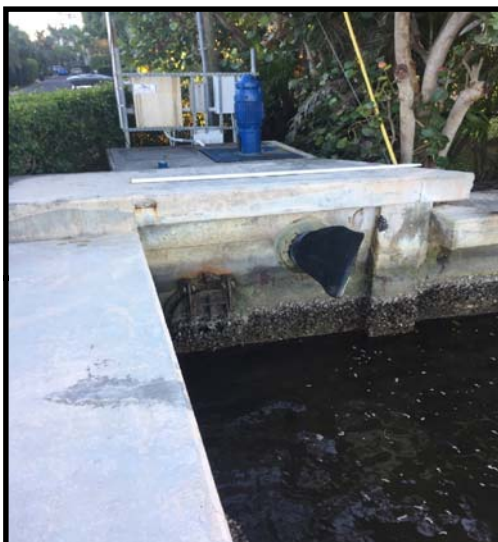
**City Owned Seawall:
Basin Drive**

Structure Type: Bulkhead Structure Material: Concrete General Condition: Fair Anchored: Yes Anchor Type: Batter Pile Toe Wall: No Dock Frontage: No Toe Scour Stones: No	Continuous: Yes Fence Railing: No Vegetation: Yes Vegetation Location: Back Property Length along Waterway: 44' Source: Other Water Depth: 3' Cap Height Relative Above MHW: 48" Joints: Yes	Cap Elevation: 3.8' NAVD Cap Width: 42" Cap Height: 18" Utilities: Yes Stormwater: Yes Outfall: Yes Outfall Pipe Diameter: 12" Outfall Material: Other
--	---	---

Storm pump is onsite. There is a duckbill backflow prevention device above MHW. There is a flap valve on an adjacent pipe below MHW. Wall is z shaped. City reported that the wall leaks.

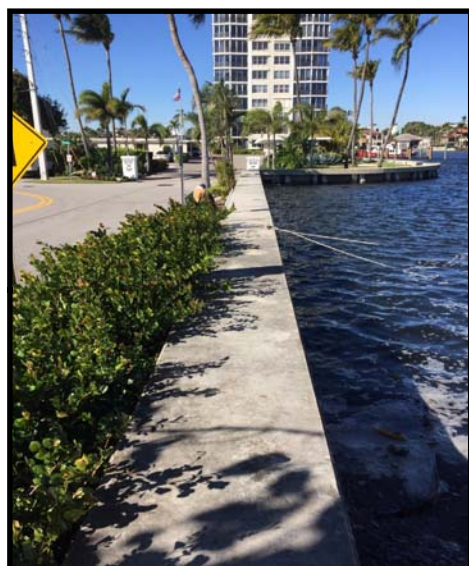
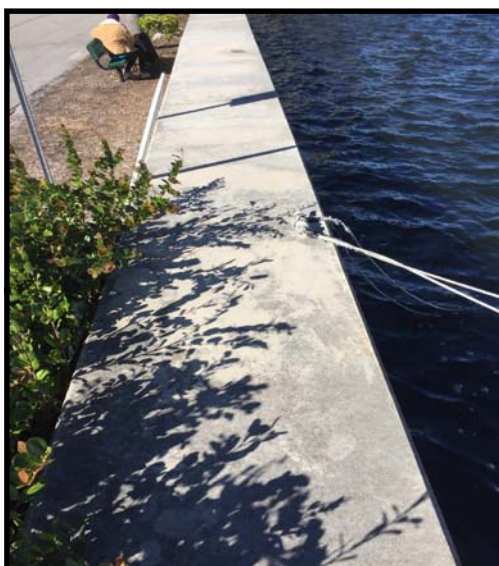
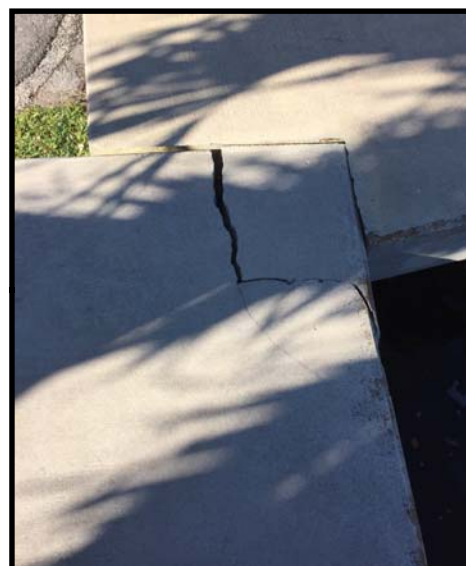
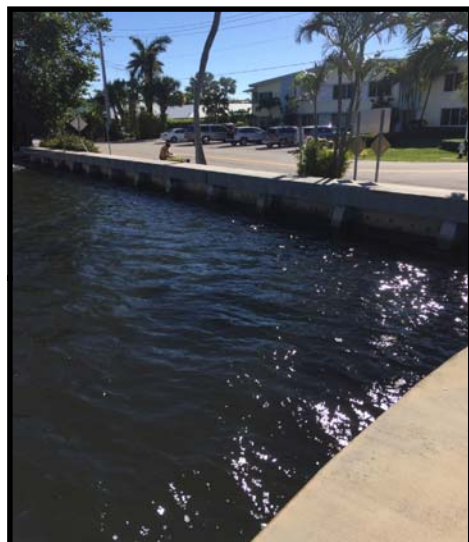
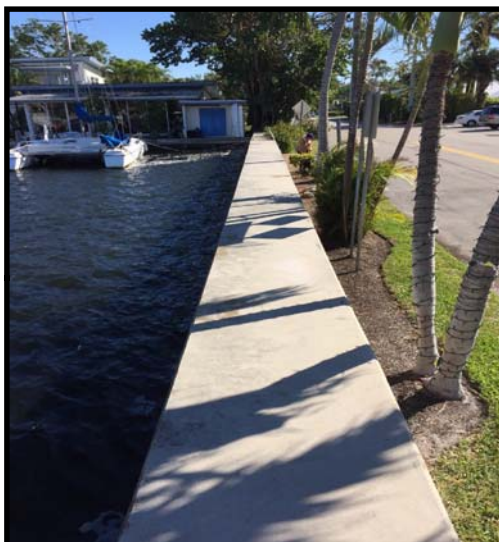
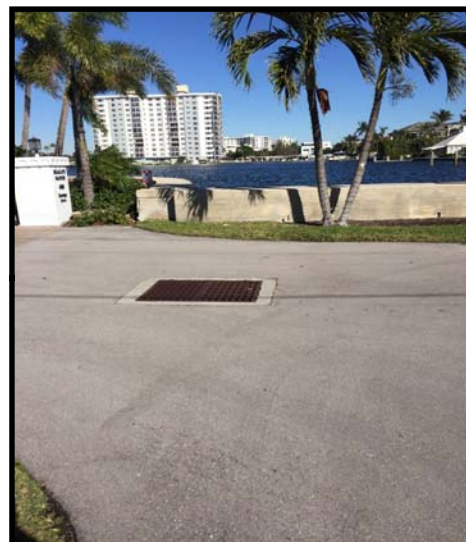
**City Owned Seawall:
Casuarina Road - North Side**

Structure Type: Bulkhead Structure Material: Concrete General Condition: Satisfactory Anchored: Unknown Anchor Type: Batter Pile Toe Wall: No Dock Frontage: No Toe Scour Stones: No	Continuous: Yes Fence Railing: No Vegetation: Yes Vegetation Location: Back Property Length along Waterway: 125' Source: Other Water Depth: 5' Cap Height Relative Above MHW: 42" Joints: No	Cap Elevation: 5.1' NAVD Cap Width: 42" Cap Height: 19" Utilities: No Stormwater: Yes Outfall: Yes Outfall Pipe Diameter: 18" Outfall Material: Concrete
---	---	---

Storm water inlet is nearby. The outfall was not seen. Outfall was identified during a separate outfall observation. There is a crack in the cap at the west adjoining wall. There is Coco plum and palms landward of the wall. Adjoining owner installed a cleat in the cap to assist in mooring their boat.

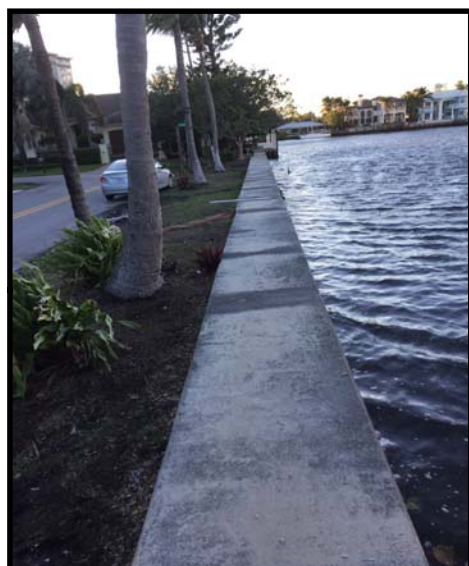
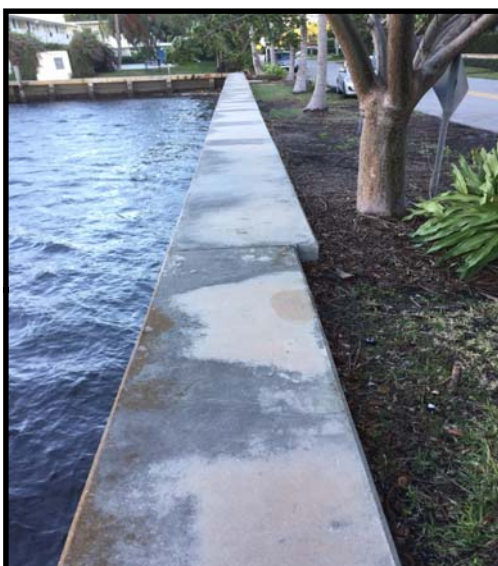
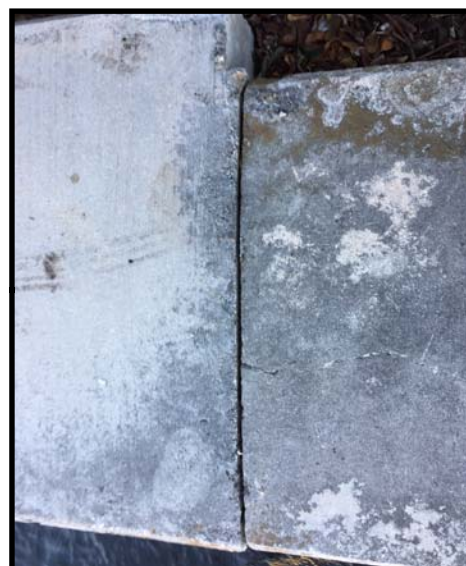
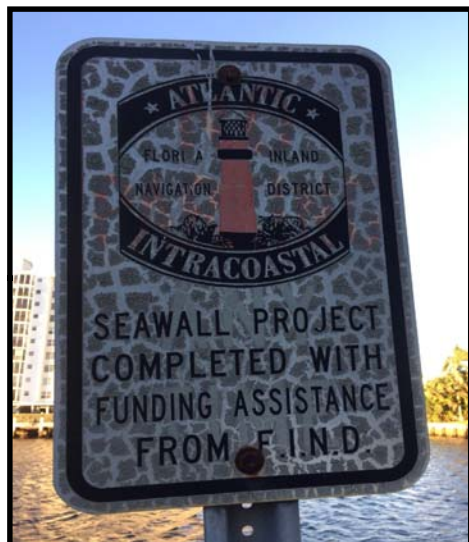
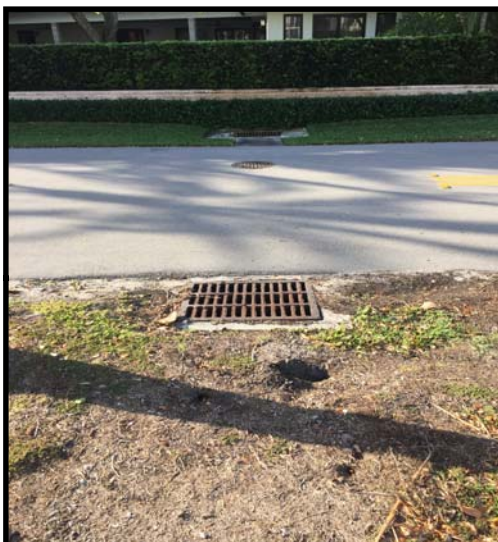
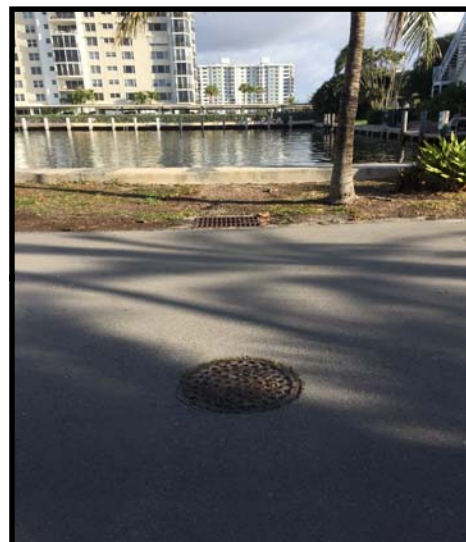
**City Owned Seawall:
Bucida Road - North Side**

Structure Type: Bulkhead Structure Material: Concrete General Condition: Fair Anchored: Yes Anchor Type: Batter Pile Toe Wall: No Dock Frontage: No Toe Scour Stones: No	Continuous: Yes Fence Railing: No Vegetation: Yes Vegetation Location: Back Property Length along Waterway: 155' Source: Other Water Depth: 3' Cap Height Relative Above MHW: 36" Joints: No	Cap Elevation: 3.2' NAVD Cap Width: 42" Cap Height: 18" Utilities: No Stormwater: Yes Outfall: Yes Outfall Pipe Diameter: 36" Outfall Material: Other
---	---	--

The seawall is a pile and panel concrete wall with relatively new batter piles and a cap replacement. There is a stormwater inlet nearby, but no observed discharge pipe in the immediate vicinity of the wall. The outfall was located during outfall observations. There is one joint (0.25 inches wide) in the wall which is not sealed. There are occasional cross cap cracks at the old pile locations. Vegetation is five palms, one gumbo limbo, dirt and weeds.

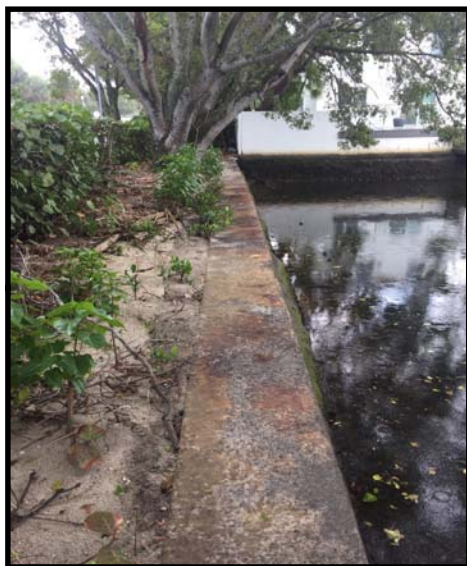
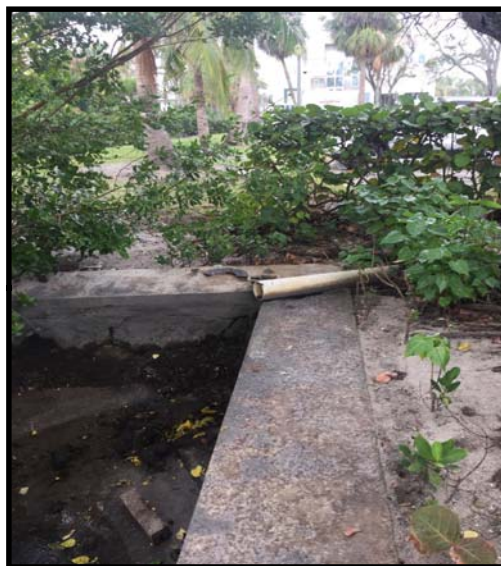
**City Owned Seawall: Atlantic Dunes Park- NW Lot between
White Drive and Rhodes Villa Avenue**

Structure Type: Bulkhead
Structure Material: Rock
General Condition:
Satisfactory
Anchored: Unknown
Anchor Type: N/A
Toe Wall: No
Dock Frontage: No
Toe Scour Stones: No

Outfall was privately constructed.

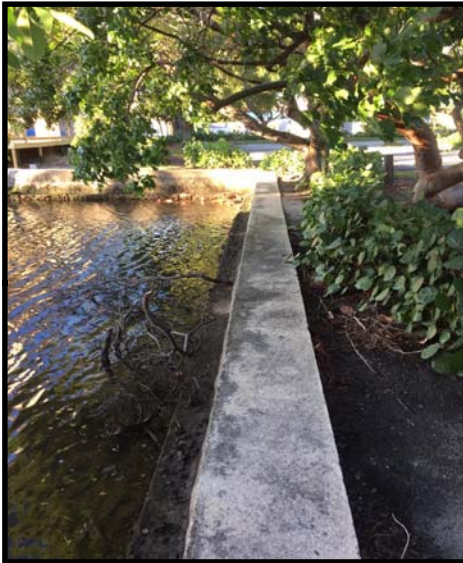
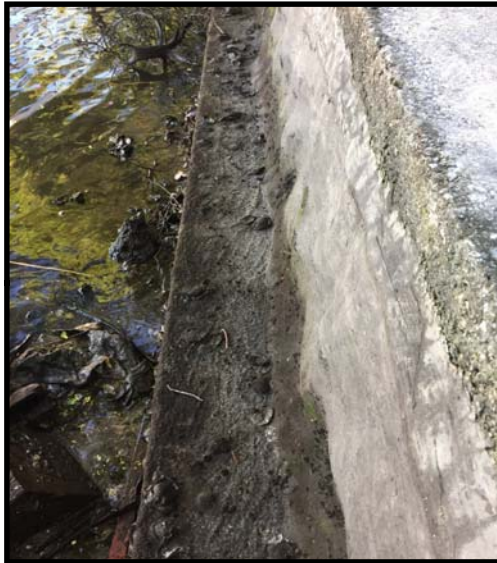
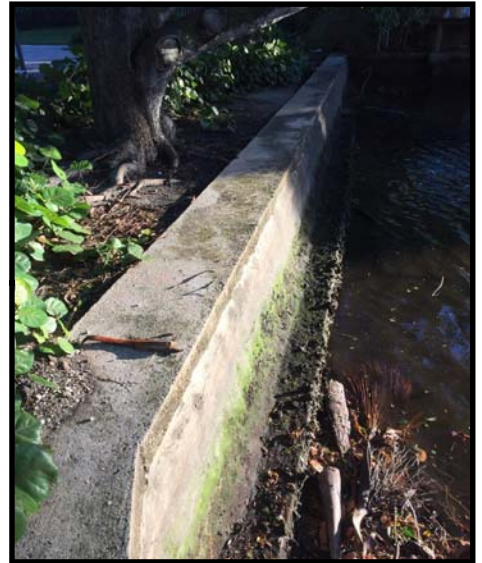
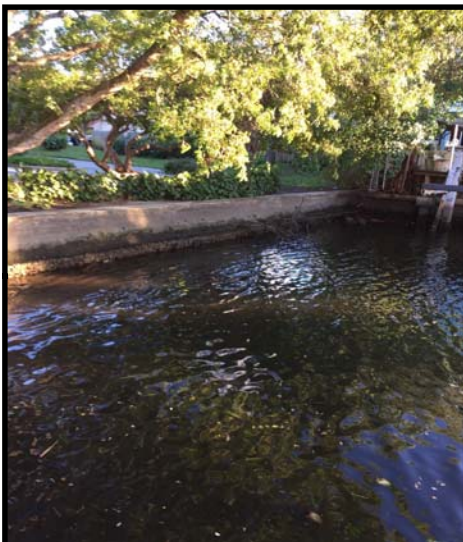
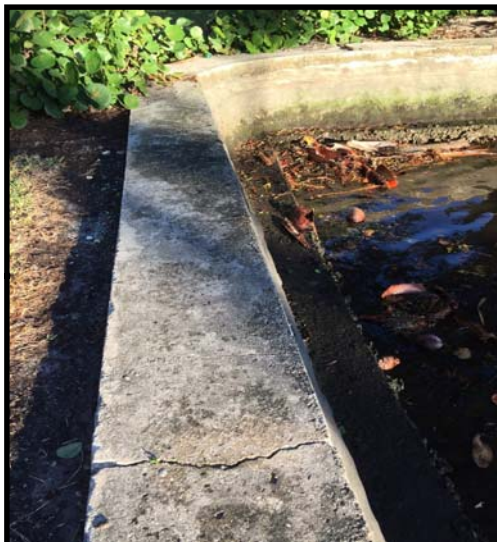
**City Owned Seawall: Atlantic Dunes Park - SW Lot between
Del Haven Drive and Rhodes Villa Avenue**

**General Condition:
Satisfactory**

Seawall appears to be a gravity wall over a poured toe wall. Concrete fascia exists over rubble. This is similar to the north west adjoining property. Two large trees behind wall. Short sea grape hedge behind. Wall is L shaped in plan view.

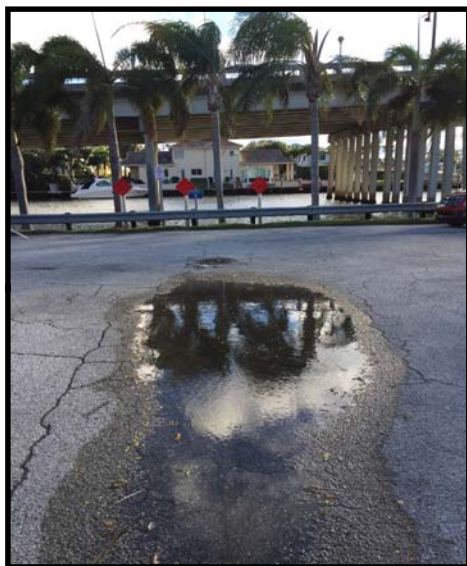
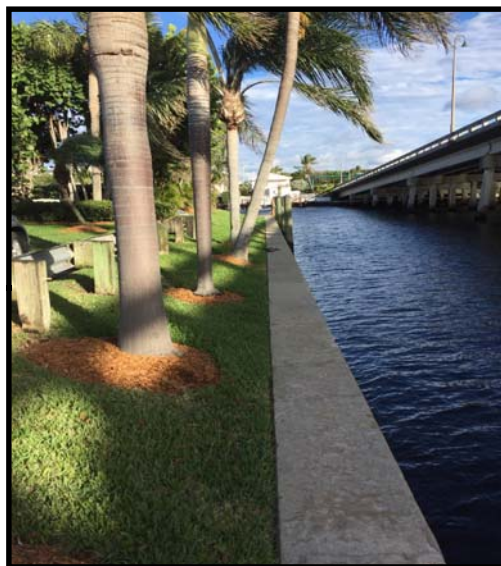
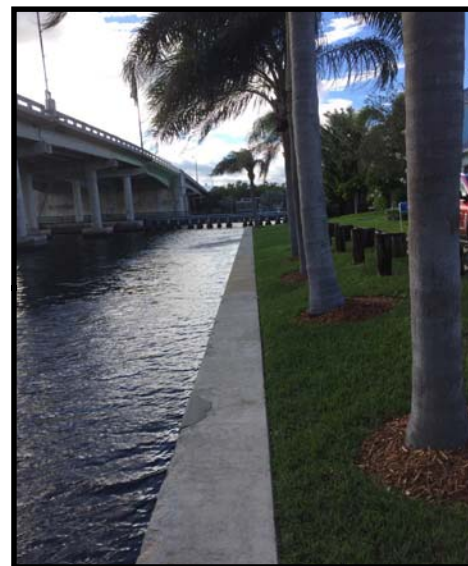
**City Owned Seawall:
Del Haven Drive**

**General Condition:
Satisfactory**

Joints in cap are cold joints. Toe stones are small 1 ft. Dock space is 60 feet. Unknown control of dock. Upland vegetation is grass and mixed palm trees. Cap has random small chips and spalls on waterway edge. Overall good shape. Sprinkler line behind cap services private grass and palms.

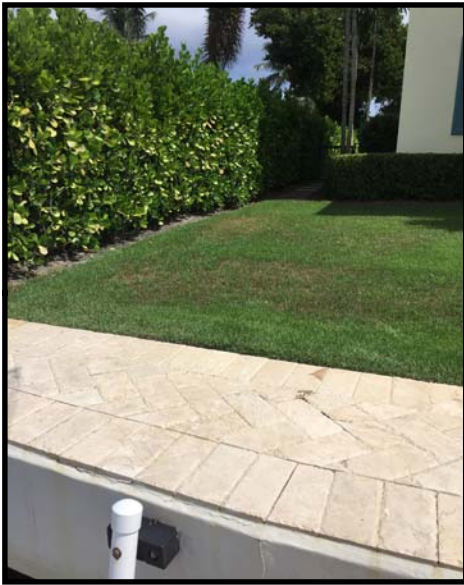
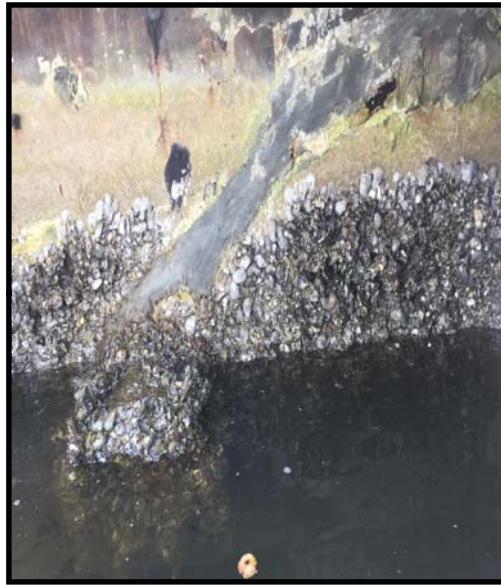
**City Owned Seawall:
808 Seasage Drive (City Easement)**

Structure Type: Bulkhead Structure Material: Concrete General Condition: Fair Anchored: Yes Anchor Type: Batter Pile Toe Wall: No Dock Frontage: No Toe Scour Stones: No	Continuous: Yes Fence Railing: No Vegetation: Yes Vegetation Location: Back Property Length along Waterway: 10' Source: Field Measure Water Depth: 4' Cap Height Relative Above MHW: 36" Joints: No	Cap Elevation: 3.9' NAVD Cap Width: 36" Cap Height: 18" Utilities: No Stormwater: Yes Outfall: Yes Outfall Pipe Diameter: 15" Outfall Material: Concrete
---	--	---

This property is privately owned with a city easement across one seawall panel. Historic outfall is grouted shut. A diagonal crack exists across the panel originating at the storm water outfall pipe. The crack has been patched with hydraulic cement. Upland soil loss repair was evident. Long term monitoring is appropriate.
