City of Delray Beach Intracoastal Waterway Water Level & Infrastructure Vulnerability Study

Submitted to:
City of Delray Beach

Submitted by:
Aptim Environmental & Infrastructure, Inc.

Project No. 631233074
October 2018

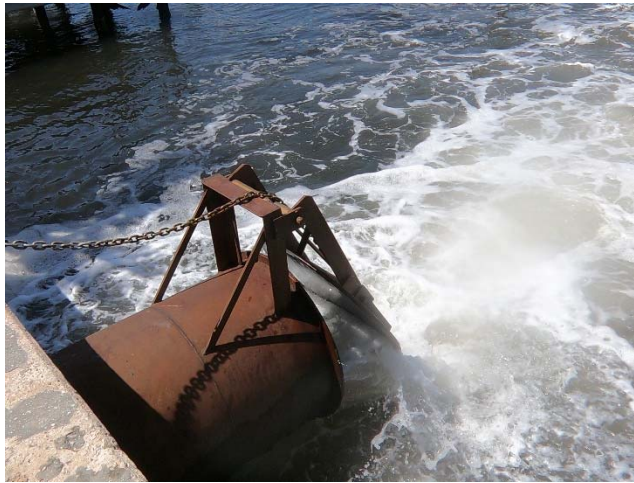
It appears that there are functioning flap gates at Thomas Street and at Palm Trail E-3 that seal. The Thomas drive pipe was discharging on both occasions that APTIM performed observations of the site. The invert elevation on the Thomas Street site is higher than most discharge pipes in the City and the discharge protrudes out from the seawall; likely as a result of these features, there is limited marine growth at this outfall. The Palm Trail E-3 discharge flap gate also protrudes out from the seawall. At the time of the site visit, the Palm Trail E-3 flap gate was opened and a few oysters were present, but the oysters did not appear to be affecting the seal. It is recommended that both flap gates be inspected twice per year to check the seals and clean off oysters and barnacles that are growing.

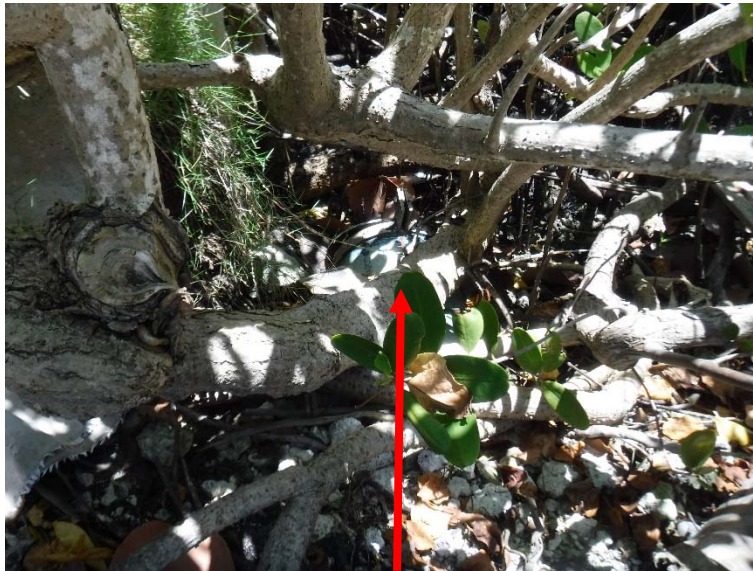
Semi-functional flap gates exist at Marine Way E-4 and E-5. Both pipes are located within a stand of mangroves, which collect significant plant detritus and flotsam. There are flaps on the PVC pipes, but neither flap appeared to close due to debris and/or poor fit of the flap valve on the end of the pipe. On outfall Marine Way E-5, the PVC pipe was cut obliquely and doesn't allow the flap to fully close. With the small size of the flap (9 inch diameter pipe), and the lack of a rubber gasket, water may flow backward up the pipe during high tidal elevations. APTIM was informed that these outfalls will be reconstructed during an upcoming City seawall project in this area.

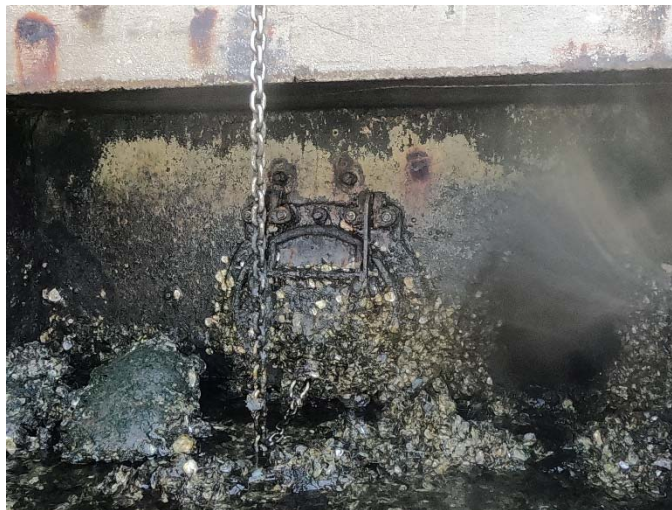
Waterway Lane

Non-functional flap gates exist at Basin Drive, Beach Drive, and Waterway Lane. These three flap gates are sealed shut either by oysters, corrosion, or through internal abandonment and grouting of the pipe. Alternate discharge pipes exist in those three locations to service the stormwater pumps. There also appear to be the remains of a flap gate on NE 5th Ave. At this site, the steel pipe has a large flange, and there are remnants of a hinge bolted to the bulkhead. As the inlet elevation is relatively high (3.4 feet NAVD), there is no immediate need to provide a new flap valve or alternate backflow prevention.

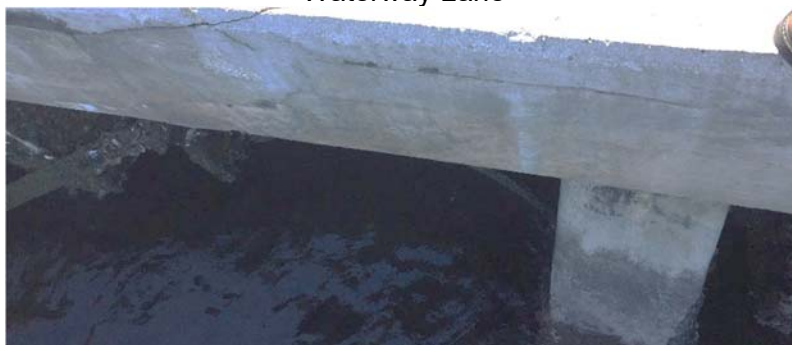
NE 5th Street.

Pipe is in the center of the picture and the hinged frame is on the left side.

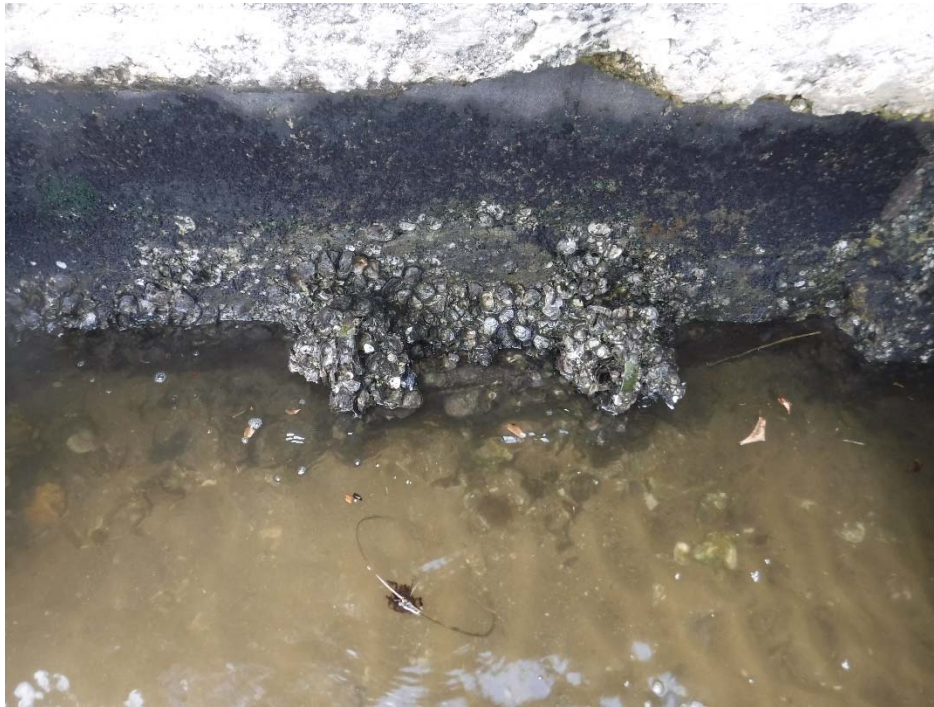
Beach Drive.

Historic flap gate is sealed shut by oysters. It is not functional.

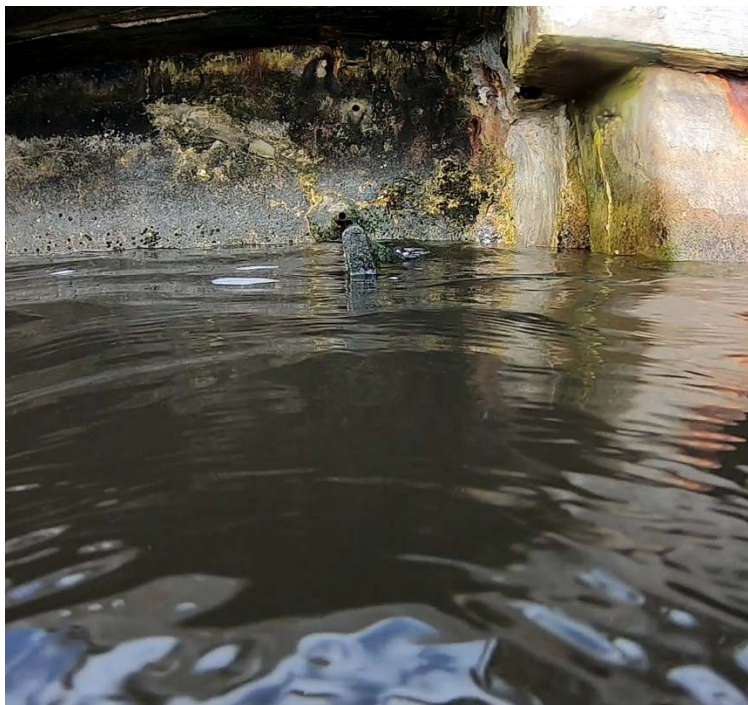
Cypress Drive E.
Oysters are in the bottom of the duckbill preventing closure.

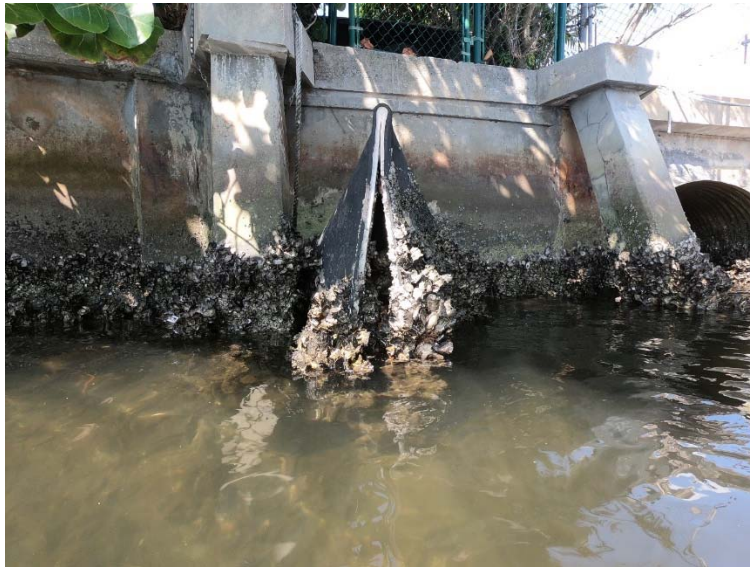
Spanish Trail E 1.
Oysters prevent closure of the duckbill.

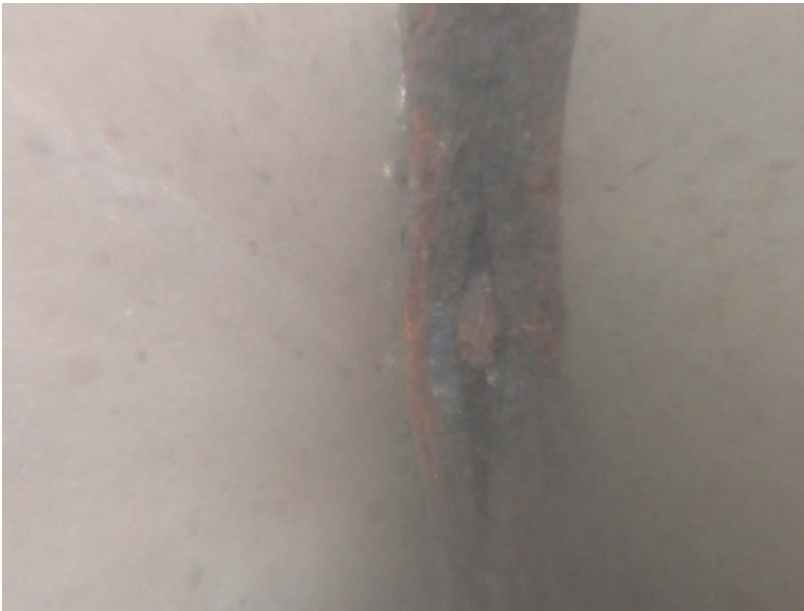
Marine Way E 2.
Duckbill does not seal.

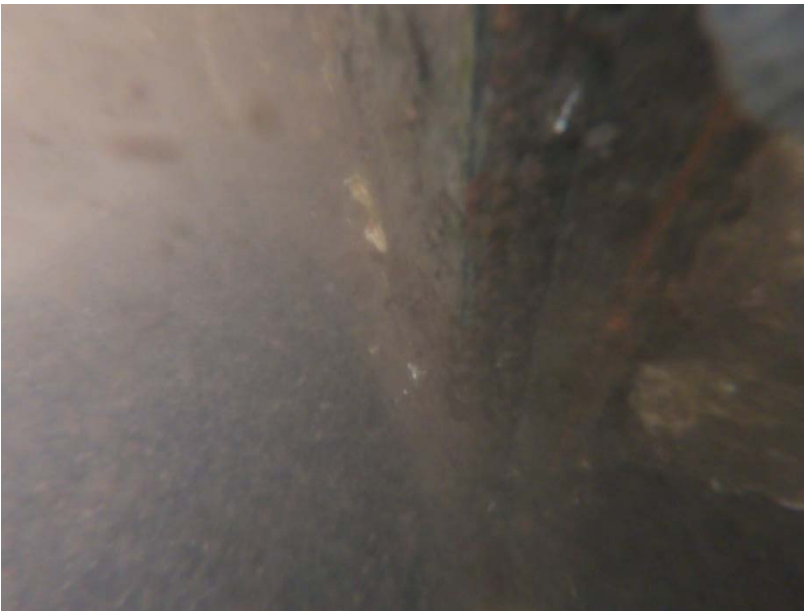
Marine Way E 3.
Duckbill does not seal.

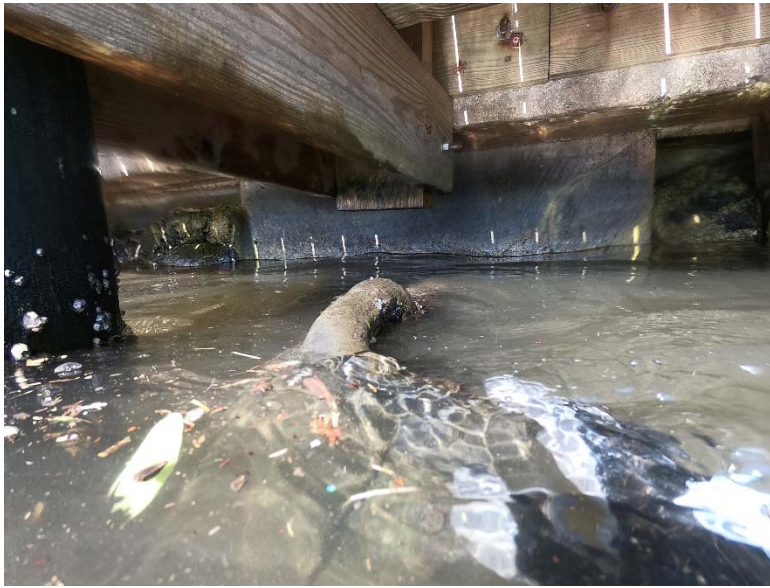
SE 1st Street E 1.
Barnacles inside of duckbill prevent closure.

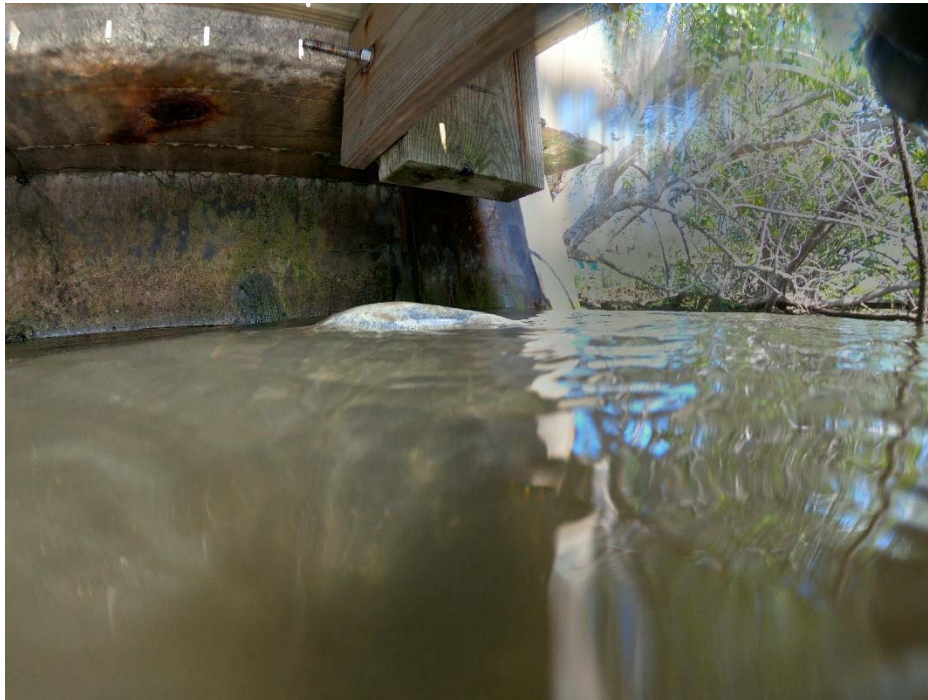
SE1st Street E 3.
Barnacles inside of duckbill prevent closure.

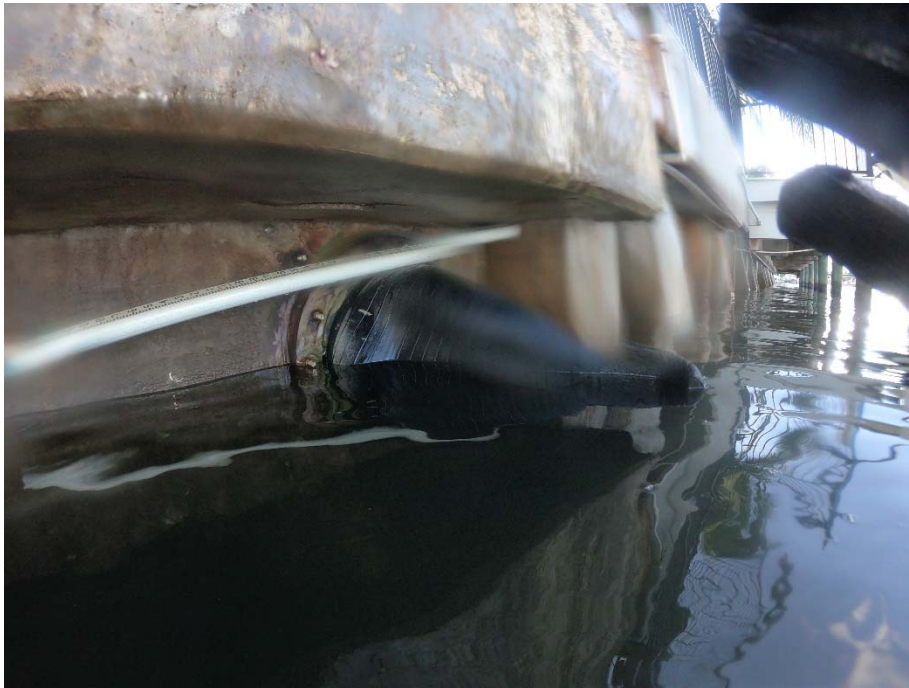
Venetian Dr W 1.
Clean. No oysters were present on the seawall.

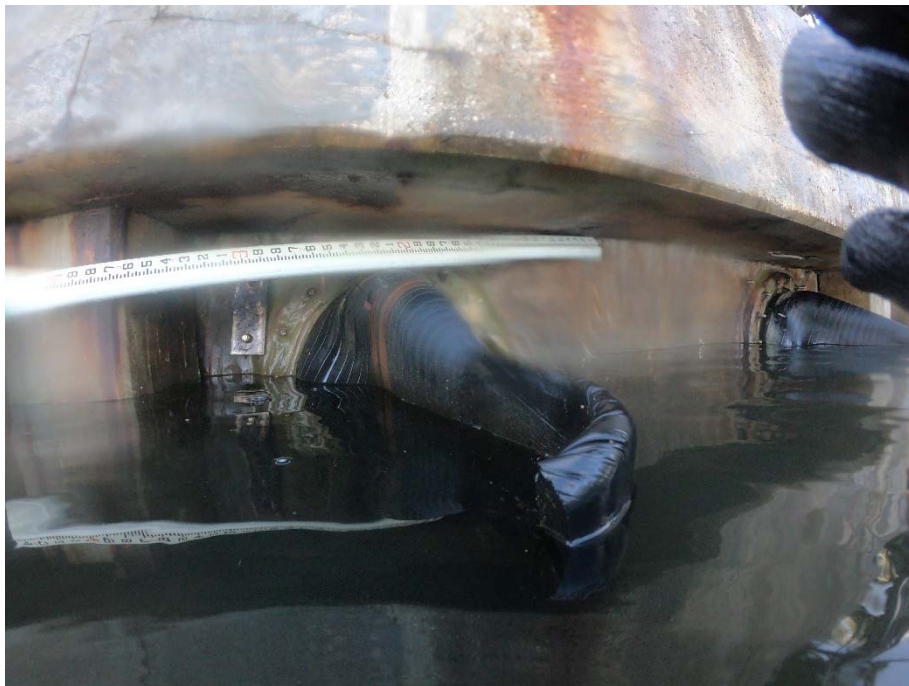
Venetian Drive W 2.
A few barnacles were present inside, but the valve did seal.
No oysters were present on the seawall.

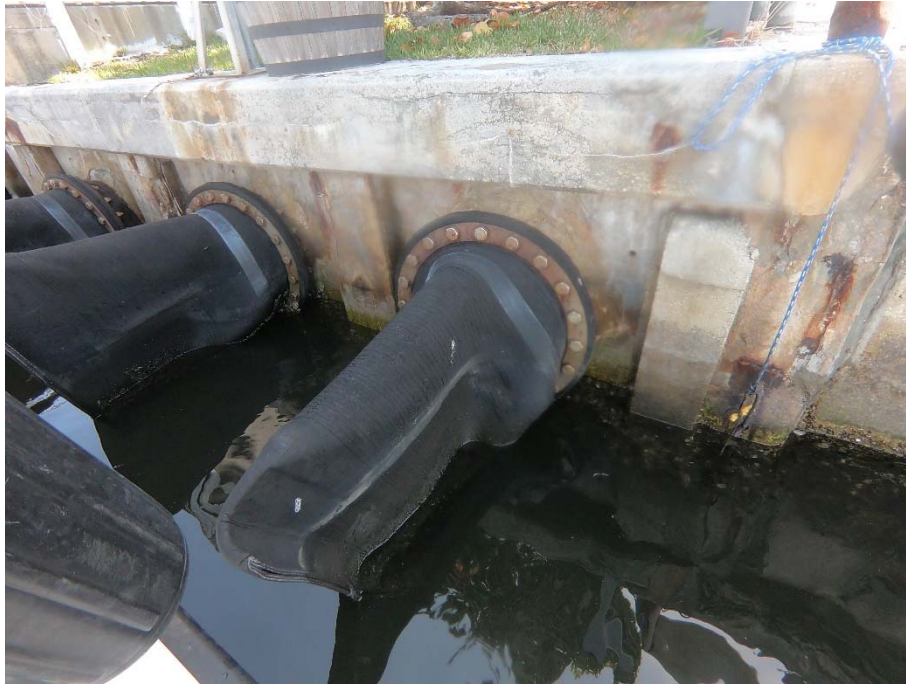
MacFarlane Drive W 4.
Barnacles in the bottom of the duckbill may prevent full closure.

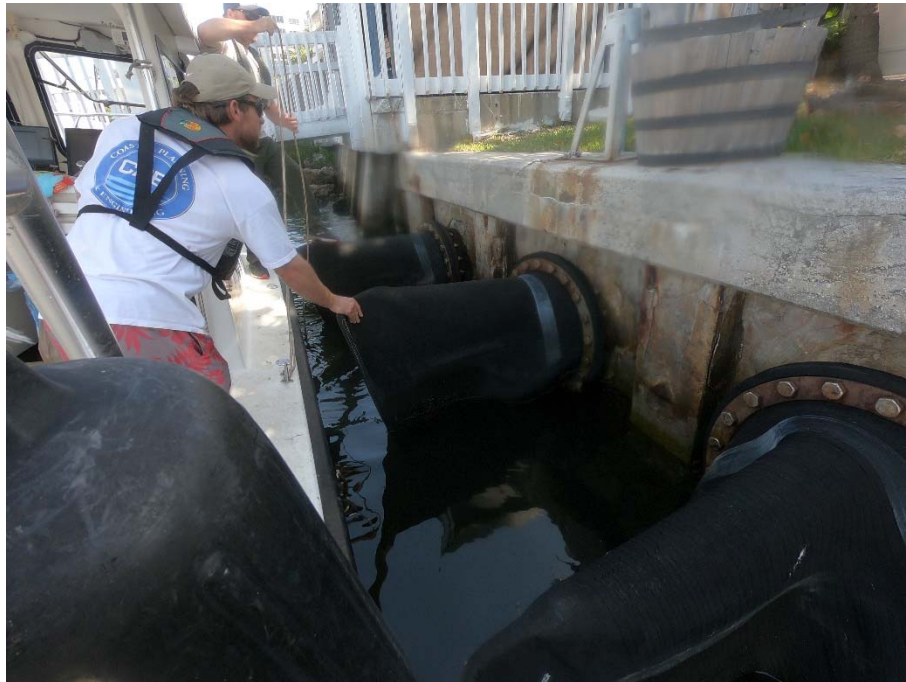
MacFarlane Drive W 5.
Barnacles in the bottom of the duckbill may prevent full closure.

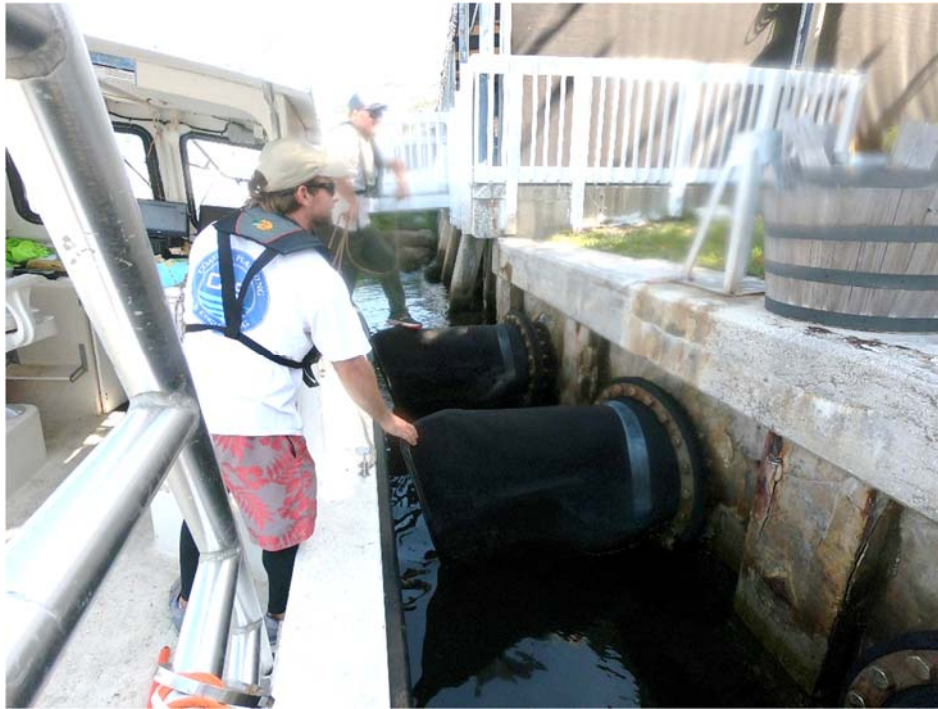
MacFarlane Drive W 6.
Barnacles in the bottom of the duckbill may prevent full closure.

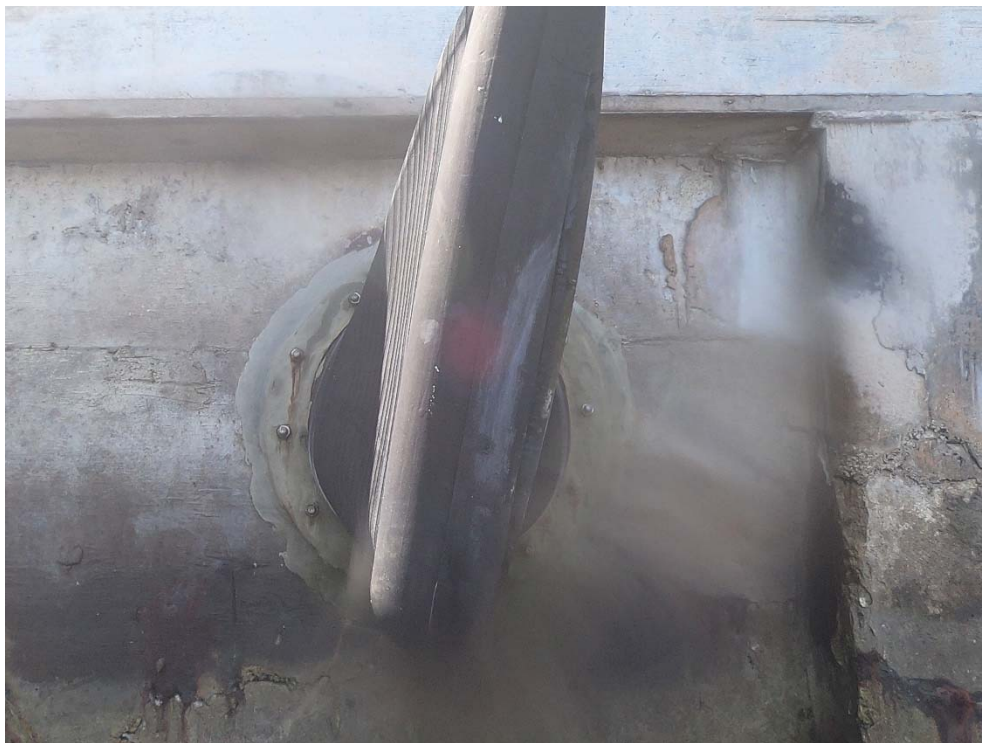
Basin Drive N 1.
Duckbill is above MHW. Clean due to high invert elevation.

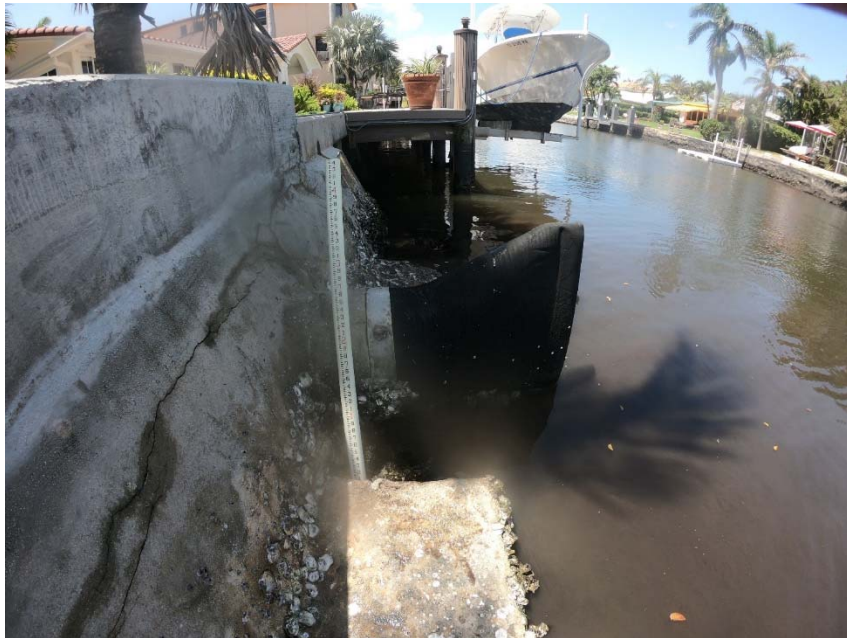
Rhodes Villa Ave N2.
Clean due to high invert elevation.

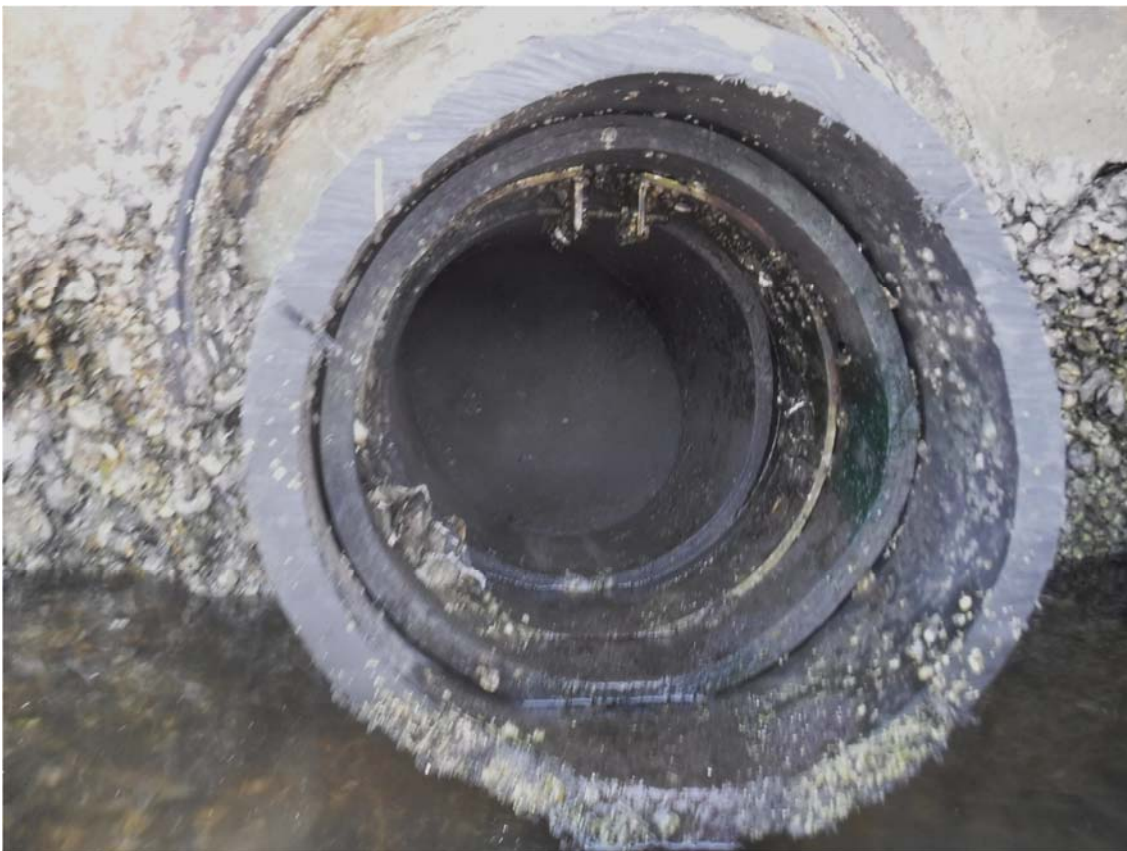
Tamarind Road W-1

The City reports having three inline check valves installed at the outfall end of pipes in the study area; with three others installed from the upstream pipe end or box. During APTIM's site visits, one inline check valve was observed at Tamarind Road W 1. The valve was sealed against the pipe and had one barnacle on the outside. This is consistent with manufacturer representative's statement that the valves do not allow marine growth. The inline check valve at Azalea Road W was not observed due to partial coverage by barnacle growth and the assumed location of the valve further up the pipe. Due to poor water quality conditions and a low invert elevation at Casuarina Road N, no inline check valve was seen.

From APTIM's observations, the inline check valve appears to be more resistant to marine growth and could require less maintenance than the duckbill check valves. It is recommended that the City consider additional installations to verify the reduced maintenance requirements. Once installed, valves should be inspected twice per year for marine growth and debris.
