**Murphy Oil Company - 16211 S. Military Tr. Delray Beach, Florida**

**MURPHY OIL USA, INC.**  
 16211 S. MILITARY TRAIL  
 DELRAY BEACH, FLORIDA

DRAWN BY: JAZ  
 DATE: 11/26/17  
**17062**  
 TREE PRESERVATION PLAN  
**LS1**

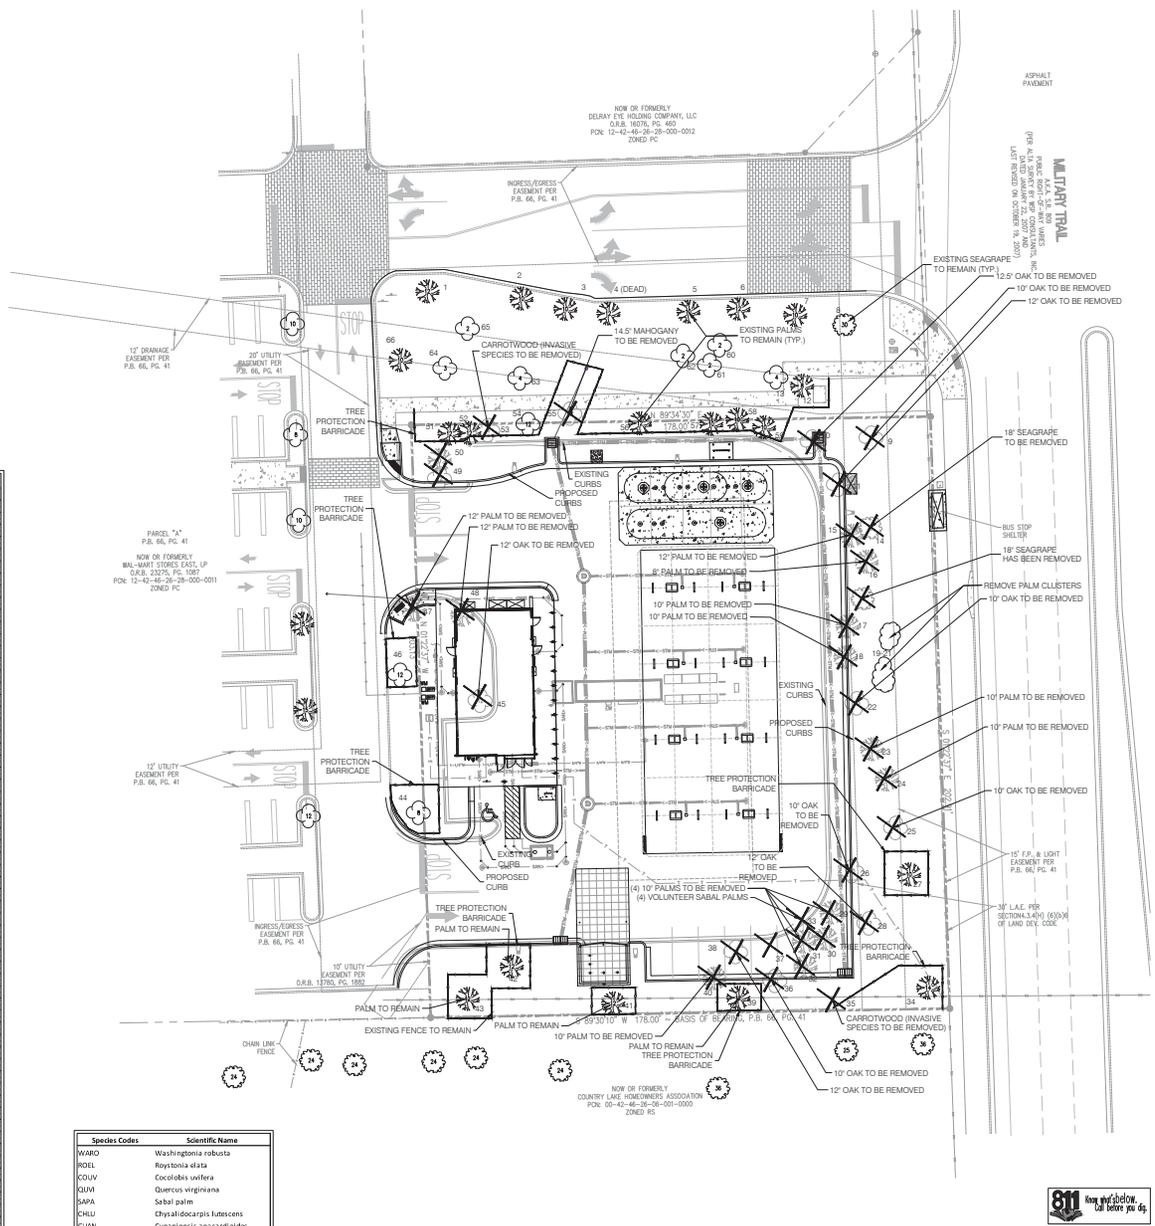
**1 TREE PROTECTION DETAIL**

LARGE TREE PROTECTION AREAS SHALL BE DEFINED DURING SITE CLEARING ACTIVITIES BY A WOVEN FABRIC FENCING ATTACHED TO 4 HT. 2' x 2' POSTS SPACED MAX. 50' O.C. LOCATION OF THIS TEMPORARY FENCING TO BE SHOWN ON THE PLANS. NO MACHINERY SHALL BE ALLOWED ON THE TREE PROTECTION SIDE OF THE TEMPORARY FENCING.

2' x 4' VERTICAL WOOD STAKES WITH 2' x 4' HORIZONTAL WOOD MEMBERS

PVC SAFETY FENCE, ATTACH TO HORIZONTAL WOOD MEMBERS AT 6' INTERVALS

LOCATE BARRICADE AT DRIP LINE OR PROTECTED TREES OR 12' OFFSET FROM EDGE OF EXISTING PAVEMENT TO REMAIN

ROOT PRUNING AT DRIP LINE IS REQUIRED FOR LOCATIONS WHERE SUB-GRADE WILL BE DISTURBED. WORK TO BE PERFORMED BY A LICENSED CERTIFIED ARBORIST.

MIN. 5' LENGTH POSTS WITH MINIMUM 1/8" EMBEDDED IN SOIL

DISTANCES ALSO APPLY TO THE PLACEMENT OF UNDERGROUND UTILITIES. UTILITIES WITHIN TREE PROTECTION BARRICADES TO BE INSTALLED VIA SUBSURFACE BORING
