CAULFIELD & WHEELER, INC.  
CIVIL ENGINEERING  
LANDSCAPE ARCHITECTURE - SURVEYING  
7000 GLADES ROAD - SUITE 100  
BOCA RATON, FLORIDA 33434  
PHONE (561) 392-1991 / FAX (561) 750-1452

2419 N. FEDERAL HWY  
TREE DISPOSITION PLAN  
DELRAY BEACH  
FLORIDA

| SHT. NO. | TD-1 |

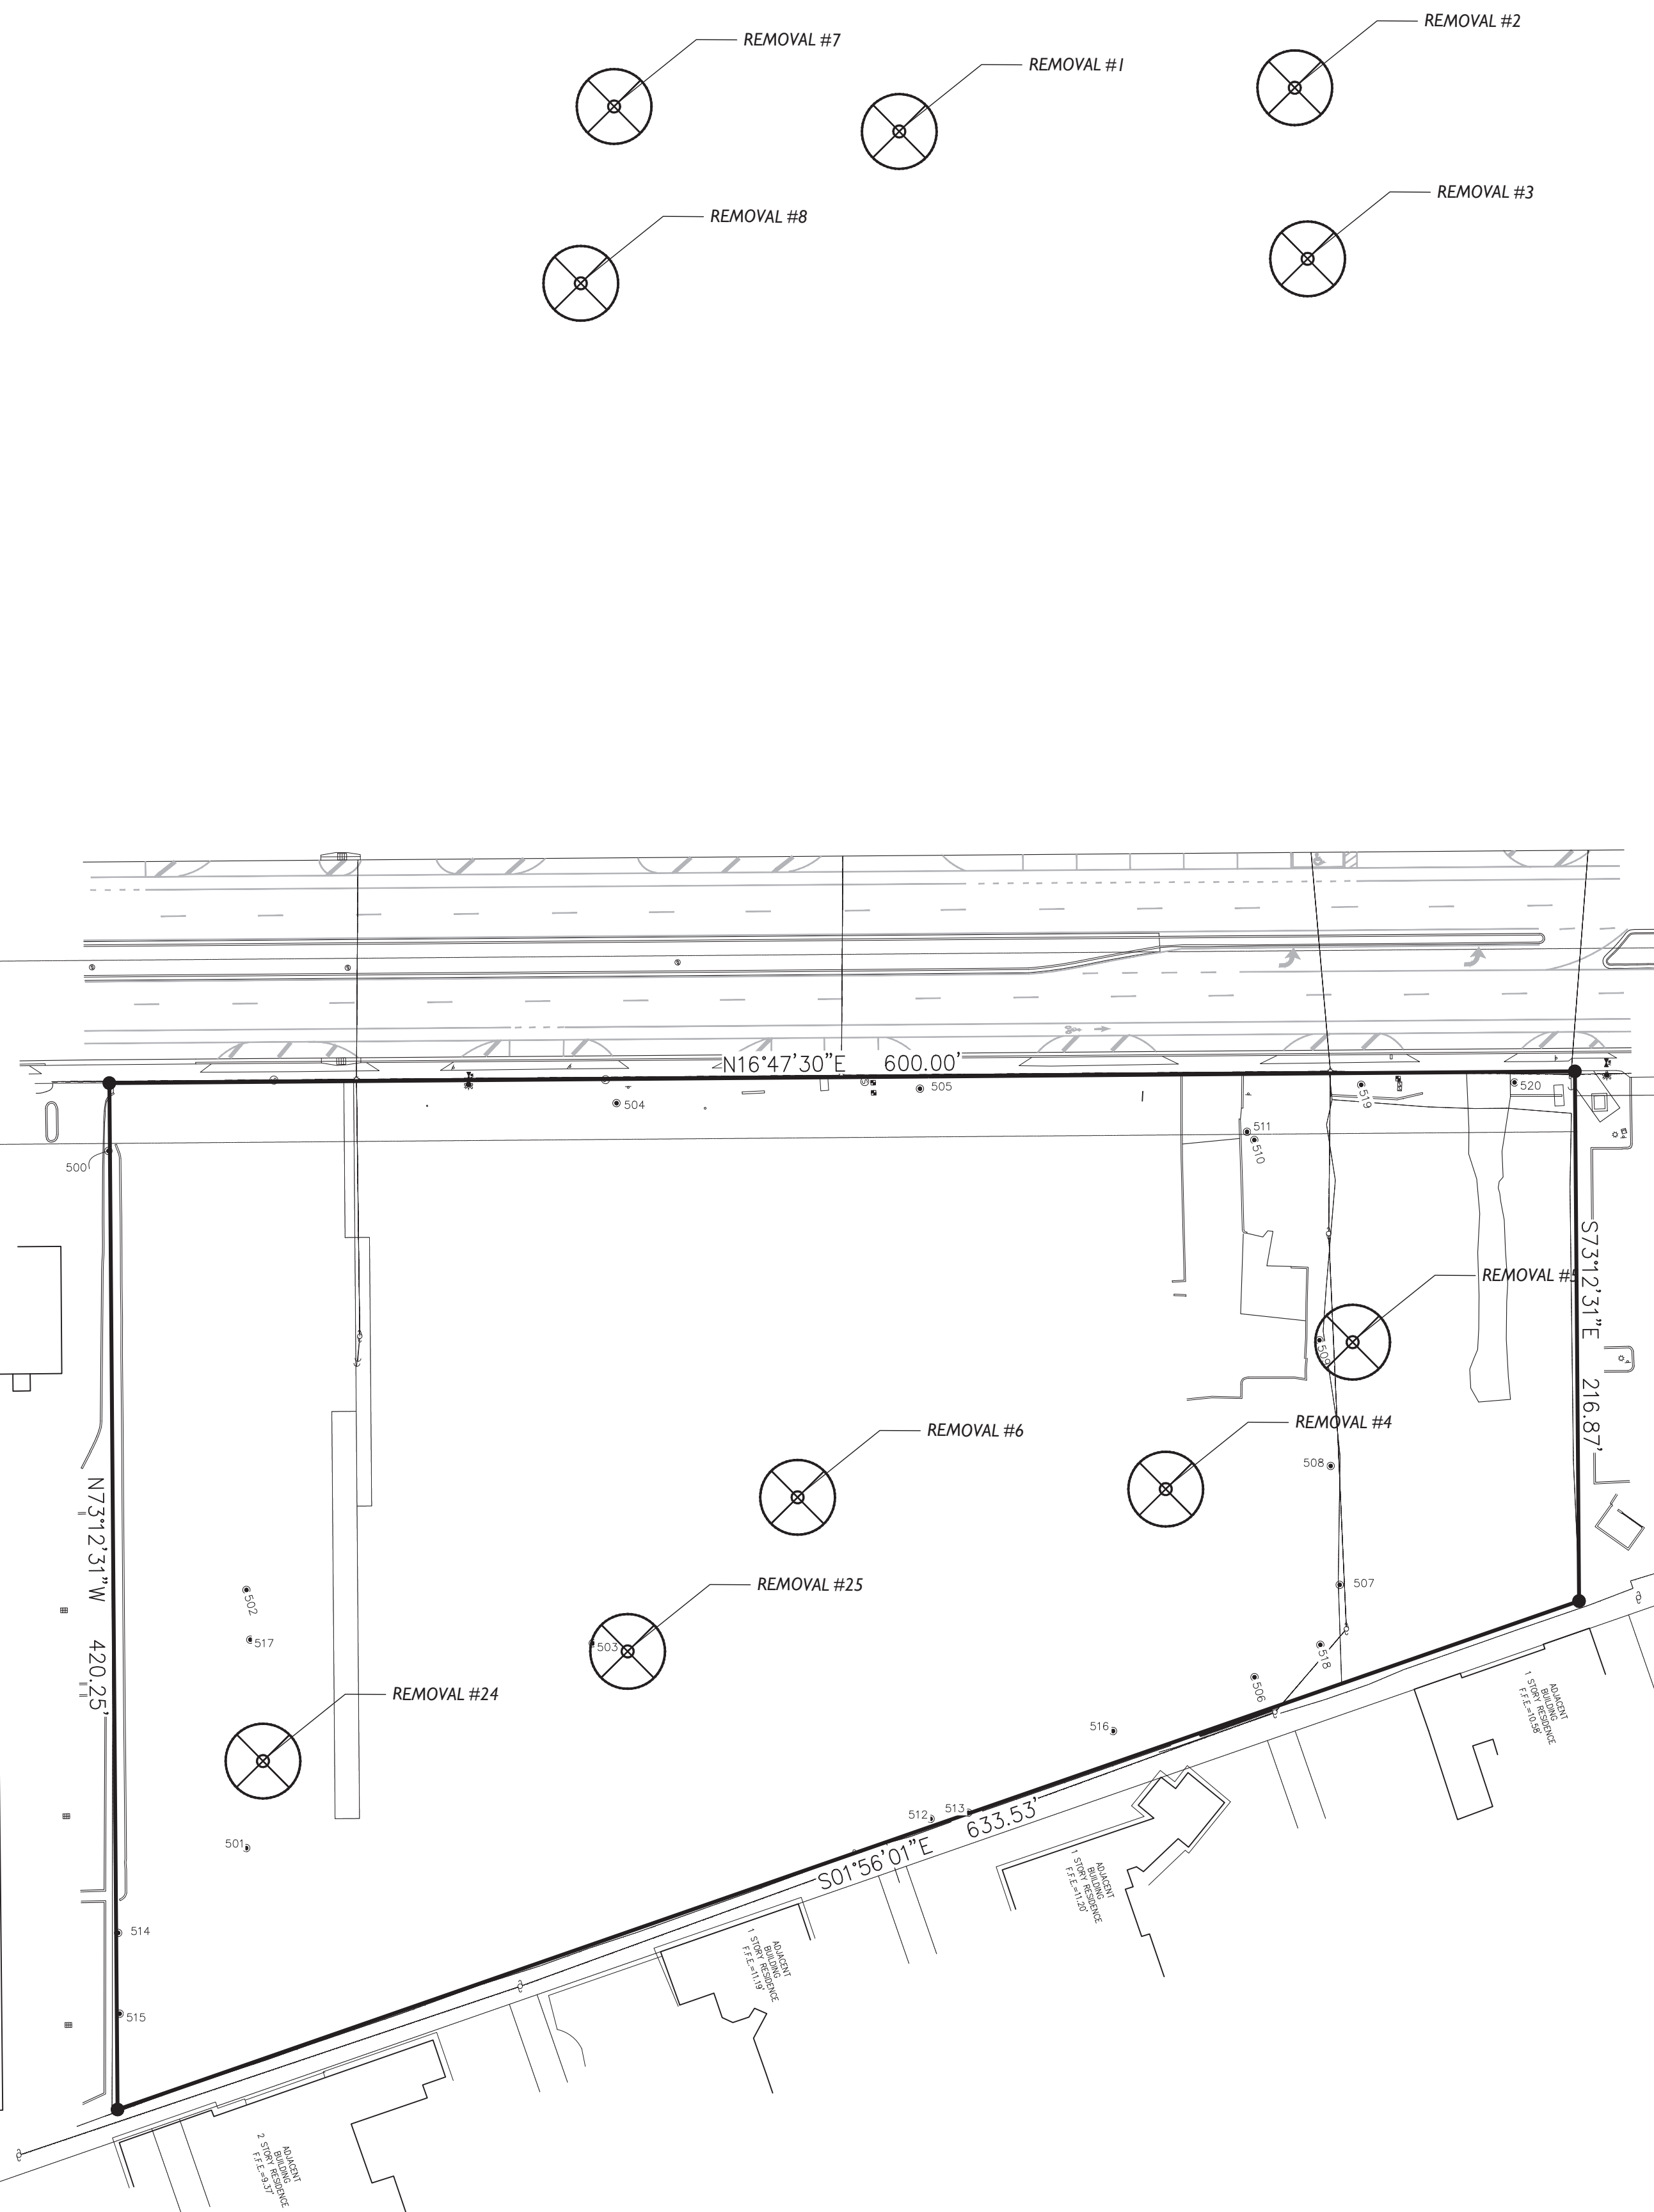
### TREE DISPOSITION SCHEDULE
