Restore 'Observations' mural panels + mural painted on new building site

Original site :Delray Camera Shop, 186 NE 2nd Avenue, Delray Beach, 33444New site:Delray Camera Shop, 217 NE 4th Avenue, Delray Beach, 33444

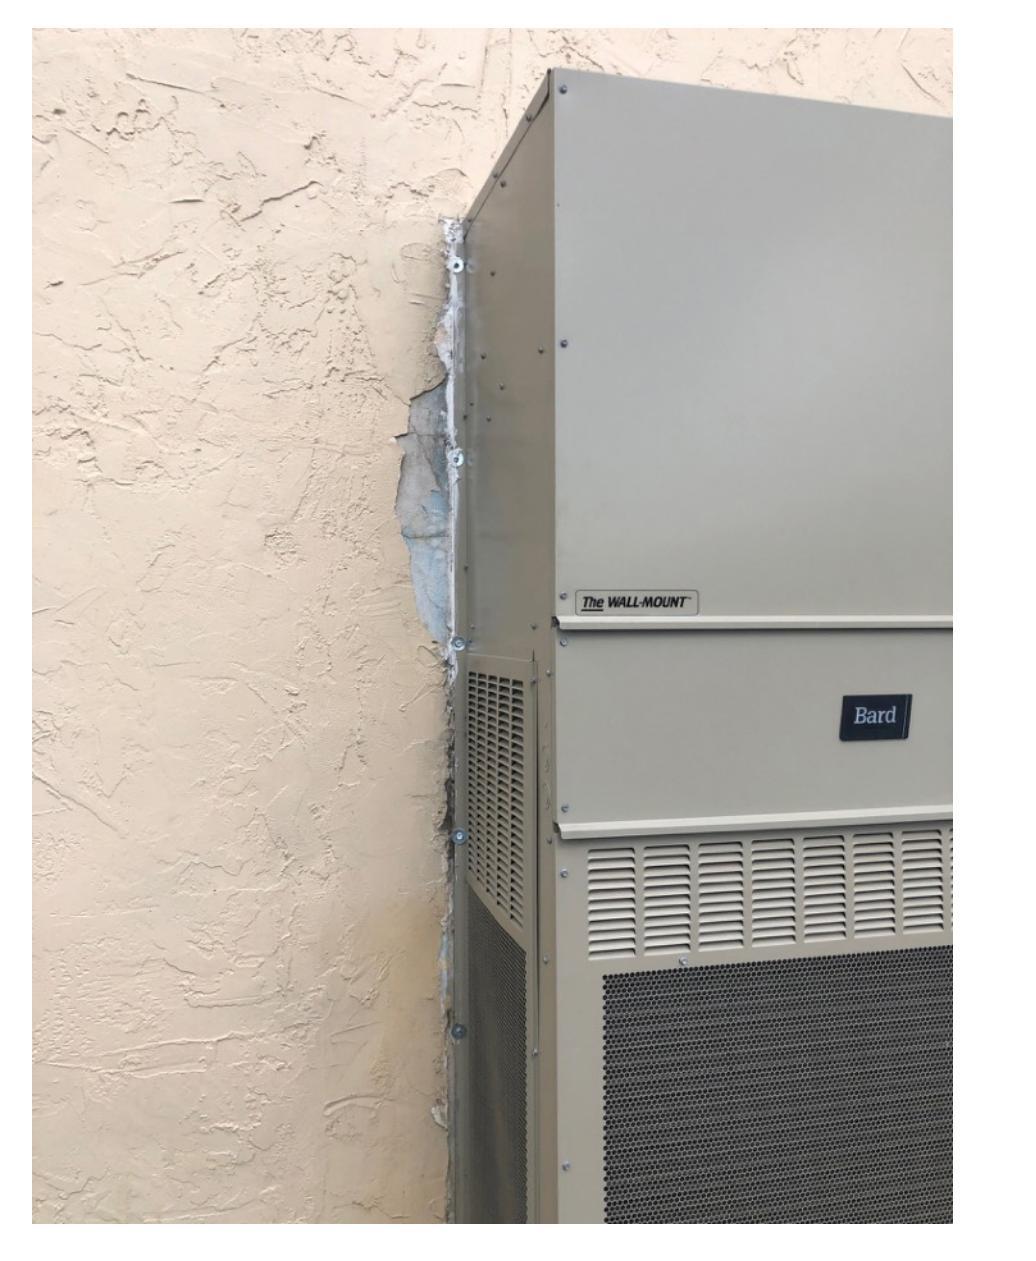
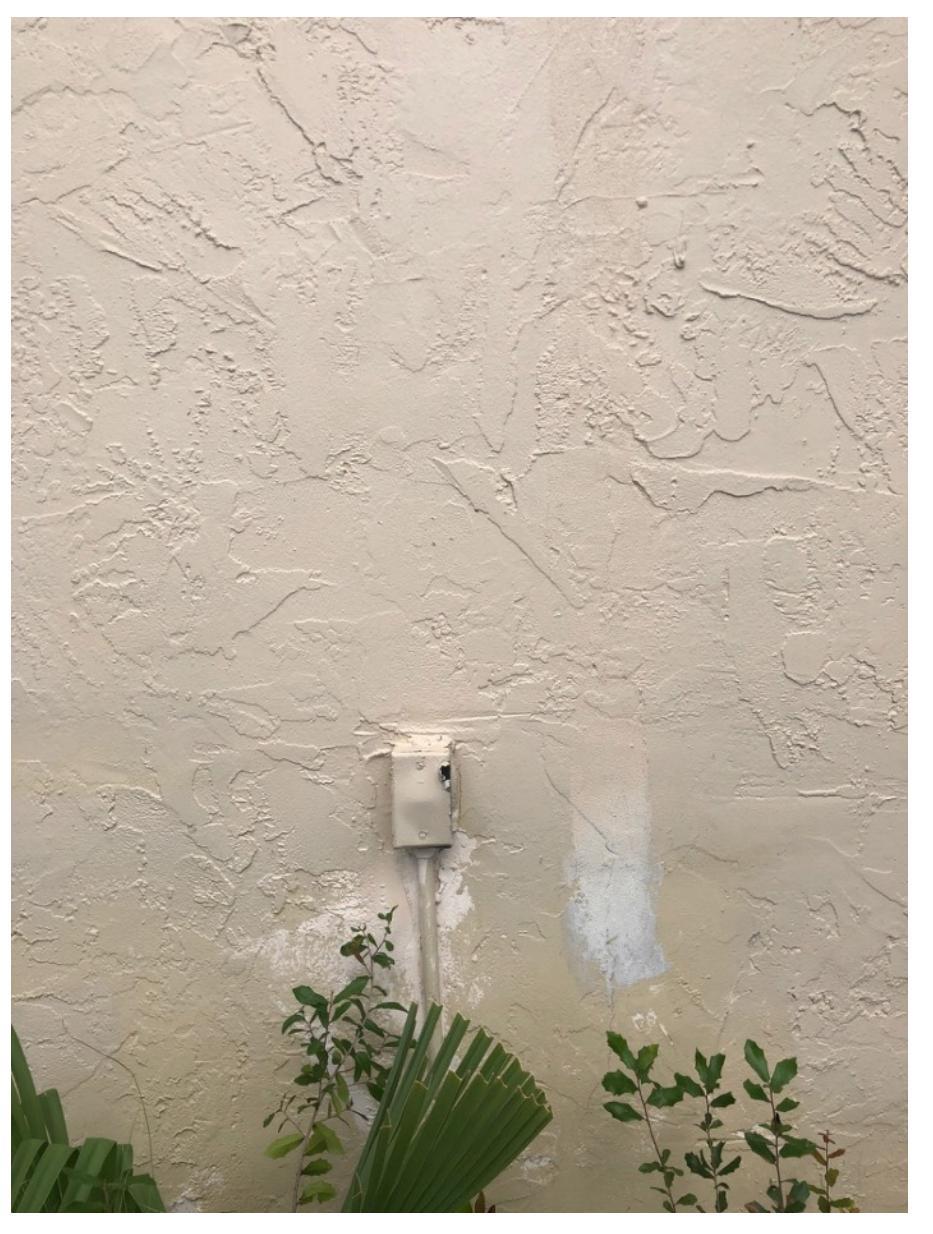
There are a few areas that require work prior to painting the mural. Near the AC unit it looks like some of the texture is lifting from the building. *See page 8*

A quick inspection of the building reveals a few areas that will need attention, please note there may be other areas The area next to the ac will continue to lift if not treated and the junction box will need to be moved or the panels will need to be cut to accommodate it
