HISTORIC PRESERVATION BOARD STAFF REPORT					
Sundy Village					
Meeting	Item				
September 1, 2021	Unsafe Structure Report				
ITEM					
The item before the Board is a report from the Chief Building Official regarding the determination of Unsafe Building of the Sundy Village Site property per LDR Section 4.5.1(G) and LDR Chapter 7.8					
GENERAL DATA					
 Owner: Sundy Village West, LLC Agent: Neil Schiller, Esq. Location: Block 61, Block 69, & Block 70 PCN: 12-43-46-16-010-69-0162 12-43-46-16-010-61-0140 12-43-46-16-010-61-0050 12-43-46-16-010-61-0010 Property Size: 6.8 Acres Zoning: OSSHAD & OSSHAD with CBD Overlay LUM Designation: HMU (Historic Mixed Use) Historic District: Old School Square Historic District Adjacent Zoning: OSSHAD (North) OSSHAD and CBD (West) OSSHAD & CBD (East) Existing Land Use: Residential & Commercial

Building H - Unsafe and Requires Removal

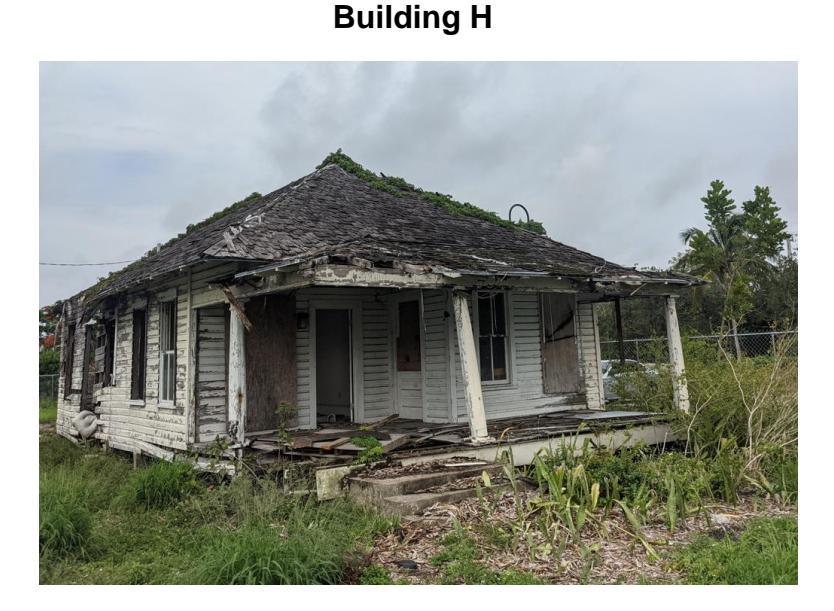
<u>Chief Building Official</u>: The Building Official has inspected the structure and determined Building H has degraded beyond repair. Building H is unsafe in its current condition and needs to be removed.

<u>Development Services Additional Comments:</u> Removal and debris removal of Building H should occur as soon as possible, as Florida is currently within an active hurricane season. The reconstruction of Building H on the Sundy House property was submitted for building permit in 2020 as a residential structure (the permit should be for commercial construction); however, the

permit has stalled. The applicant should re-submit the building permit for the reconstructed structure and commence construction as soon as possible.

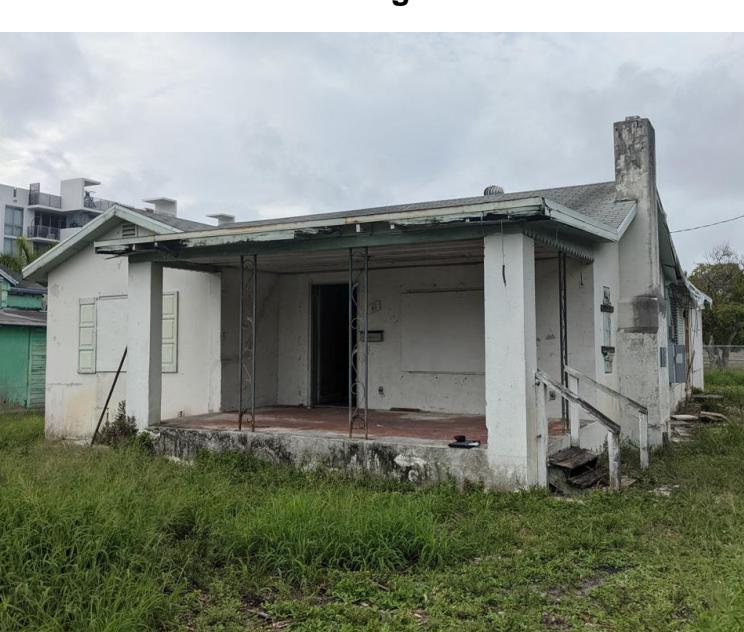
<u>Chief Building Official</u>: This building has been allowed to deteriorate over the years. Water damage is impacting the front porch and a visible hole is in the roof in the rear room of the building. Building W is unsafe in its current condition and requires repair, particularly to the roof.

<u>Development Services Additional Comments:</u> The structure, which has clearly been occupied by vagrants, needs to be cleaned out, secured, and inspected regularly by the property owner for security purposes.

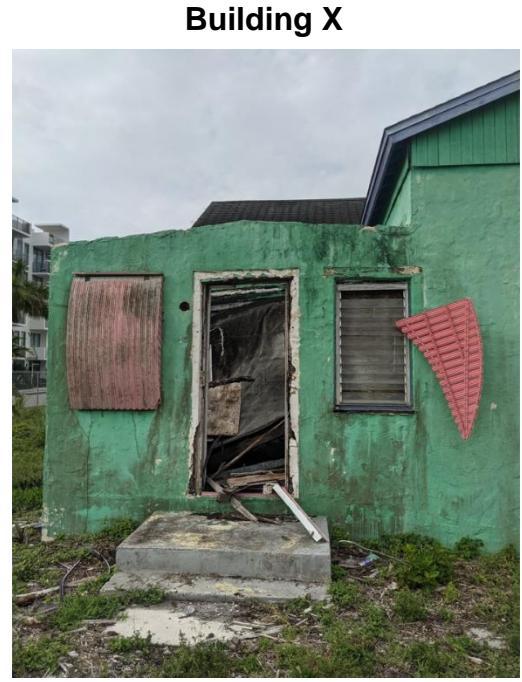
<u>Chief Building Official</u>: This building has deteriorated over the years, including the front porch roof collapsing and the carport parapet separating from the structure. Water damage is visible in the front room and exterior stucco damage is evident. The foundation appears to be intact. Building X is unsafe in its current condition and requires repair.

<u>Development Services Additional Comments</u>: The structure, which has clearly been occupied by vagrants, needs to be cleaned out, secured, and inspected regularly by the property owner for security purposes.

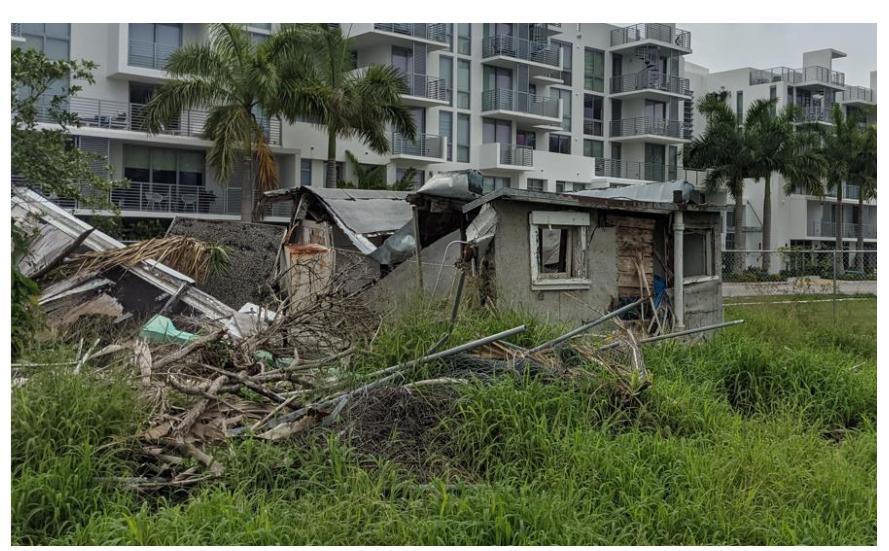
<u>Chief Building Official</u>: This building has collapsed and is no longer repairable. Building Y is unsafe in its current condition and should be removed.

<u>Development Services Staff</u>: Debris removal should occur as soon as possible, as Florida is currently in an active hurricane season.

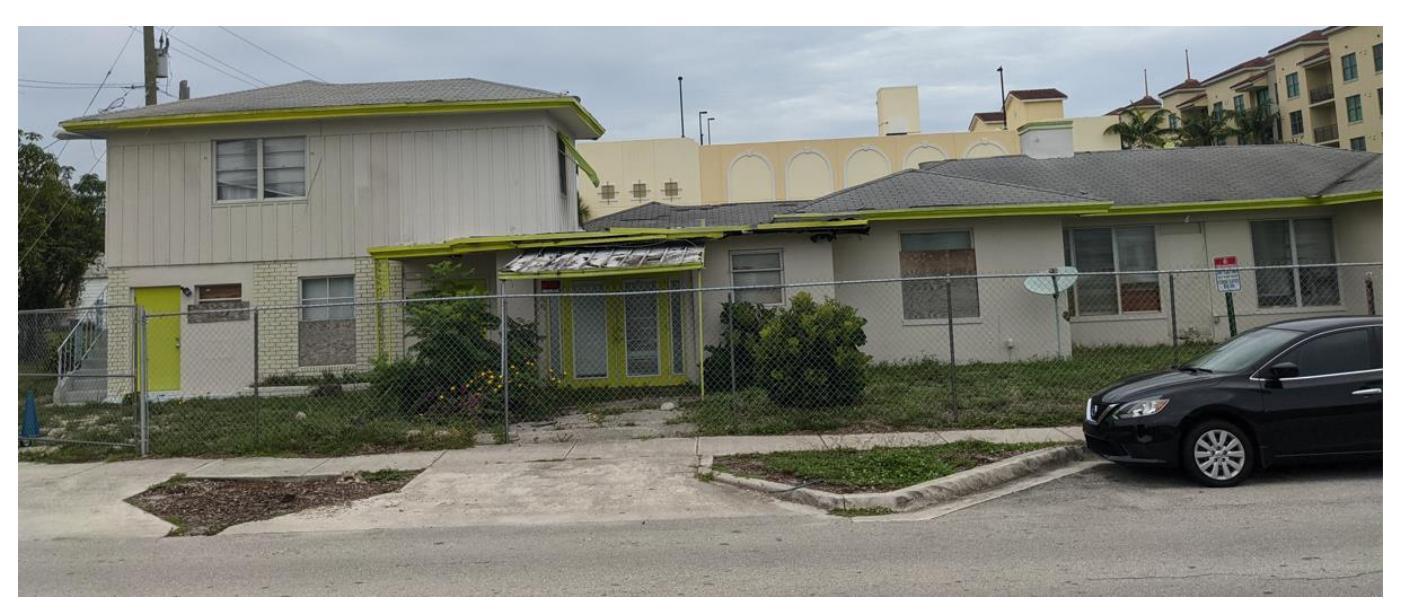
<u>Chief Building Official:</u> This building has been in generally good repair; however, a recent site inspection revealed a compromised roof and ongoing water damage accelerating the deterioration of the condition of the building. Building Z is unsafe in its current condition and requires repair.

<u>Development Services Staff</u>: The structure, which has been occupied by vagrants, needs to be cleaned out, secured, and inspected regularly by the property owner for security purposes.

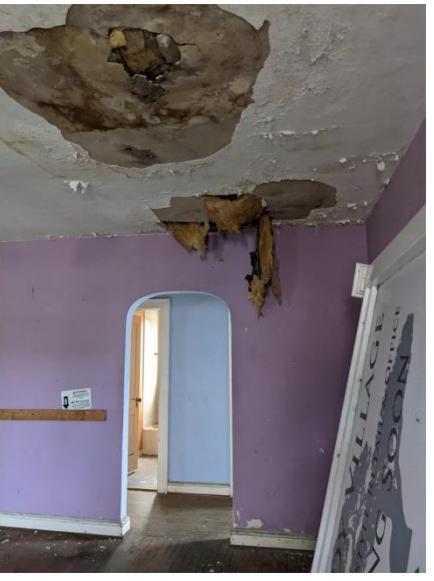
The other buildings on the project site are slated to be preserved, either relocated within the project (Buildings A, B, C, D and F) or remaining in place (Buildings E and G). These buildings are the most important historic resources in the project and require improved, ongoing maintenance and security to prevent them from further deteriorating. Termite activity was noted in all the structures and should be addressed immediately. Building A, the Rectory, has a distinct odor that may be caused by water intrusion and should be further inspected and addressed. Building C was not accessible for inspection. Finally, Building F has evidence of water intrusion in the ceiling, which is degrading the historic materials. Roof repair is needed.
