HISTORIC PRESERVATION BOARD

CITY OF DELRAY BEACH STAFF REPORT

ITEM: **218 NE 5th Court, Del-Ida Park Historic District (2017-011)** – Certificate of Appropriateness and Variance request for the demolition of a contributing structure and new construction of a single-family residence, and reduction to the rear setback from the required 10' to 4'3".

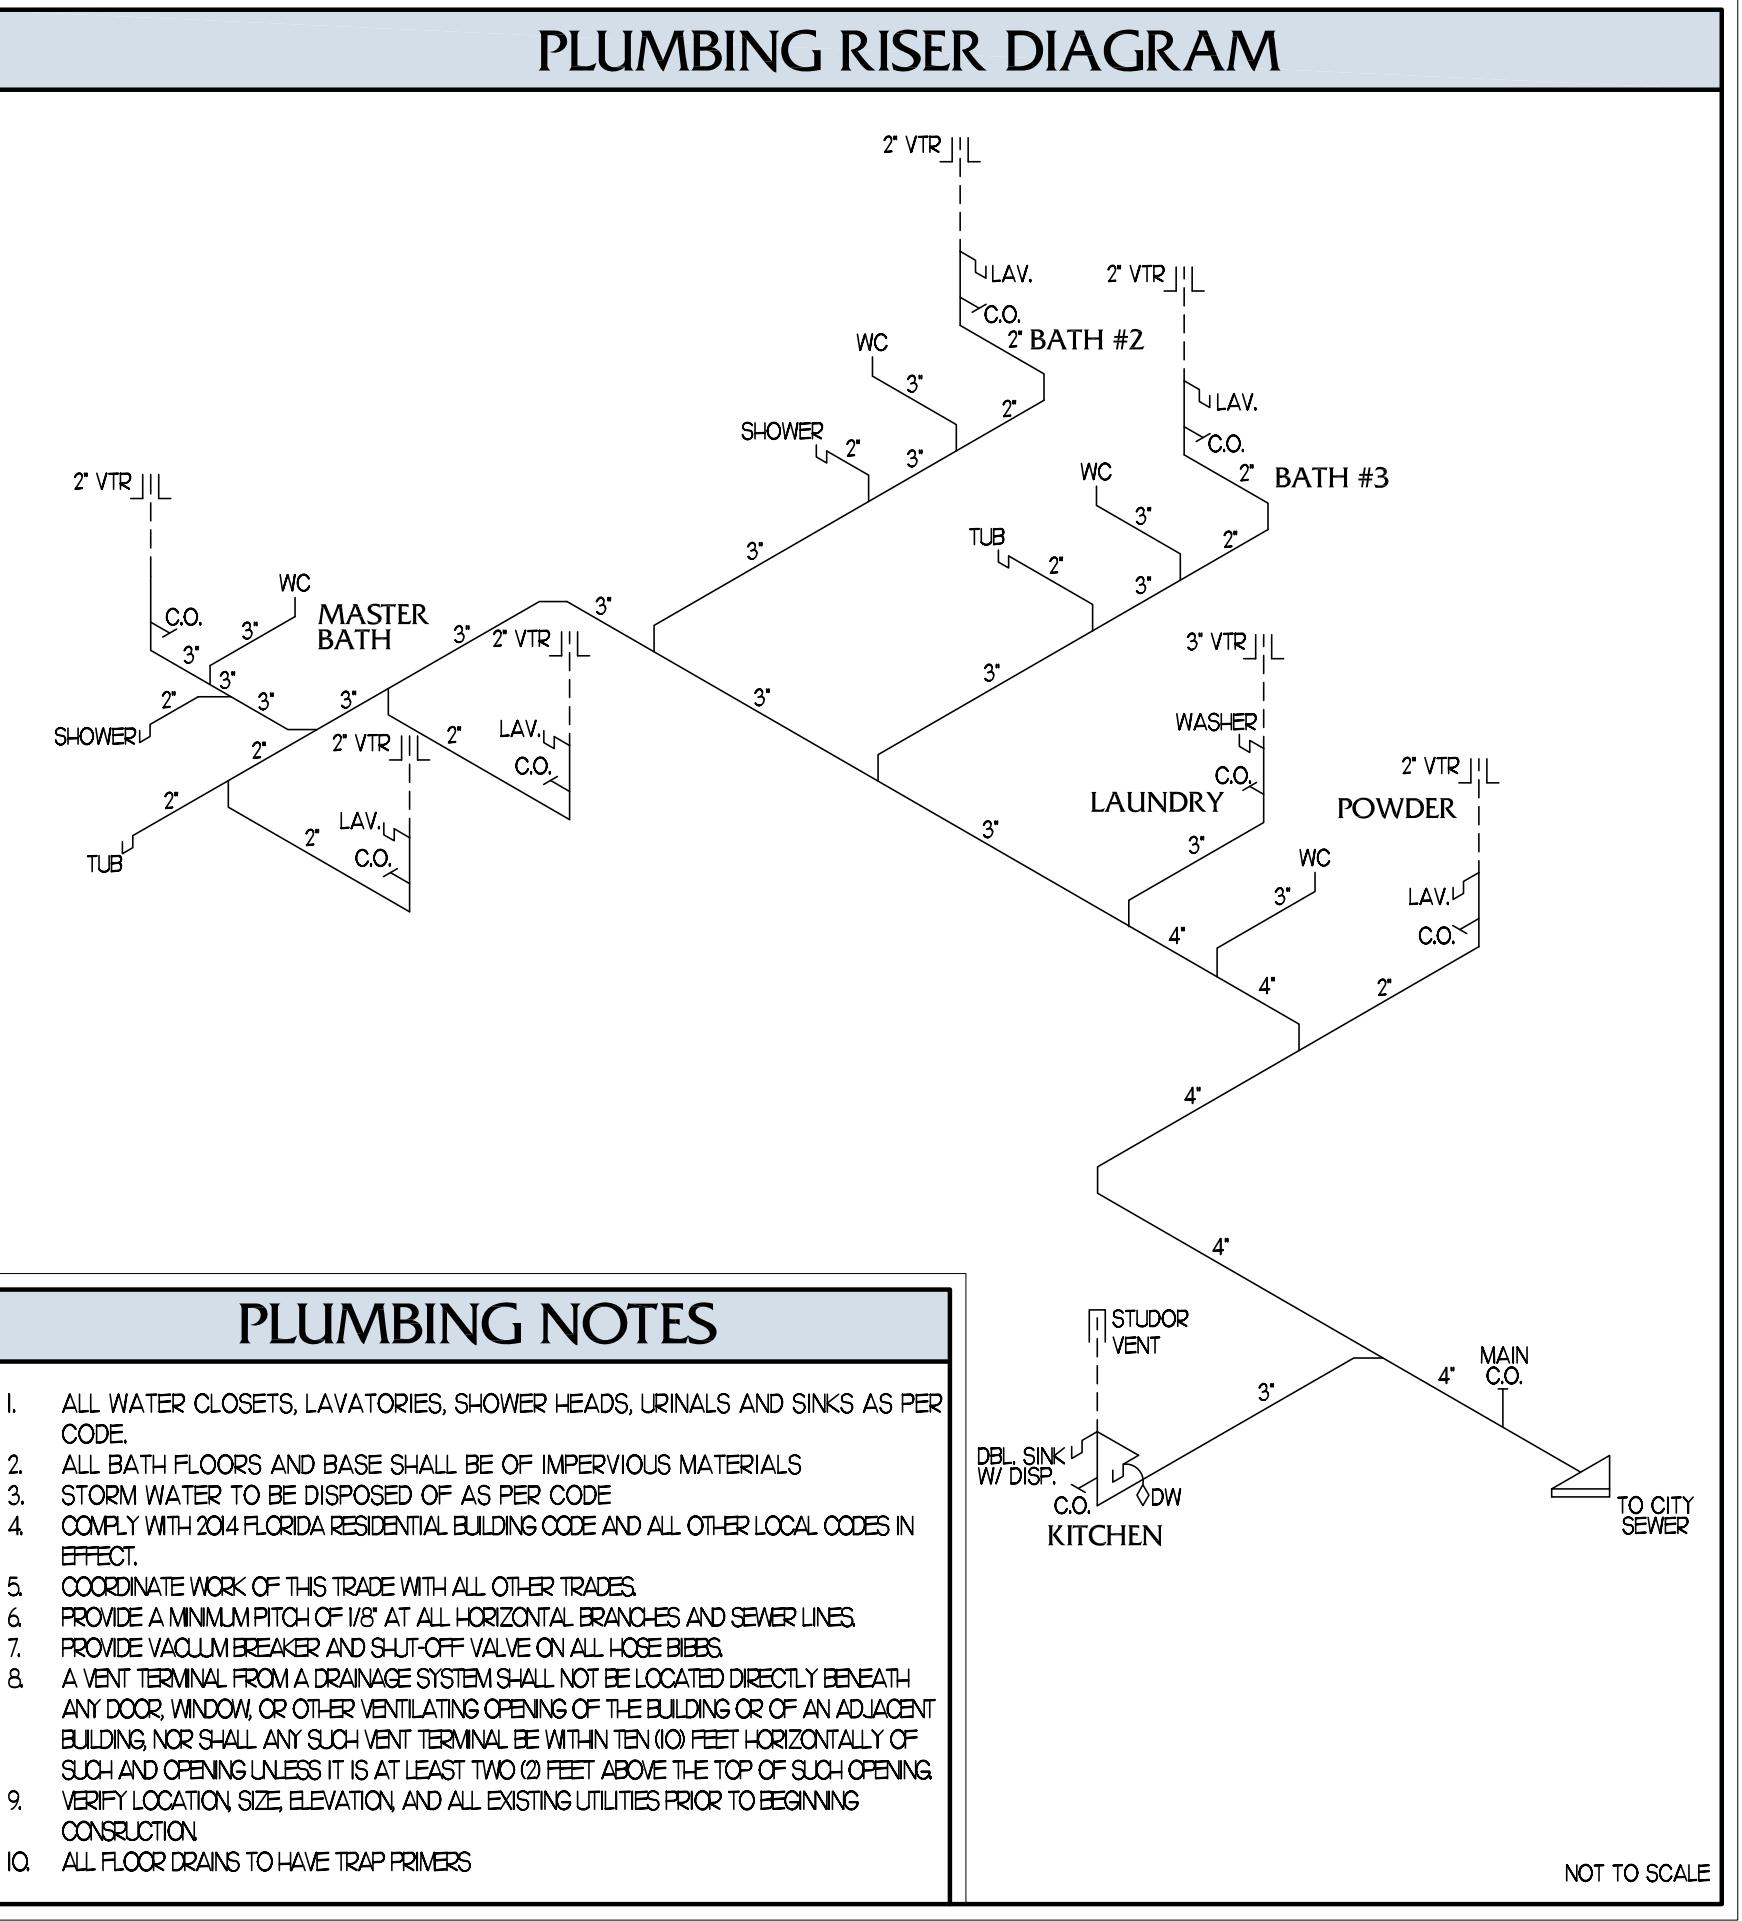
PLUMBING RISER DIAGRAM

1. ALL WATER CLOSETS, LAVATORIES, SHOWER HEADS, URINALS AND SINKS AS PER CODE.
2. ALL BATH FLOORS AND BASE SHALL BE OF IMPERVIOUS MATERIALS
3. STORM WATER TO BE DISPOSED OF AS PER CODE

7. PROVIDE VACUUM BREAKER AND SHUT-OFF VALVE ON ALL HOSE BIBBS.
8. A VENT TERMINAL FROM A DRAINAGE SYSTEM SHALL NOT BE LOCATED DIRECTLY BENEATH ANY DOOR, WINDOW, OR OTHER VENTILATING OPENING OF THE BUILDING OR OF AN ADJACENT BUILDING, NOR SHALL ANY SUCH VENT TERMINAL BE WITHIN TEN (10) FEET HORIZONTALLY OF SUCH AN OPENING UNLESS IT IS AT LEAST TWO (2) FEET ABOVE THE TOP OF SUCH OPENING.

9. VERIFY LOCATION, SIZE, ELEVATION, AND ALL EXISTING UTILITIES PRIOR TO BEGINNING CONSTRUCTION
10. ALL FLOOR DRAINS TO HAVE TRAP PRIMERS
