**HISTORIC PRESERVATION BOARD STAFF REPORT**

**824 E Atlantic Avenue**

Meeting	File No.	Application Type
August 7, 2024	2024-180	Certificate of Appropriateness

The item before the Board is consideration of a Certificate of Appropriateness (2024-180) for a partial exterior color change on a contributing commercial structure located at **824 E. Atlantic Avenue, Marina Historic District.**

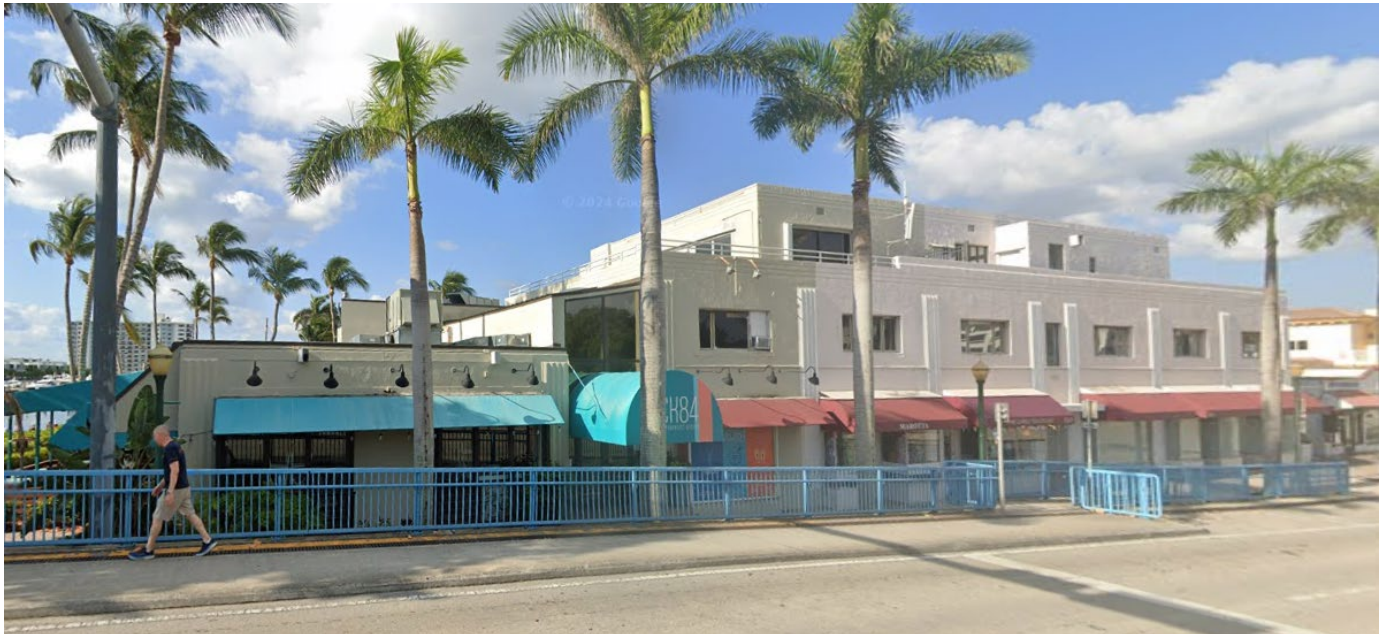
In 2021, the east portion of the three-story existing structure was painted to match the Deck 84 portion of the site. The owner did not receive approval from the city for repainting this portion of the building (see photo below).

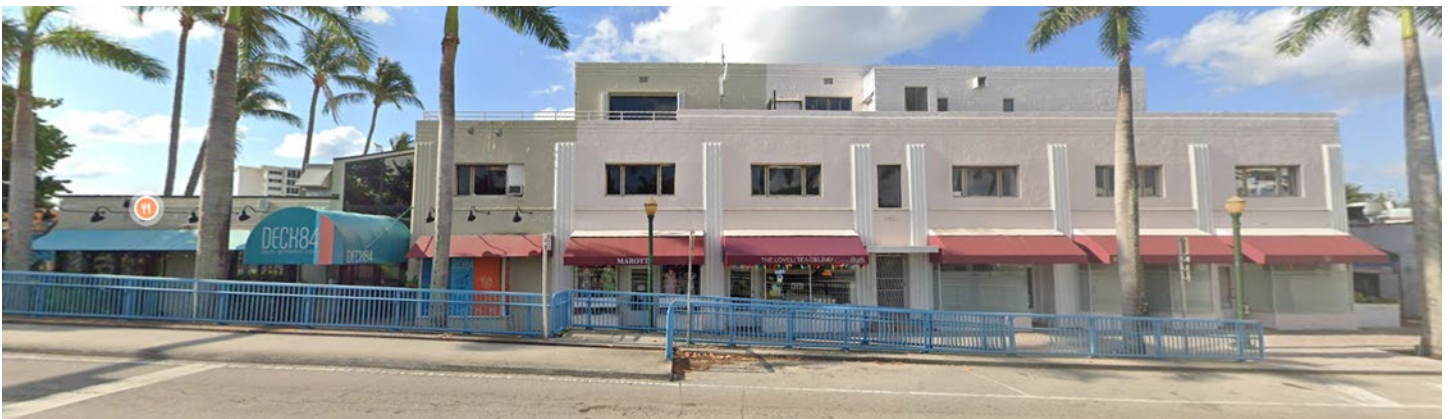
Standards 2, 3, and 5 are applicable to the request. There is concern with regard to Standards 2, 3, and 5, as the fluted pilasters on the side of Deck 84 (see image below) have been painted the same beige hue as the walls of the structure, the muted designs along with the wall color difference from the rest of the building giving the illusion that these are separate structures and diminishing the architectural detailing of the building. This method of painting a structure is not typical as it creates a conjectural design which is not recommended for an historic structure as it does not fully communicate the style and detailing of the Art Moderne architecture.

In order to protect the building’s distinguishing character and the pilaster elements, which contribute to the visual character of the Art Moderne building design, the pilaster elements should be painted the same color, consistently across the span of the façade (not the same color as the wall facades). Consideration could be given to painting the walls of the structure one consistent color in order to protect the character and simplicity of the Art Moderne style building. However, it could be seen appropriate for the one-story portion of the structure and with the associated glass façade to remain as they exist.

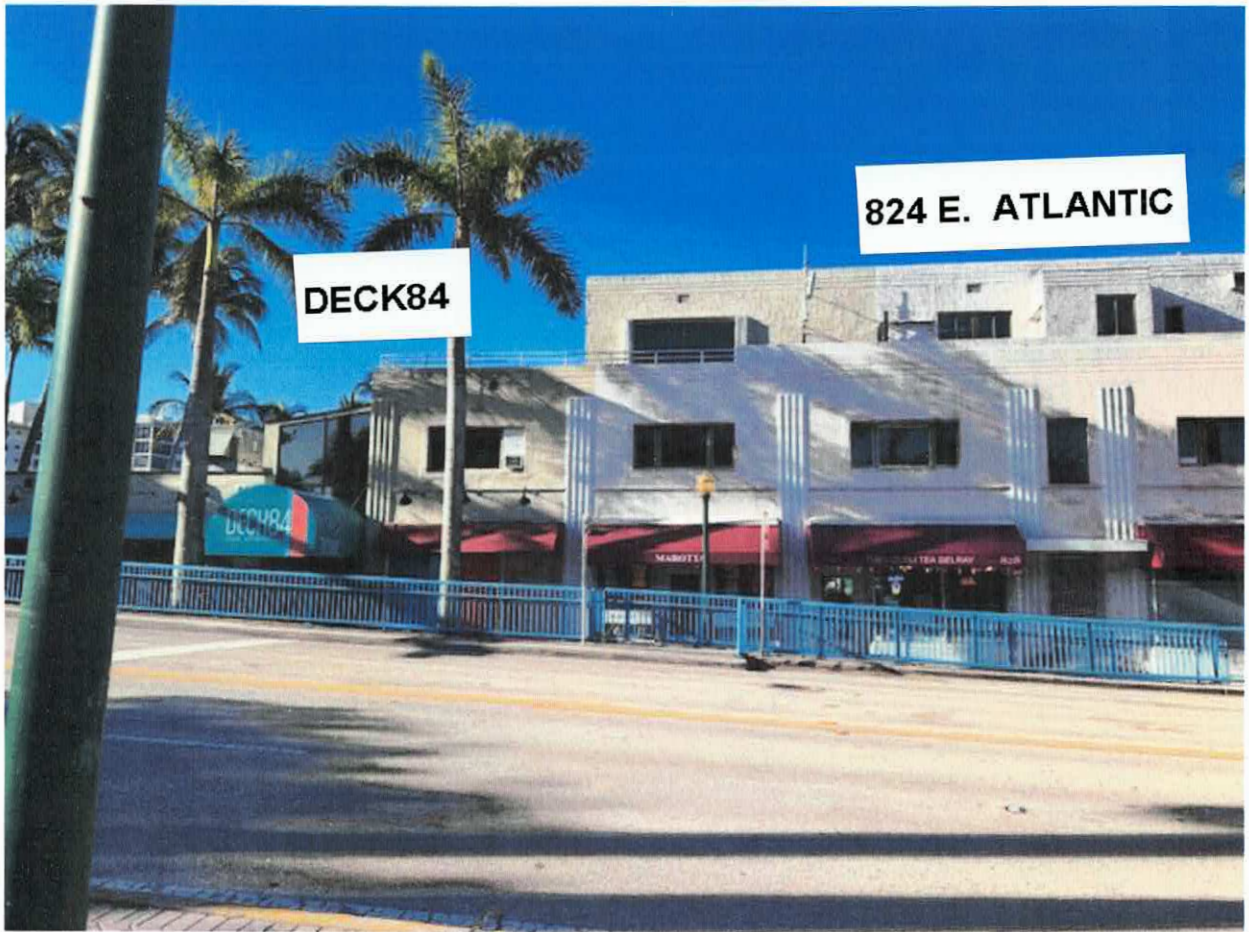
DECK84

824 E. ATLANTIC

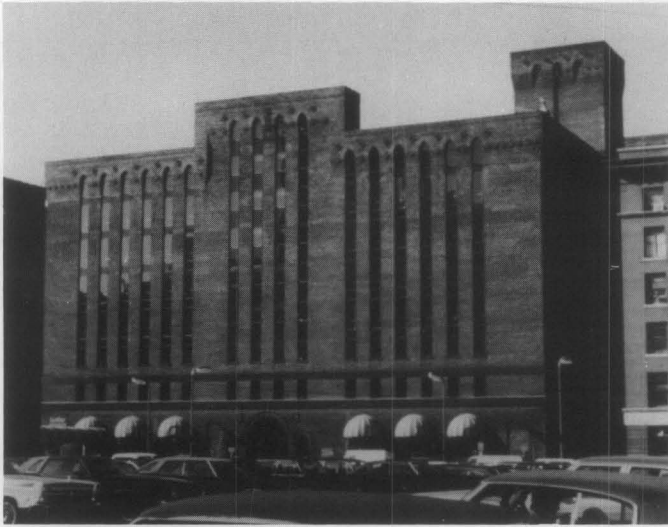
**Overall Visual Character: Shape**

The shape of a building can be an important aspect of its overall visual character. The building illustrated here, for example, has a distinctive horizontal box-like shape with the middle portion of the box projecting up an extra story. This building has other visual aspects that help define its overall character, including the pattern of vertical bands of windows, the decorative horizontal bands which separate the base of the building from the upper floors, the dark brown color of the brick, the large arched entranceway, and the castle-like tower behind the building.

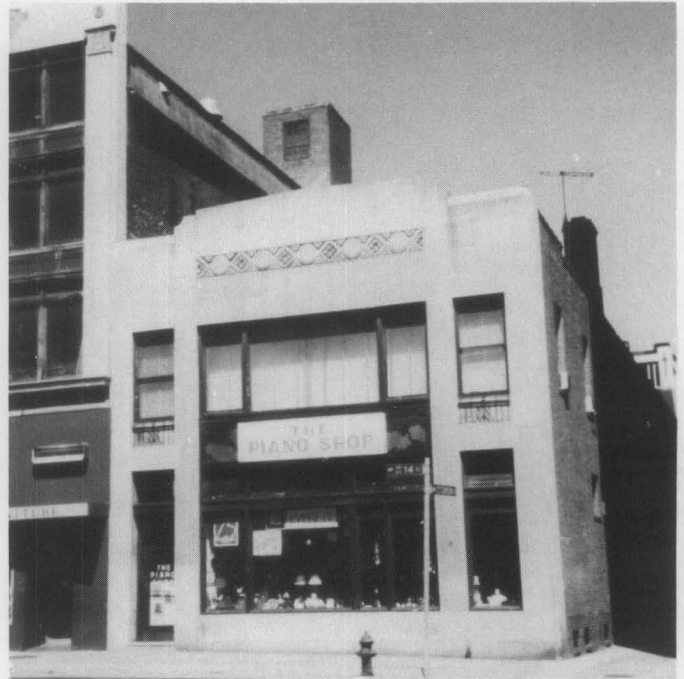
**Overall Visual Character: Shape**

It should not be assumed that only large or unusual buildings have a shape that is distinctive or identifiable. The front wall of this modest commercial building has a simple three-part shape that is the controlling aspect of its overall visual character. It consists of a large center bay with a two story opening that combines the storefront and the windows above. The upward projecting parapet and the decorative stonework also relate to and emphasize its shape. The flanking narrow bays enframe the side windows and the small iron balconies, and the main entrance doorway into the store. Any changes to the center portion of this three-part shape, could drastically affect the visual character of this building. Photo by Emogene A. Bevitt

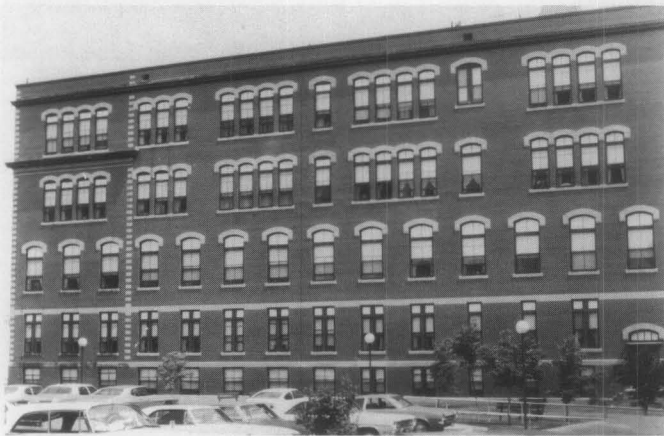
**Overall Visual Character: Openings**

Window and door openings can be important to the overall visual character of historic buildings. This view shows only part of a much larger building, but the windows clearly help define its character, partly because of their shape and rhythm: the upper floor windows are grouped in a 4,3,4,1,4 rhythm, and the lower floor windows are arranged in a regular 1,1,1,... rhythm. The individual windows are tall, narrow and arched, and they are accented by the different colored arched heads, which are connected where there are multiple windows so that the color contrast is a part of its character. If additional windows were inserted in the gap of the upper floors, the character would be much changed, as it would if the window heads were painted to match the color of the brick walls. Photo by Susan I. Dynes

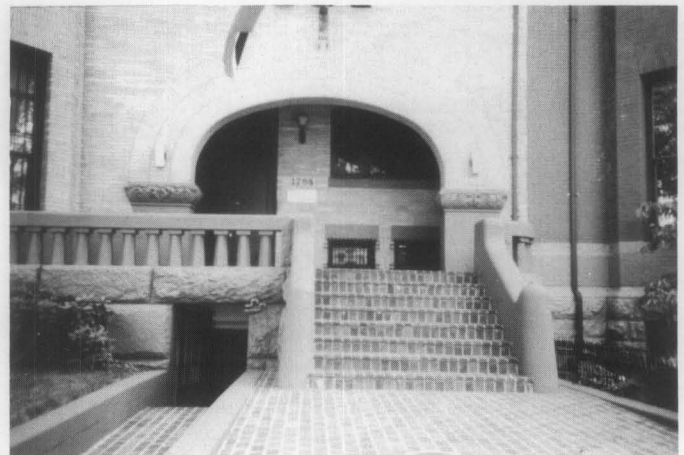
**Overall Visual Character: Openings**

The opening illustrated here dominates the visual character of this building because of its size, shape, location, materials, and craftsmanship. Because of its relation to the generous staircase, this opening places a strong emphasis on the principal entry to the building. Enclosing this arcade-like entry with glass, for example, would materially and visually change the character of the building. Photo by Lee H. Nelson.

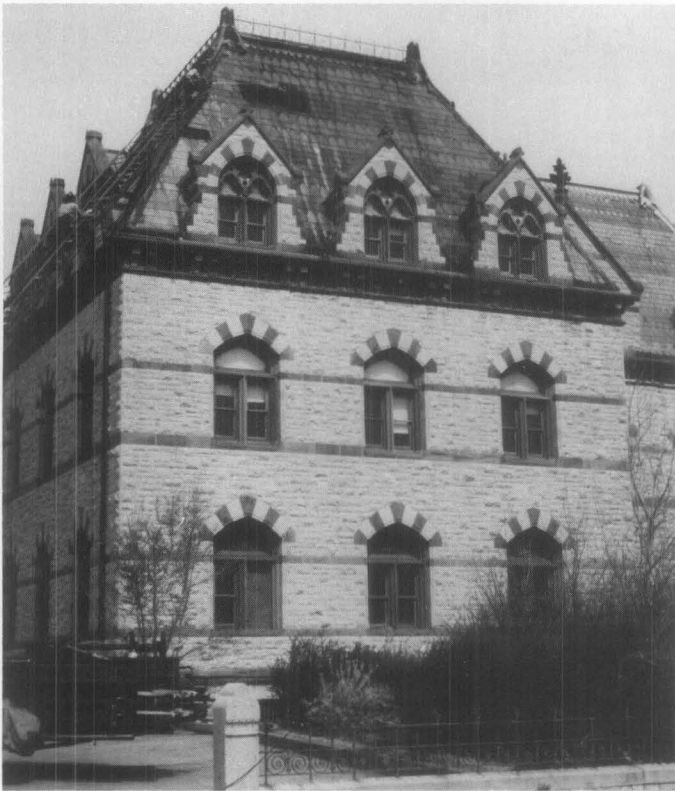
**Overall Visual Character: Roof and Related Features**

This building has a number of character-defining aspects which include the windows and the decorative stonework, but certainly the roof and its related features are visually important to its overall visual character. The roof is not only highly visible, it has elaborate stone dormers, and it also has decorative metalwork and slatework. The red and black slates of differing sizes and shapes are laid in patterns that extend around the roof of this large and freestanding building. Any changes to this patterned slatework, or to the other roofing details would damage the visual character of the building. Photo by Laurie R. Hammel

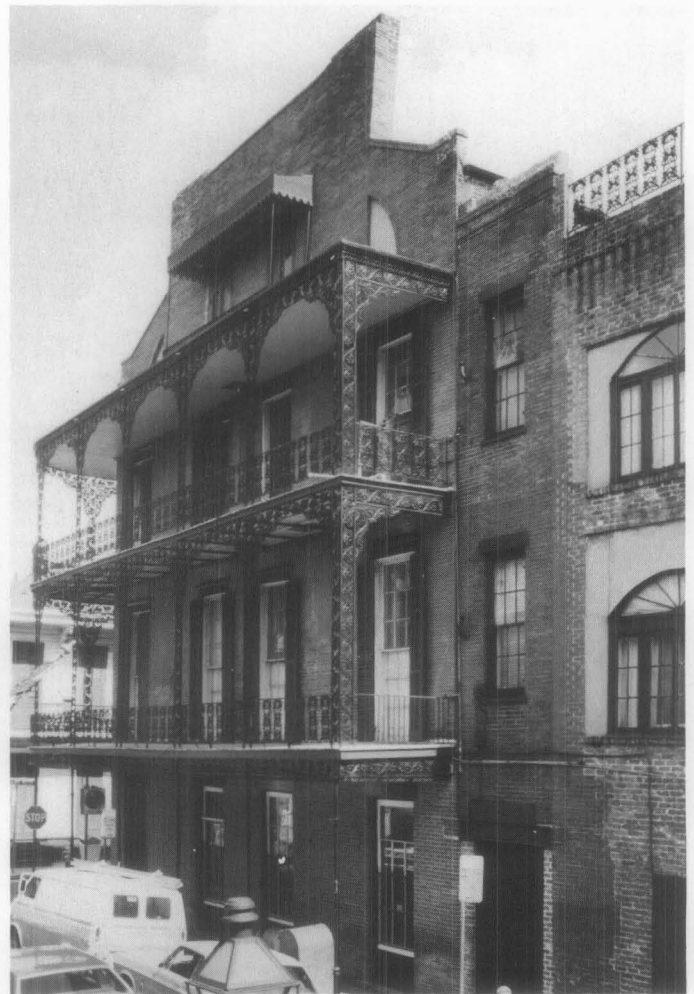
**Overall Visual Character: Projections**

A projecting porch or balcony can be very important to the overall visual character of almost any building and to the district in which it is located. Despite the size of this building (3 1/2 stories), and its distinctive roofline profile, and despite the importance of the very large window openings, the lacy wrap-around iron balcony is singularly important to the visual character of this building. It would seriously affect the character to remove the balcony, to enclose it, or to replace it with a balcony lacking the same degree of detail of the original material. Photo by Baird M. Smith

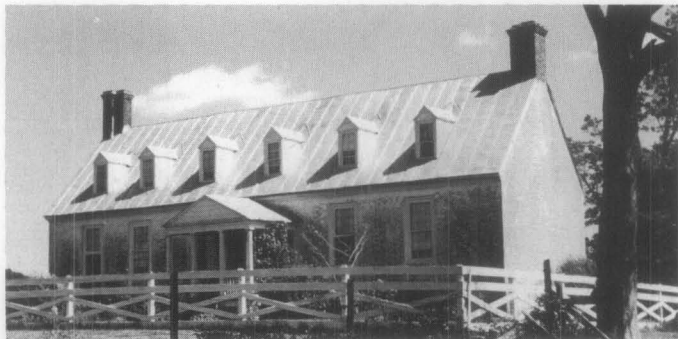
**Overall Visual Character: Roof and Related Features**

On this building, the most important visual aspects of its character are the roof and its related features such as the dormers and chimneys. The roof is important to the visual character because its steepness makes it highly visible, and its prominence is reinforced by the patterned tinwork, the six dormers and the two chimneys. Changes to the roof or its features, such as removal or alterations to the dormers, for example, would certainly change the character of this building. This does not discount the importance of its other aspects, such as the porch, the windows, the brickwork, or its setting; but the roof is clearly crucial to understanding the overall visual character of this building as seen from a distance. Photo by Lee H. Nelson

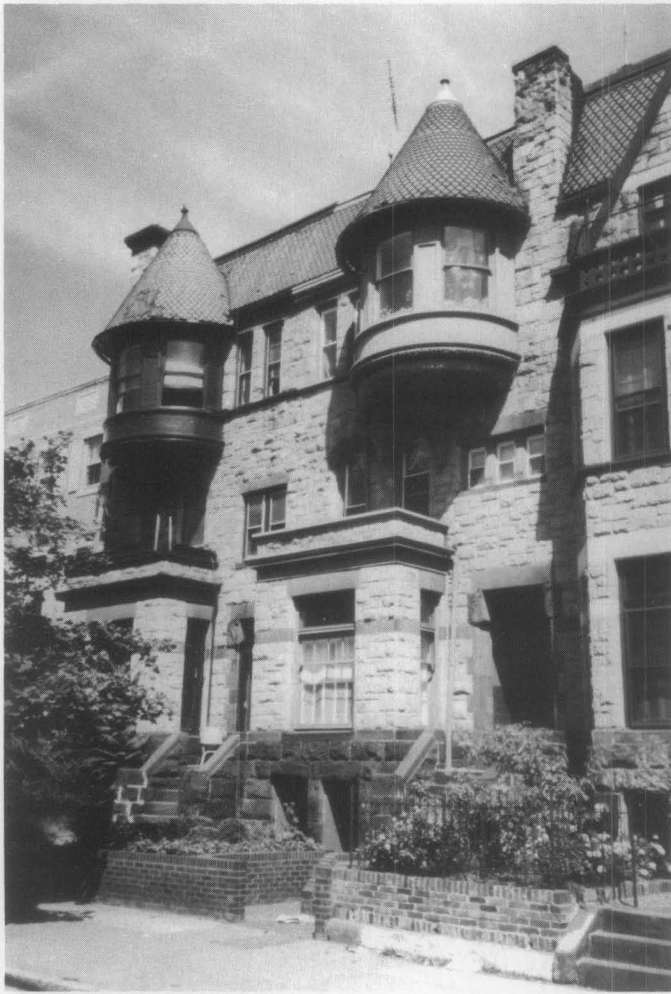
**Overall Visual Character: Projections**

Since these are row houses, any evaluation of their visual exterior character is necessarily limited to the front and rear walls; and while there are a number of things competing for attention in the front, it is the half round projecting bays with their conical roofs that contribute most prominently to the visual character. Their removal would be a devastating loss to the overall character, but even if preserved, the character could be easily damaged by changes to their color (as seen in the left bay which has been painted a dark color), or changes to their windows, or changes to their tile roofs. Though these houses have other fine features that contribute to the visual character and are worthy of preservation, these half-round bays demonstrate the importance of projecting features on an already rich and complex facade. Because of the repetitive nature of these projecting bays on adjacent row houses, along with the buildings' size, scale, openings, and materials, they also contribute to the overall visual character of the streetscape in the historic district. Any evaluation of the visual character of such a building should take into account the context of this building within the district. Photo by Lee H. Nelson

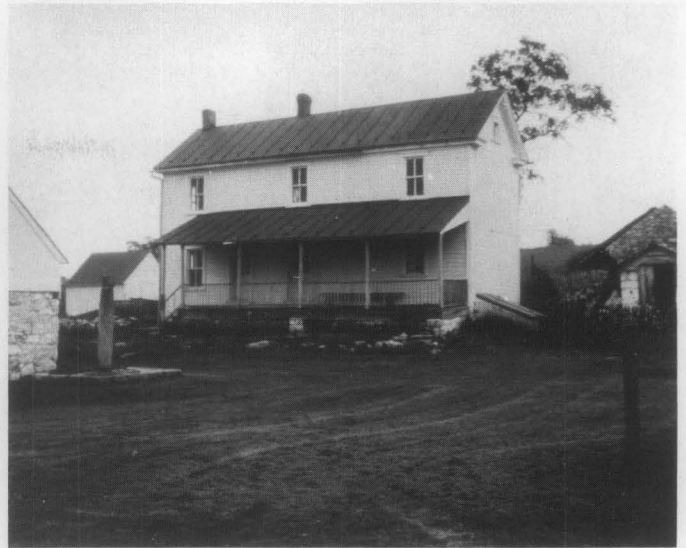
**Overall Visual Character: Projections**

Many buildings have projecting features such as porches, bay windows, or overhanging roofs, that help define their overall visual character. This projecting porch because of its size and shape, and because it copies the pitch and material of the main roof, is an important contributor to the visual character of this simple farmhouse. The removal or alteration of this porch would drastically alter the character of this building. If the porch were enclosed with wood or glass, or if gingerbread brackets were added to the porch columns, or if the tin roof was replaced with asphalt, or if the porch railing was opened to admit a center stairway, the overall visual character could be seriously damaged. Although this projecting porch is an important feature, almost any other change to this house, such as changes to the window pattern, or changes to the main roof, or changes to the setting, would also change its visual character. Photo by Hugh C. Miller

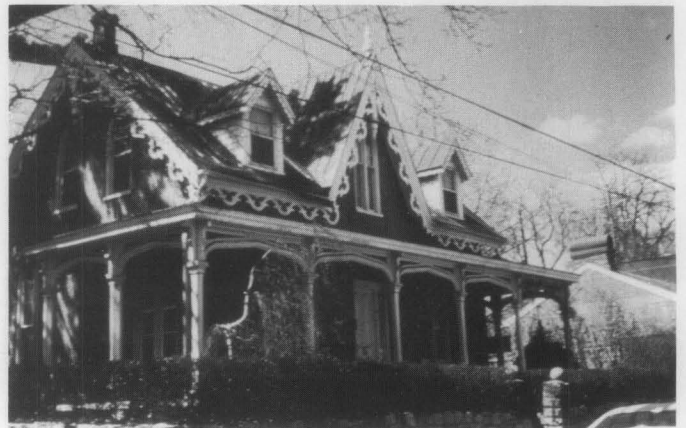
**Overall Visual Character: Trim**

If one were to analyze the overall shape or form of this building, it would be seen that it is a gable-roofed house with dormers and a wrap-around porch. It is similar to many other houses of the period. It is the wooden trim on the eaves and around the porch that gives this building its own identify and its special visual character. Although such wooden trim is vulnerable to the elements, and must be kept painted to prevent deterioration; the loss of this trim would seriously damage the overall visual character of this building, and its loss would obliterate much of the close-up visual character so dependent upon craftsmanship for the moldings, carvings, and the see-through jigsaw work. Photo by Hugh C. Miller

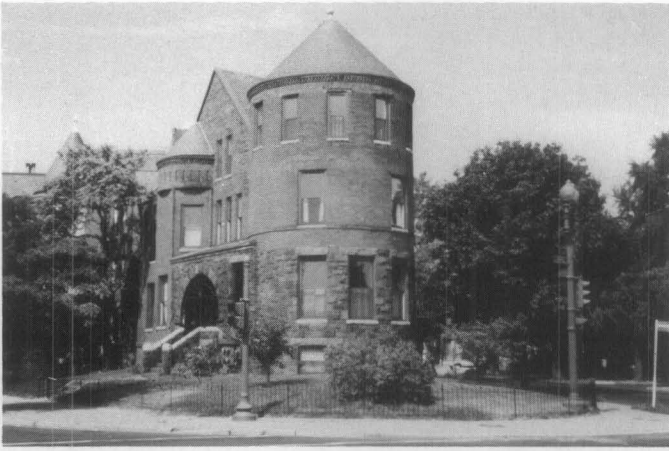
**Overall Visual Character: Setting**

In the process of identifying the overall visual character, the aspect of setting should not be overlooked. Obviously, the setting of urban row houses differs from that of a mansion with a designed landscape. However, there are many instances where the relationship between the building and its place on the streetscape, or its place in the rural environment, in other words its setting, may be an important contributor to its overall character.

In this instance, the corner tower and the arched entryway are important contributors to the visual character of the building itself, but there is also a relationship between the building and the two converging streets that is also an important aspect of this historic building. The curb, sidewalk, fence, and the yard interrelate with each other to establish a setting that is essential to the overall visual character of the historic property. Removing these elements or replacing them with a driveway or parking court would destroy an important visual aspect. Photo by Lee H. Nelson

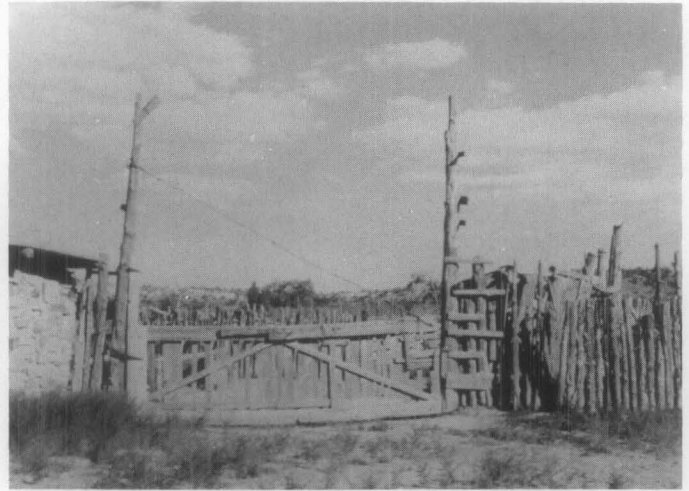
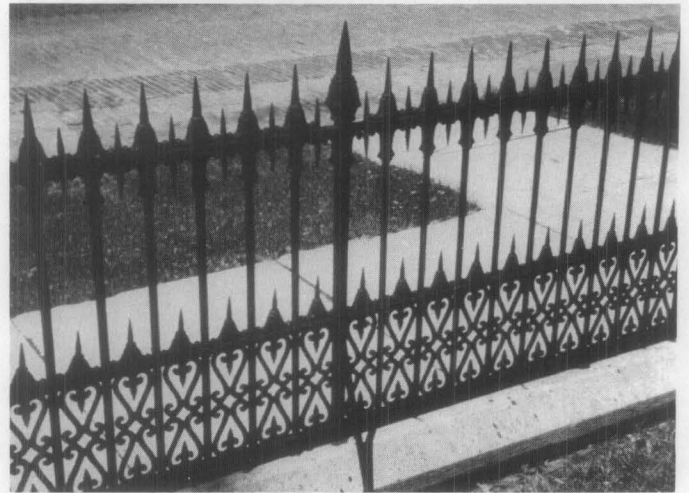
**Overall Visual Character: Setting**

Among the various visual aspects relating to the setting of an historic property are such site features as gardens, walks, fences, etc. This can include their design and materials. There is a dramatic difference in the visual character between these two fence constructions—one utilizing found materials with no particular regard to their uniformity of size or placement, and the other being a product of the machine age utilizing cast iron components assembled into a pattern of precision and regularity. If the corral fence were to be repaired or replaced with lumberyard materials its character would be dramatically compromised. The rhythm and regularity of the cast iron fence is so important to its visual character that its character could be altered by accidental damage or vandalism, if some of the fence top spikes were broken off thus interrupting the rhythm or pattern. Photos by Lee H. Nelson

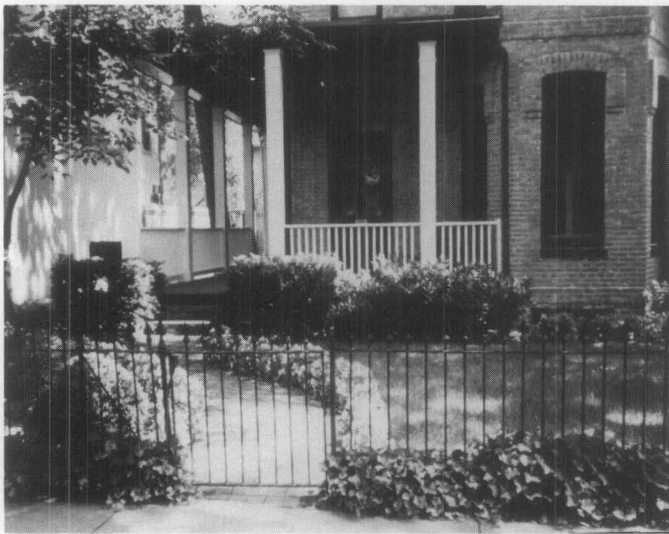
**Overall Visual Character: Setting**

Even architecturally modest buildings frequently will have a setting that contributes to their overall character. In this very urban district, set-backs are the exception, so that the small front yard is something of a luxury, and it is important to the overall character because of its design and materials, which include the iron fence along the sidewalk, the curved walk leading to the porch, and the various plantings. In a district where parking spaces are in great demand, such front yards are sometimes converted to off-street parking, but in this instance, that would essentially destroy its setting and would drastically change the visual character of this historic property. Photo by Lee H. Nelson

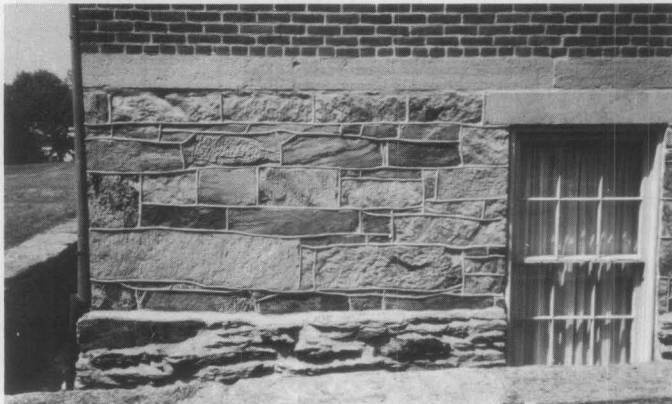
**Arm's Length Visual Character: Materials**

At arm's length, the visual character is most often determined by the surface qualities of the materials and craftsmanship; and while these aspects are often inextricably related, the original choice of materials often plays the dominant role in establishing the close-range character because of the color, texture, or shape of the materials.

In this instance, the variety and arrangement of the materials is important in defining the visual character, starting with the large pieces of broken stone which form the projecting base for the building walls, then changing to a wall of roughly rectangular stones which vary in size, color, and texture, all with accentuated, projecting beads of mortar, then there is a rather precise and narrow band of cut and dressed stones with minimal mortar joints, and finally, the main building walls are composed of bricks, rather uniform in color, with fairly generous mortar joints. It is the juxtaposition and variety of these materials (and of course, the craftsmanship) that is very important to the visual character. Changing the raised mortar joints, for example, would drastically alter the character at arm's length. Photo by Lee H. Nelson

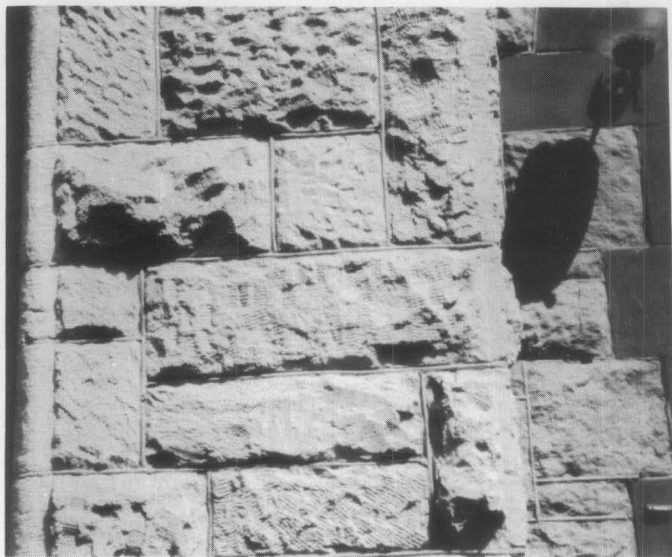
**Arm's Length Visual Character: Craft Details**

There are many instances where craft details dominate the arm's length visual character. As seen here, the craft details are especially noticeable because the stones are all of a uniform color, and they are all squared off, but their surfaces were worked with differing tools and techniques to create a great variety of textures, resulting in a tour-de-force of craft details. This texture is very important at close range. It was a deliberately contrived surface that is an important contributor to the visual character of this building. Photo by Lee H. Nelson

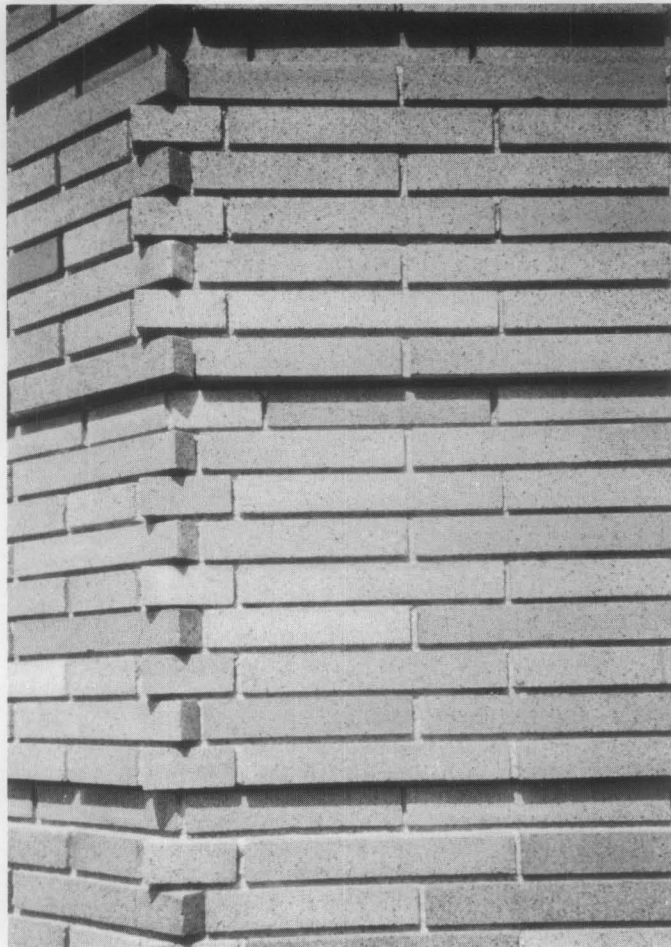
**Arm's Length Visual Character: Craft Details**

The arm's length visual character of this building is a combination of the materials and the craft details. Most of the exterior walls of this building consist of early 20th century Roman brick, precisely made, unusually long bricks, in varying shades of yellow-brown, with a noticeable surface spotting of dark iron pyrites. While this brick is an important contributor to the visual character, the related craft details are perhaps more important, and they consist of: unusually precise coursing of the bricks, almost as though they were laid up using a surveyor's level; a row of recessed bricks every ninth course, creating a shadow pattern on the wall; deeply recessed mortar joints, creating a secondary pattern of shadows; and a toothed effect where the bricks overlap each other at the corner of the building. The cumulative effect of this artisantry is important to the arm's length visual character, and it is evident that it would be difficult to match if it were damaged, and the effect could be easily damaged through insensitive treatments such as painting the brickwork or by careless repointing. Photo by Lee H. Nelson

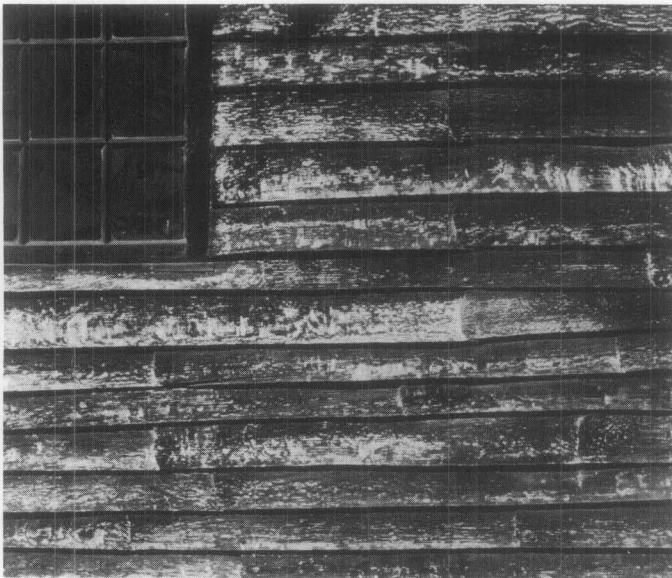
***Arm's Length Visual Character: Craft Details***

On some buildings, there are subtle aspects of visual character that cannot be perceived from a distance. This is especially true of certain craft details that can be seen only at close range. On this building, it is easily understood that the narrow, unpainted, and weathered clapboards are an important aspect of its overall visual character; but at close range there are a number of subtle but very important craft details that contribute to the handmade quality of this building, and which clearly differentiate it from a building with machine sawn clapboards. The clapboards seen here were split by hand and the bottom edges were not dressed, so that the boards vary in width and thickness, and thus they give a very uneven shadow pattern. Because they were split from oak that is unpainted, there are occasional wavy rays in the wood that stand against the grain. Also noticeable is the fact that the boards are of relatively short lengths, and that they have feather-edged ends that overlap each other, a detail that is very different from butted joints. The occasional large nail heads and the differential silver-gray weathering add to the random quality of the clapboards. All of these qualities contribute to the arm's length visual character. Photo by Lee H. Nelson

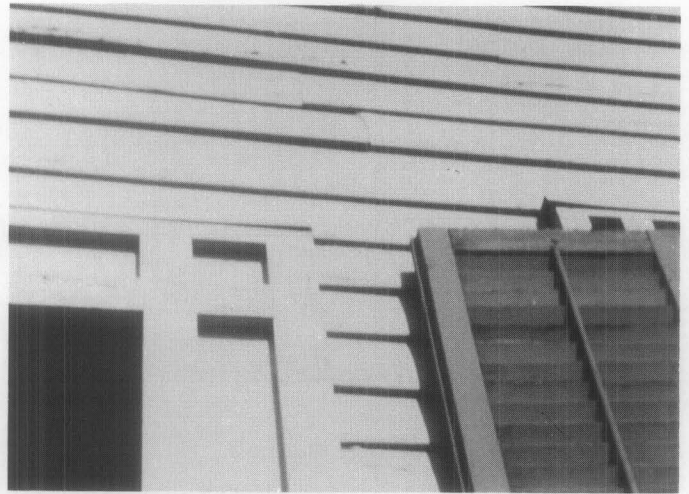
***Arm's Length Visual Character: Craft Details***

While hand-split clapboards are distinctive visual elements in their own way, machine-sawn and painted wood siding is equally important to the overall visual character in most other instances. At arm's length, however, the machine sawn siding may not be so distinctive; but there might be other details that add visual character to the wooden building, such as the details of wooden trim and louvered shutters around the windows (as seen here), or similar surface textures on other buildings, such as the saw marks on wall shingles, the joints in leaded glass, decorative tinwork on a rain conductor box, the rough surface of pebble-dash stuccowork, or the pebbly surface of exposed aggregate concrete. Such surfaces can only be seen at arm's length and they add to the visual character of a historic building. Photo by Hugh C. Miller

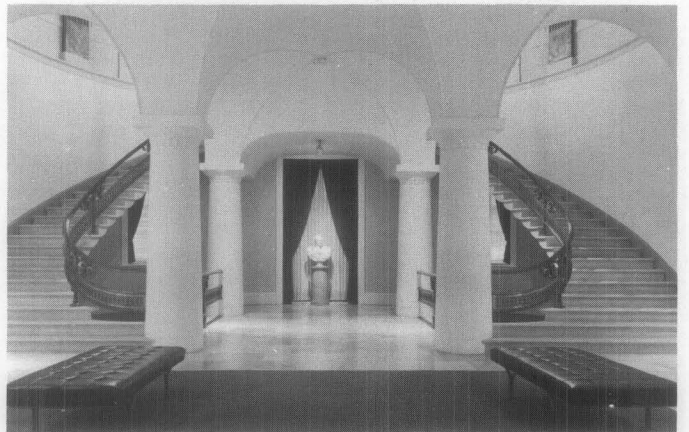
***Interior Visual Character: Individually Important Spaces***

In assessing the interior visual character of any historic building, it is necessary to ask whether there are spaces that are important to the character of this particular building, whether the building is architecturally rich or modest, or even if it is a simple or utilitarian structure.

The character of the individually important space which is illustrated here is a combination of its size, the twin curving staircases, the massive columns and curving vaulted ceilings, in addition to the quality of the materials in the floor and in the stairs. If the ceiling were to be lowered to provide space for heating ducts, or if the stairways were to be enclosed for code reasons, the shape and character of this space would be damaged, even if there was no permanent physical damage. Such changes can easily destroy the visual character of an individually important interior space. Thus, it is important that the visual aspects of a building's interior character be recognized before planning any changes or alterations. Photo by National Portrait Gallery

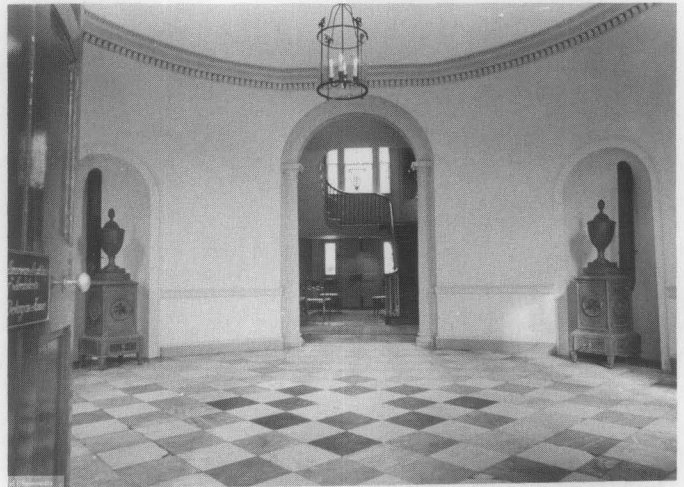
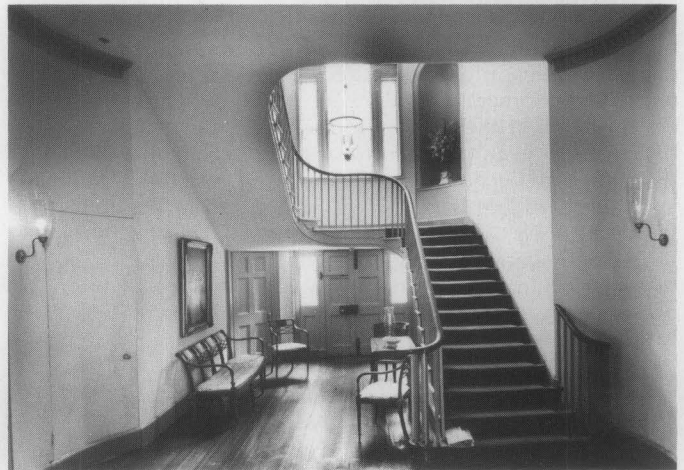
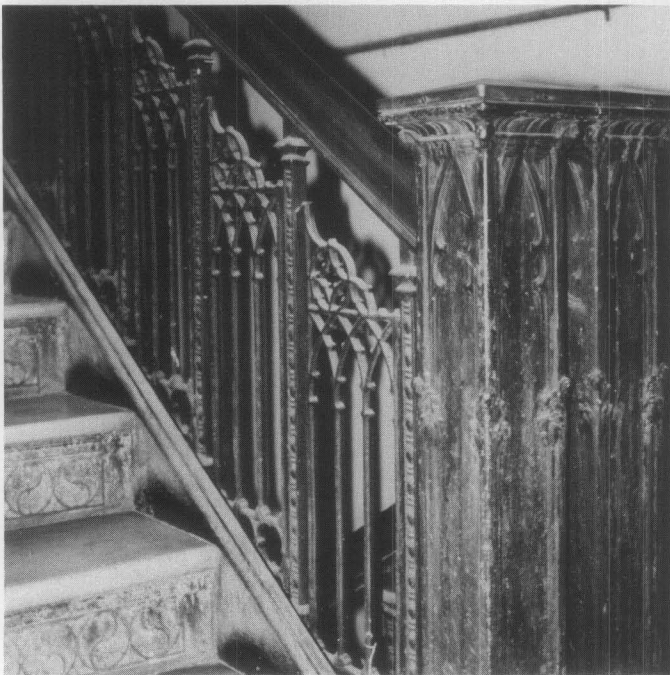
The stairway is the third part of this sequence of related spaces, and it provides continuing access to the upper floors.

These related spaces are very important in defining the interior character of this building. Almost any change to these spaces, such as installing doors between the vestibule and the hallway, or enclosing the stair would seriously impact their character and the way that character is perceived. Top photo by Mel Chamowitz, others by John Tennant

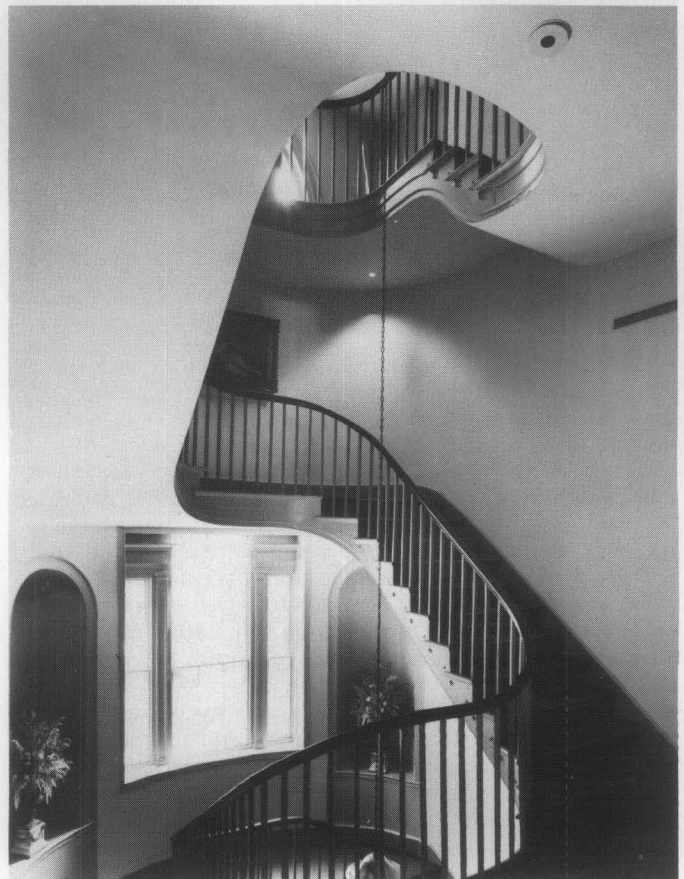
### ***Interior Visual Character: Interior Features***

Interior features are three-dimensional building elements or architectural details that are an integral part of the building as opposed to furniture. Interior features are often important in defining the character of an individual room or space. In some instances, an interior feature, like a large and ornamental open stairway may dominate the visual character of an entire building. In other instances, a modest iron stairway (like the one illustrated here) may be an important interior feature, and its preservation would be crucial to preserving the interior character of the building. Such features can also include the obvious things like fireplace mantles, plaster ceiling medallions, or panelling, but they also extend to features like hardware, lighting fixtures, bank tellers cages, decorative elevator doors, etc. Photo by David W. Look

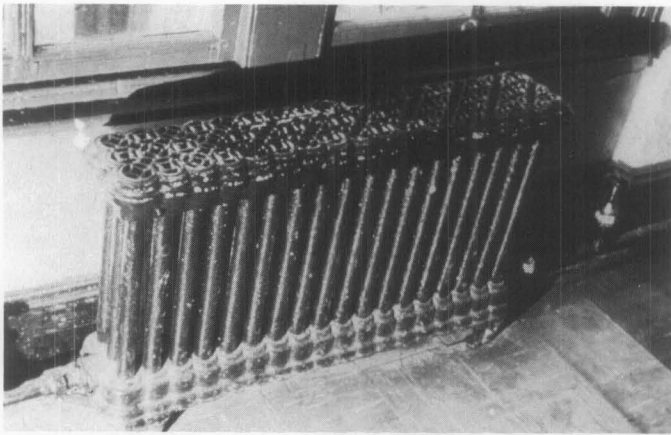
***Interior Visual Character: Interior Features***

Modern heating or cooling devices usually add little to the interior character of a building; but historically, radiators, for instance, may have contributed to the interior character by virtue of their size or shape, or because of their specially designed bases, piping, and decorative grillage or enclosures. Sometimes they were painted with several colors to highlight their integral, cast-in details. In more recent times, it has been common to overpaint and conceal such distinctive aspects of earlier heating and plumbing devices, so that we seldom have the opportunity to realize how important they can be in defining the character of interior rooms and spaces. For that reason, it is important to identify their character-defining potential, and consider their preservation, retention, or restoration. Photo by David W. Look

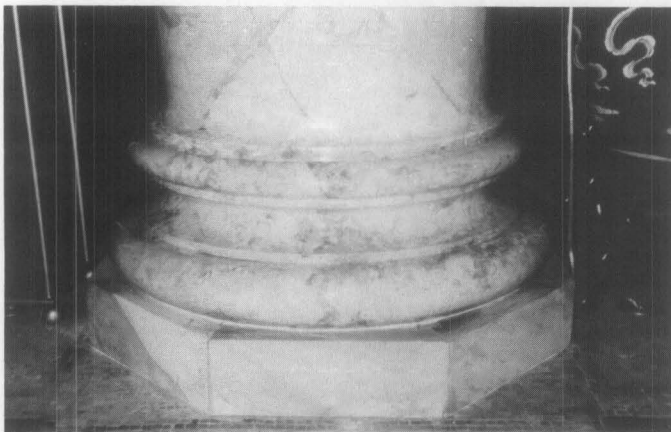
***Interior Visual Character: Surface Materials and Finishes***

When identifying the visual character of historic interior spaces one should not overlook the importance of those materials and finishes that comprise the surfaces of walls, floors and ceilings. The surfaces may have evidence of either hand-craft or machine-made products that are important contributors to the visual character, including patterned or inlaid designs in the wood flooring, decorative painting practices such as stenciling, imitation marble or wood grain, wallpapering, tinwork, tile floors, etc.

The example illustrated here involves a combination of real marble at the base of the column, imitation marble patterns on the plaster surface of the column (a practice called scagliola), and a tile floor surface that uses small mosaic tiles arranged to form geometric designs in several different colors. While such decorative materials and finishes may be important in defining the interior visual character of this particular building, it should be remembered that in much more modest buildings, the plainness of surface materials and finishes may be an essential aspect of their historic character. Photo by Lee H. Nelson

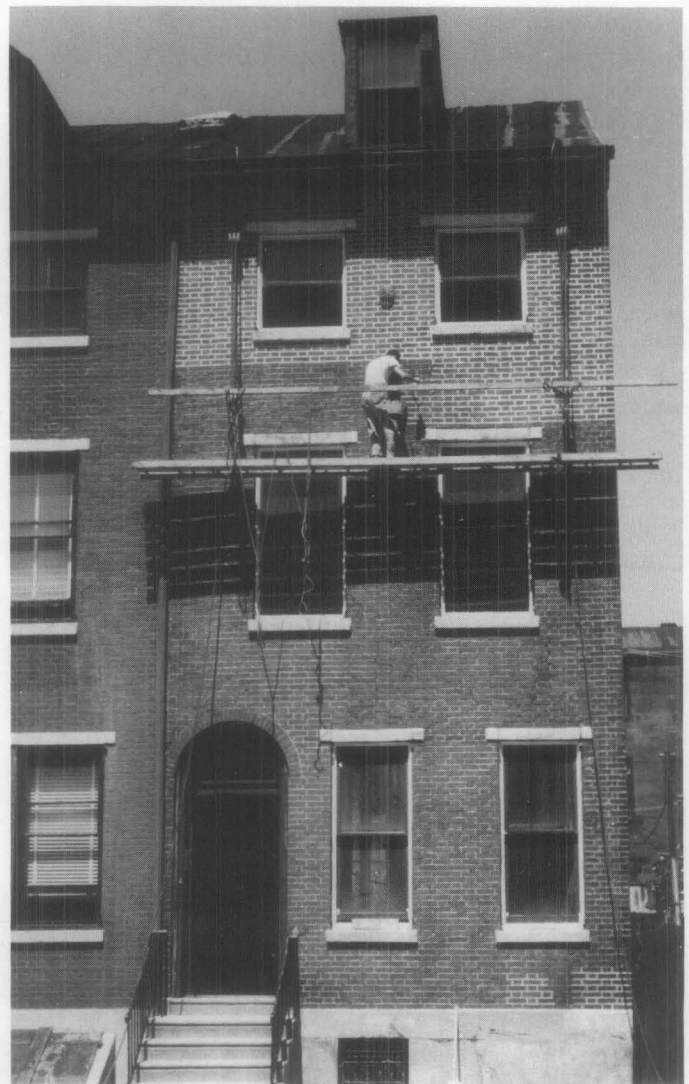
***Fragility of A Building's Visual Character***

Some aspects of a building's visual character are fragile and are easily lost. This is true of brickwork, for example, which can be irreversibly damaged with inappropriate cleaning techniques or by insensitive repointing practices. At least two factors are important contributors to the visual character of brickwork, namely the brick itself and the craftsmanship. Between these, there are many more aspects worth noting, such as color range of bricks, size and shape variations, texture, bonding patterns, together with the many variable qualities of the mortar joints, such as color, width of joint and tooling. These qualities could be easily damaged by painting the brick, by raking out the joint with power tools, or repointing with a joint that is too wide. As seen here during the process of repointing, the visual character of this front wall is being dramatically changed from a wall where the bricks predominate, to a wall that is visually dominated by the mortar joints. Photo by Lee H. Nelson
