# Property Damage Appraisers (PDA Miami, Fort Lauderdale)

Damage Assessed By: Orlando Fontela  
 Classification: Field

Type of Loss: Collision

Description: 2016 Freightliner M2  
 Type/Component: Truck  
 VIN: 1FVACWDUXGHHN3050  
 Mileage: 1  
 OEM/ALT: O  
 Color: RED

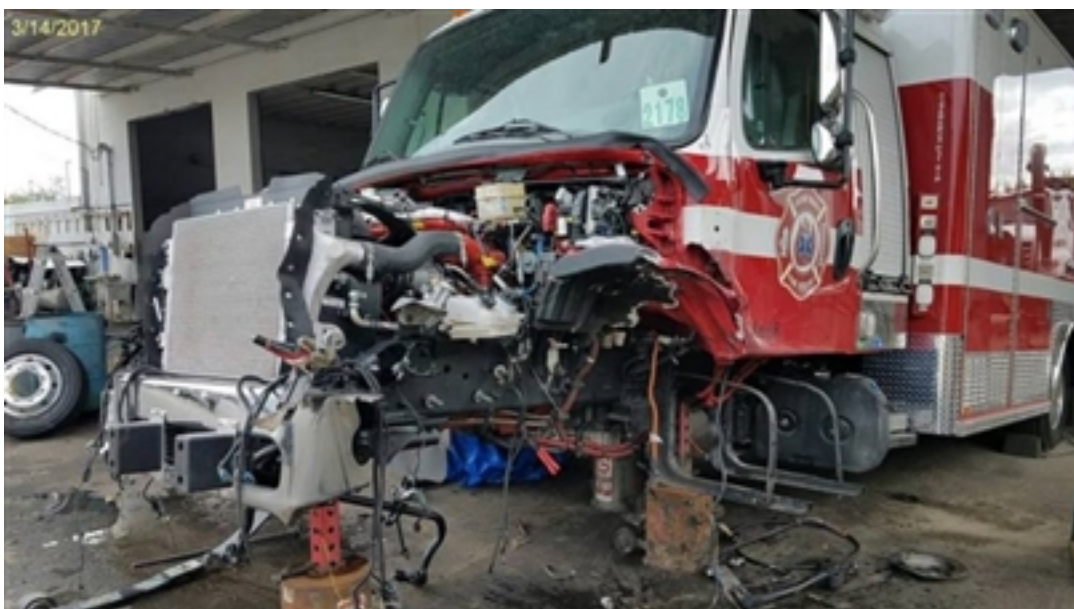
| Recommendations: | <p>I met with Joe at Southeast Truck Specialist and he pointed out the truck and left front collision damage. Major left front corner collision damage with additional secondary damage to left side cab and module. Front axle is currently removed but was set back on impact. Left front wheel and lower door opening contact damage. Extensive left side door opening and cab cowl panel damage. Left side aluminum diamond plate fuel tank, def, and battery cover removed from truck, but shop provided photos of damaged parts. Battery acid stains on brite alum module covers. Several aux components and signal lamps broken (please reference estimate for list). A copy of the repair appraisal has been forwarded to Joe with Southeast Truck Specialist.</p> <p>Parts Quoted by Loubachrodt Freightliner &amp; Horton Parts Dept.</p> | | | | | | | |

Document Name: 17 POI LEFT FRONT CORNER AND SIDE.jpg

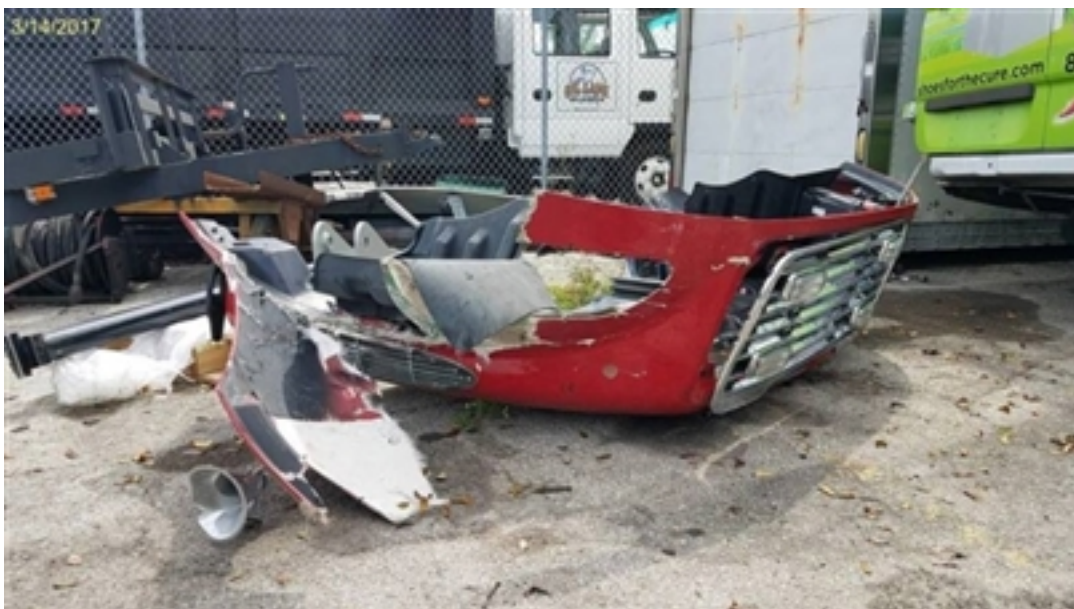
Document Name: 18 HOOD PANEL DAMAGE.jpg

| 25 | 000053 | BDY | REMOVE/REPLACE | Hood Panel | N.A. | | 2,914.36 | * 6.0 |

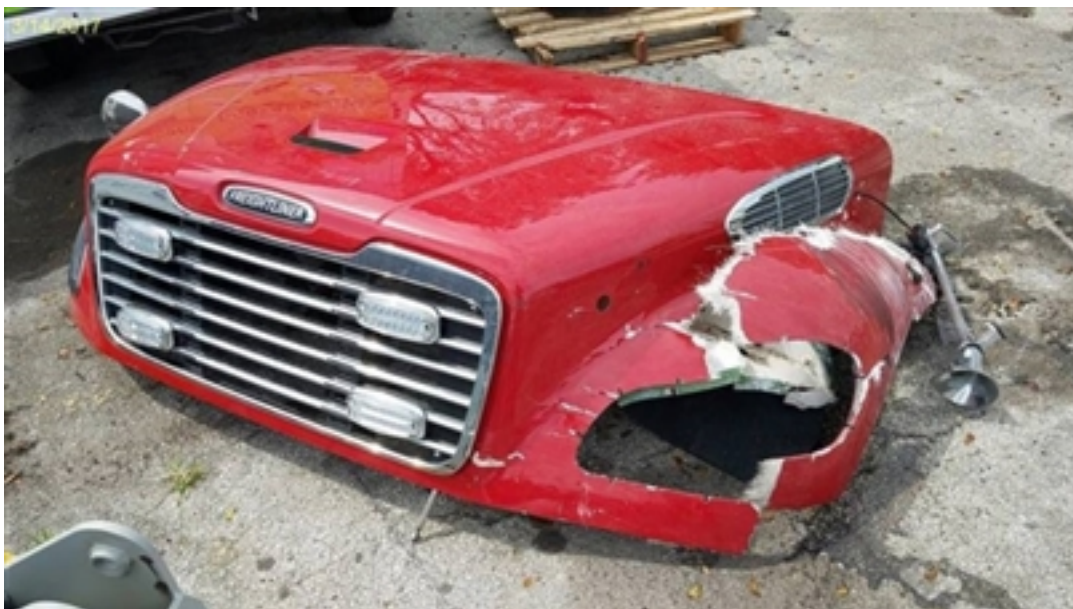
Document Name: 19 LEFT SIDE HOOD PANEL DAMAGE.jpg

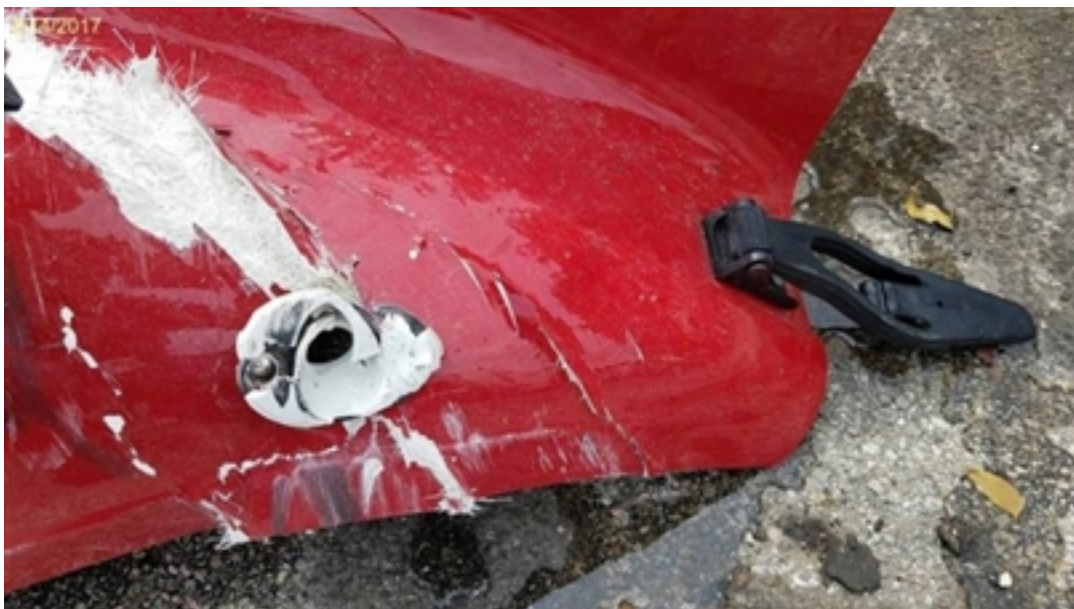
Document Name: 20 LEFT SIDE SIGNAL LAMP AND HOOD LATCH DAMAGE.jpg

| 30 | 000067 | BDY | REMOVE/REPLACE | L Hood Latch | N.A. | | 39.70 | * 0.2 |

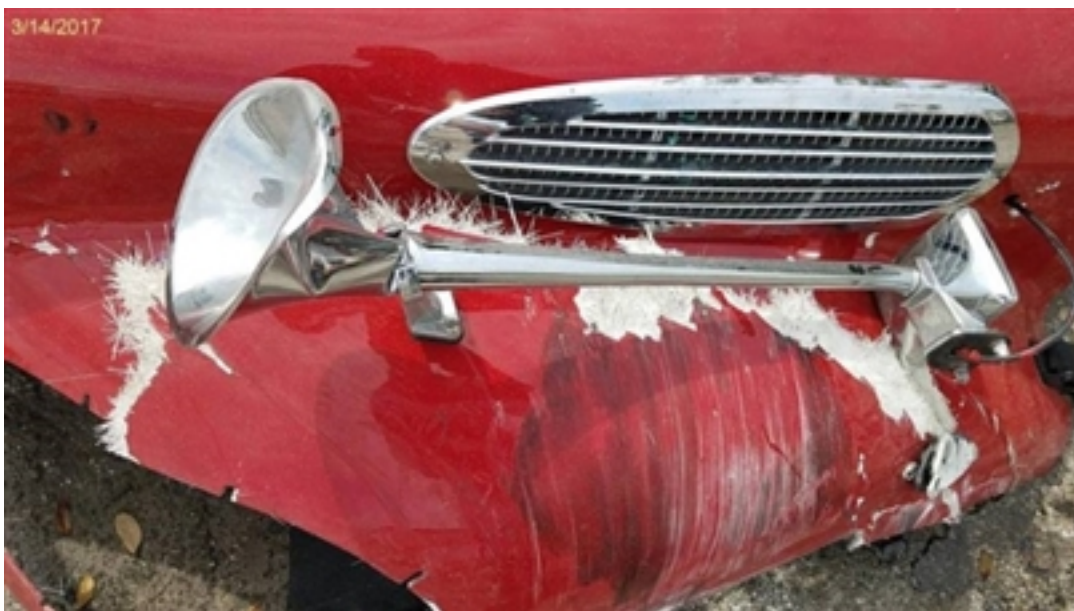
Document Name: 21 LEFT SIDE HOOD GRILLE AND HORN DAMAGE.jpg

| 29 | 000064 | BDY | REMOVE/REPLACE | L Hood Grille | N.A. | | 192.14 | * 0.3 |

| 143 | 900500 | BDY * | REMOVE/REPLACE | Horn, Hood | New | 238.84 | * | 0.5* |

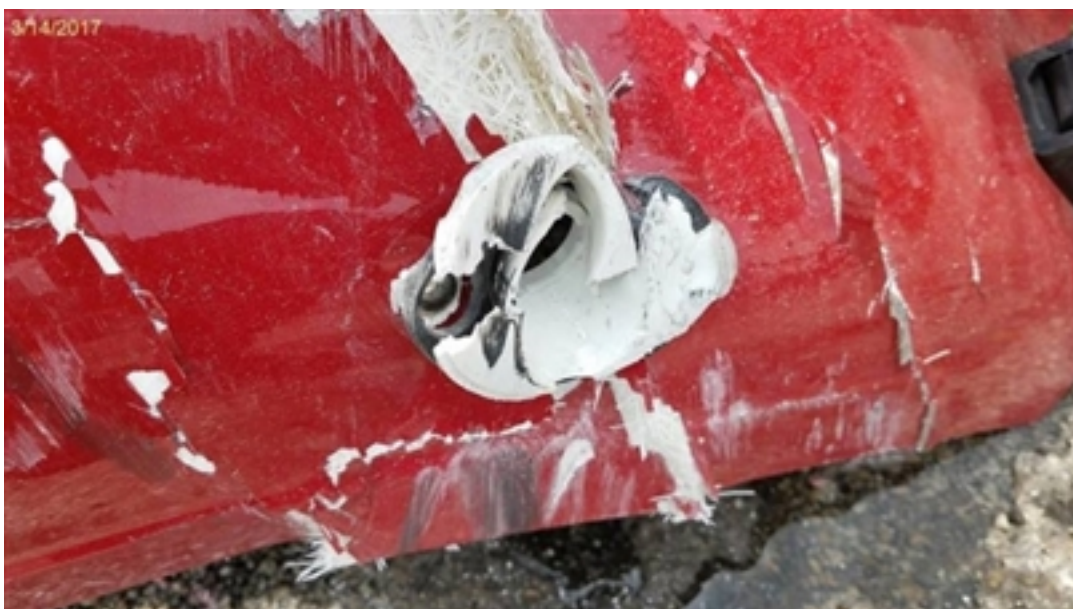
Document Name: 22 SIGNAL LAMP DAMAGE.jpg

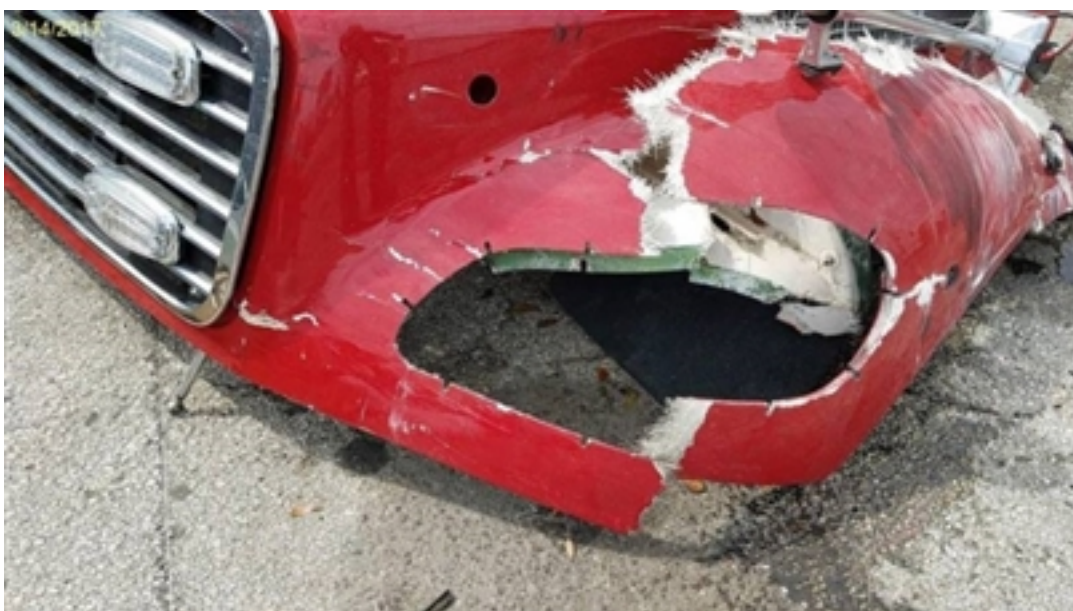
Document Name: 23 LEFT SIDE HEADLAMP BROKEN OFF.jpg

| Line Item | Entry Number | Labor Type | Operation | Line Item Description | Part Type/Part Number | Dollar Amount | Labor Units |
|---|---|---|---|---|---|---|---|
| 19 | 000021 | BDY | REMOVE/REPLACE | L Frt Combination Lamp Assembly | N.A. | 199.05 | * 0.0* |

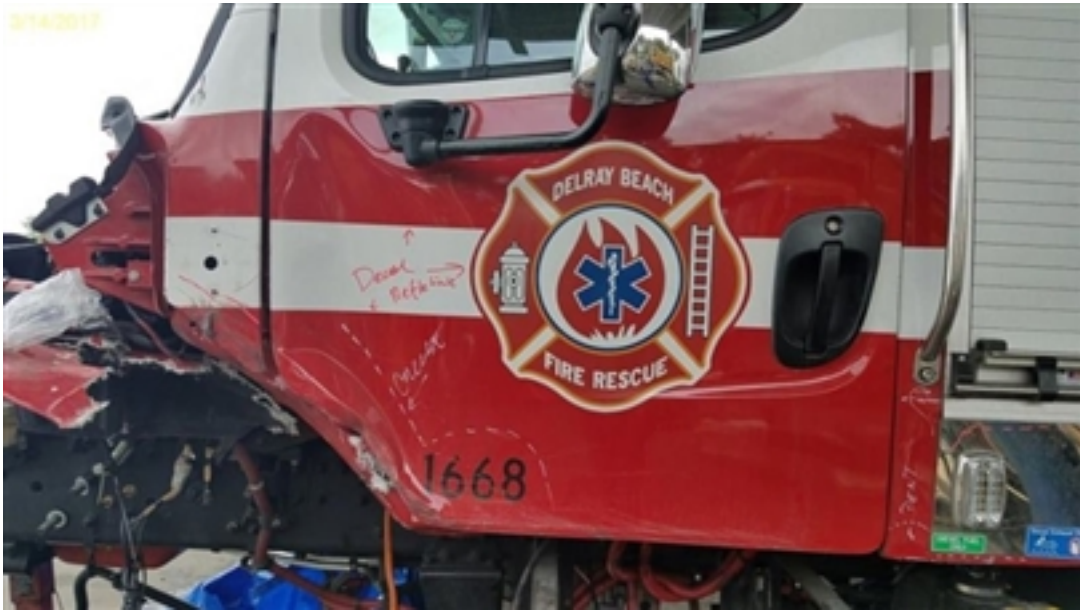
Document Name: 26 LEFT SIDE CAB DAMAGE.jpg

| 98 | 000648 | BDY | REPAIR | L Cab Side Panel | Existing | | | 12.5* |

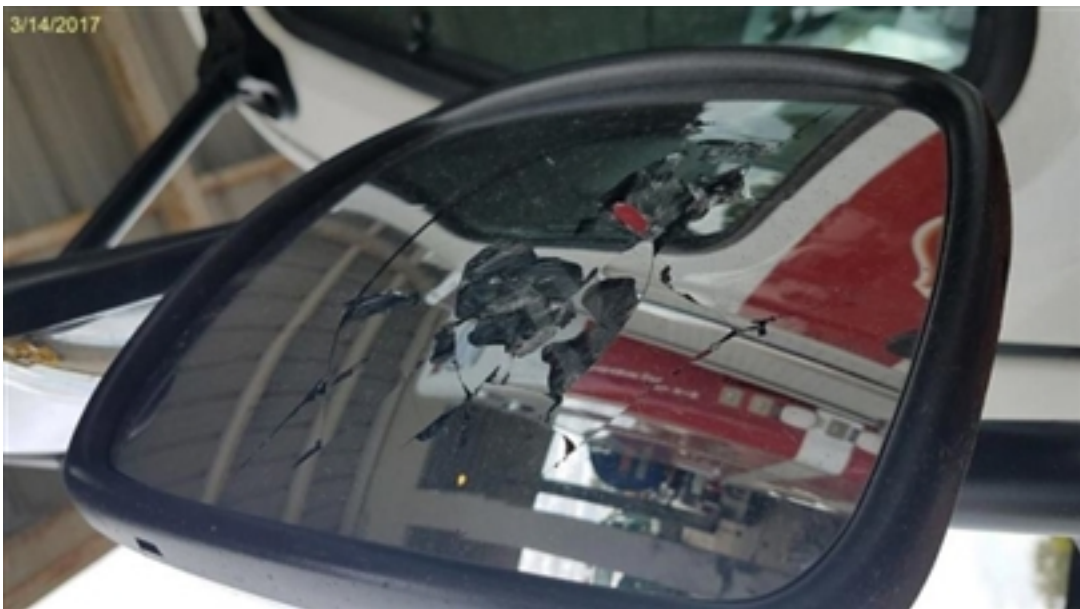
Document Name: 27 LEFT SIDE CONVEX MIRROR CRACKED.jpg

| 111 | 001012 | BDY | REMOVE/REPLACE | L Frt Door Auxiliary Mirror | N.A. | 72.43 | * | 0.1 |

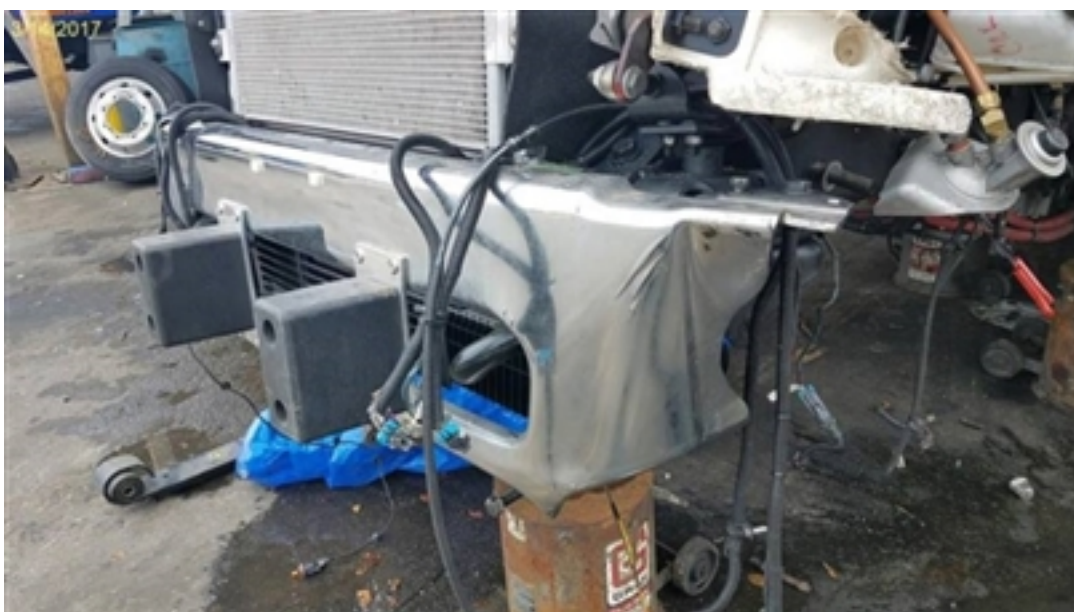
Document Name: 29 LEFT SIDE BUMPER END AND CENTER BUMPER DAMAGE.jpg

| Line Item | Entry Number | Labor Type | Operation | Line Item Description | Part Type/Part Number | Dollar Amount | Labor Units |
|---|---|---|---|---|---|---|---|
| 12 | 000008 | BDY | REMOVE/REPLACE | L Frt Bumper End | N.A. | 580.47 | * 0.0*# |
| 13 | 000009 | BDY | REMOVE/REPLACE | Frt Ctr Bumper | N.A. | 895.72 | * 0.0* |

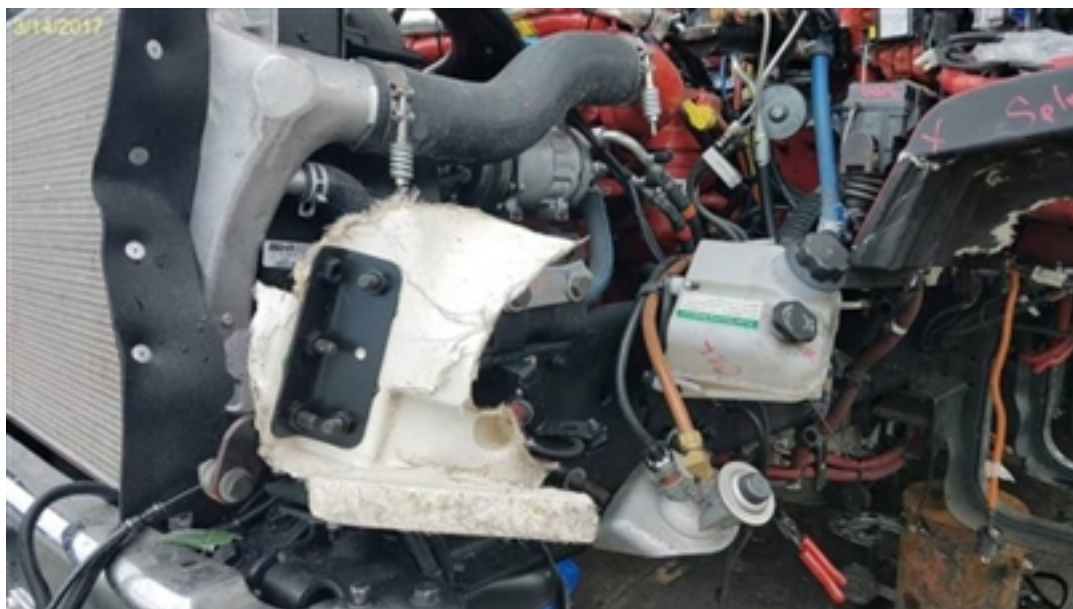
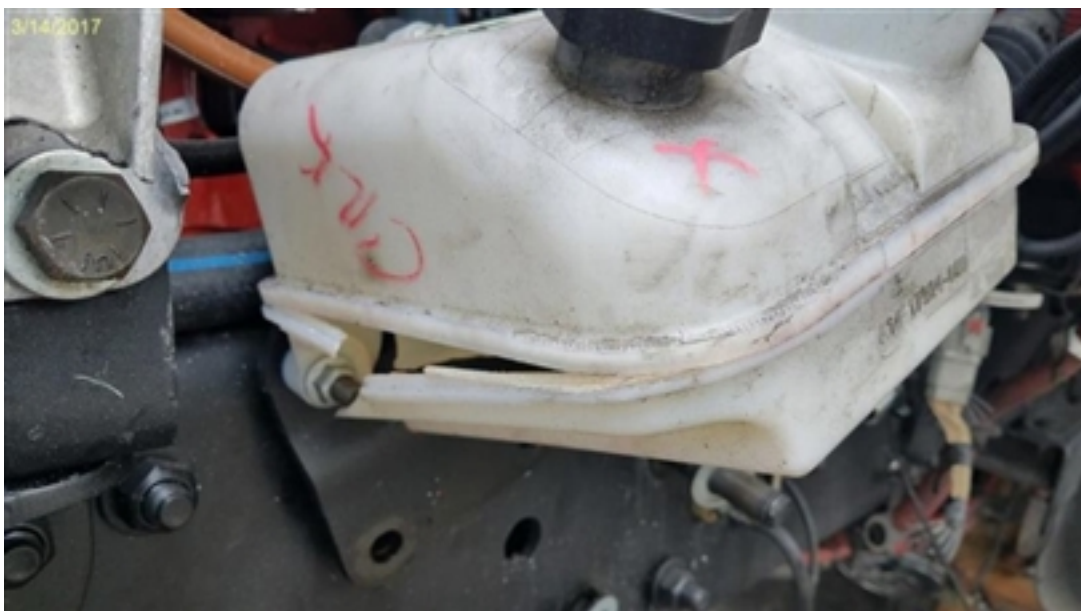
Document Name: 30 STEERING RESERVOIR CRACKED.jpg

Document Name: 32 STEERING RESERVOIR CRACKED.jpg

| 78 | 002357 | MCH | REMOVE/REPLACE | Steering Fluid Reservoir | -M | N.A. | 67.62 | * 0.8 |

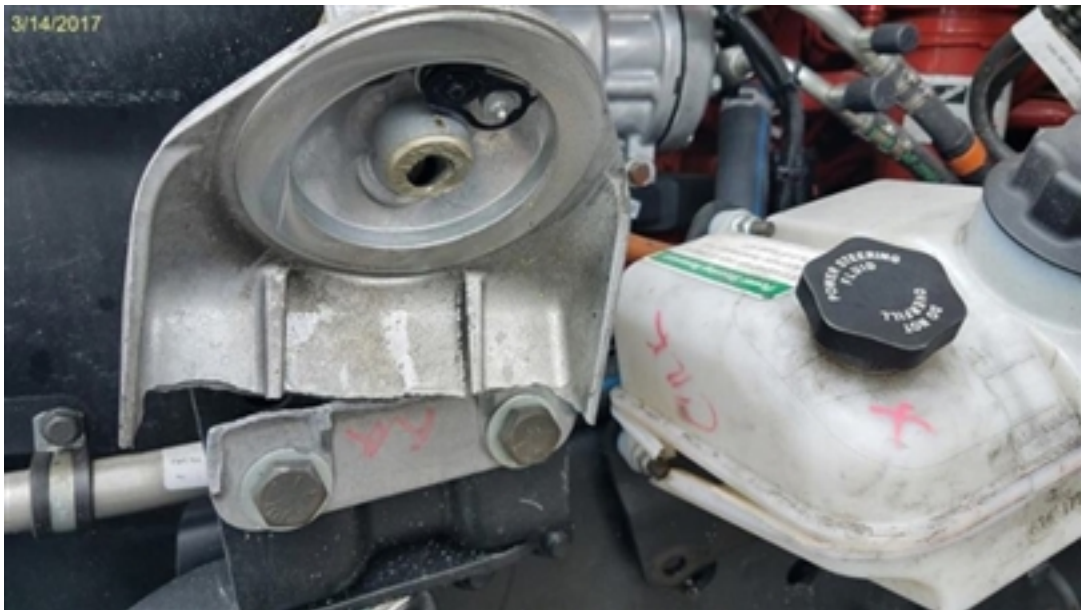
Document Name: 31 FUEL FILTER HEAD CRACKED.jpg

| 80 | 900500 | MCH* | REMOVE/REPLACE | Fuel Filter Head, Assy | | New | 120.84 | * 0.4* |

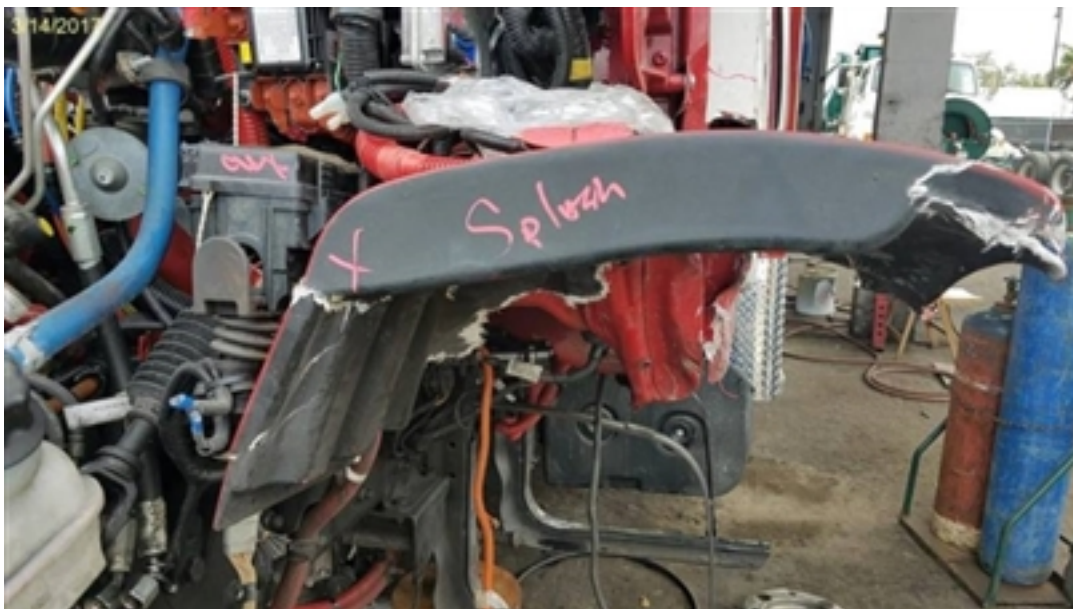
Document Name: 33 SPLASHGUARD FENDER CRACKED.jpg

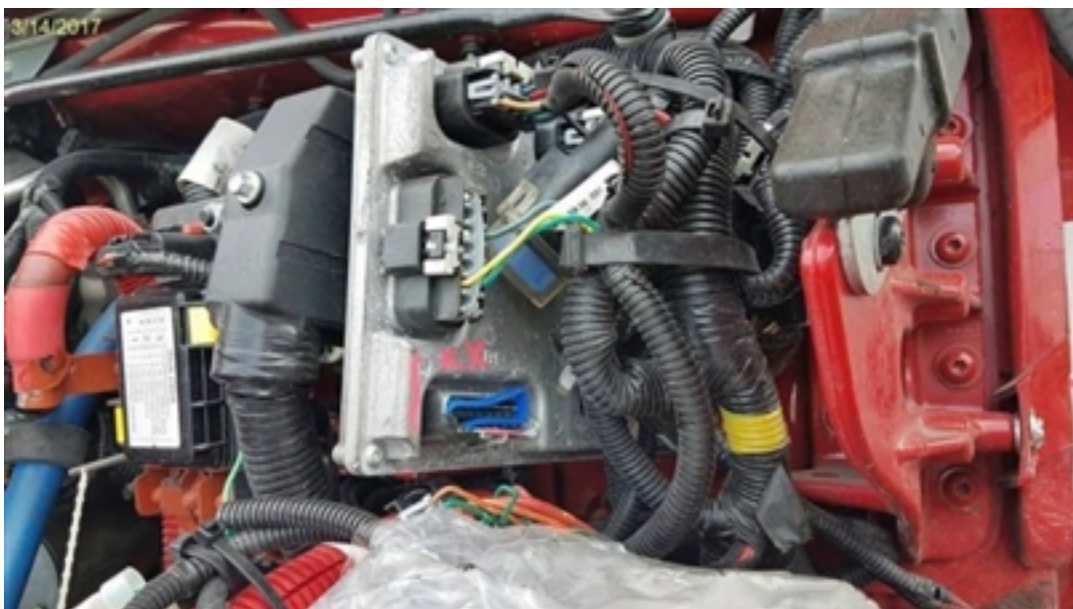
Document Name: 34 CONTROL MODULE DAMAGE.jpg

| 136 | 900500 | MCH* | REMOVE/REPLACE | Control Module | New | 627.04 | * | 2.8* |

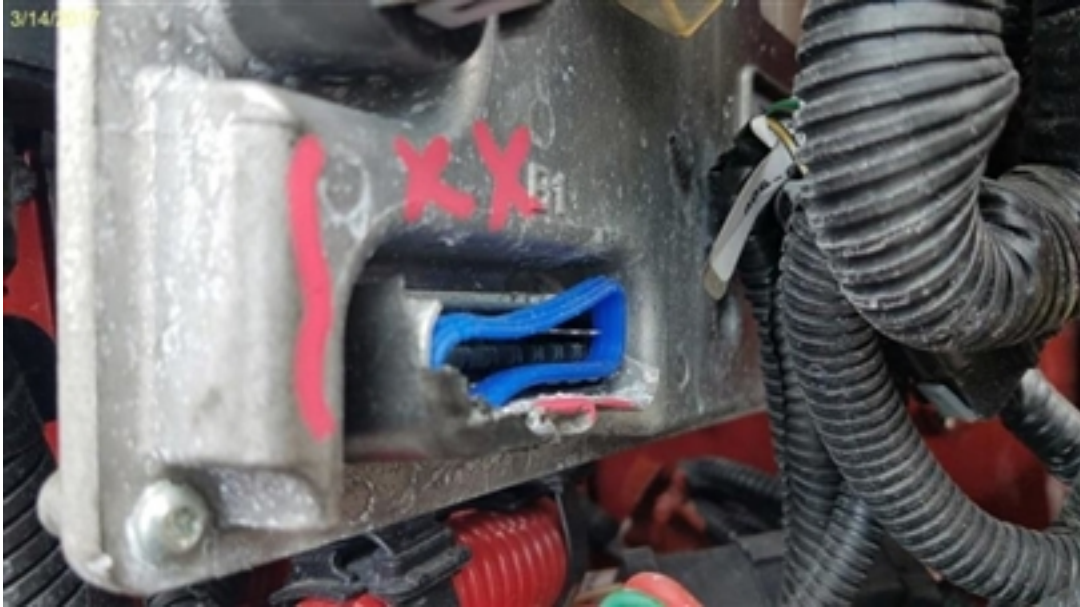
Document Name: 35 CONTROL MUDULE RECP DAMAGE.jpg

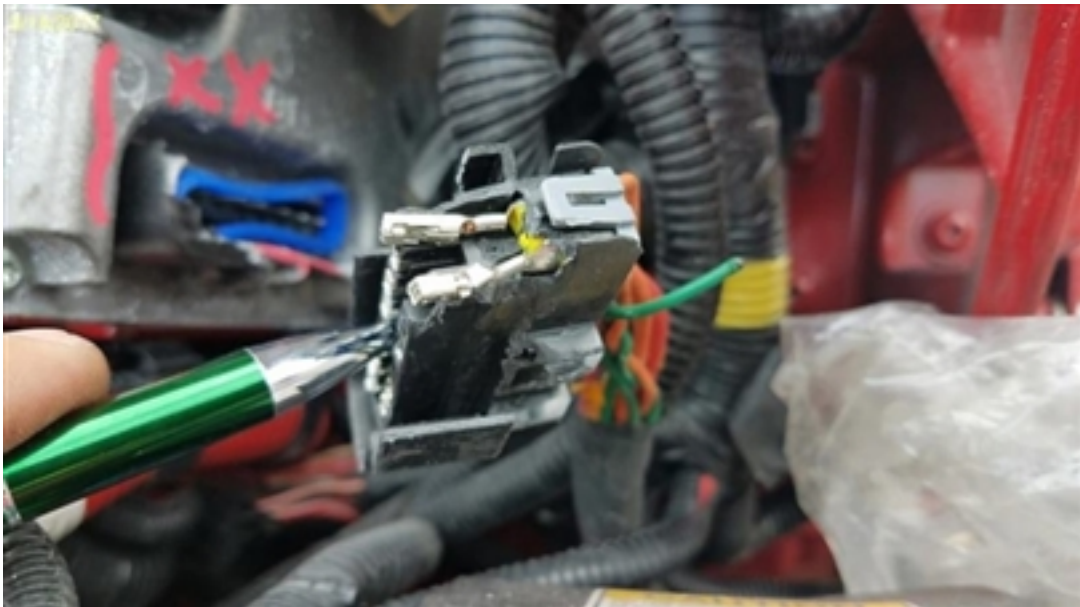
Document Name: 36 CONTROL MODULE HARNESS DAMAGE CRUSHED.jpg

| 137 | 900500 | MCH* | REMOVE/REPLACE | Wiring Harness | New | 335.09 | * | 5.5* |

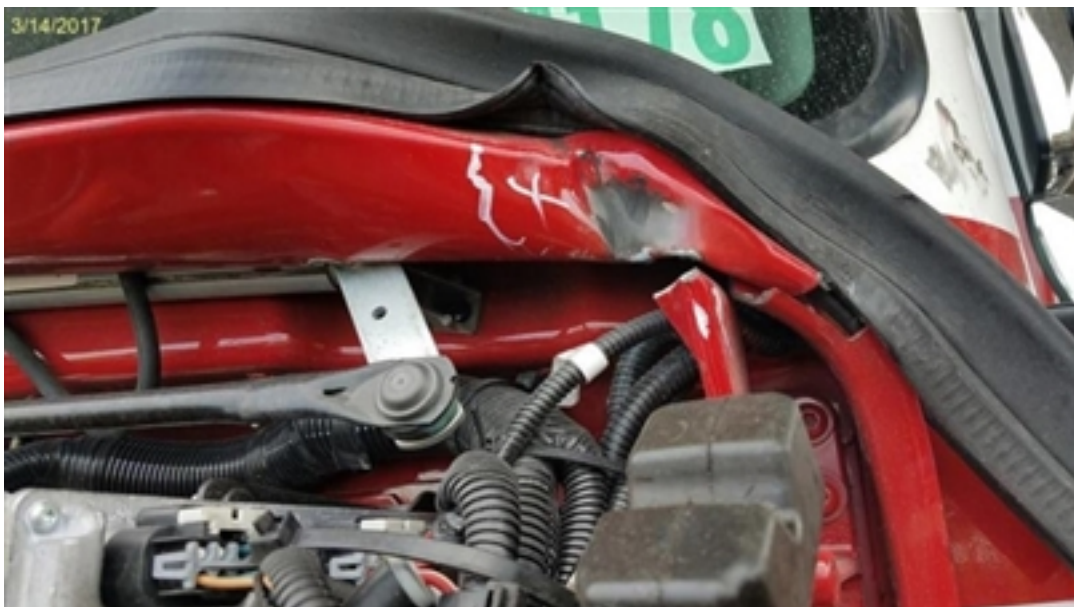
Document Name: 37 WINDSHIELD COWL PANEL AND WS REINF DAMAGE.jpg

| 90 | 000626 | BDY | REMOVE/REPLACE | Cab Cowl Top Panel (HSS) | N.A. | 523.59 | * | 3.0* |

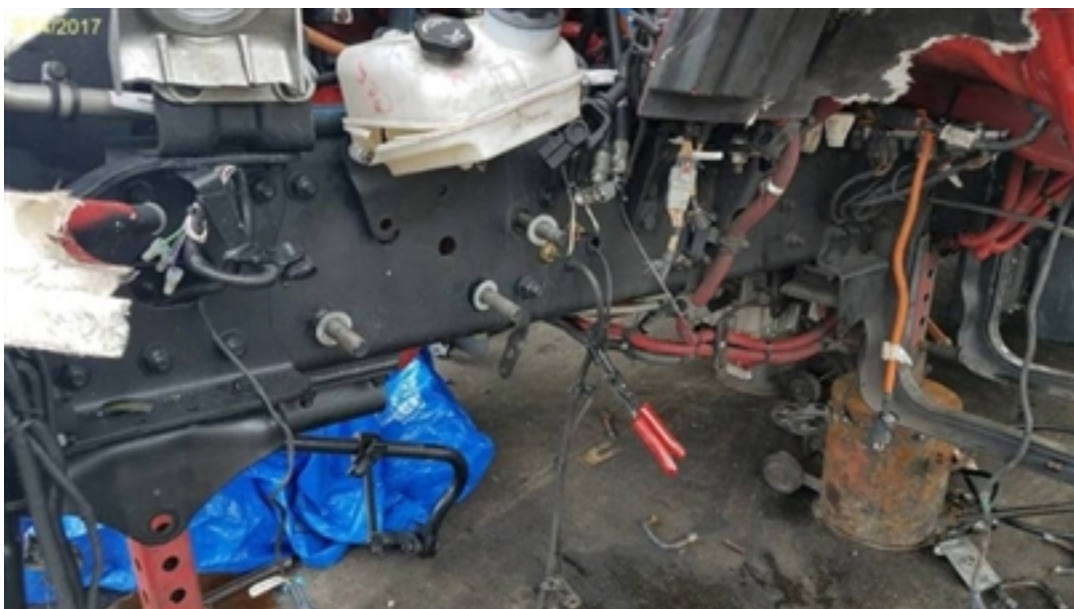
Document Name: 38 LEFT SIDE FRAME RAIL.jpg

| 39 | 000181 | FRM | REPAIR | L Frame Rail | -F | Existing | | 2.5*# |

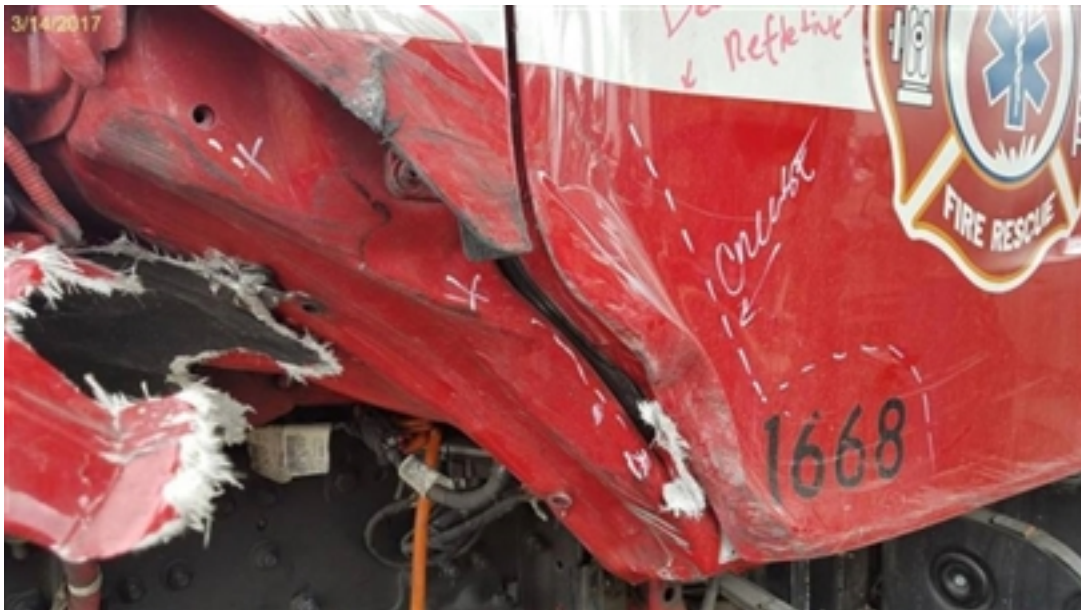
Document Name: 41 LOWER DOOR FRAME OPENING AND FLOOR DAMAGE.jpg

| 95 | 000634 | BDY | REMOVE/REPLACE | L Cab Door Opening Frame | N.A. | 1,002.85 | * | 8.9 |
| 101 | 000737 | BDY | REPAIR | Cab Floor Pan | Existing | | | 8.0*# |

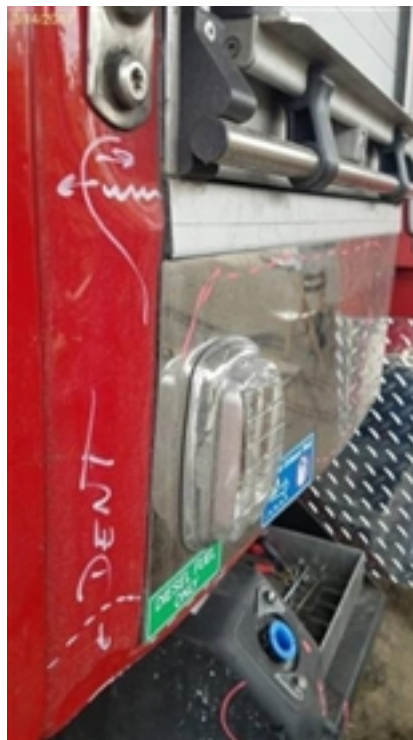
Document Name: 42 LEFT SIDE REAR CAB PANEL SS COVER DAMAGE.jpg

| 149 | 900500 | BDY * | REMOVE/REPLACE | SS Panel, L | New | 148.00 | * | 2.0* |

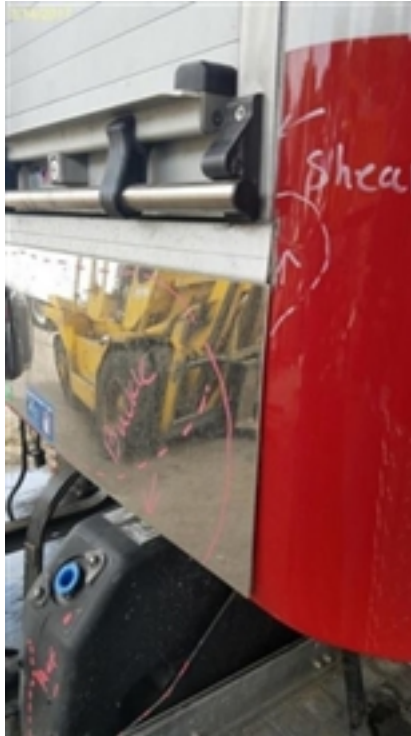
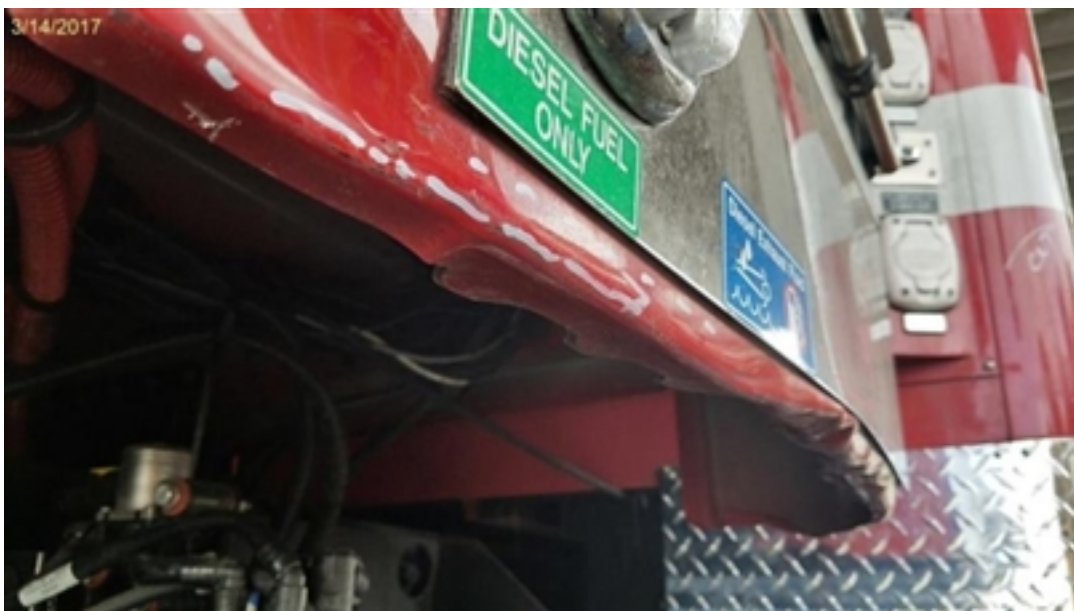
Document Name: 43 LEFT SIDE REAR CAB PANEL DAMAGE.jpg

Document Name: 46 LEFT SIDE REAR CAB PANEL DAMAGE.jpg

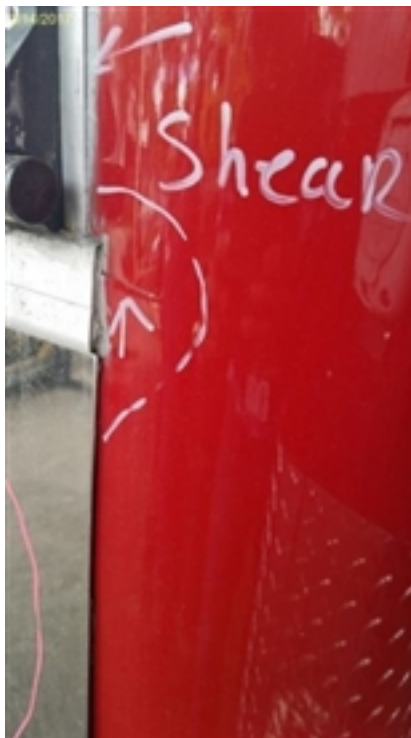
Document Name: 44 LEFT SIDE REAR CAB PANEL POST DAMAGE BY ROLL UP DOOR.jpg

| 125 | 900500 | BDY * | REPAIR | Corner Post, L Frt | Existing | | | 3.0* |

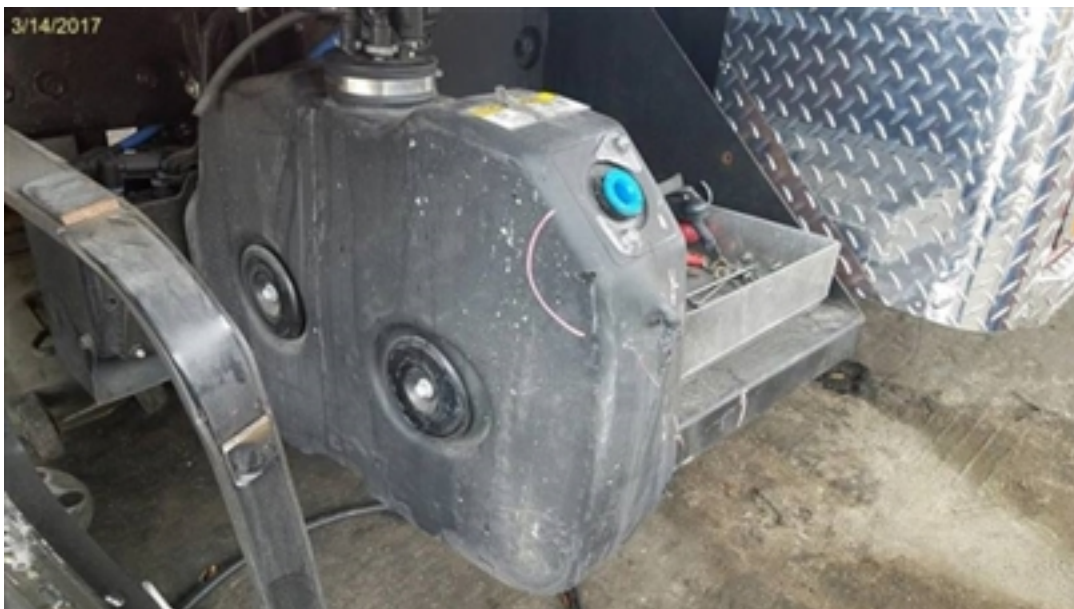
Document Name: 45 DEF TANK DAMAGE.jpg

| 51 | 900500 | MCH* | REMOVE/REPLACE | Tank Assy, DEF | | New | 752.44 | * 2.0* |

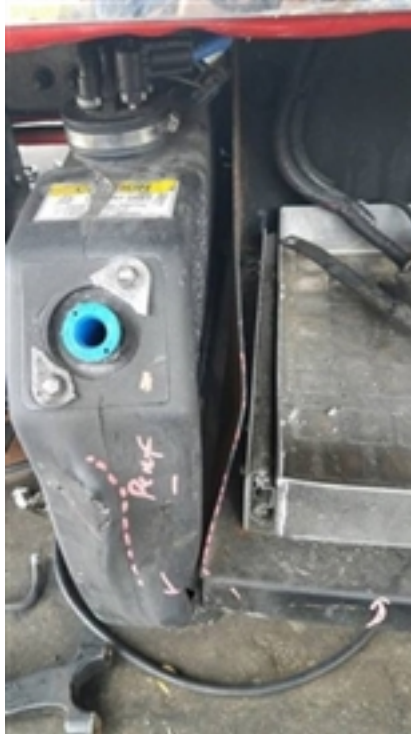
Document Name: 47 DEF TANK CAP MISSING.jpg

| 53 | 900500 | MCH* | REMOVE/REPLACE | Tank, Cap | | New | 42.86 | * 0.0* |

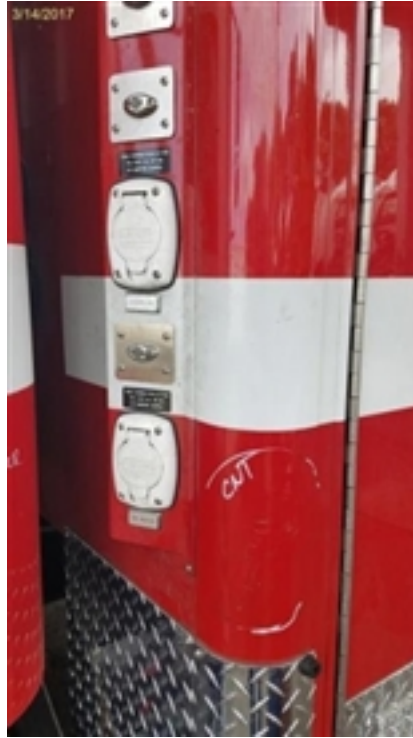
Document Name: 49 LEFT SIDE MODULE CORNER POST CONTACT DAMAGE.jpg

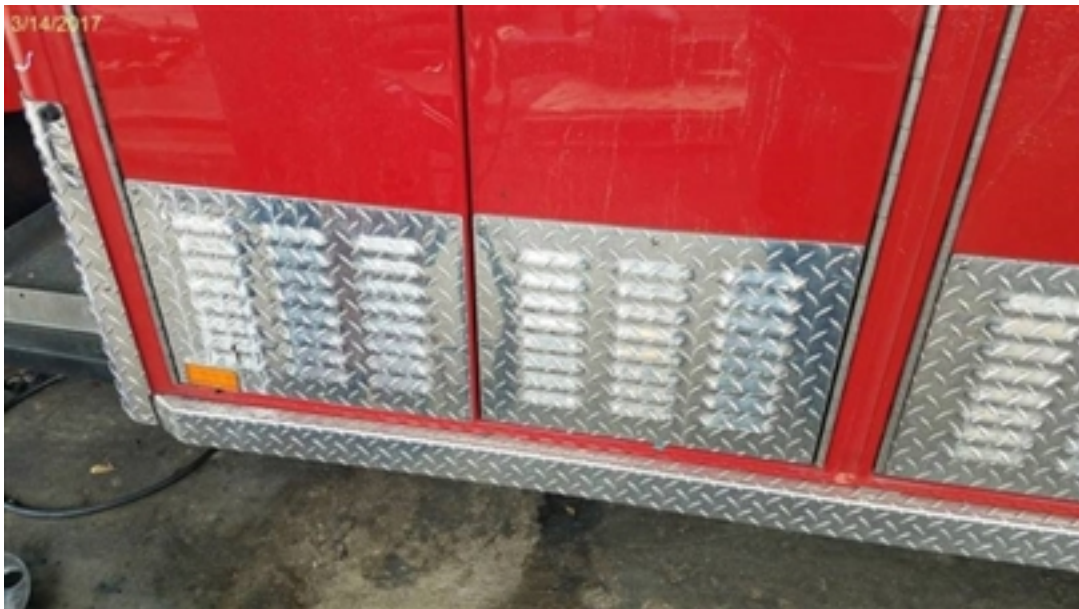
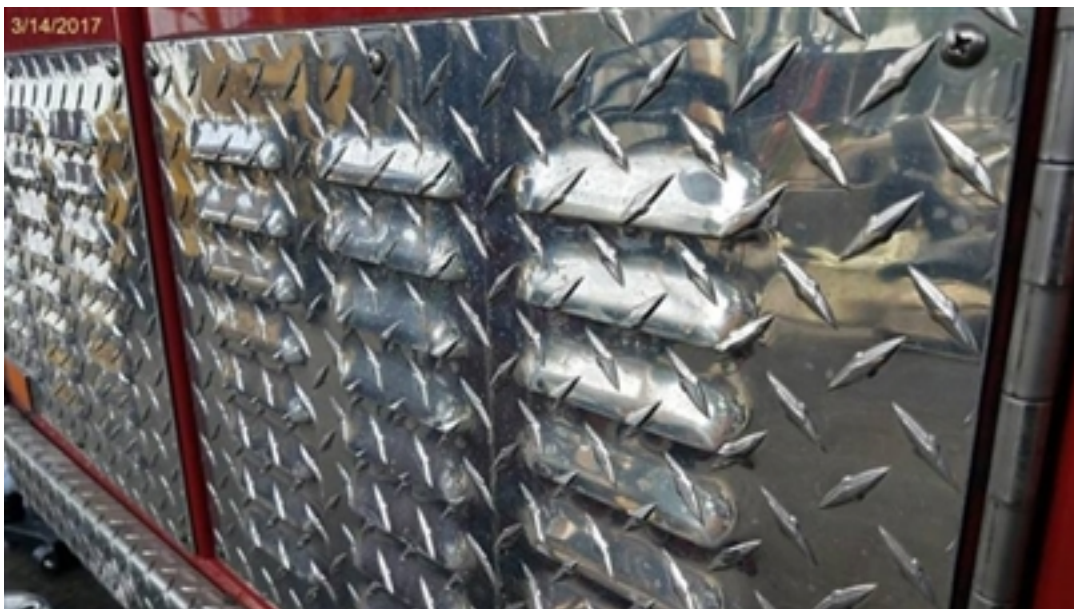
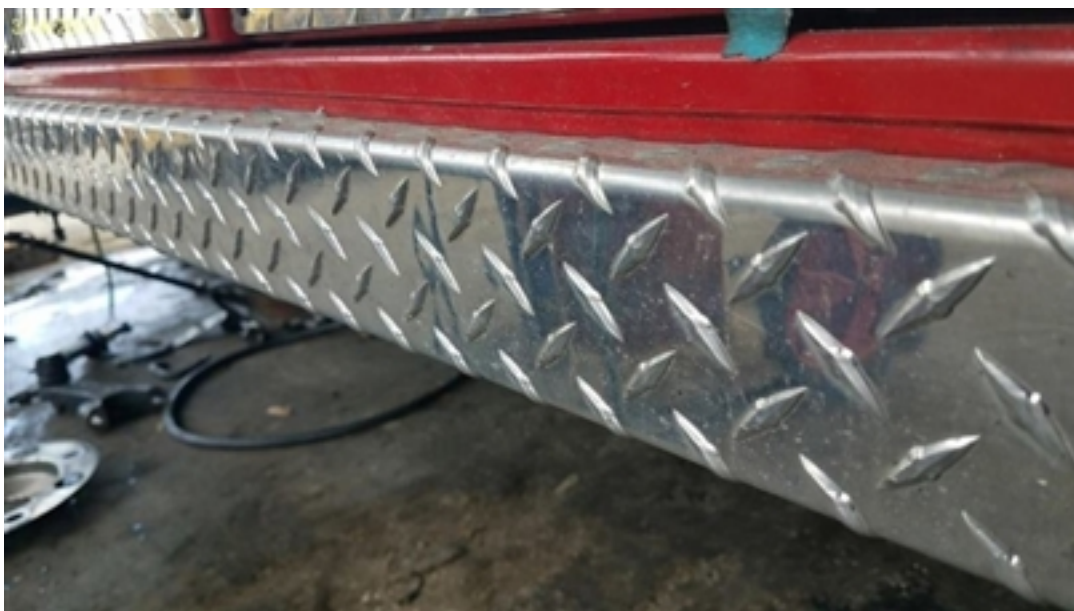
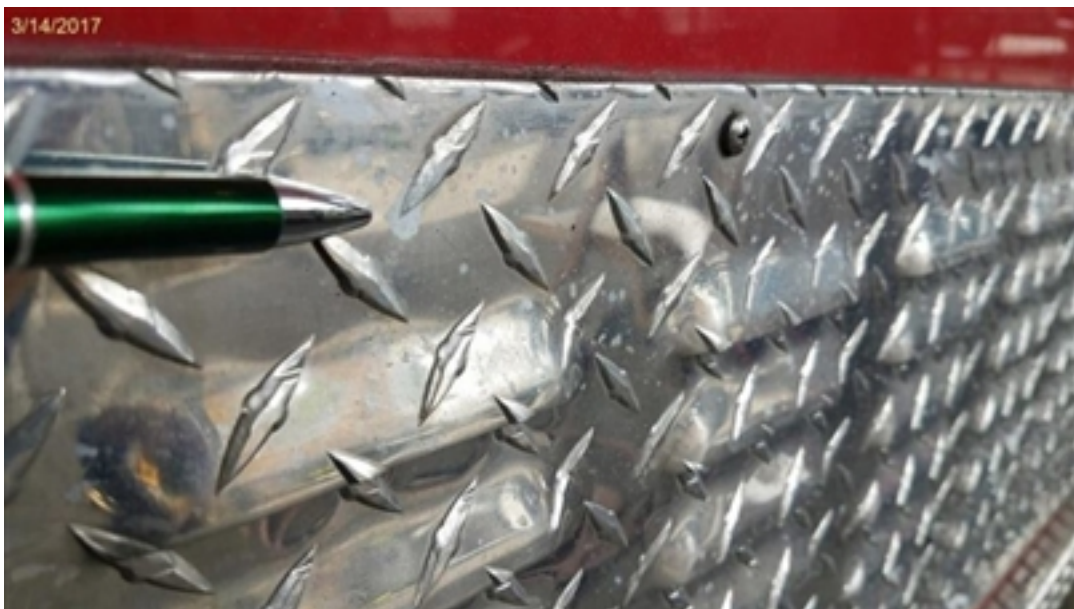
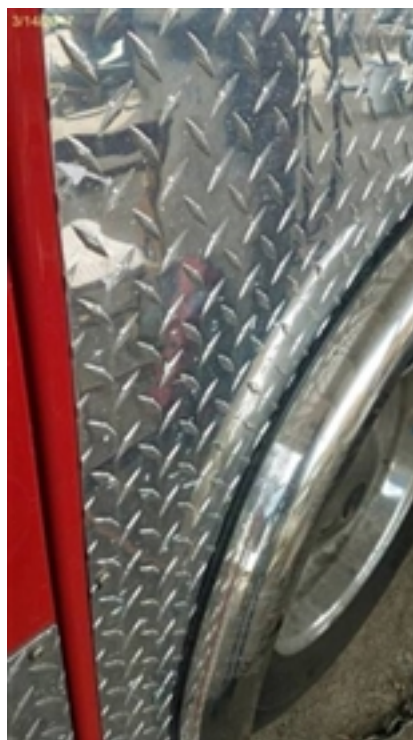
Document Name: 51 LEFT SIDE VENTED ALUM PANEL ACID STAINED.jpg

Document Name: 52 ALUMINUM PANELS STAINED WITH BATTERY ACID.jpg

Document Name: 53 RUBRAIL L STAINED WITH BATTERY ACID.jpg

Document Name: 54 BATTERY ACID STAINS.jpg

Document Name: 55 WHEELHOUSE ALUM PANEL BATTERY ACID STAINS.jpg

| Line Item | Entry Number | Labor Type | Operation | Line Item Description | Part Type/Part Number | Dollar Amount | Labor Units |
|---|---|---|---|---|---|---|---|
| 7 | 900500 | BDY * | REMOVE/REPLACE | Wheelhouse Panel, Alum L | New | 268.50 | * 4.0* |

| 128 | 900500 | BDY * | REMOVE/REPLACE | Rubrail, L | New | 297.50 | * | 3.0* |
| 147 | 900500 | BDY * | REMOVE/REPLACE | Louvered Panel, Alum L 2@269.40 | New | 538.80 | * | 4.0* |

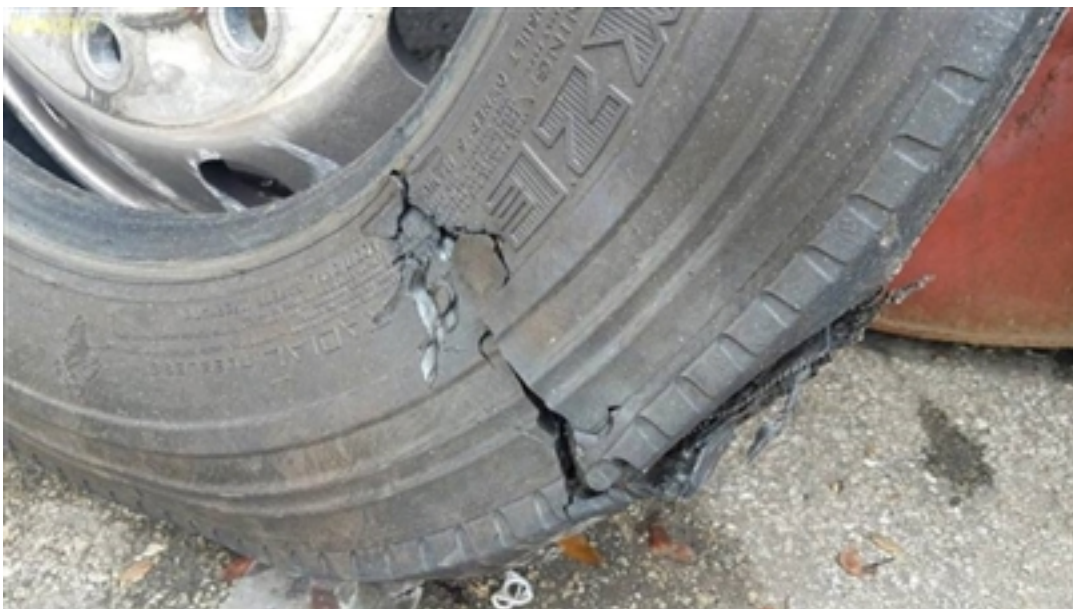
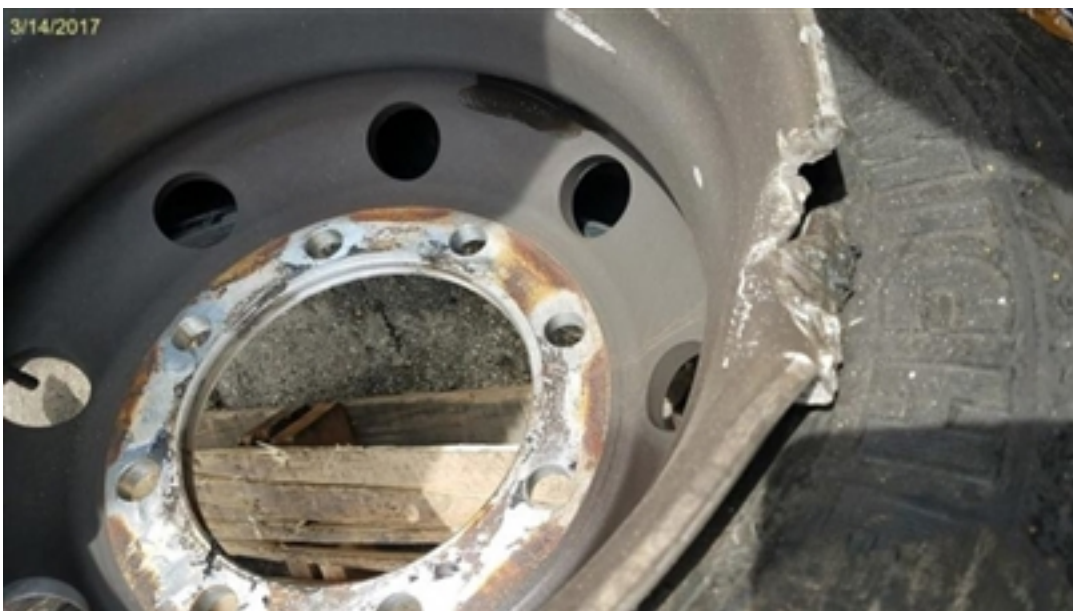
Document Name: 56 LEFT SIDE WHEEL AND TIRE DAMAGE.jpg

Document Name: 57 LEFT SIDE WHEEL DAMAGE.jpg

| Line Item | Entry Number | Labor Type | Operation | Line Item Description | Part Type/Part Number | Dollar Amount | Labor Units |
|---|---|---|---|---|---|---|---|
| 1 | 931117 | BDY | REMOVE/REPLACE | Left Front Tire | New | 454.98 | * 0.4* |

| 55 | 001814 | BDY | REMOVE/REPLACE | Alloy Wheel | | N.A. | 520.94 | * 0.0*# |

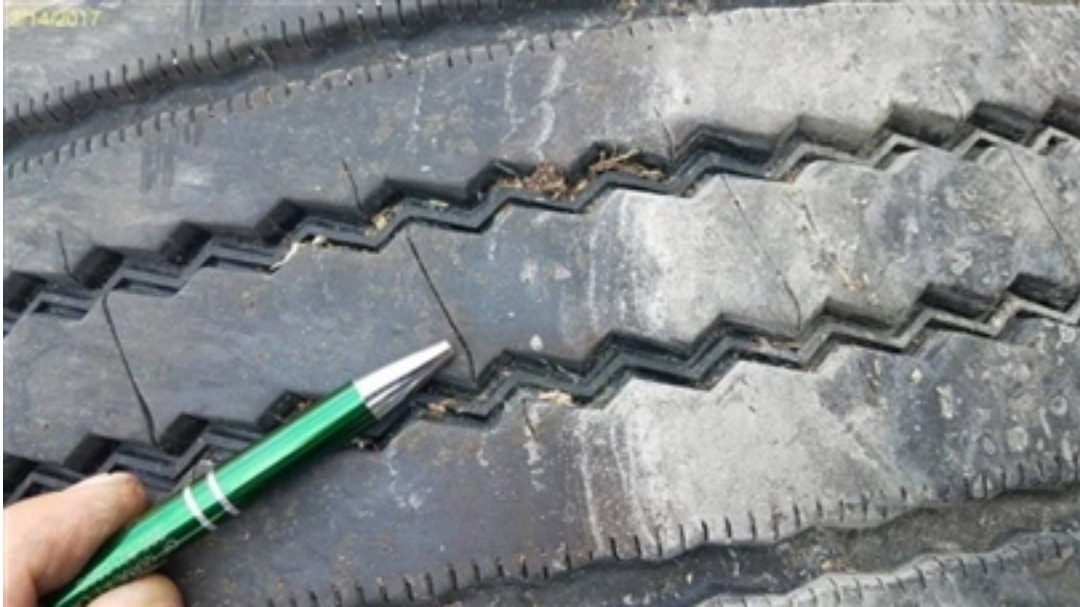
Document Name: 58 RIGHT SIDE TIRE SLICED.jpg

| Line Item | Entry Number | Labor Type | Operation | Line Item Description | Part Type/Part Number | Dollar Amount | Labor Units |
|---|---|---|---|---|---|---|---|
| 3 | 931118 | BDY | REMOVE/REPLACE | Right Front Tire | New | 454.98 | * 0.4* |

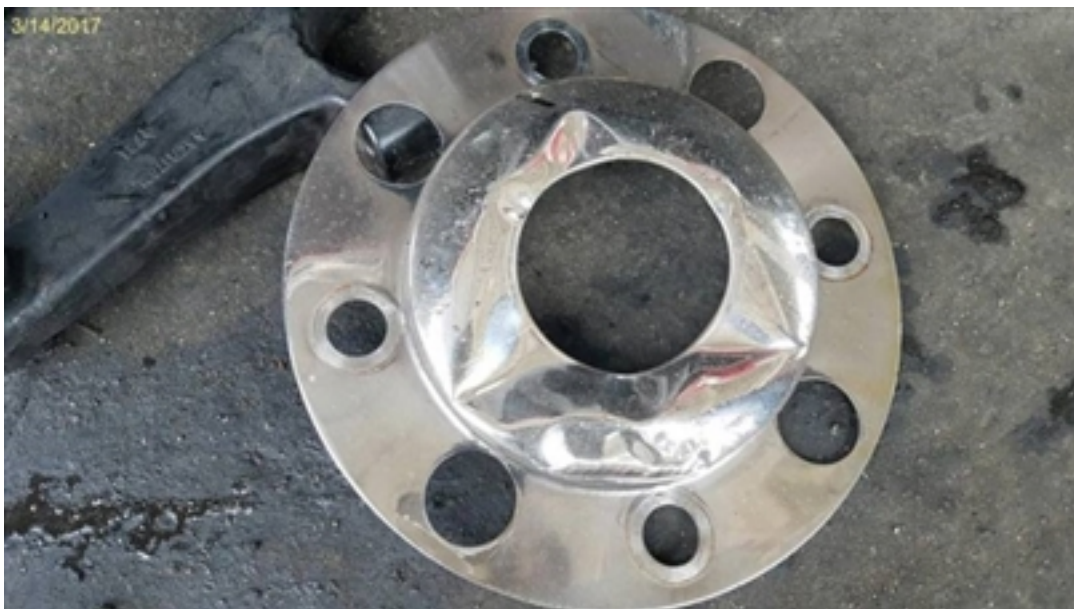
Document Name: 61 HUB COVER DAMAGE.jpg

| 121 | 900500 | BDY * | REMOVE/REPLACE | Hub Cover, L | New | 113.61 | * | 0.2* |
